**Surface Characterization of Metal-Metal Hip
Implants Tested in a Hip Simulator**

Adi Wang

**Metallurgical Engineering Department
McGill University, Montreal**

**A thesis submitted to the Faculty of Graduate Studies and Research in partial
fulfillment of the requirements of the degree of Masters of Engineering**

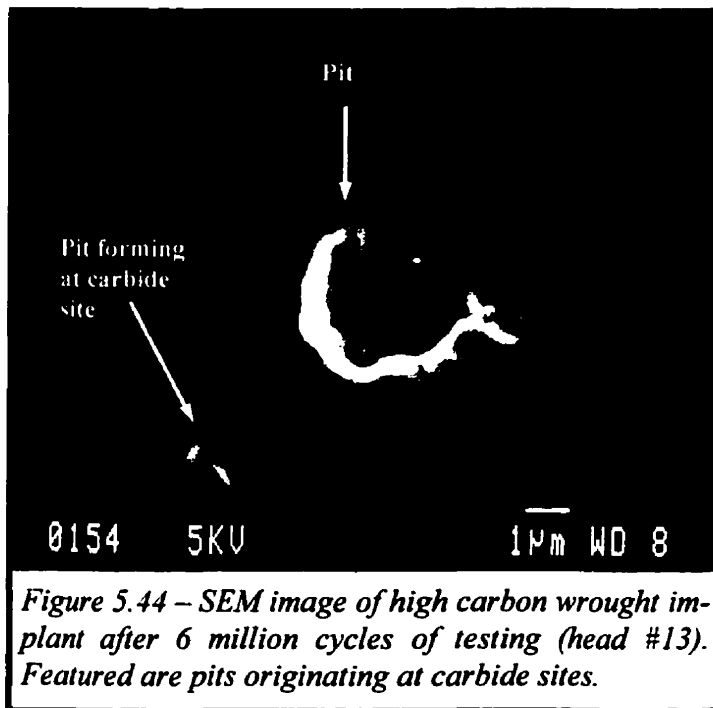
Figure 5.44 – SEM image of high carbon wrought implant after 6 million cycles of testing (head #13). Featured are pits originating at carbide sites.

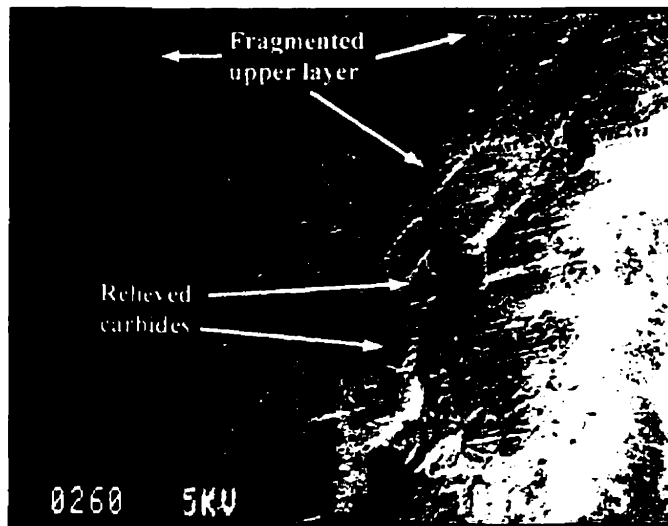
Figure 5.46 – SEM image of cast implant tested to 6 million cycles (head #12). Featured is a fragmented upper layer resting on a non-fragmented lower layer. Carbides in the upper layer were relieved below matrix surface.

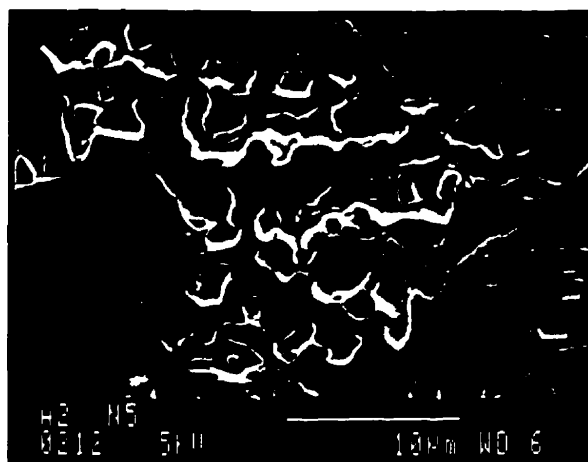
Figure 5.57 – SEM image of head #2 after 2 million cycles of testing. Featured is the same relieved carbide chain as in Figs. 5.55 & 5.56. Pits present at 1 million cycles were not present at 2 million cycles

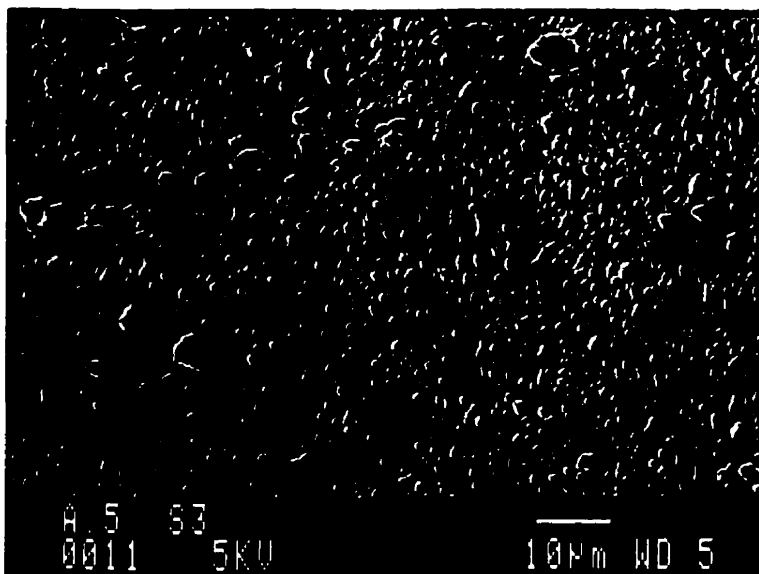
Figure 5.59 – SEM image of high carbon wrought implant after 0.45 million cycles of testing (head #4). Featured are varying size pits that were evenly distributed on surface.
