AN EROSION CONTROL PLAN FOR PART OF
THE GREEN'S CREEK RAVINE

BY
ROBERT BOYD BONNELL

REPORT SUBMITTED IN PARTIAL FULLFILLMENT
FOR COURSE 336-490D

APRIL, 1983.

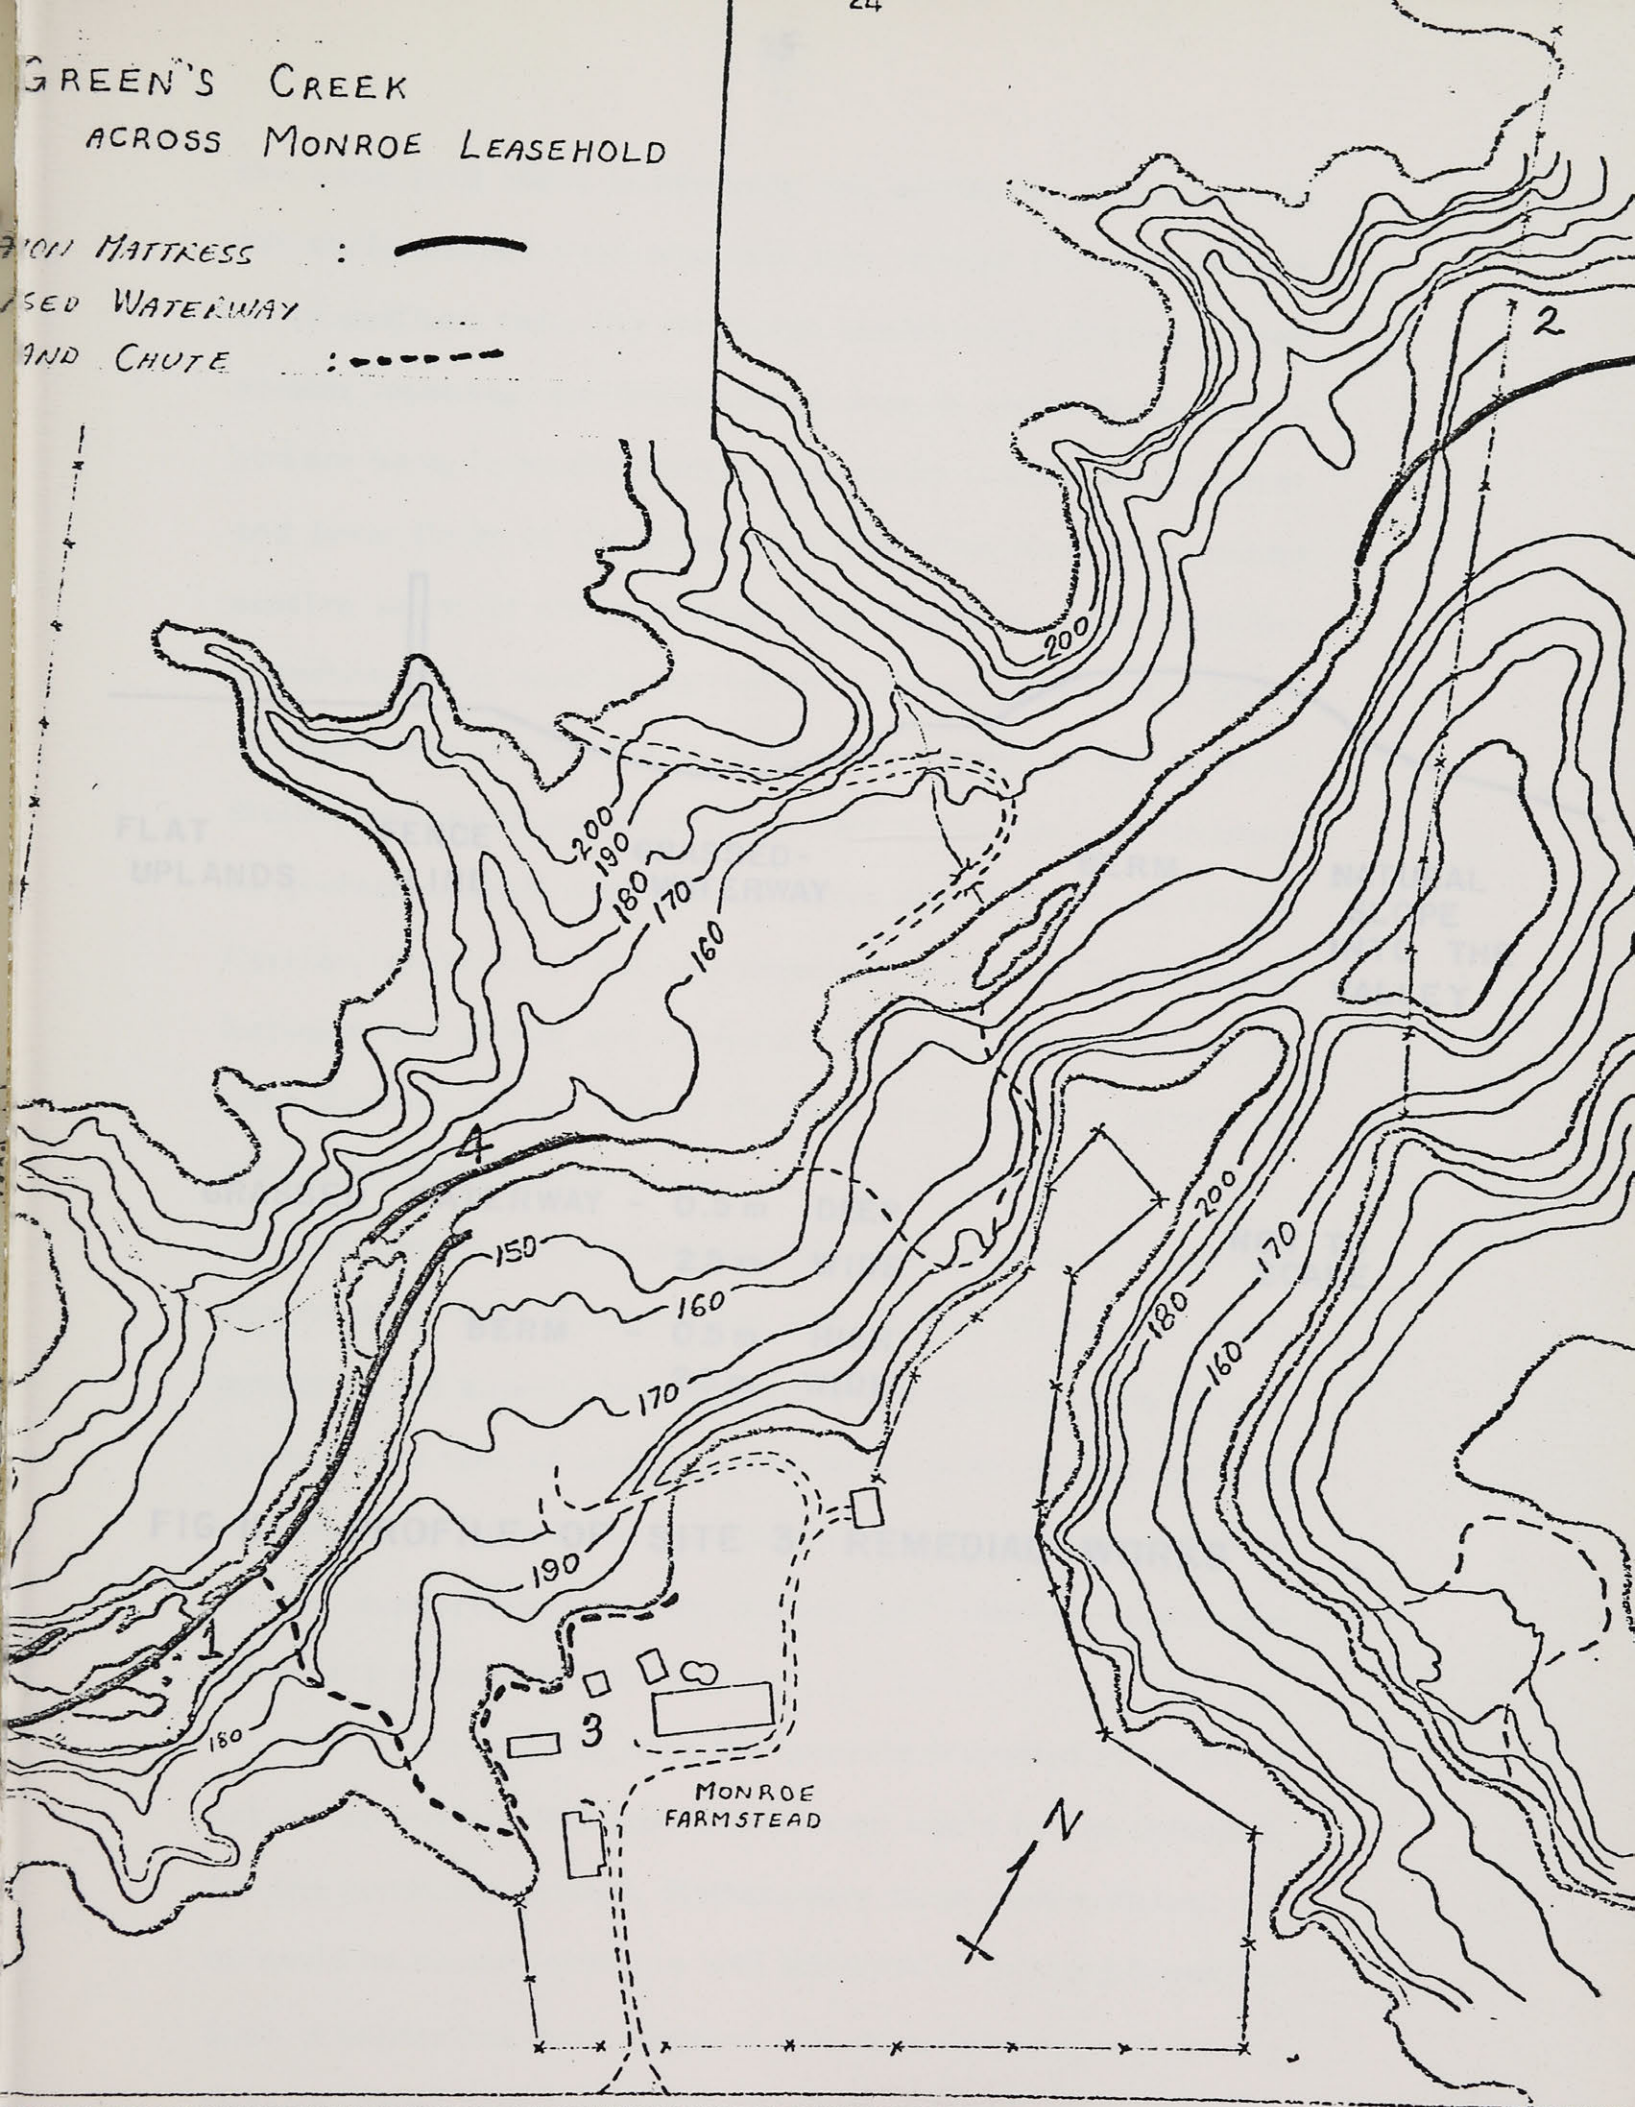
FIG 7 LOCATIONS OF WORK SITES

Site three (see fig. 7) is a case in point of adjacent overland runoff causing erosion of the valley slopes. To the south and south-east of the Monroe farmstead is a field measuring seven hectares. Runoff from Innes Road and these fields combine and flow through the Monroe cattle corrals (picking up pollutants from the manure) and down the valley slopes at site three. A berm measuring 0.5 metres high by 2.0 metre wide should be constructed along the top edge of the slope and a grassed waterway maintained parallel to this berm (see fig. 11). A small ditch may be required to divert the overland flow around the corral. The cattle should not be allowed access to this waterway and berm area. The grassed waterway can carry the water to a chute constructed in the ravin to the west of the farmstead. This chute could then carry the water in a non-erosive manner down to the stream proper. The chute can be constructed of inverted half culverts imbedded and anchored into the slope with stakes. An alternative would be to use a gabion mattress of 150mm thickness anchored in the same manner. The latter would be more expensive but more aesthetically pleasing in that, with time, vegetal cover would obscure them from view.

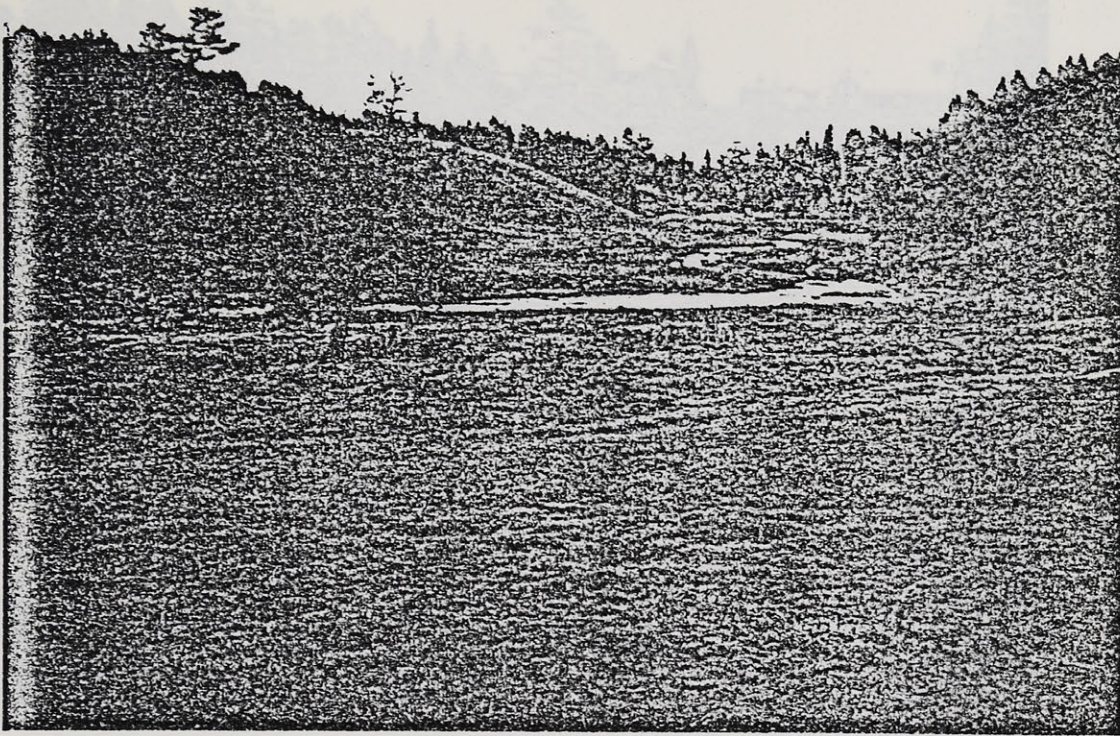
Photo 1. Green's Creek at low flow exhibiting its meandering behavior which results in toe erosion of the slopes.

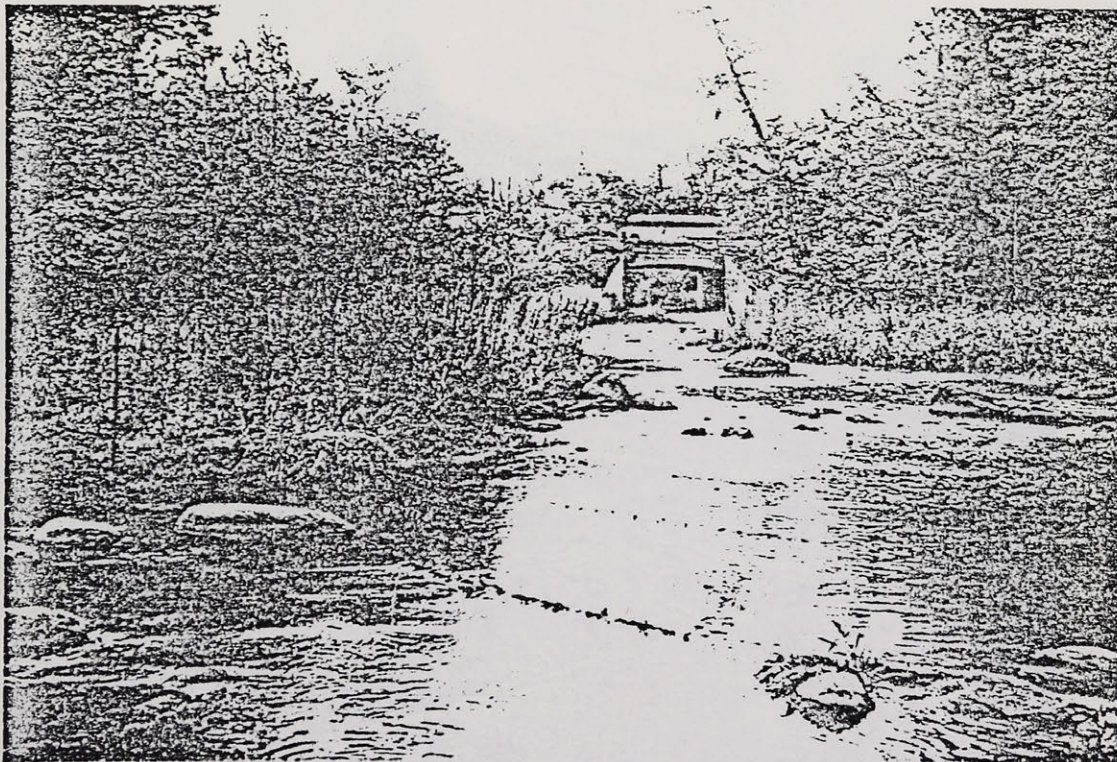
Photo 2. Without grazing more vegetal growth affords better protection of the valley slopes.

All these erosive processes can be controlled to varying degrees and at varying costs. The third listed can be corrected completely. Cattle grazing within the valley must be stopped. The topography and vegetation are too sensitive for this practice to continue. Cattle movement over the stream banks and valley slopes remove the vegetation to the point of exposing the soil to water erosion. It also prevents natural reforestation of the valley and steepens the slopes.

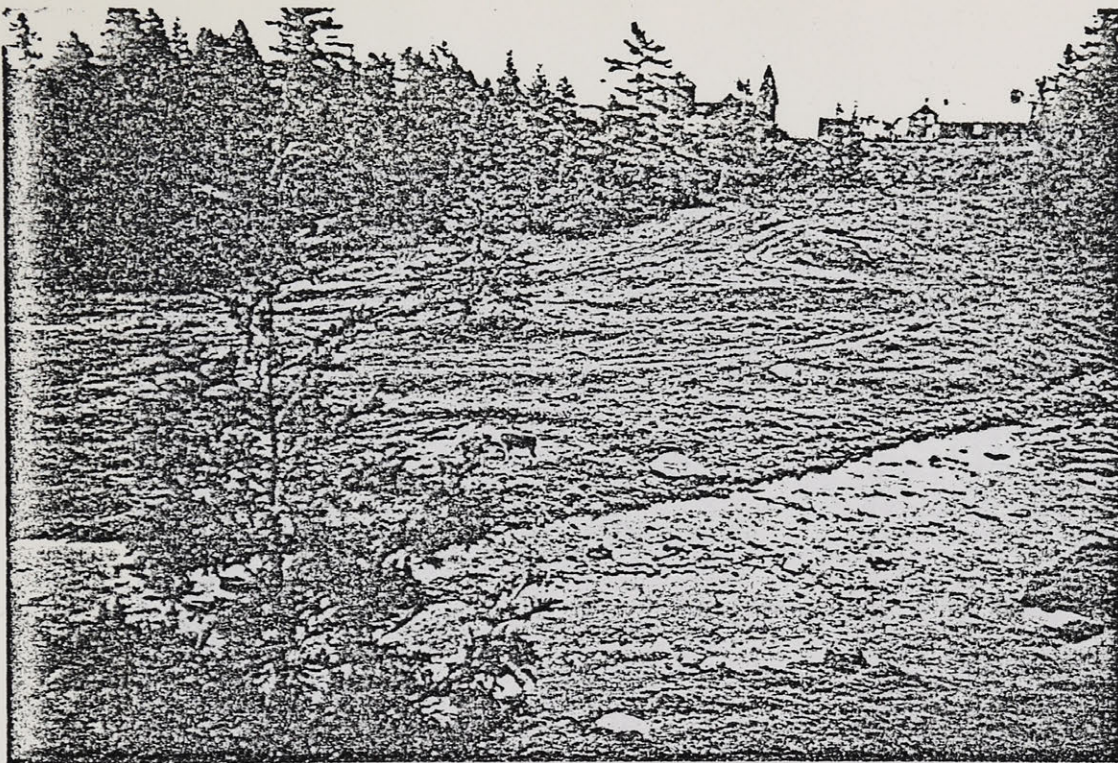
Photo 3. Evidence of cattle grazing; causing soil erosion and water pollution. Also note the rill and gully erosion of the slope below the farmstead.

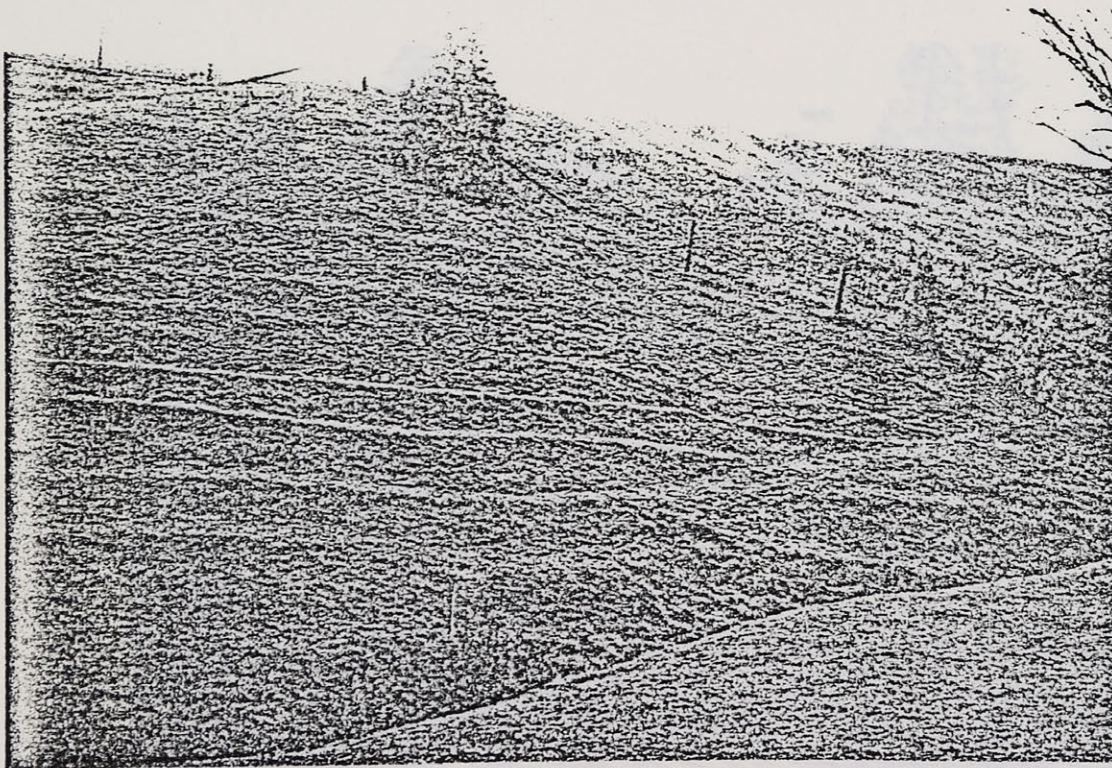
Photo 4. Grazing results in short vegetation and the development of ridges on the slopes (Cattle have access only to the left side of the fence line).

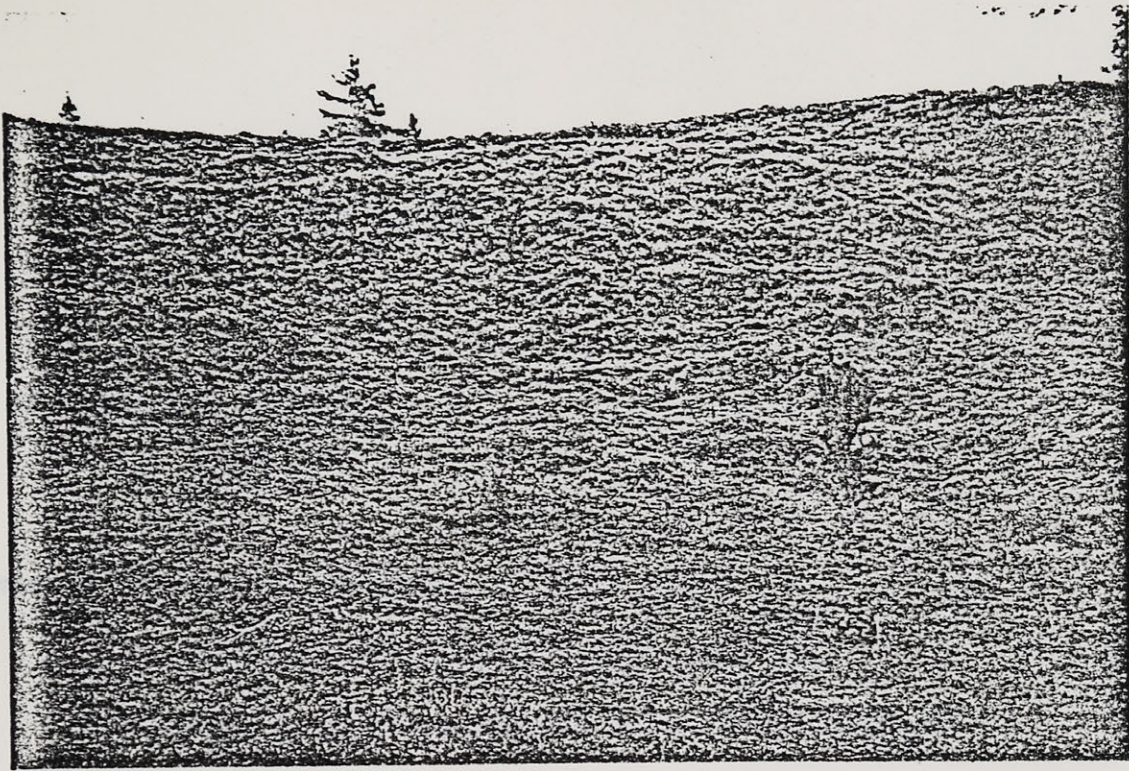
Photo 5. The upper section of a slumped area. Note the characteristic bowl shape, the steepness of the head wall and the cracks at the top of the slope.

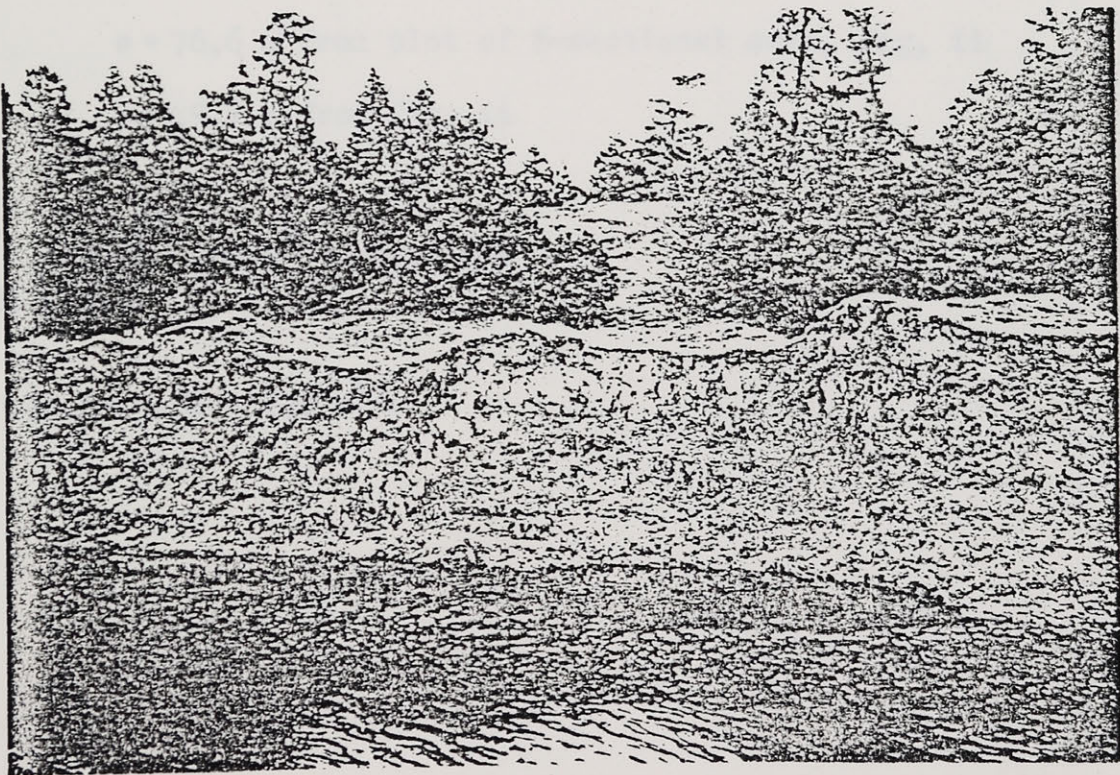
Photo 6. The toe of the same slump. This gives an indication of the sediment load caused by these slumps. Note the criss-cross tilting of the trees caused by the soil movement.
