Erosion of undisturbed clay samples from the banks of the St Lawrence River

Abstract: In some regions the clay banks of the St. Lawrence River along the Montreal to Lac St. Pierre reach have recession rates of up to 1 to 3 m per year. The banks are formed of structured marine clays of the Champlain Sea (Leda clay). In this laboratory study, undisturbed samples of this inorganic clay of high plasticity, taken at Iles de Verchères, were subjected to a unidirectional current and a constant wave climate to investigate the mechanisms of erosion and the factors influencing erosion rates. Initially surface erosion resulted in the formation and enlargement of cracks, and the smoothing of competent surfaces. The dominant erosion process was a mass erosion of the blocks of clay delineated by the cracks. Desiccation or weathering significantly increased erosion rates, as tension cracks formed due to drying and, upon re-wetting, the formation of micro-fissures resulted in disintegration into small easily erodible flakes. The estimated critical shear stress of the samples was 6-20 Pa. For the St. Lawrence River, these results suggest that waves are the dominant erosion mechanism, with shipping

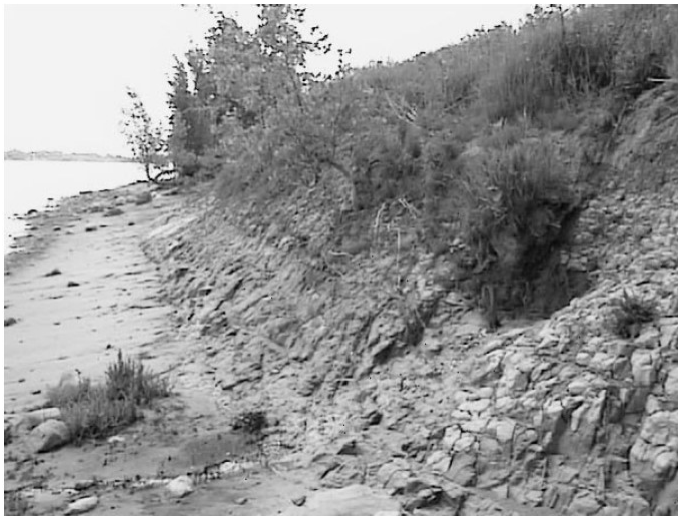
Figure 2. Typical eroding clay bank on the south shore of Iles de Verchères.

To relate the results of this study directly to the phenomena occurring in the St Lawrence River, undisturbed samples from the study reach were used in order to have representative material properties such as structure, moisture content, composition and vegetation levels. Fifteen samples were collected from the south shore of Iles de Verchères and two from the south shore of the St. Lawrence River just upstream of Contrecoeur. This was to check that the clay deposit was similar on both sides of the channel. Samples were collected at low water levels and all samples were taken just above the water level on the gently sloping foreshore (slope of 0.02 to 0.07) below the steep backshore bluff in the strata of gray and compact clay, which is overlain by a thin layer of sand (Figure 2). The water level of the St. Lawrence River was fluctuating during the sampling period (May – June, 2000) due to precipitation events and temperature changes modifying runoff rates and hence the river discharge. As the samples were taken during low water level periods, they did not have significant surface weathering. Vegetation on the banks is found primarily on the backshore bluff, however as the summer progresses and the water level decreases, seasonal vegetation is also found on the gently sloping foreshore.

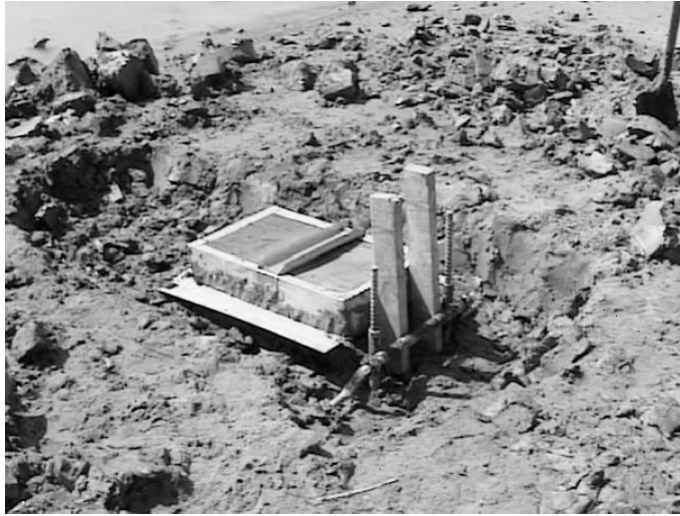
Figure 3. Method for obtaining undisturbed clay samples.

The following sampling method was developed to minimize disturbance to the sample (Figure 3). A metal frame (0.4 m x 0.6 m x 0.15 m deep) was carefully pushed into the clay and the clay around the frame removed. A metal cutting sheet cut the sample from the underlying clay. The winch attached to the sheet ensured that the sheet could be pulled slowly and evenly through the

clay to avoid major disturbances to the sample. The sample was transferred to a plywood sheet, wrapped in plastic, sealed with paraffin wax and stored in a humid room until testing. Prior to testing, the sides of the samples were trimmed using a wire cutter to 0.30 m x 0.45 m, but the top (testing) surface was left untouched. Standard soil testing procedures were used to determine the properties of the clay.

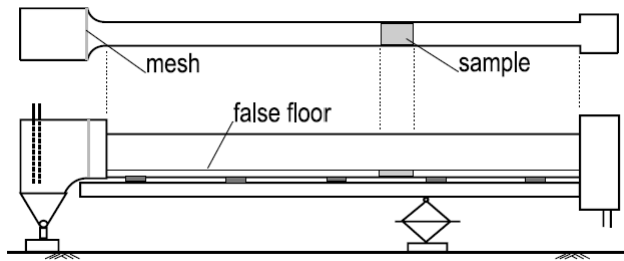
Figure 4. Tilting flume for tests of erosion due to a unidirectional current.

The erosion at the bed of a channel having a unidirectional current was investigated. The test flume used was a tilting flume with a width of 0.30 m, depth of 0.45m, length of 9 m, a slope of up to 0.04 and a maximum flow rate of 100 l/s (Figure 4). A false floor was installed in the flume and the sample was placed in a recessed box. The box was fitted with a lifting mechanism so that the top of the sample could be adjusted to be flush with the false floor of the flume. Once the sample was placed in the flume it was subjected to a constant flow velocity and its erosion observed, its surface profile measured and its appearance recorded with a camera. Once erosion at a given velocity had decreased to a negligible rate, the flow velocity was incrementally increased and the procedure repeated. This continued until the maximum flow velocity of the flume was reached. Starting with the third sample, the samples were pre-soaked for 72 hrs to allow for swelling of the sample. This allowed erosion rates to be estimated, as volume changes were due only to erosion rather than the combined effect of swelling and erosion. The limitation of using an open channel flume for the experiments was the low range of possible flow velocities.

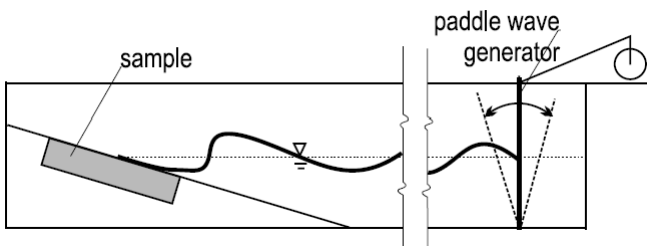
Figure 5. Wave tank for tests of erosion due to a constant wave climate.

The erosion due to breaking waves at the shore was investigated. The wave tank used was of the paddle wave generation type (Figure 5). The tank was 4 m long x 0.30 m wide x 0.50 m deep. The sample was recessed into the bank so that the surface was flush with the bank slope of either 0.18 (10°) or 0.36 (20°). The mean water level was at the midpoint elevation of the sample and corresponded to a water depth of 0.25 m. The paddle-generated waves had an average wave height of 0.06 m, average wave period of 0.8 s and a wavelength of 1.0 m. The waves are classified as transitional waves (with depth/wavelength = 0.25, USACE 1984), which were observed in the tests to be surging waves for the 10° slope and surging-plunging waves for the 20° slope. This wave climate could result from wind action at the field site. For each experiment, the sample was subjected to the waves for a period of time, after which measurements were taken to determine the volume of eroded material and the sample was photographed. This continued until either the sample was completely eroded or 7 days had elapsed.

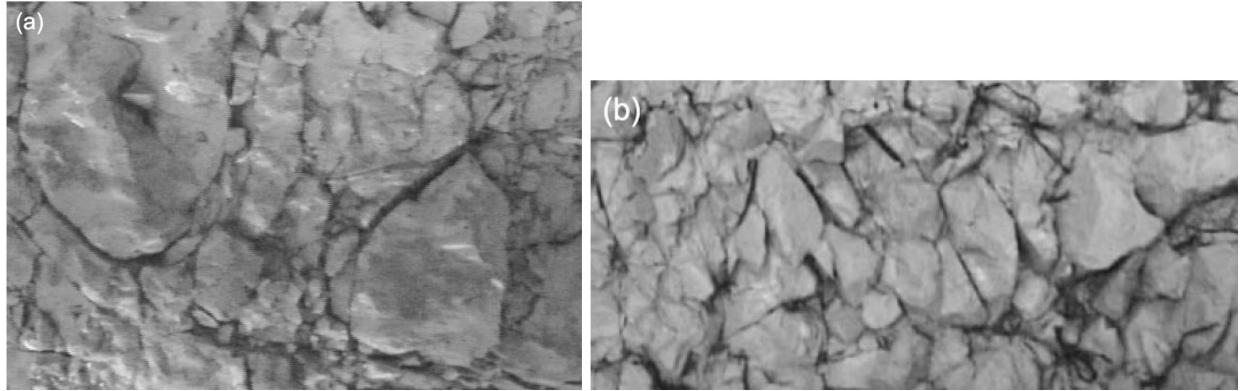
Figure 6. Typical test sample after erosion, a) due to a unidirectional current and b) due to waves.

The process of erosion of the clay was, in general, quite similar for all tests on samples at their natural moisture content (i.e. non-desiccated), both that due to a current and that due to waves. Some of the samples had a thin layer of sand lying on the surface; these particles were quickly removed as soon as the flow or the waves were started. Erosion then proceeded as small cracks and fissures appeared and were enlarged in a process of surface erosion. Surface erosion, visible as polishing, also occurred to a small amount on the surfaces surrounded by the cracks. As the cracks enlarged they began to isolate and loosen blocks of clay. These blocks were then eroded in a mass erosion process as they were removed once the flow or wave turbulence was large enough. Figure 6 shows typical samples during the erosion process.

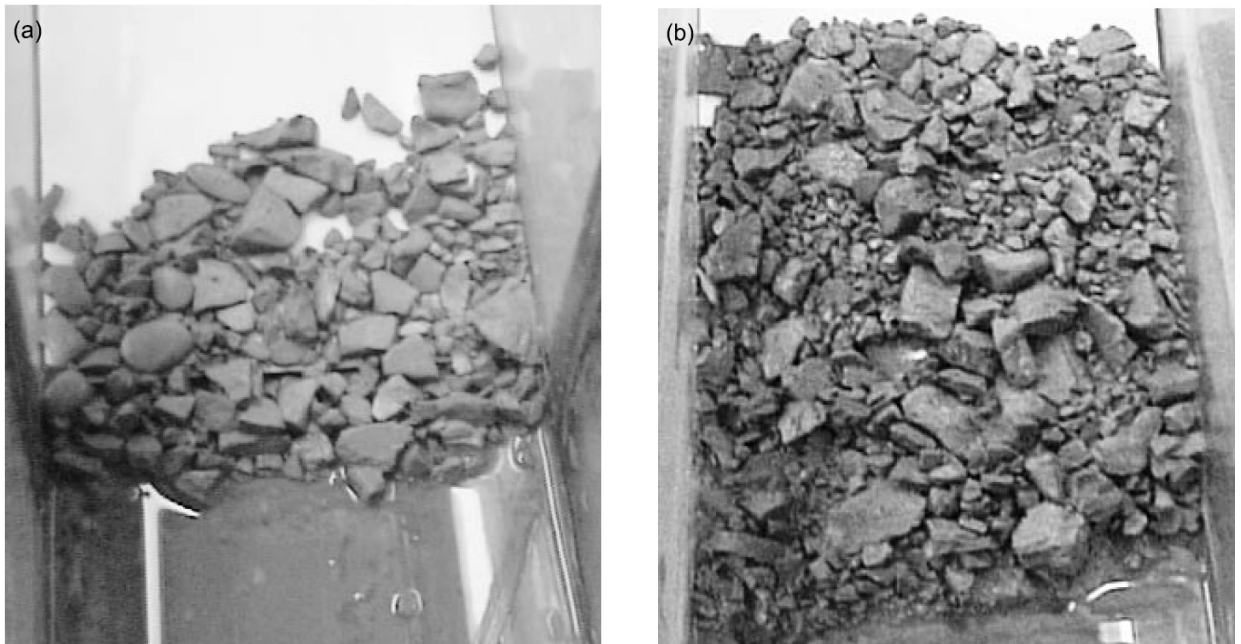
Figure 7. Blocks of clay removed by waves as a result of the mass erosion process, a) slope of 0.18 (10°) and b) slope of 0.36 (20°).

turbulence at the discontinuities and the oscillating pressures and shear stresses resulted in enlargement of cracks and fissures. This crack system, which is a function of the natural structure of the clay, began to delineate blocks (Figure 6b). These were then removed in a mass erosion process due to the combined action of the lift and drag forces due to the turbulent flow velocities and to the oscillating pressures in the breaking waves. The erosion occurred predominantly at the point where the plunging breakers were crashing onto the sample for the samples without roots, but for the samples with roots the erosion was more even over the sample.

Erosion of the samples at their natural moisture content occurred predominantly due to mass erosion, as blocks of clay delimited by the cracks, with a size range of < 1 mm to ~ 50 mm for their longest axis, were removed. The effect of an increased bank slope, from 0.18 to 0.36, was a doubling of erosion rates and an increase by approximately 20% in the maximum size of the eroded particles (Figure 7a for the 0.18 slope and Figure 7b for the 0.36 slope). The effect of the root matrix in the sample was complex, both increasing the number of cracks and slowing the removal rate of loosened blocks. These tests indicated that the net result was a reduced erosion, with the effect lessened for the pre-soaked sample and not discernable for the dried sample. The presence of the root matrix also resulted in an increase in the swelling of the sample during pre-soaking as the roots allowed greater penetration of the water. Pre-soaking the sample increased the moisture content of the surface, hence softening it, and resulted in a small increase in erosion rates. The effect of reducing the initial moisture content of the sample by drying (equivalent to weathering), samples 7 to 10, resulted in dramatically increased erosion of the desiccated material. The drying increased the number and extent of the tension cracks and, upon re-wetting of the sample by the waves, differential expansion of the clay resulted in the formation of micro-

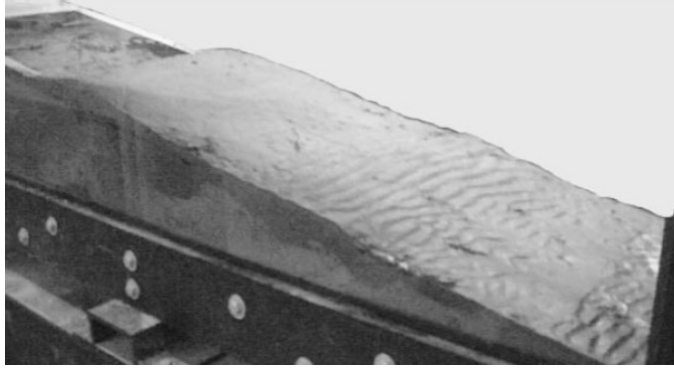
Figure 8. Erosion due to waves of a sample with low initial moisture content due to desiccation.

fissures. The sample disintegrated into 0.5 to 2 mm flakes that eroded very rapidly, resulting in complete erosion of the sample in less than 2 hours (Figure 8).

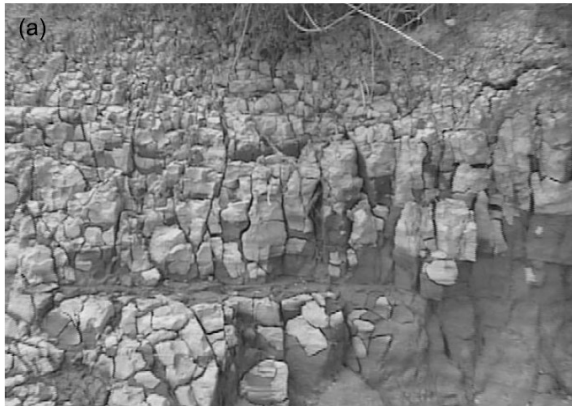
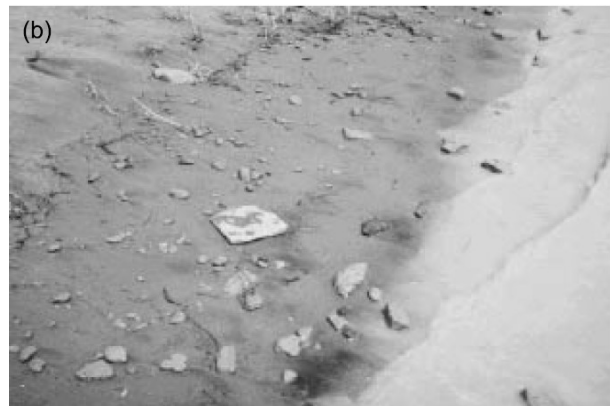
Figure 9. a) Typical bank exhibiting desiccation, b) clay “stones” resulting from erosion of bank.

Montreal to Contrecoeur reach of the St. Lawrence River are the natural structure of the clay and the degree of weathering of the clay. Figure 9 shows the natural structure of the clay in the banks of the St. Lawrence becoming apparent due to weathering. The clay “stones” on the shoreline are evidence of the mass erosion process occurring.

Any desiccation of the bank followed by a rapid wetting, or weathering, will result in significant erosion. Figure 9 shows a typical bank showing the effect of desiccation or weathering. Desiccation will occur any time that the bank is exposed to dry air, either due to low water levels, loss of protective vegetation or a period of time without precipitation. The loss of moisture causes a shrinking of the clay and the formation of tension cracks. This results in a macroscopic clay structure of blocks of material separated by cracks with little cohesion between adjacent blocks. The formation of micro-fissures and disintegration of the structure of the clay blocks into small particles and 0.5 to 2mm flakes will result due to differential expansion and deaeration from the rapid wetting caused by rising water levels, wave run-up, precipitation or the surge caused by a passing ship. An experiment showed that deaeration becomes a dominant process when the water content of a rewetted sample is lower than 30 to 35% before rewetting. Therefore, upon rewetting, the desiccated clay is very susceptible to erosion by rain, overland flow, current or wave action. Figure 10 illustrates the disintegration of a desiccated clay sample when immersed in water. When rewetting is due to changing water levels it is, therefore, their fluctuation and frequency of fluctuation rather than their absolute magnitude that results in significant erosion. Also, once the clay banks have been weathered, even the low velocities

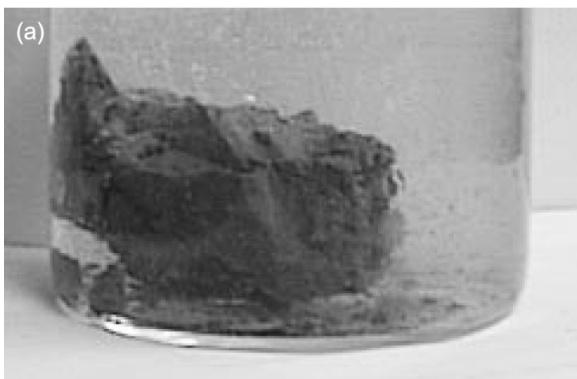
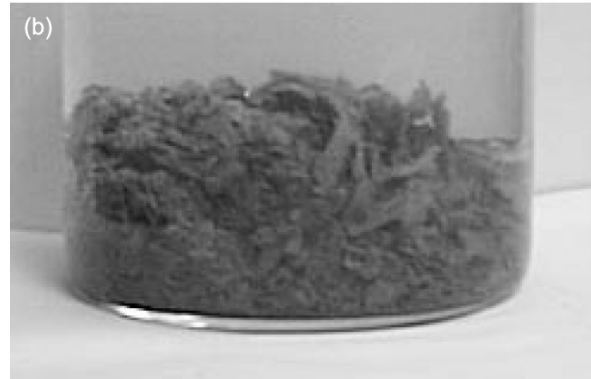
Figure 10. Disintegration of desiccated clay sample upon rewetting, a) at $t = 0$ mins and b) at $t = 5$ mins.

The desiccated samples showed greatly increased erosion both due to a current and due to waves. Drying increased the number of tension cracks and, with re-wetting of the samples, the formation of micro-fissures resulted in the sample disintegrating into 0.5 to 2 mm flakes. The samples were then very susceptible to erosion and completely eroded in under 2 hours.

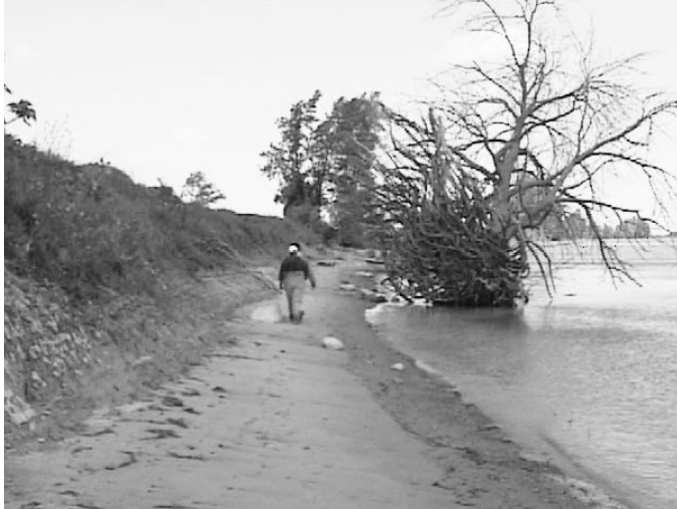
Figure 11. Vegetation on the river banks showing erosion.

Vegetation has a number of influences on the erosion of the banks. Figure 11 shows a bank on Iles de Verchères with typical early summer vegetation and the results of erosion of a mature tree. The root matrix of vegetation increases the number of small cracks in the clay, and water uptake by plants will lower the moisture content of the clay, both of which will increase erosion. The canopy will reduce the flow velocities at the water/clay interface when submerged. The canopy and plant mulch will shade the clay above the water line reducing drying. The net effect of these influences is usually reduced erosion. Therefore loss of vegetative cover is likely to have contributed to increased erosion along the banks of the St. Lawrence River. In addition, experiments were performed that show that the presence of roots in the clay matrix increases the breakdown of this type of material when air temperature changes cause cyclic freezing and thawing of the moist bank. This suggests that unlike the summer period, the presence of vegetation in late winter - early spring may increase erosion of the bank.
