### Flume tests on fluvial erosion mechanisms in till-bed channels

Pike, L., Gaskin, S.J., Ashmore, P. (2018) Flume tests on fluvial erosion mechanisms in till-bed channels, Earth Surface Processes and Landforms, 43(1):259–270. doi:10.1002/esp.4240

**Flume tests on fluvial erosion mechanisms in till-bed channels**

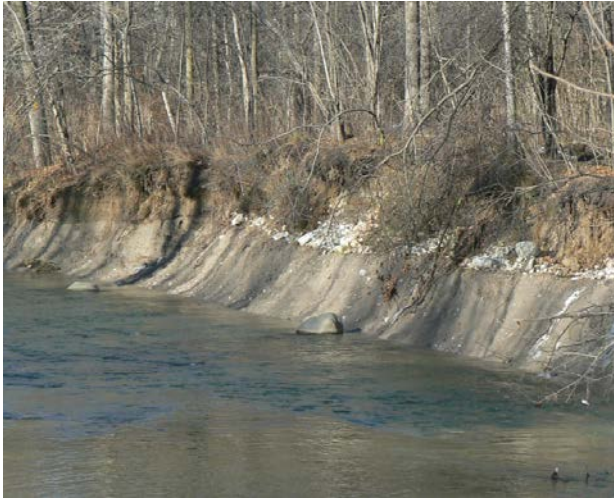
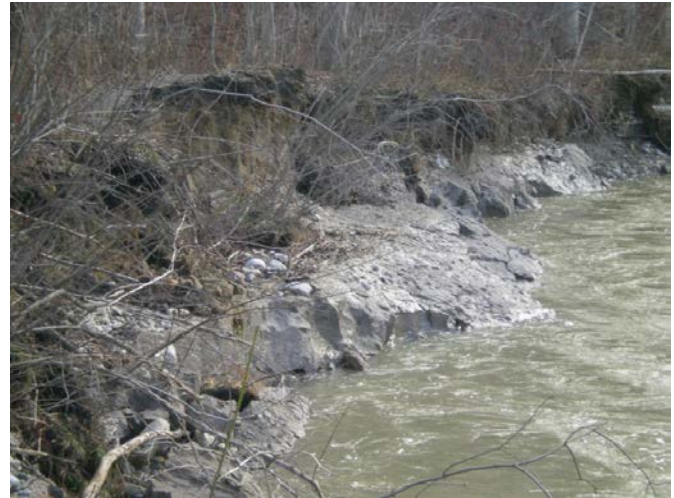
Figure 2 a) Medway Creek bank showing till in lower bank with overlying sand and gravel  
b) Till at base of bank extending across the bed below the water

recurrence intervals are approximately 60 and 80 m<sup>3</sup>/s. Till is exposed in the bed and banks along the sampled reach (slope of 0.0042) and in places is covered by a layer of alluvial gravel-cobble up to 0.3 m thick (Hrytsak, 2012) (Figure 2).

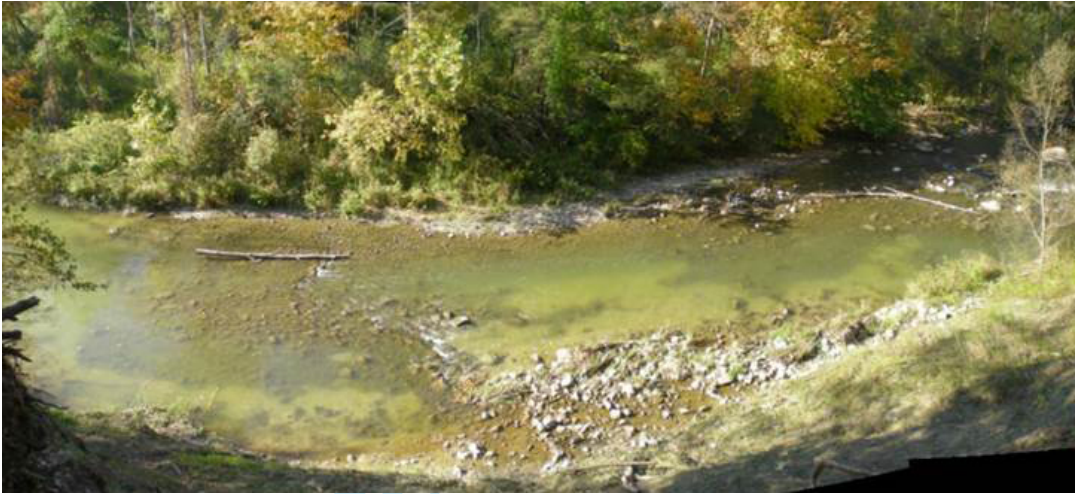
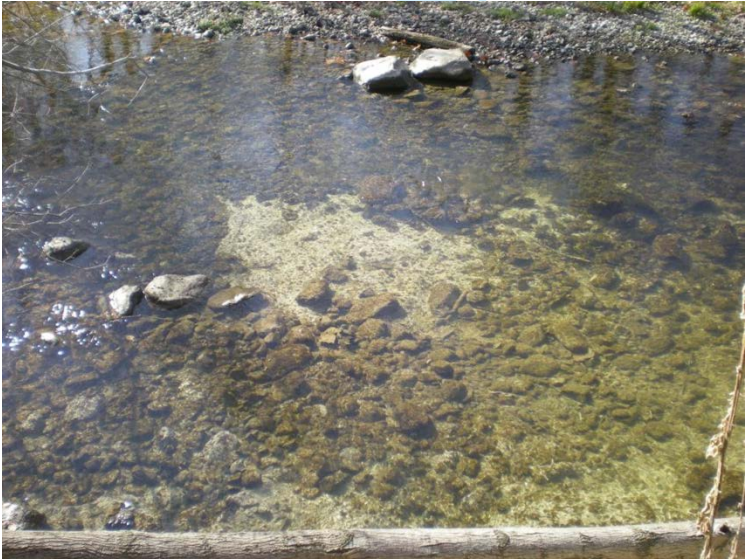
Figure 5    a) Overview of channel showing exposed till (light patches) and thin gravel cover layer (Photo by Tatiana Hyrtsak)  
              b) Close up view of till patch exposed beneath gravel cover

Gravel and cobbles could be seen embedded in the till, and pockets were visible where embedded particles had been removed. The till may therefore be a source of the gravel-cobble cover on the bed, as are the thin gravel layers in the eroding banks. Loose gravel mantles some areas of the bank toe and a discontinuous gravel-cobble alluvium with occasional boulders covers the river bed (Figure 5). Previous sampling in the reach (Hyrtsak, 2012) showed that 50-70% of the bed area has some cover. In some areas the cover is only one grain thick, but thicker (and finer-grained) bar deposits also occur. Averaged over the reach, gravel cover thickness is 0.24 m (Hrytsak, 2012).

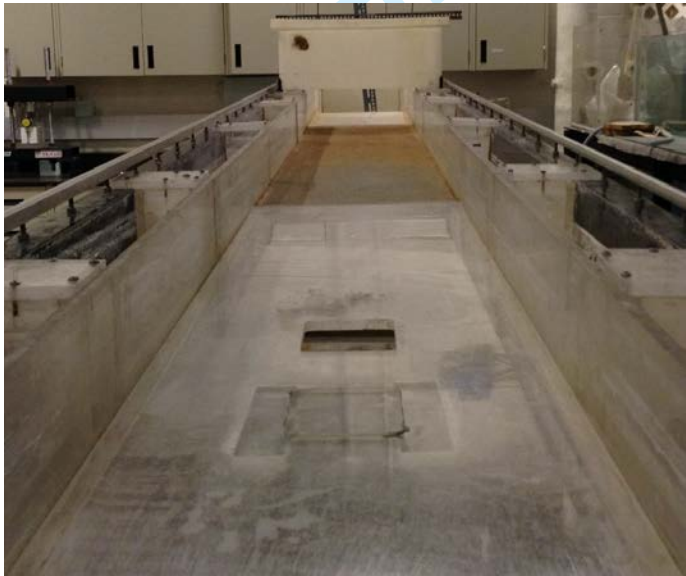
Figure 6 a) Plan view of flume and sample location  
b) Photo of flume photo showing block placement

Erodibility tests in a hydraulic flume allowed observation of erosion mechanisms in a set-up similar to that in the field with the intact (not remoulded) samples subjected to tangential fluvial stresses equivalent to those at the bed of the channel. The shear stress is the parameter causing erosion and the size of the sample selected (10 cm x 10 cm) was large enough to study the mass erosion due to the till's structure. A 4 m long by 0.4 m wide by 0.15 m deep recirculating hydraulic flume was used to test the samples (Figure 6).

Each sample was placed in the flume such that the top surface of the sample was flush with the channel floor. This was achieved by placing the sample on a height-adjustable platform beneath the flume’s plexiglass false floor in a 10 cm x 10 cm hole located at a distance of 2.5 m from the upstream end of the channel (Figure 6). The platform was adjusted throughout testing to maintain the erosion surface of the sample approximately level with the flume floor at all times (adjustment occurred when the difference was greater than approximately 2-5 mm)– the frequency of adjustment depended on the erosion rate ranging from every 5 minutes to twice in an erosion test of 16 hours.

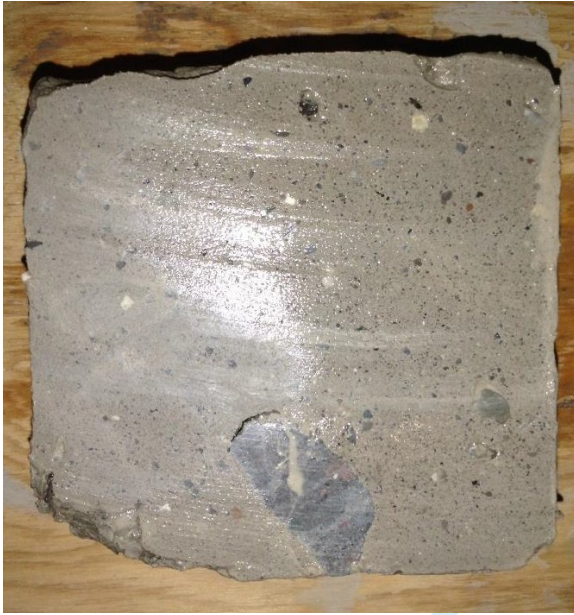
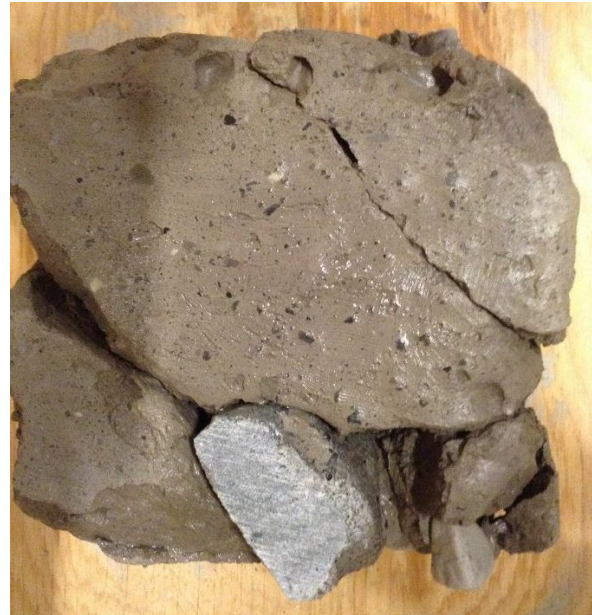
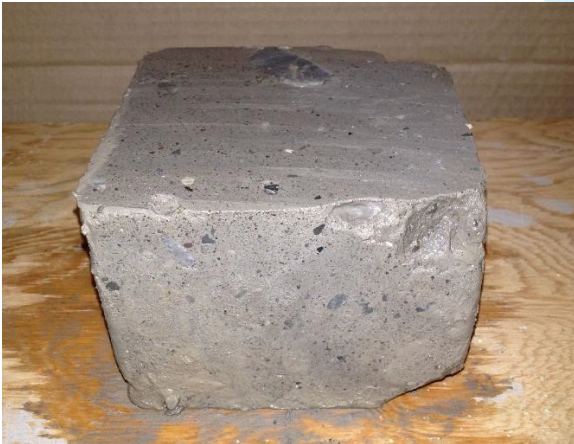
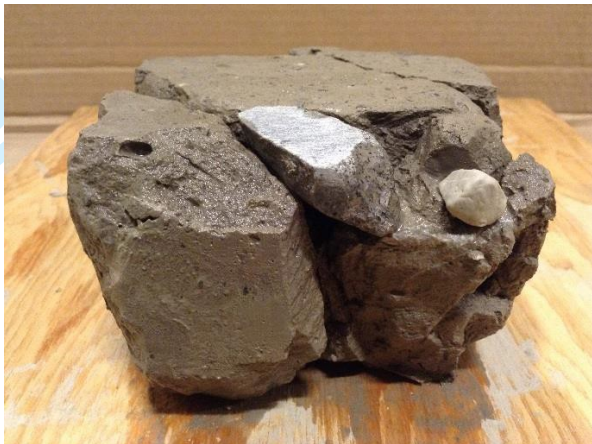
Figure 8 Sample 2, initial saturated moisture content clear water flow, a) before and b) after erosion test top view, and c) before and d) after erosion test side view.

Samples 1 and 2 showed similar erosion behaviour (Figure 8, sample 2 shown) as mass erosion defined as block separation and detachment and fluvial scour or surface erosion. Sample 1 eroded by a mass erosion process in which spontaneous fracturing delineated small blocks of till, which eventually detached from the sample. The first sign of weakening of the till sample was a crack developing down the middle of the sample at an applied shear stress of 6.7 Pa, appearing to split the entire sample in half. With a further increase in the applied shear stress to 7.9 Pa, a block of till adjacent to the crack became detached and eroded - this point was assumed to be the critical shear stress of the sample. Further increase in the shear stress did not yield more mass erosion (block separation and detachment), however, embedded gravel pieces within the surface of the sample were slowly revealed as fluvial scour (surface erosion) of the clay matrix occurred. In Sample 2, very small gravel pieces were eroded from the surface of the sample by first becoming more exposed by surface erosion of the matrix and then being plucked from the surface at a shear stress of 6.7 Pa. With a further increase to 7.6 Pa, cracks began

36  
37 after testing (a mass of very small particles) had increased to 23-24% (compared to 10-  
38  
39 11% of the initial water content sample) due to the microfissures resulting in a higher  
40  
41 surface area and allowing for increased absorption of water. These observations show  
42  
43 that wetting and drying has a substantial effect on the erosional resistance, as seen in a  
44  
45 comparison of Figures 8 and 9.  
46  
47  
48  
49  
50  
51  
52

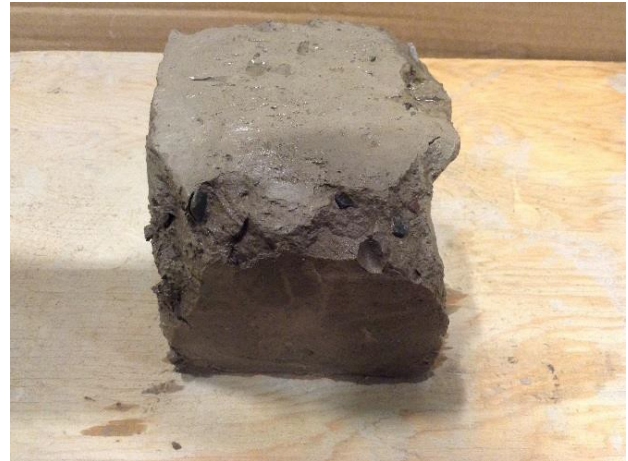
Figure 10 Samples 6, initial saturated moisture content gravel abrasion, a) before and b) after erosion test

40  
41 Sample 6 showed similar effects, including erosion of the till while it was covered with  
42  
43 gravel (Figure 10), which occurred at shear stresses below 7.9 Pa. At higher stresses the  
44  
45 rolling gravel caused the sample to erode more quickly by first cracking, the cracks  
46  
47 delineating blocks, and finally separation and detachment of the blocks in a mass erosion  
48  
49 process. Blocks detaching from the sample caused irregularities in the surface of the  
50  
51 sample that was subsequently smoothed by the gravel particles. The shear stress versus  
52  
53 time trajectory for samples 5 and 6 has gaps as shear stress values on the till surface  
54  
55 were unknown due to the presence of the gravel. The gravel increased the flow depth,  
56  
57 channeled the flow and/or protected the till from exposure to the shear stress.  
58  
59  
60
