Improved Resistance to Thaumaside Formation in Cement Pastes by Early Age Carbonation

Department of Civil Engineering and Applied Mechanics

McGill University

A thesis submitted to McGill University in partial fulfillment of the requirements for
the degree of Master of Engineering

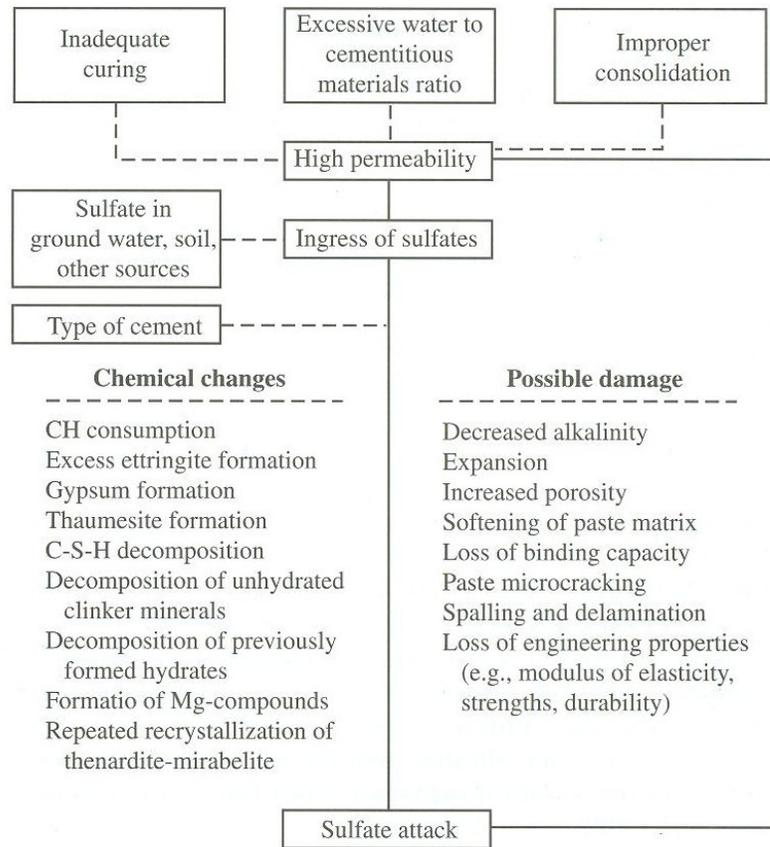
Figure 2-1: Summary of ESA related issues (Skalny et. al 2002, p. 106)

External Sulphate Attack (ESA) is induced by a source of sulphates that is exterior to concrete. ESA induced damage will occur if there is a sulphate rich environment, permeable concrete and with the presence of water (Collepardi 2003). Damage from ESA includes excessive expansion, crack formation, surface spalling, delamination and loss of strength. The chemical process involved in External Sulphate Attack is strongly linked to the type of sulphate involved in the reaction. Once the sulphates enter the concrete from an outside source, by means of several transport mechanisms, one of three chemical processes can occur depending on the predominant reaction. These processes lead to the formation of gypsum, ettringite or thaumasite, when exposed at low temperatures (Collepardi 2003). A summary of ESA related issues is shown in Figure 2-1 below.

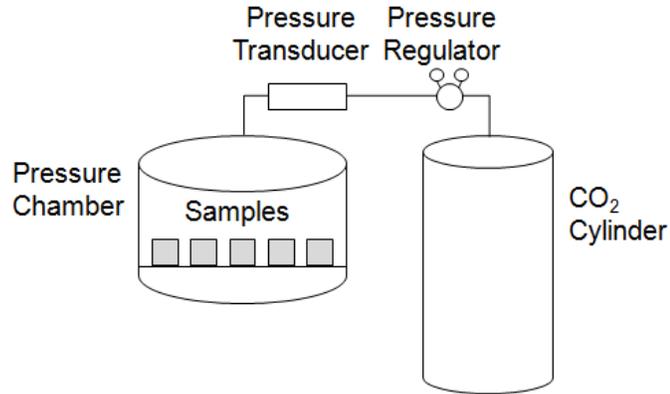
Figure 3-1: Carbonation setup

As mentioned previously, specimens were carbonated following initial air curing. The early carbonation curing setup is illustrated in Figure 3-1.

After initial open air curing, specimens were placed in a pressure chamber as shown in Figure 3-1. Carbon dioxide of 99.5% purity was injected and kept at a constant pressure of 0.15 MPa. The pressure was monitored and verified using a pressure regulator. Both mortar and paste specimens were carbonated for a period of four hours.

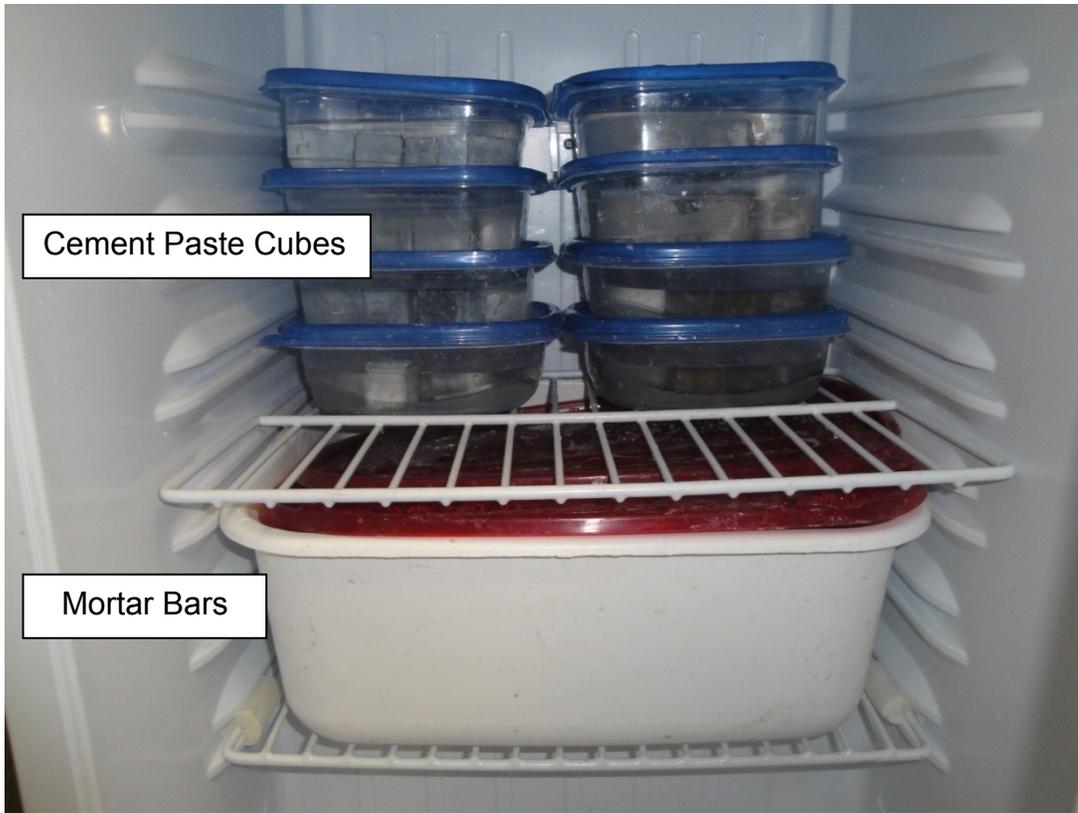
Figure 3-2: Low temperature sulphate attack test setup

The submerged samples were kept at 5°C, as low temperatures have been found to promote thaumasite formation. The samples were therefore stored in a refrigerator, shown in Figure 3-2. The cement paste cubes and mortar bars were stored separately.

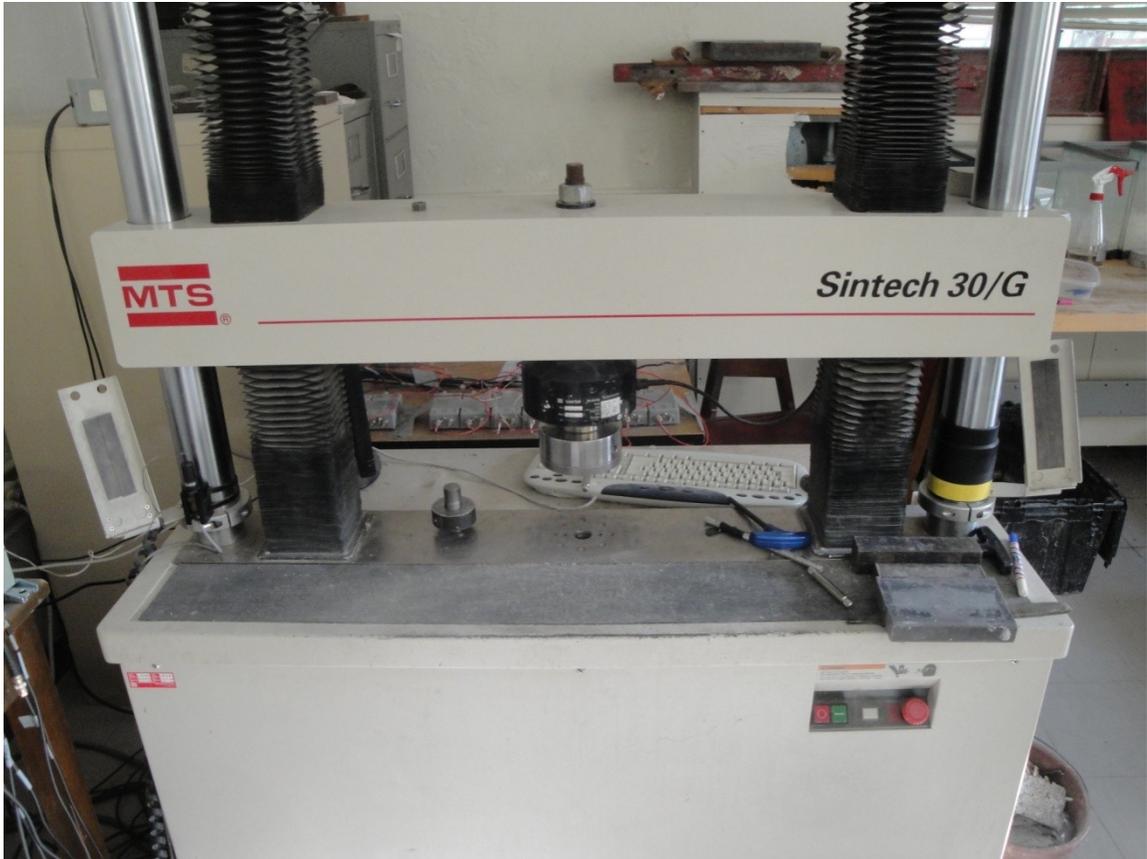
Figure 3-3: MTS Sintech

Compressive strength measurements were obtained using the MTS Sintech machine shown in Figure 3-3.

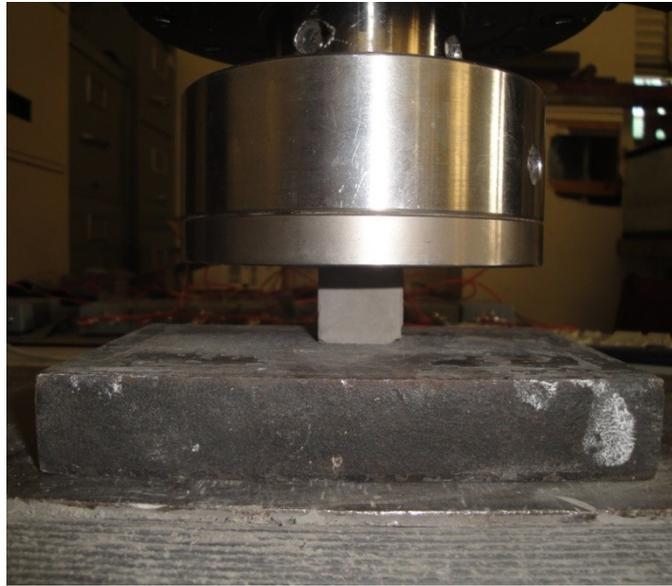
Figure 3-4: Compression strength tests

The compression area of one inch square was used, which corresponds to the side of the cube, as shown in Figure 3-4. A minimum of three samples of each batch were tested to produce a representative average.

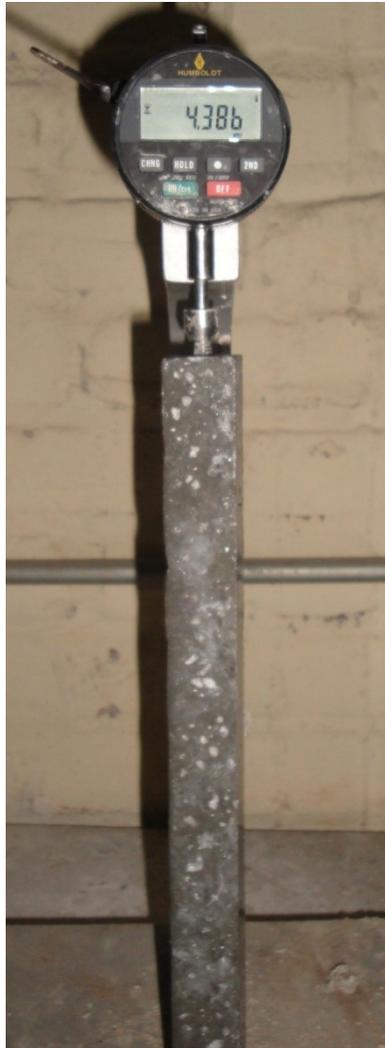
Figure 3-5: Change in length of mortar bar measurements

The setup for length measurements is shown in Figure 3-5.

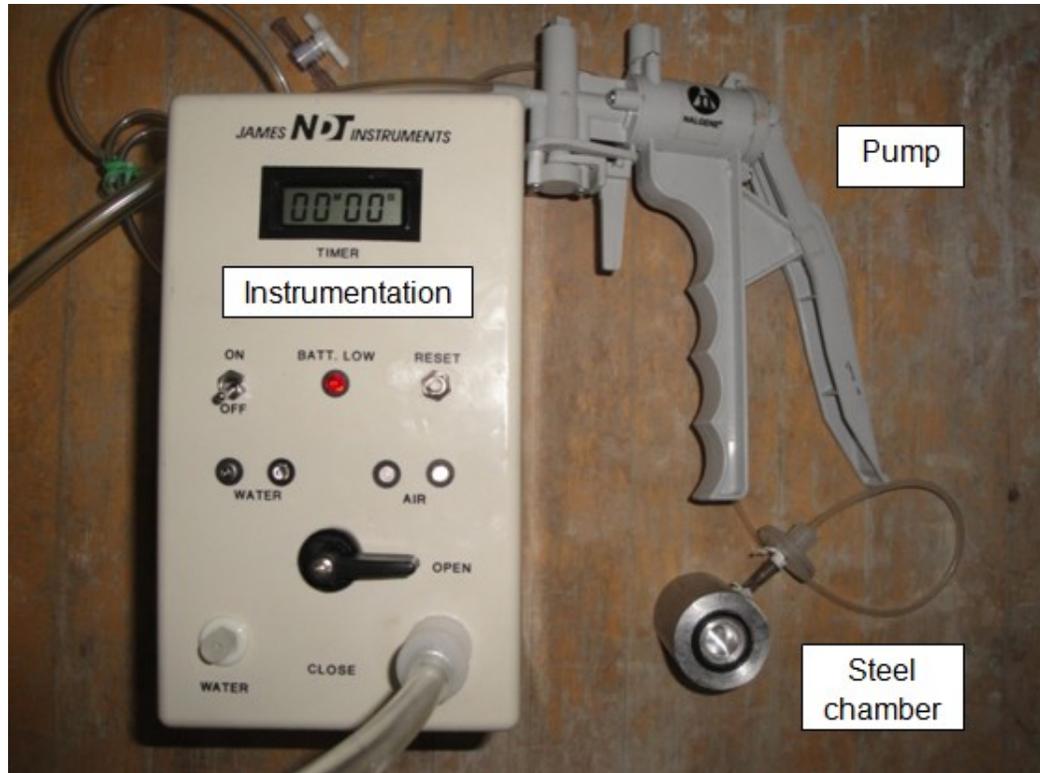
Figure 3-6: Surface air permeability test apparatus

In order to compare the surface air permeability of the four groups of cement paste cubes, a poroscope (James Instrument Inc, Model P-6050) was used. The poroscope included a steel chamber to be clamped to the surface of the samples. The chamber is sealed and subsequently subject to a vacuum. The chamber is then connected to the instrumentation. In turn, the instrumentation is connected to a hand vacuum pump. The test apparatus is shown in Figure 3-6.

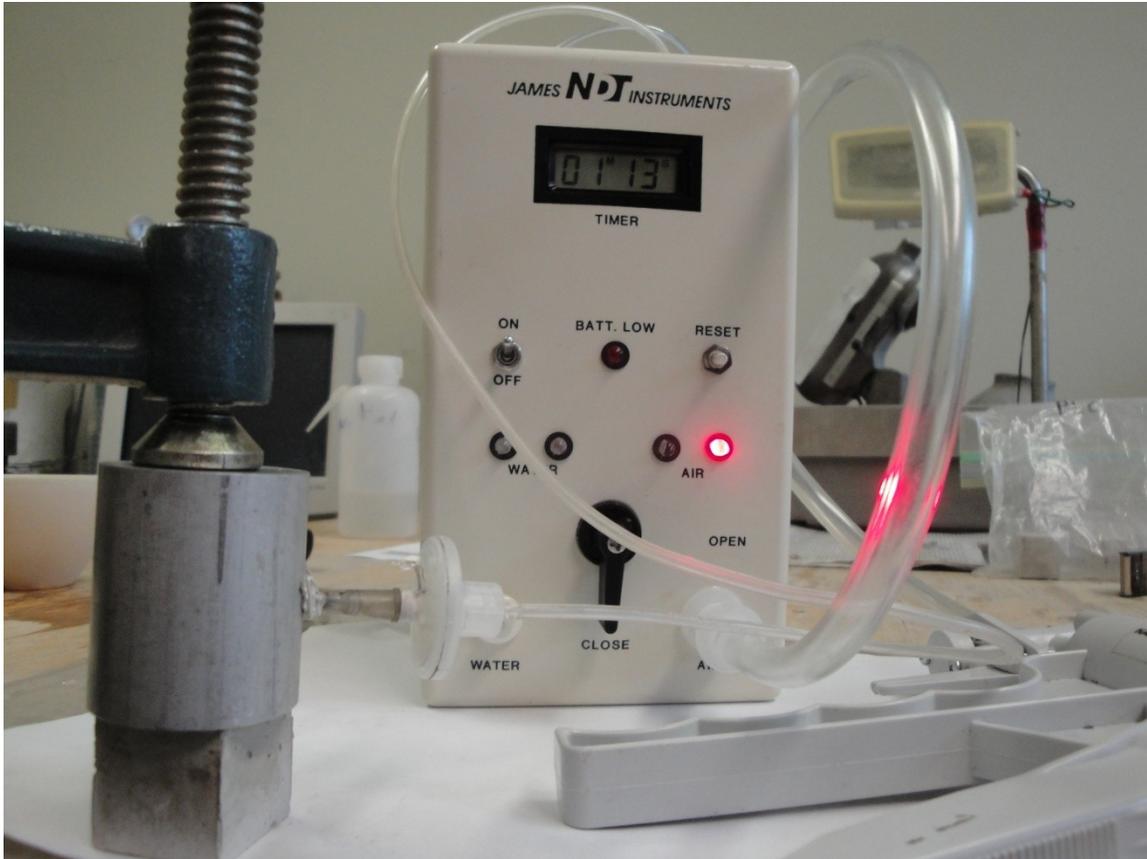
Figure 3-7: Surface air permeability test setup

The pump provides a negative pressure of -55 kPa in the chamber. Meanwhile, the instrumentation measures the time required for the negative pressure in the chamber to climb to -50 KPa. The parameter considered to be representative of the surface air permeability of the cement paste cubes was the time it took for the vacuum pressure to increase by 5 kPa. The steel chamber provided by the manufacturer was however too wide for the cubes. Therefore, a narrower steel chamber was built with the exact same volume as the steel chamber provided with the instrument. The setup is shown in Figure 3-7 below.

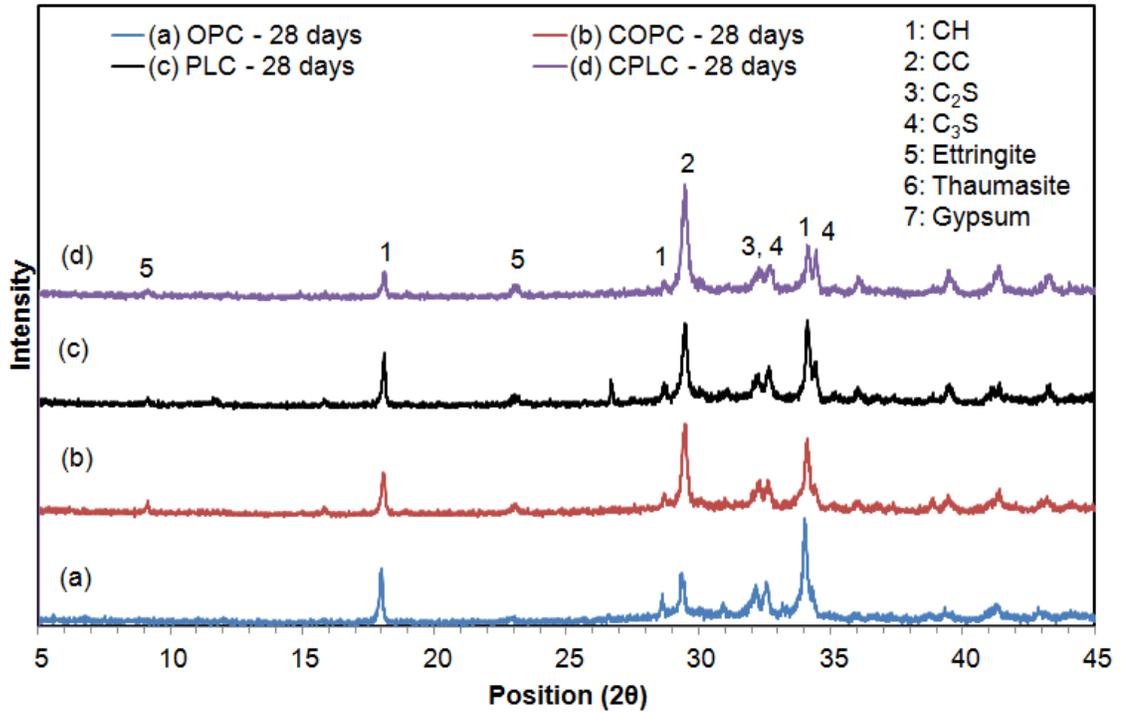
Figure 4-1: XRD patterns of pastes after 28 days of curing

Figure 4-1 shows the XRD patterns of paste specimens following carbonation and subsequent hydration. The peaks corresponding to Calcium Hydroxide (CH) were slightly consumed in carbonated specimens. The Calcium Carbonate (CC) peaks were amplified in carbonated specimens. Hydrated PLC had stronger calcium carbonate peaks than hydrated OPC due to the presence of limestone powder. The carbonated OPC showed amplified calcium carbonates similar to hydrated PLC because their CaCO_3 contents were in the same range, the former being 15.6% and the latter 15.2%. Carbonated PLC had shown much stronger CaCO_3 peaks corresponding to CaCO_3 contents of 25.9%, due to the limestone addition and carbonation curing. This observation confirmed the formation of calcium carbonates through the carbonation curing reaction, and the consumption of CH.

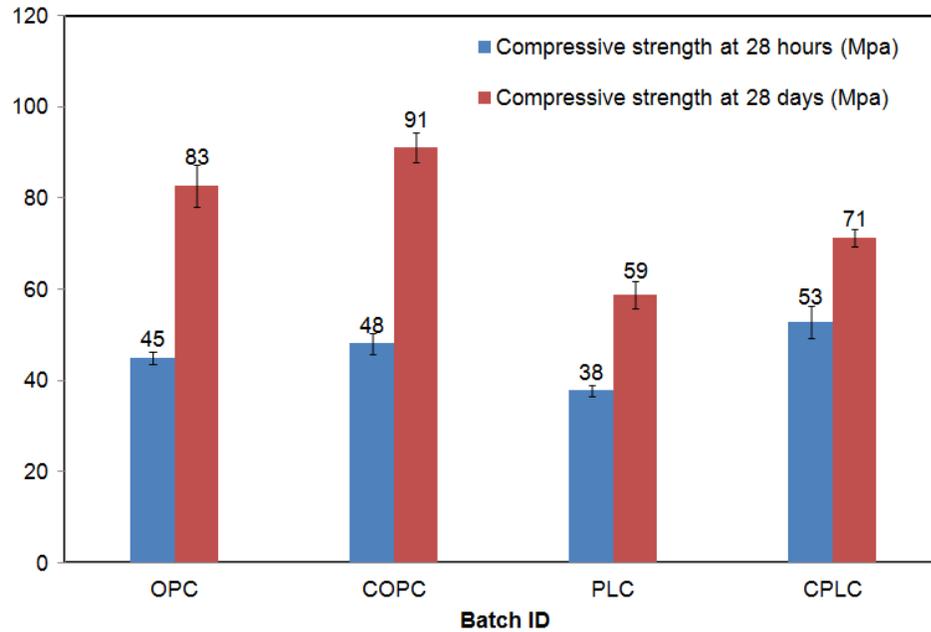
Figure 4-2: Compressive strength of cement pastes after 28 hours and 28 days of curing

The compressive strength of cement pastes is a good indicator of hydration and carbonation curing. Figure 4-2 shows the compressive strength of cement paste cubes after 28 hours and 28 days of curing. For hydrated references, the cubes were sealed in plastic containers and tested at 28 hours and 28 days. There was no water loss during curing. For carbonated pastes, the cubes went through a process that involved 24-hour open air curing, 4-hour carbonation curing and water compensation to surface saturation. Three specimens per batch were then tested for average right after carbonation to determine the 28-hour strength and more were sealed for continued hydration to 28 days.

While the compressive strength of carbonated OPC specimens was comparable to hydrated specimens right after carbonation, despite losing a significant amount of water during the curing period, the carbonated PLC actually had a higher strength right after carbonation than hydrated PLC. This increase in strength in carbonated PLC was attributed to the higher carbon uptake found in CPLC. Hydrated PLC had exhibited lower strength than the hydrated OPC even though PLC had a finer particle size. It was the clinker content that was more dominant in strength gain. At 28 days, carbonated and hydrated specimens had very similar strengths. Therefore, it was apparent that the carbonated specimens were able to reach similar strength than hydrated specimens, as long as the initial water content was restored by water compensation following air curing and carbonation curing. At 28 days, OPC specimens were found to have a much

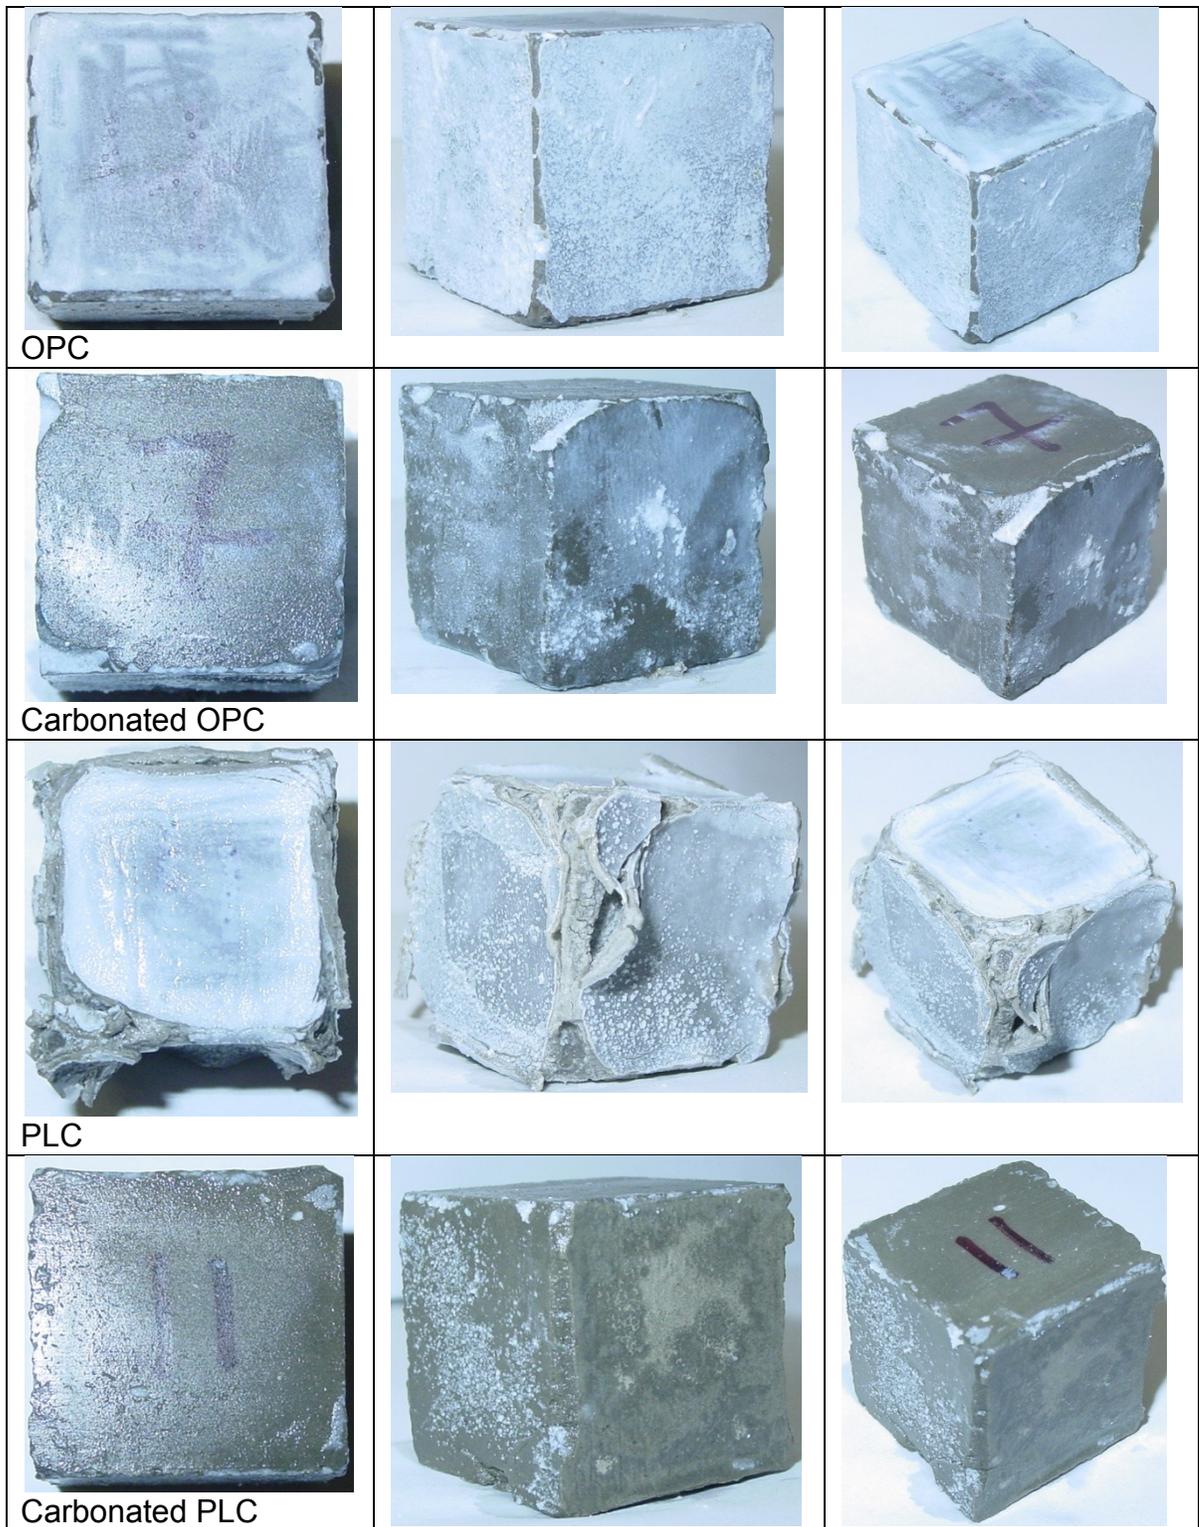
Figure 4-3: Cement paste cubes after submerged in a 5% MgSO₄ solution for 6 months at 5°C

the cubes. The damage was clearly due to the loss of cohesion in the CSH binding phase leading to a mushroom-type spalling. The damage in PLC specimens was attributed to the presence of the higher percentage of limestone filler. Similar damage was also reported by other researchers (Kakali et al. 2003, Tsvilis et al. 2007, Torres et al. 2004). However, despite the presence of the same amount of limestone filler and additional carbonates from carbonation, carbonated PLC specimens did not show any spalling damage after an exposure of 6 months. Instead, carbonated PLC specimens maintained a perfect surface around all sides of the cube, including the corners. The carbonation process changed the way the cement paste was reacting to the sulphate solution. When taking photographs, it was not possible to clean out the white powder on the outer surface of hydrated specimens, whereas the similar white powder layer on outer face of carbonated specimens was easily removed. This phenomenon is also noticeable in Figure 4-3, where it is nearly impossible to see the numbering of hydrated specimens, as opposed to the clean surface of carbonated specimens.

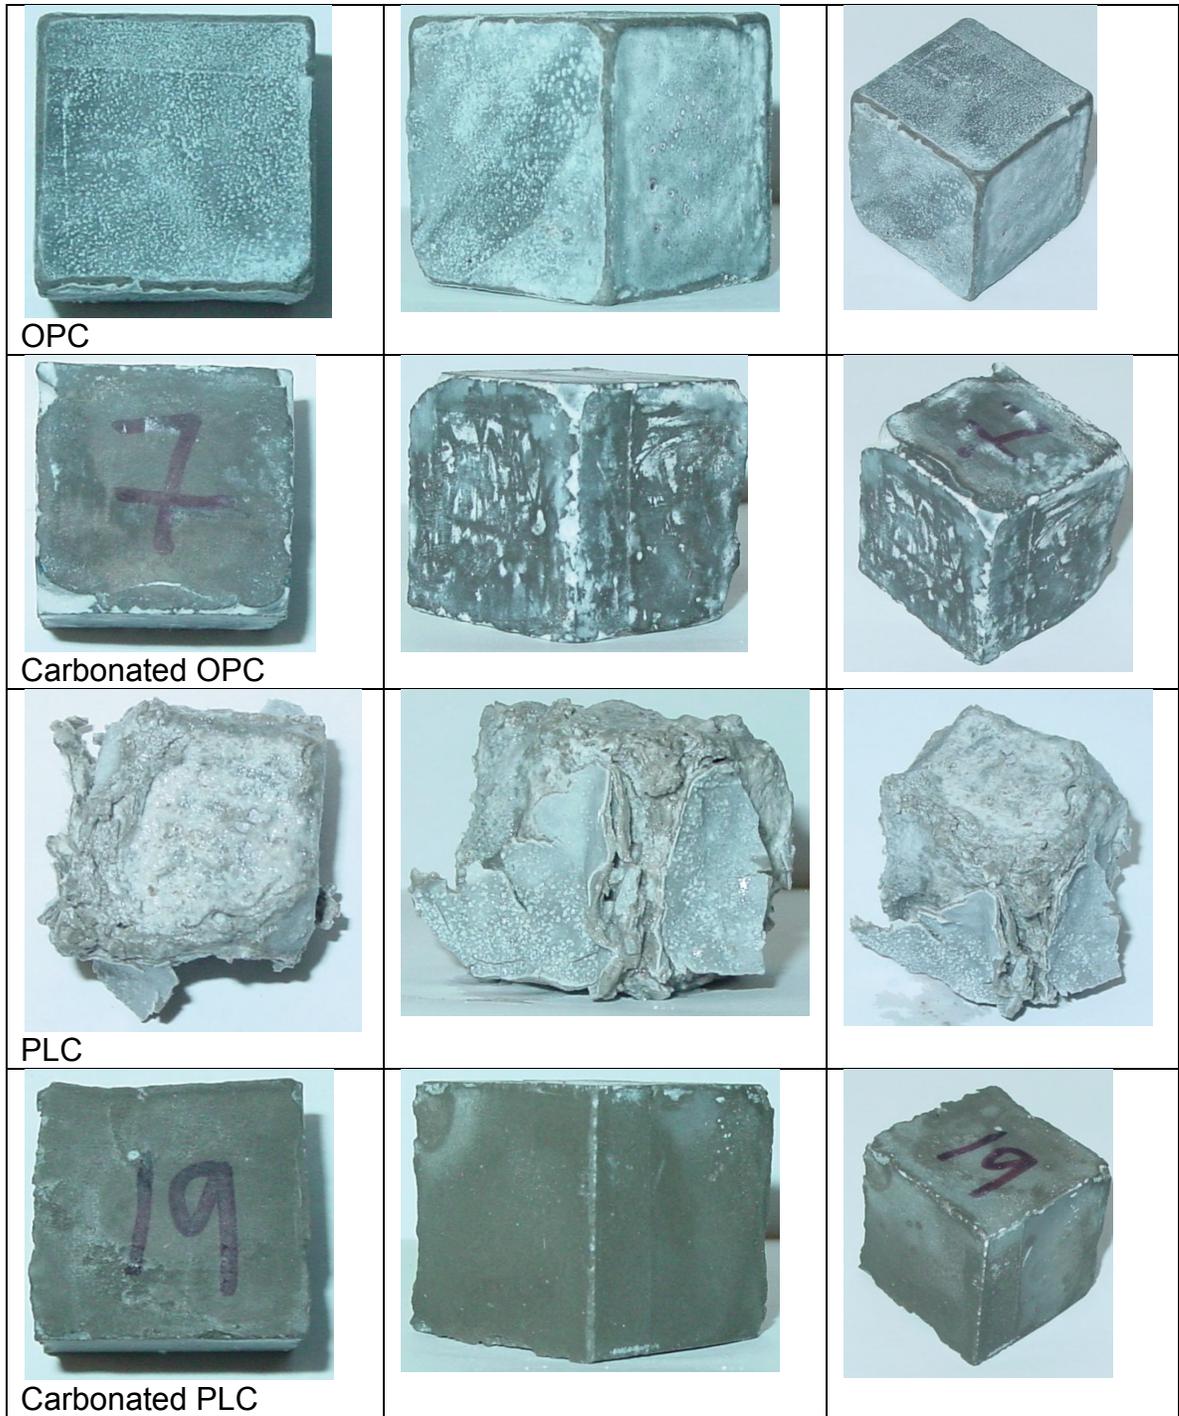
Figure 4-4: Cement paste cubes after submerged in a 5% MgSO₄ solution for 10 months at 5°C

Figure 4-4 displays the specimens after 10 months of submersion to the magnesium sulphate solution, at 5°C. At this stage of exposure, there was no visible damage in hydrated OPC specimens. Carbonated OPC specimens still did not show any apparent sign of deterioration. PLC specimens underwent extensive cracking, spalling and expansion. The outside surface was almost completely spalled off in all specimens. When comparing this image to that of 6 months, it is clear that the reaction in PLC had progressed considerably during this period. Therefore, it was concluded that the deterioration increased in hydrated PLC with an increased exposure time. Nevertheless, carbonated PLC specimens still did not show any sign of deterioration. Also, once more, when taking photographs, it was not possible to clean the white powder on outer surface of the hydrated OPC specimens, whereas the outer face of carbonated specimens was easily cleaned and the white layer removed. Therefore, visually, it can be concluded that the resistance of carbonated PLC specimens is improved. Both hydrated and carbonated OPC had shown excellent resistance to TSA. While hydrated OPC contained 5.0% ground limestone and was not vulnerable to TSA, the carbonated OPC had a 15.6% CaCO₃ content, which was of close value to hydrated PLC. Nevertheless, carbonated PLC was much more resistant to TSA than hydrated PLC, despite having a CaCO₃ content of 25.9%.

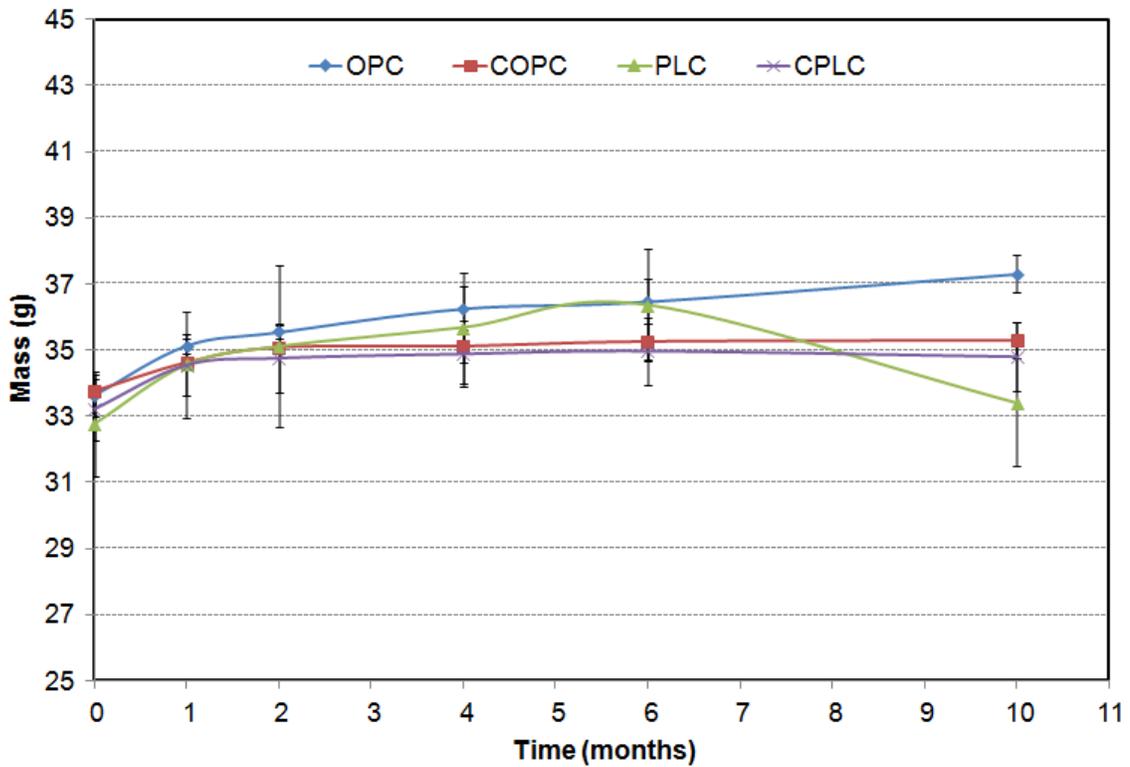
Figure 4-5: Mass change of cement paste cubes versus time
Mass change of cement paste cubes versus time

Another indicator of thaumasite-induced damage is mass loss in specimens, which can be caused due to spalling of the outer layer of specimens. The spalling of specimens is caused by a loss of cohesion due to the decalcification of the CSH. In turn, the decalcification of the CSH causes the loss in cohesion of concrete. Therefore, to help assess the thaumasite-induced damage, the mass of the cement paste specimens was monitored throughout the exposure period. The average mass of four specimens throughout the exposure period is shown in Figure 4-5.

The mass of the hydrated OPC specimens increased for the entire 10 months of exposure, as shown in Figure 4-5. The increase in mass was attributed to the specimens absorbing the sulphate solution. As well, hydrated OPC specimens were not deteriorated to the point of spalling up to 10 months of exposure. There was no mass loss in hydrated OPC.

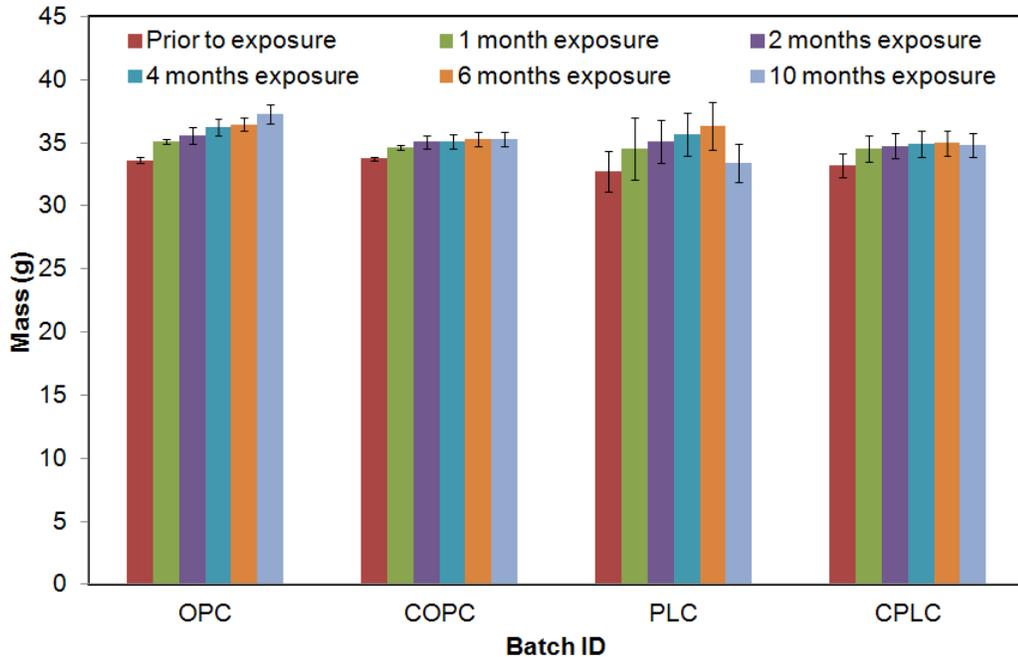
Figure 4-6: Mass change of cement paste cubes

Both carbonated OPC and PLC specimens had seen an increase in mass during the first month of exposure. During the following 9 months of exposure, the specimen mass difference was negligible. From this result, it was concluded that hydrated specimens were more absorptive, which could indicate that an open structure was generated. The resilience of carbonated specimens to absorb the sulphate solution could be explained by the densification of the pore structure on the specimen surface during carbonation. This phenomenon can also be seen in Figure 4-6.

As mentioned previously, the only mass loss happened in PLC specimens, and occurred between 6 and 10 months of exposure to the sulphate solution. However, mass was lost from these specimens at 6 months of exposure, but was offset by the mass gain due to the absorption of sulphates in specimens. Therefore, mass loss has not proven to be a valid indicator of sulphate attack induced damage at early age of the deterioration. This indicator should become more representative at later stages of the deterioration, where mass loss is expected to be more significant, and will offset the absorbed solution. Results showed that carbonation reduced the absorption due to the smaller increase in mass. Therefore, less damage would be expected with less ingress of sulphates in the specimens. The comparison in mass loss between PLC and CPLC did indicate that carbonated specimens were more resistant to thaumasite formation, which was in accordance with visual inspection results.

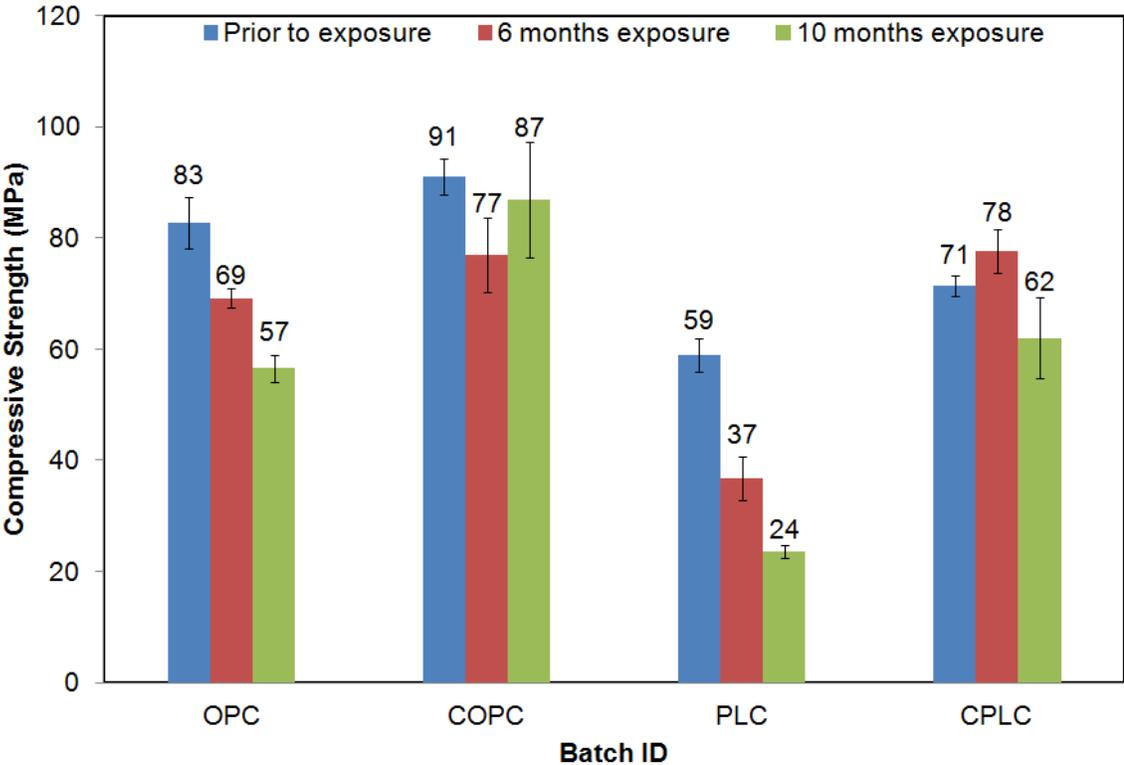
Figure 4-7: Compressive Strength of Cement Paste Specimens

Thaumasite induced damage can also cause a decrease in the compressive strength of cement in later stages of the deterioration. Compressive strength is not the best indicator of cracks caused in conventional sulphate attack due to the ettringite formation, as the mechanical test tends to close cracks. However, with thaumasite induced damage, the deterioration causes loss of cohesion of concrete. As the deterioration progresses, the concrete can even turn to mush. Therefore, the compressive strength of the cement paste cubes was also monitored to study the resistance of carbonated specimens subject to TSA. Compressive strengths of the cement paste specimens are shown in Figure 4-7.

The hydrated OPC specimens had seen a strength reduction of 17% at 6 months and 31% at 10 months, although there was no apparent mass loss due to TSA. This drop in strength could be explained by the formation of sulphate attack compounds such as ettringite and gypsum. The strength reduction in carbonated OPC was much less. If the standard deviation was considered, the change of strength was negligible, indicating that the carbonated OPC was more resistant to TSA.

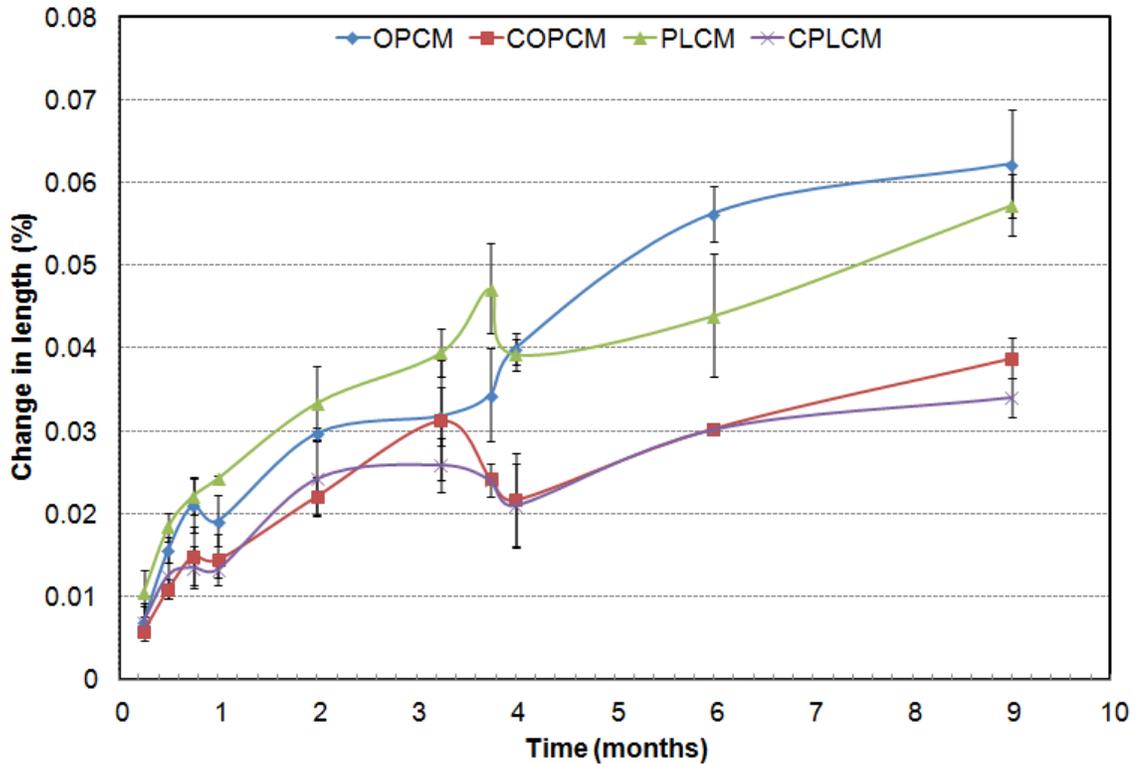
Figure 4-8: Expansion of mortar bars

Another common physical parameter used to interpret the resistance of cement to sulphate attack is expansion. As discussed in Chapter 2, this test method is mainly relevant when testing for conventional sulphate attack. In this type of sulphate attack, the main deterioration is caused by the formation of ettringite rods in hardened concrete. In turn, ettringite rods cause expansion of the concrete. Inherently, thaumasite does not cause expansion, but rather loss of cohesion. Therefore, the ASTM C1012 standard test was modified to examine if ettringite was also being formed, causing expansion, in a 5% MgSO_4 solution at 5°C. As well, this test was useful to investigate if the main damage induced by thaumasite is due to expansion. Therefore, the ASTM C1012 standard was modified to assess the expansion of both hydrated and carbonated mortar bars at 5°C. The expansion of the hydrated and carbonated mortar bars, over the exposure period, is presented in Figure 4-8.

Up to 4 months, the largest expansion was recorded for hydrated PLC specimens. Subsequently, hydrated OPC specimens expanded more for the remaining of the exposure period. The fact that both hydrated and carbonated cement pastes experienced expansion in a range of 0.03 to 0.06% was indicative that ettringite could be formed in cement pastes exposed to a 5% MgSO_4 solution at 5°C.

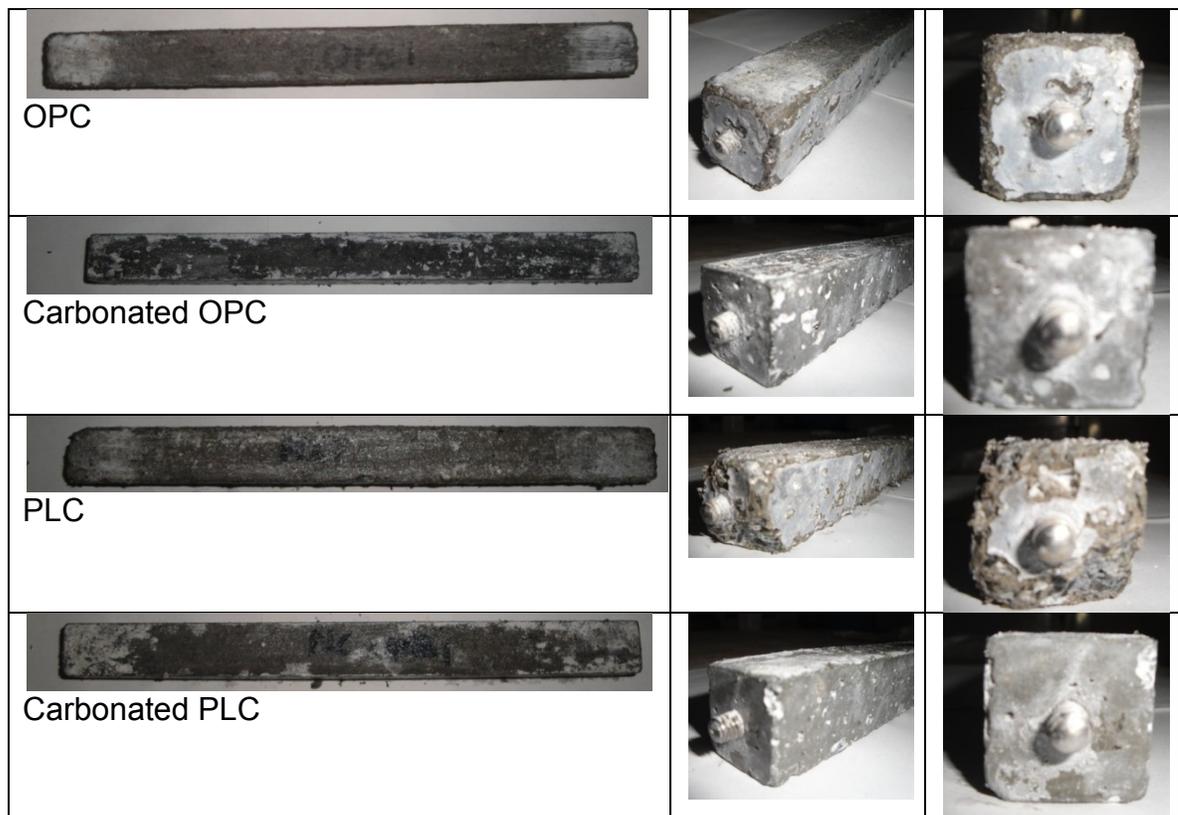
Figure 4-9: Mortar bars following 10 months of exposure to $MgSO_4$ at $5^\circ C$

expansion was not the best indicator for TSA-induced damage since the hydrated PLC mortar bars also experienced significant cracking, spalling and mass loss, which did not translate to length change. It is demonstrated by Figure 4-9 in which hydrated PLC mortar bars were strongly deteriorated.

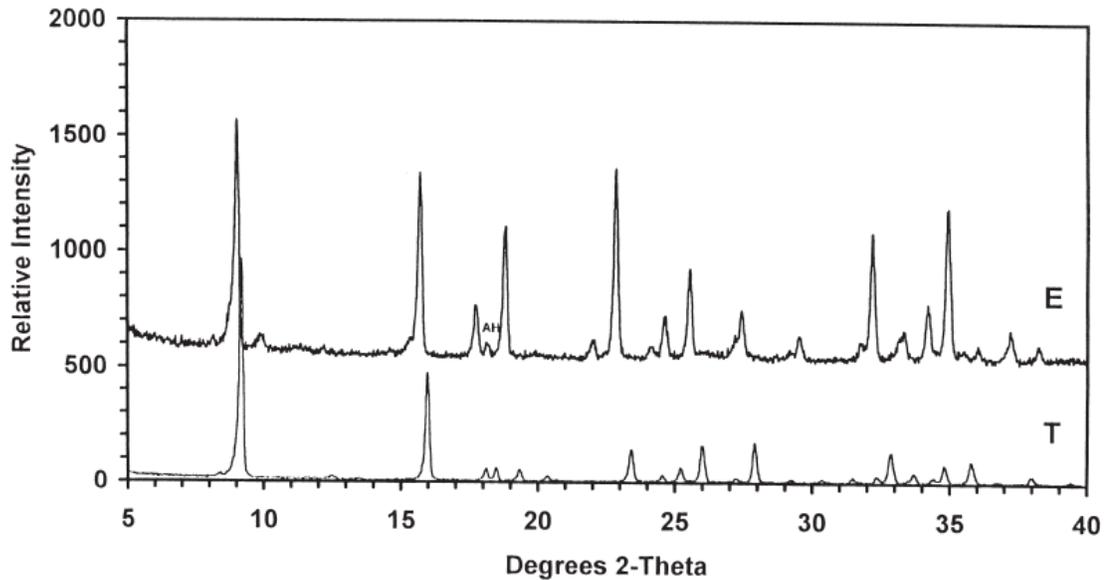
Figure 4-10: XRD patterns of ettringite (E) and thaumasite (T) (hartshorn et al., 1999)

of ettringite can be confirmed by its characteristic peaks at around 15.8, 18.9, 22.9, 25.5° 2θ (Kakali et al. 2003).

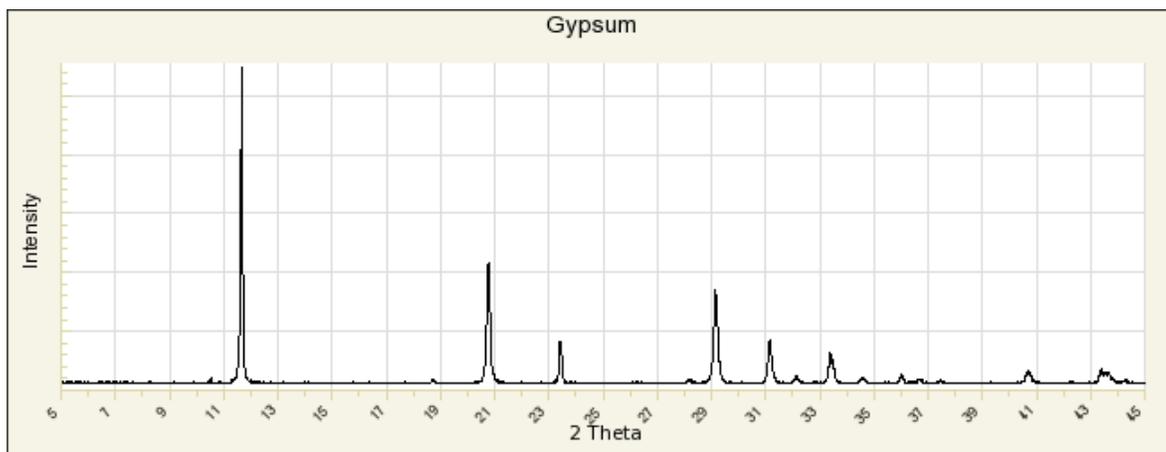
Figure 4-11: XRD pattern of Gypsum

The XRD pattern of gypsum is shown in Figure 4-11(Downs, 2006).

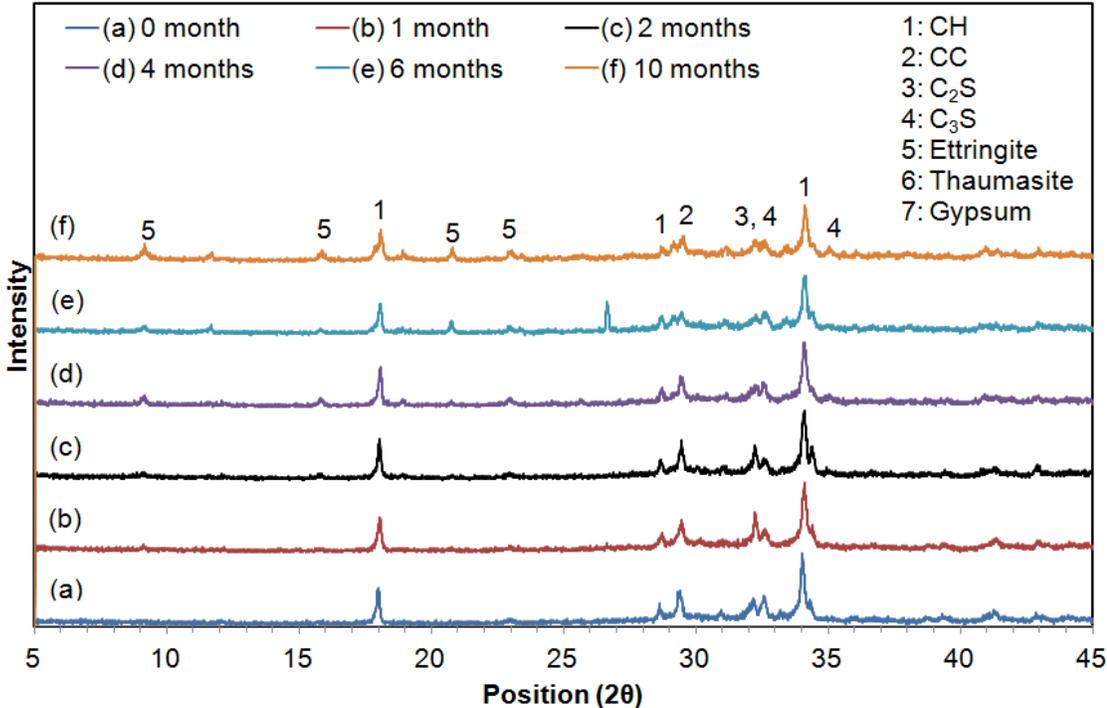
Figure 4-12: XRD pattern of hydrated OPC specimens

Every batch of cement paste cubes were tested for XRD throughout the exposure period. Figure 4-12 shows the XRD patterns for OPC specimens from 0 to 10 months of exposure to the sulphate solution. The 0 month measurement corresponds to the XRD pattern observed prior to submerging the specimens in the sulphate solution.

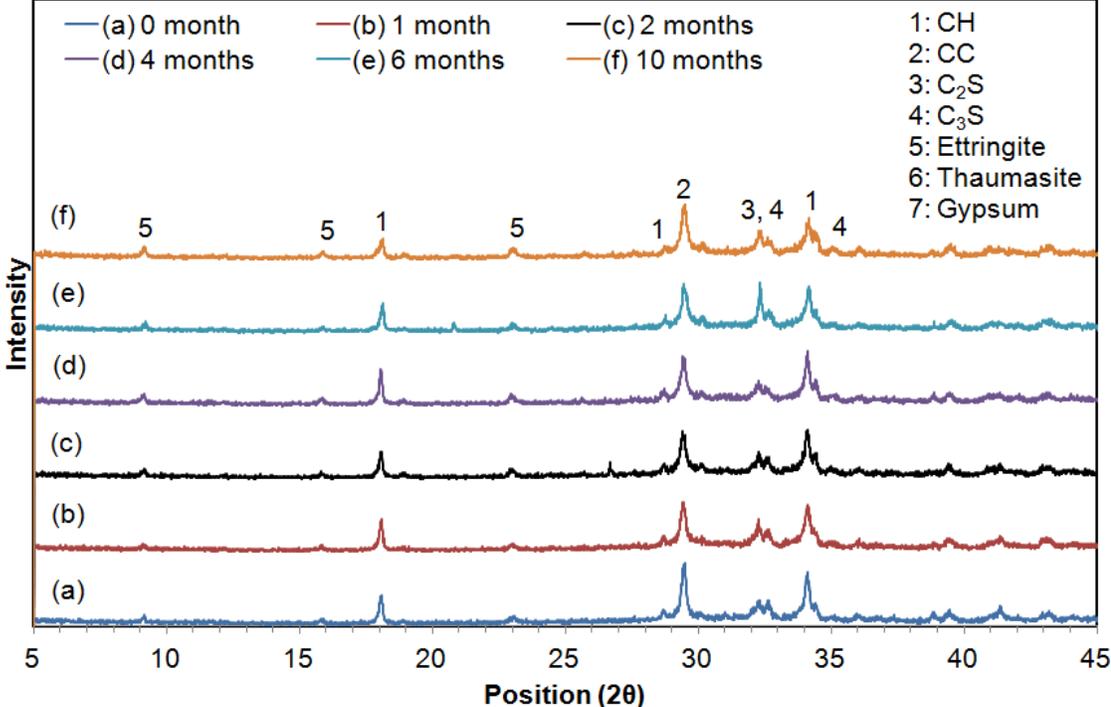
Figure 4-13: XRD patterns of carbonated OPC specimens

Figure 4-13 displays XRD patterns for carbonated OPC specimens throughout the exposure, from 0 to 10 months.

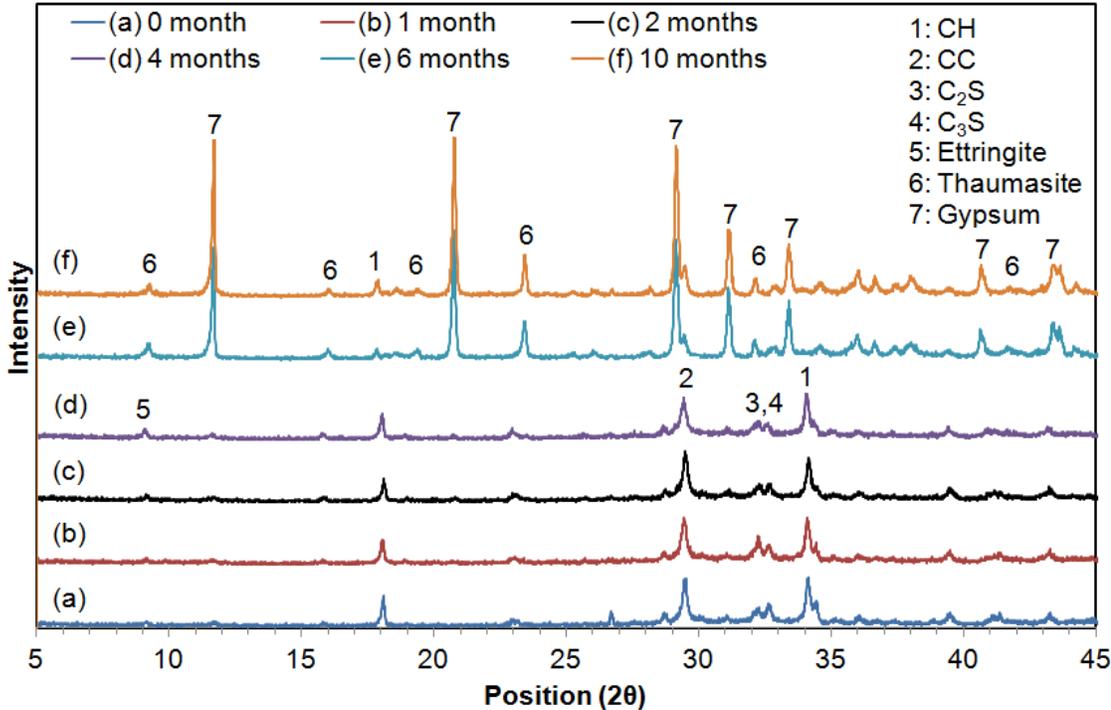
Figure 4-14: XRD patterns of hydrated PLC specimens

the analysis in all batches. Therefore, at 6 and 10 months, when specimens had spalled, the lost material was collected and tested for the XRD results.
