Improved Resistance to Thaumaside Formation in Cement Pastes by Early Age Carbonation

Department of Civil Engineering and Applied Mechanics

McGill University

A thesis submitted to McGill University in partial fulfillment of the requirements for
the degree of Master of Engineering

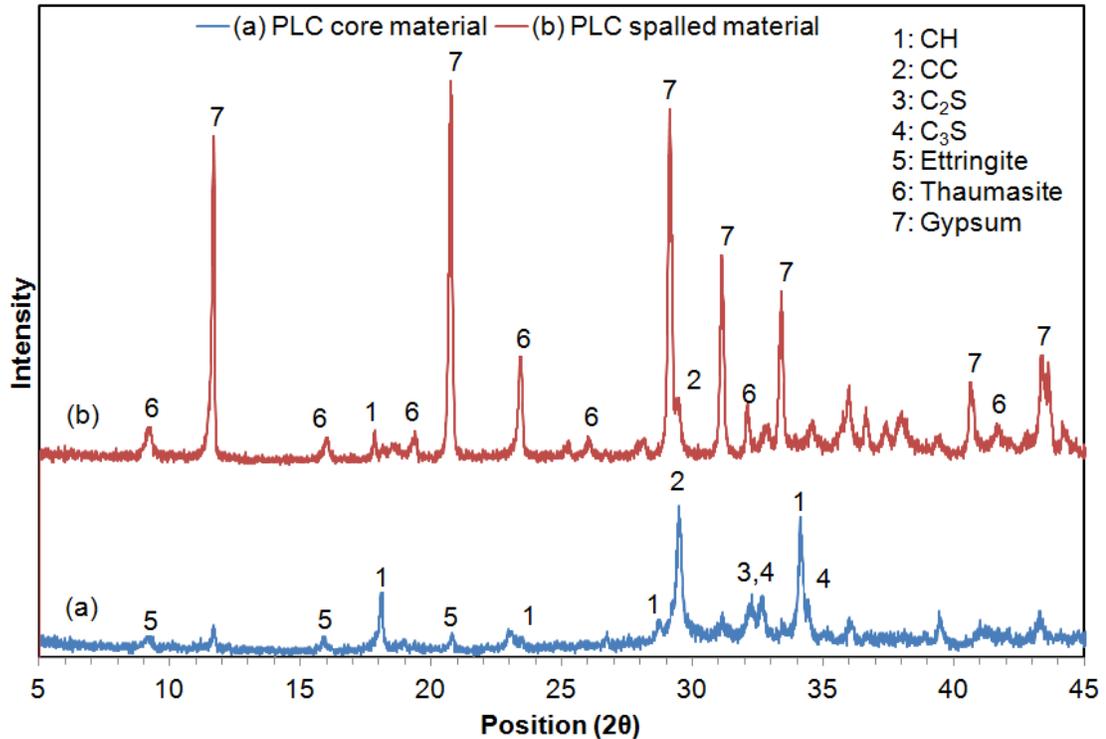
Figure 4-15: XRD patterns of spalled and core of hydrated PLC specimen

In order to assess the mineralogy of the core of deteriorated PLC specimens, phase analysis was also performed on the core of the specimen at 6 months of exposure. Figure 4-15 shows the XRD pattern of the spalled material versus the XRD pattern of the core material at 6 months of exposure.

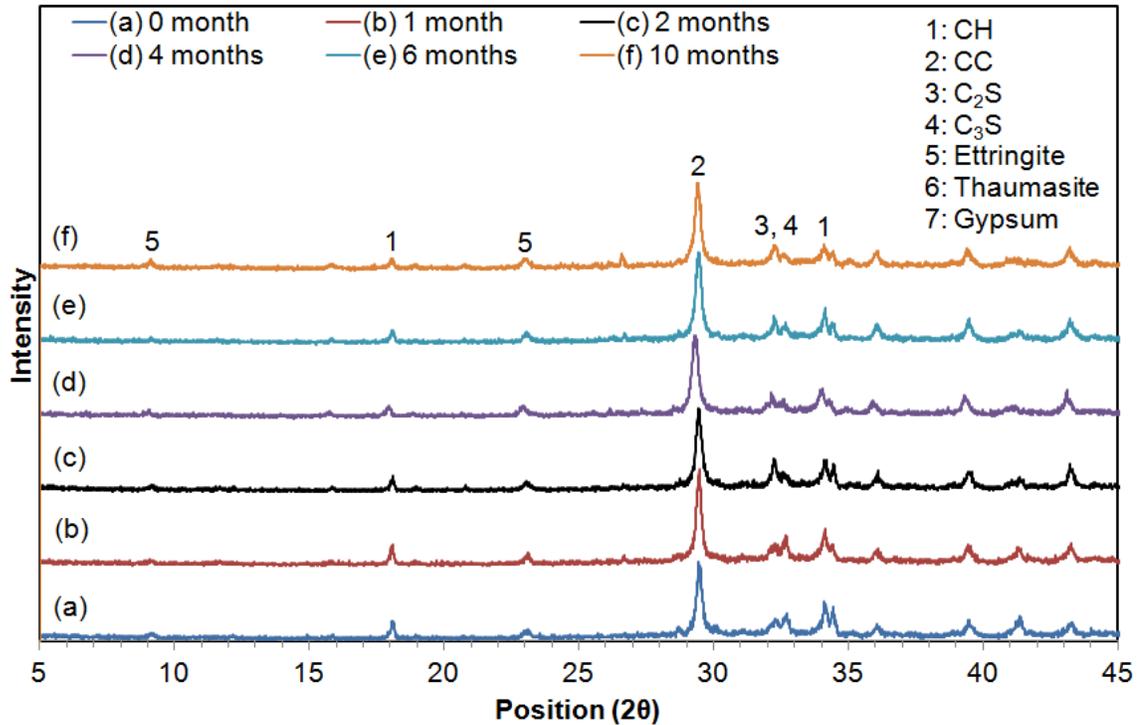
Figure 4-16: XRD patterns of carbonated PLC specimens

Finally, Figure 4-16 presents XRD patterns corresponding to carbonated PLC specimens taken throughout the deterioration, from 0 to 10 months of exposure. As no material had spalled during the first 10 months of the exposure period, the powder that was tested was taken from the outer surface of the cement paste cubes, similarly to OPC and COPC.

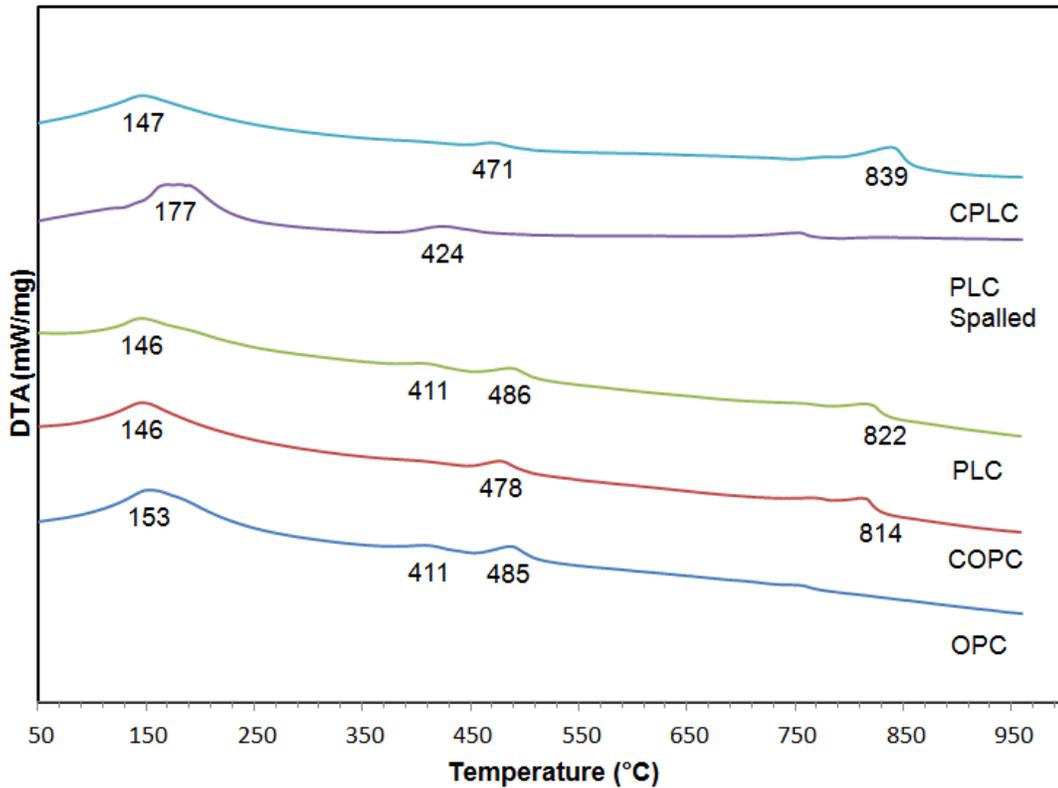
Figure 4-17: DTA of cement pastes at 10 months of $MgSO_4$ exposure

The DTA results are shown in Figure 4-17. The peak observed in all instances at approximately 150°C, except in the case of spalled PLC, was attributed to the decomposition of bound water. It was seen that the spalled PLC material was affected by thaumasite, which was observable by the mineralogical decomposition. There was a broad endothermic peak ranging from approximately 130°C to 220°C. This peak was attributed to the decomposition of thaumasite, which has an endothermic peak at approximately 130°C (Kakali 2003). The endothermic peak at approximately 820°C in COPC, PLC and CPLC was associated to crystalline calcium carbonates. Therefore, it was possible to confirm the presence of thaumasite using DTA, and reinforce the notion that the spalled PLC material was strongly affected by the deterioration.

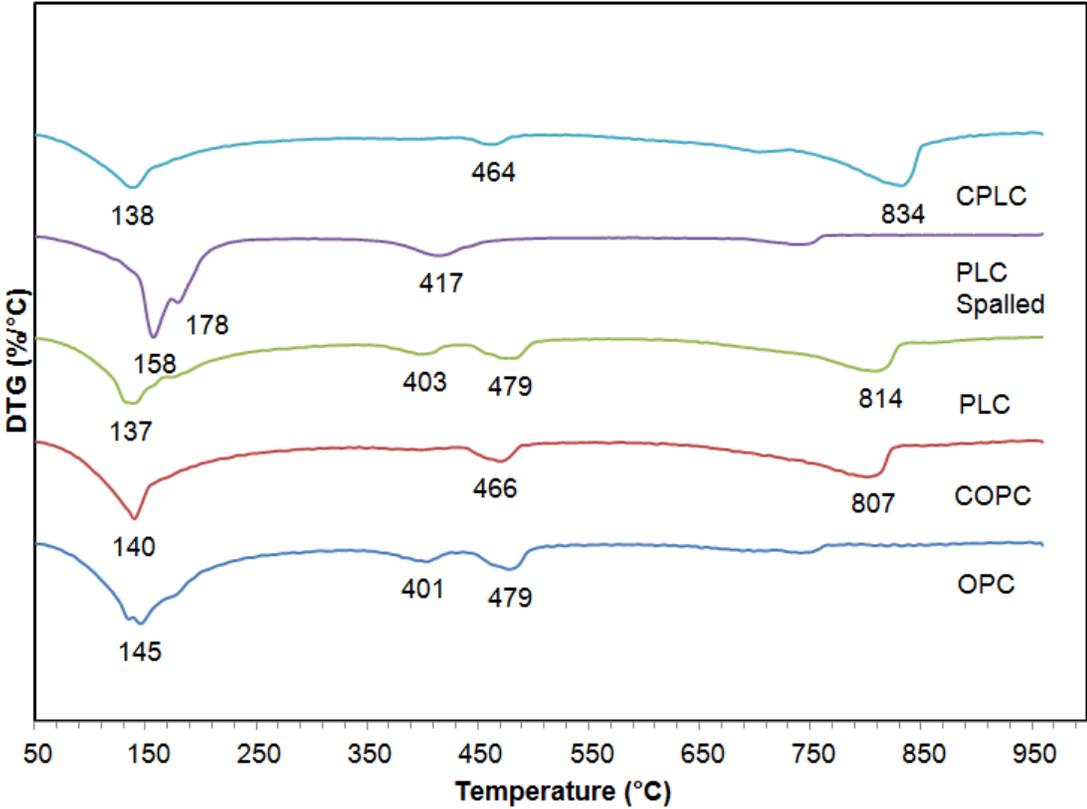
Figure 4-18: DTG of cement pastes at 10 months of MgSO₄ exposure

of thaumasite and gypsum. The dehydration of ettringite and other hydration products took place at lower temperature between 137 – 145 °C in all cements unaffected by sulphate attack.

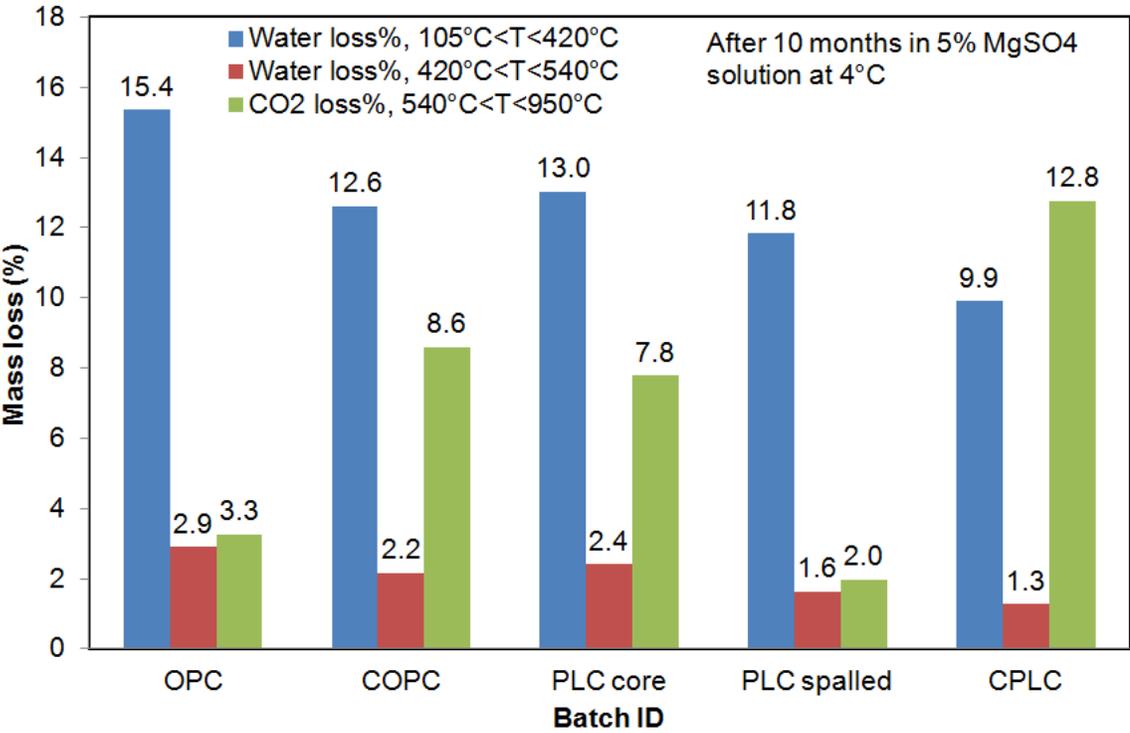
Figure 4-19: Quantitative TG analysis of cement paste at 10 months of MgSO₄ exposure

thaumasite. In the case of carbonated specimens, the value of CO₂ loss was close to CO₂ content determined by carbon analyzer (Table 4-2). It was 6.87% by carbon analyzer versus 8.6% by TG in carbonated OPC, and 11.4% by carbon analyzer versus 12.8% by TG in carbonated PLC. It was noted that the CO₂ content was measured on a surface layer of 2-mm thick in carbonated cements. This result indicated that the carbonates produced from carbonation curing were not consumed, and therefore thaumasite was not formed.

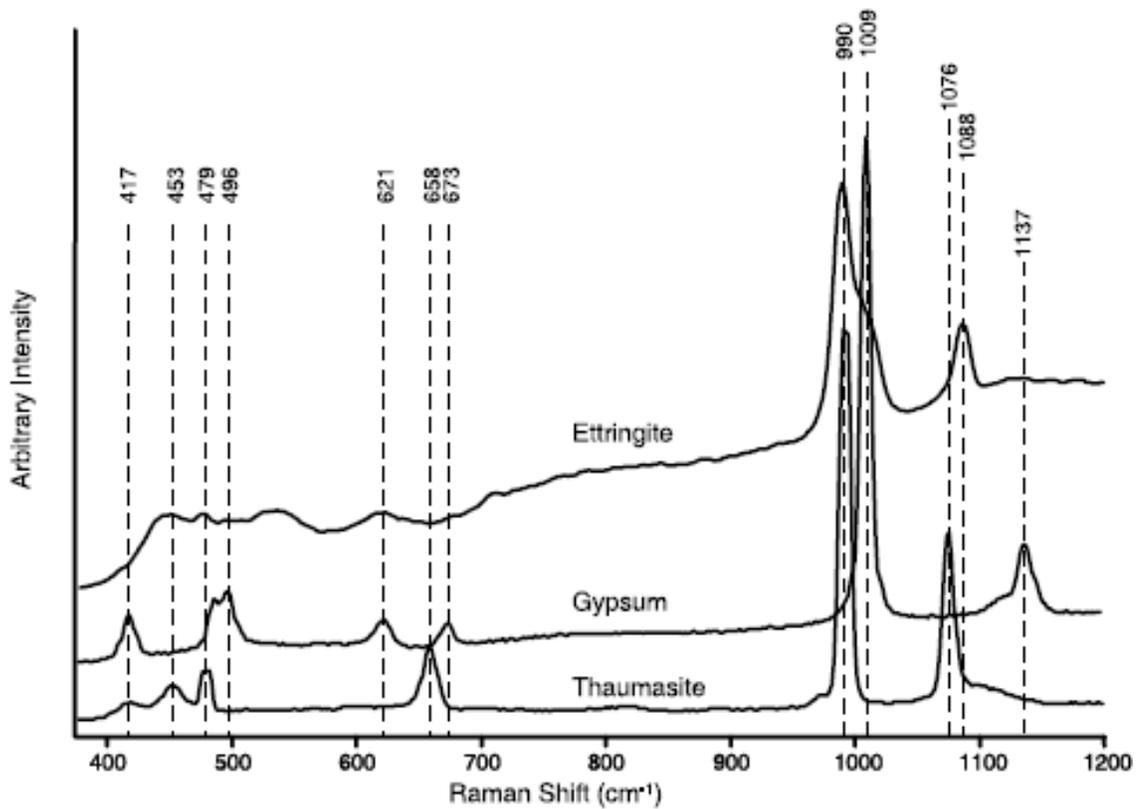
Figure 4-20: Raman spectra of thaumasite, ettringite and gypsum (Sadananda et. al. 2002)

The presence of thaumasite and the effect of TSA on the mineralogical composition of cement paste specimens was also assessed using Raman spectroscopy. This type of experiment allows for the identification of thaumasite due to a distinct peak at 658 cm^{-1} , which corresponds to sulfur. The peaks corresponding to thaumasite, gypsum and ettringite are shown in Figure 4-20.

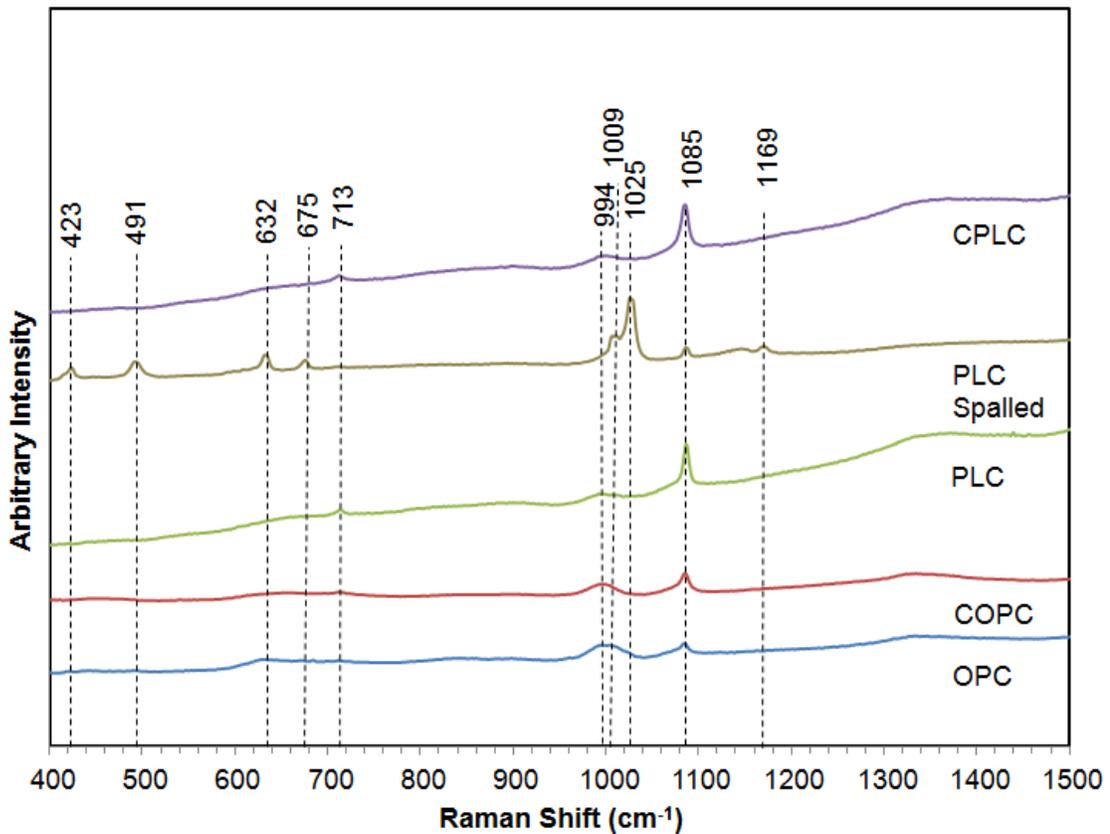
Figure 4-21: Raman spectra of cement paste cubes exposed to sulphate attack for 10 months at 5°C

Therefore, powder taken from the outermost layer was used for the experiment, similarly to previous XRD experiments. The Raman spectra of OPC, COPC, PLC core, PLC spalled and CPLC specimens are shown in Figure 4-21.

The peak recorded at 1085 cm^{-1} was also consumed in the spalled material compared to all other specimens. This peak likely corresponded to

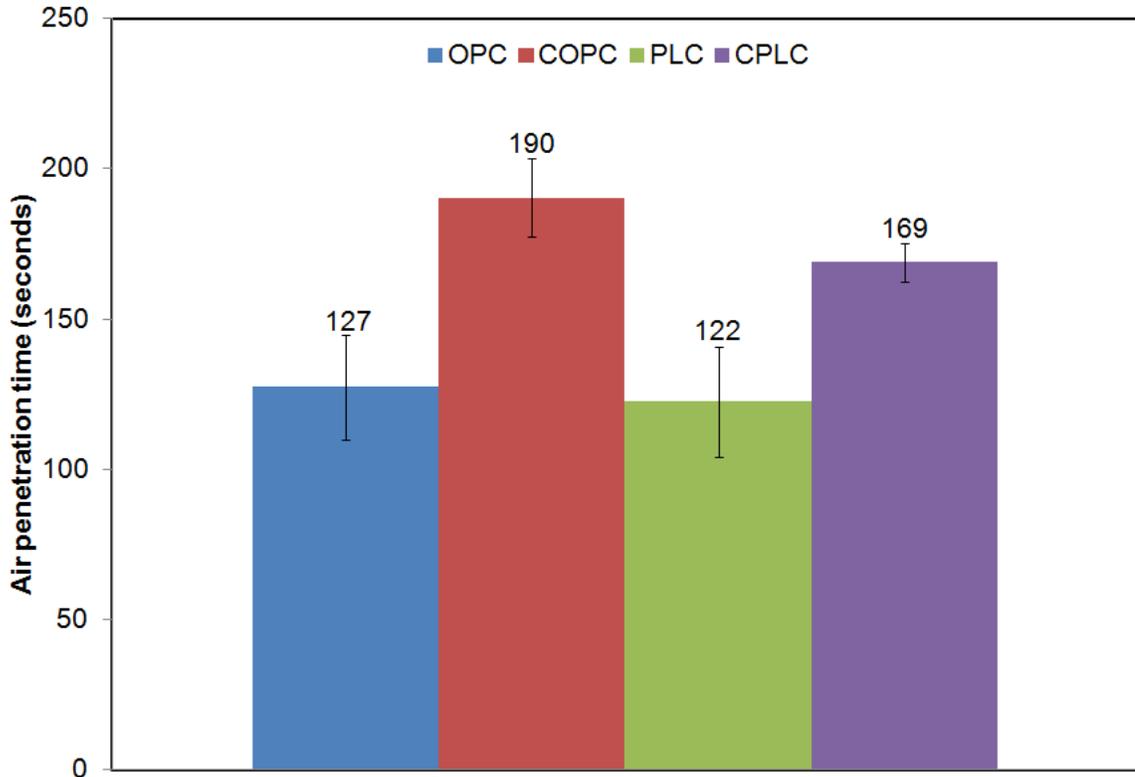
Figure 4-22: Surface air permeability of cement paste specimens

To examine the difference between hydrated and carbonated specimens, surface air permeability was determined. Indeed, XRD results showed that thaumasite was being formed from the surface inwards. These results were validated using TGA, DTA, and Raman spectroscopy. From this information, it was seen that surface permeability played a predominant role in the damage experienced by TSA. Surface air permeability was considered an important indicator that could explain the difference in deterioration and microstructure of the specimens exposed to the sulphate solution. The surface air permeability results are presented in Figure 4-22.

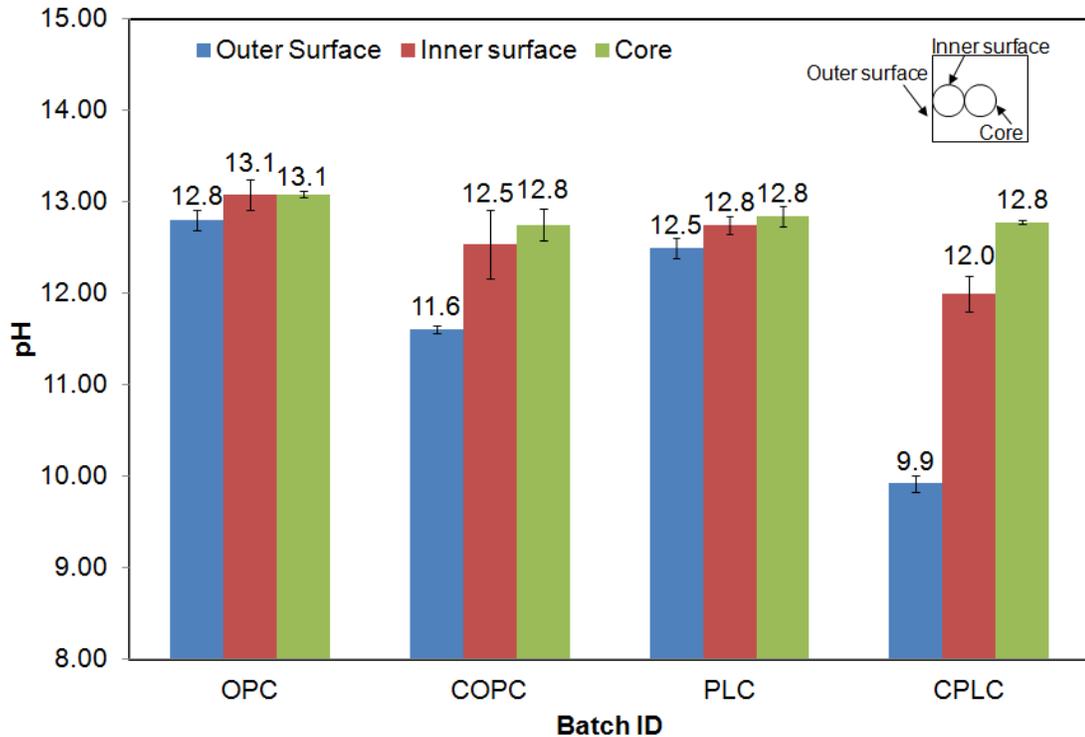
Figure 4-23: pH of cement paste cubes

The pH of the specimens can have an influence on whether or not thaumasite formation will occur. It has been found that the higher the pH, the higher the likelihood of thaumasite being formed (Crammond 2003). The pH of the specimens measured at the outer surface, inner surface and core using a pH meter equipped with a flat sensor head of 9mm in diameter is shown in Figure 4-23.

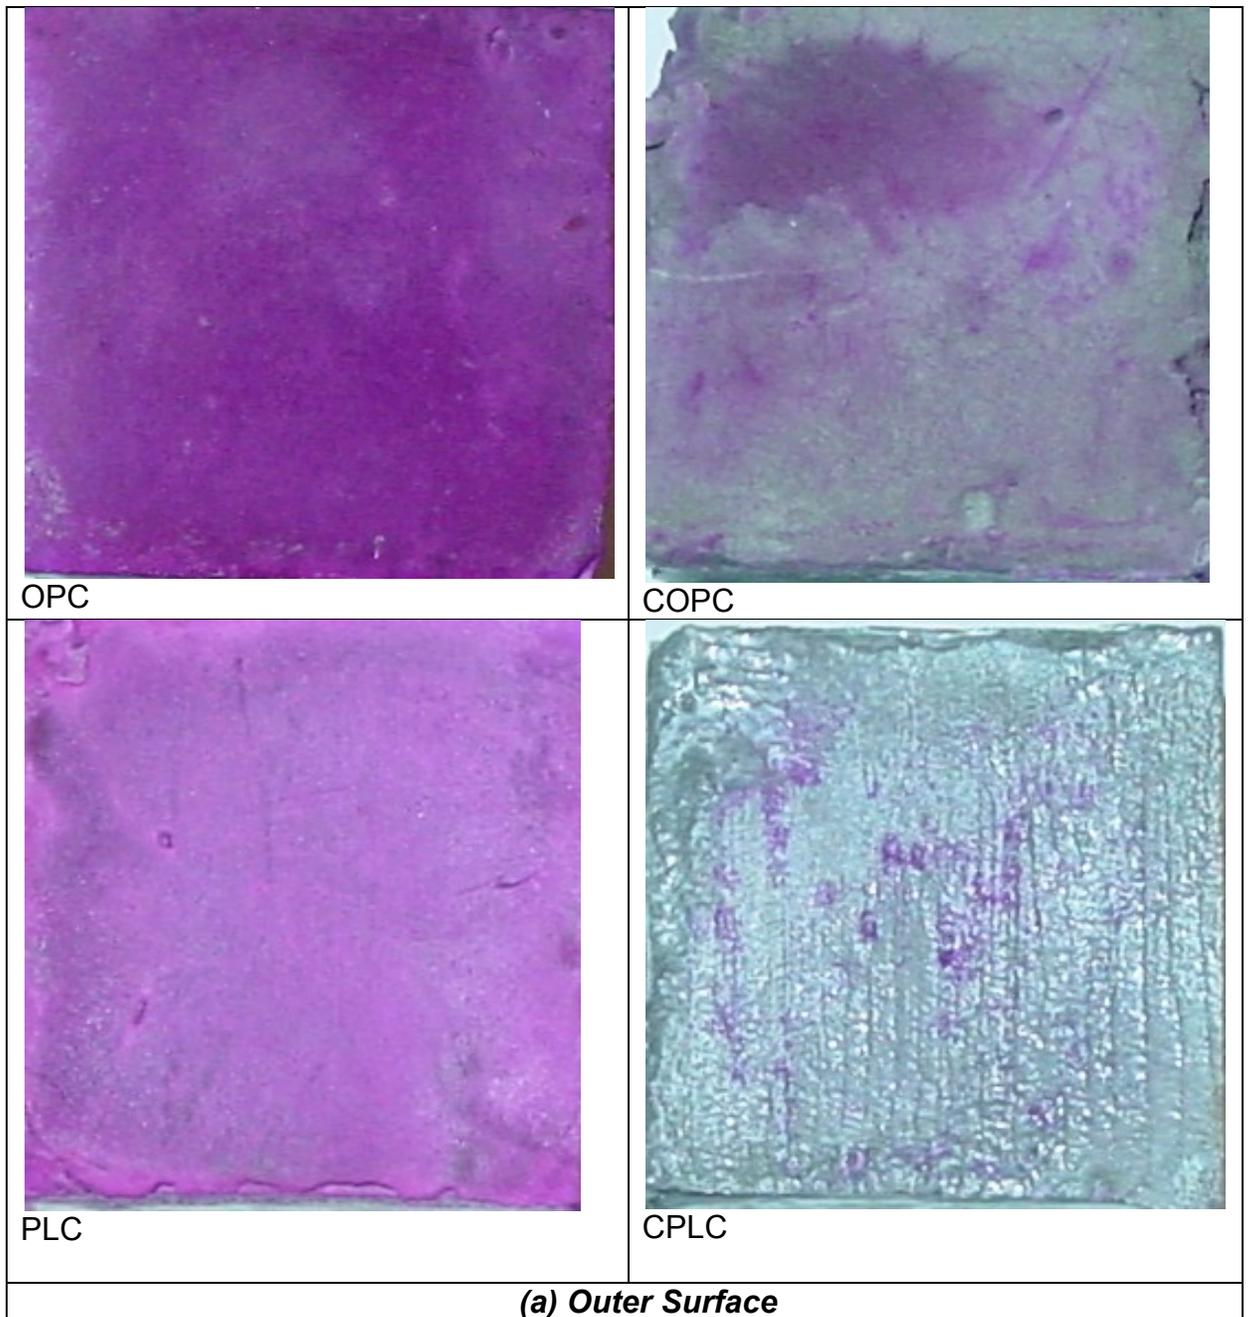
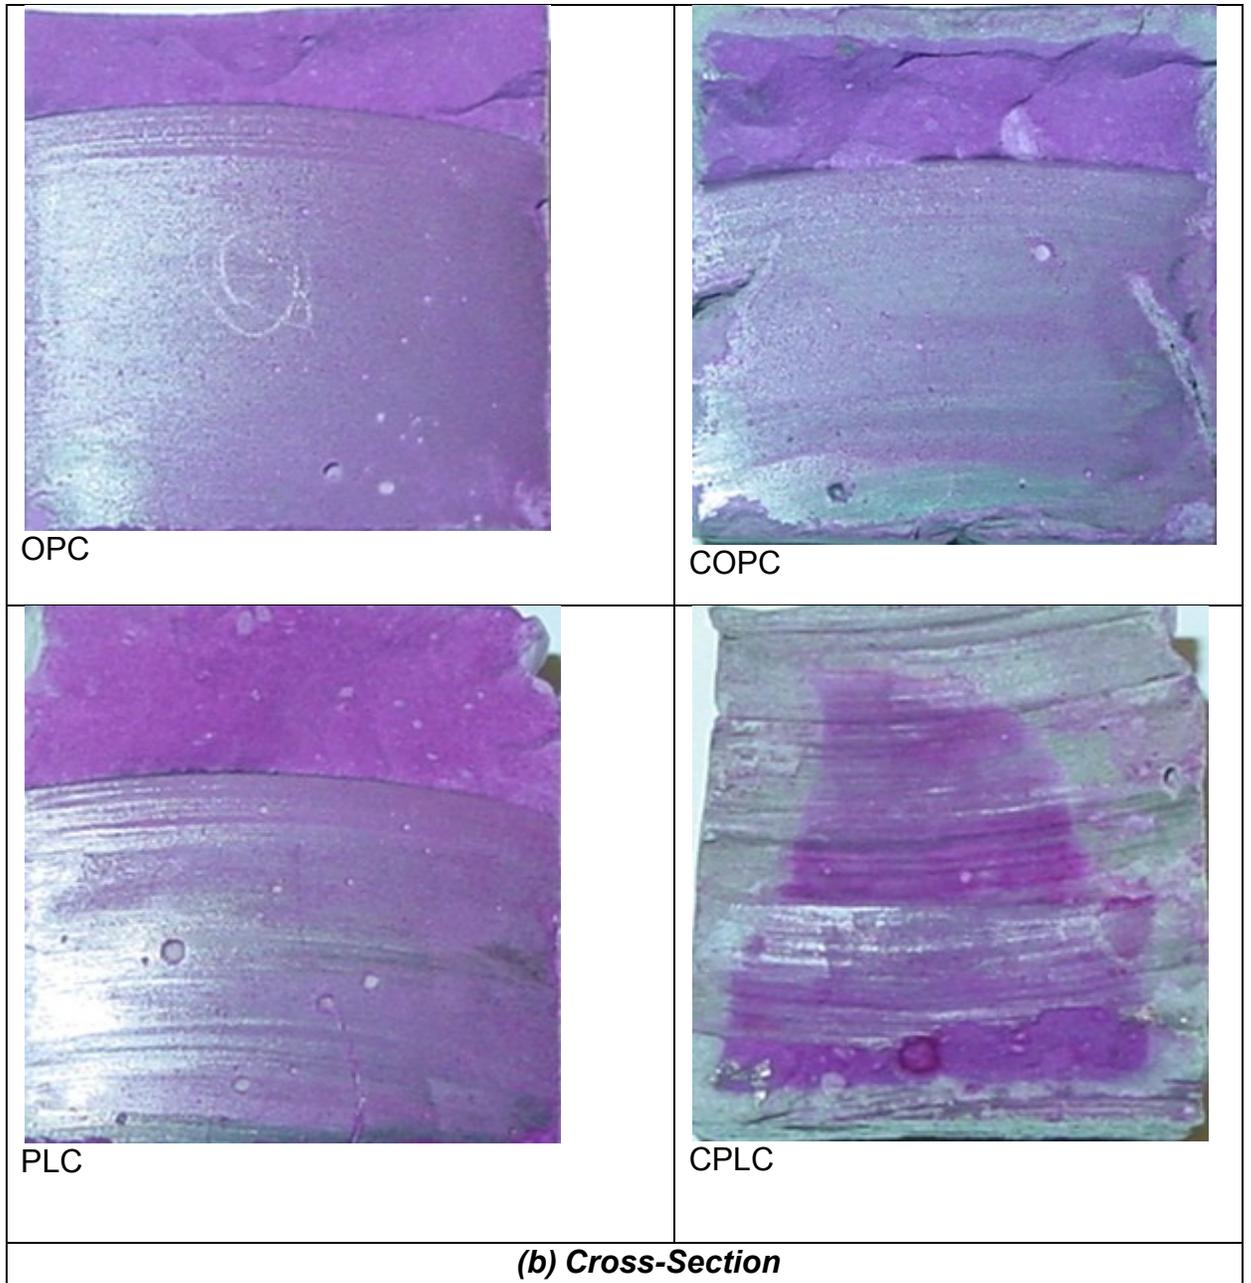
Figure 4-24: Phenolphthalein photographs at the outer surface (a) and cross-section (b) of specimens

apparent at the cross-section, but still noticeable when comparing hydrated PLC and carbonated PLC specimens. It was seen that carbonation had not reached the core of specimens. Therefore, the phenolphthalein tests confirmed the pH readings.
