STREAMBANK STABILITY IN OPEN CHANNEL
DRAINAGE IN THE OTTAWA-ST. LAWRENCE LOWLANDS

A Thesis
Submitted to the
Faculty of Graduate Studies and Research
in Partial Fulfillment for the
Degree of Master of Science

Department of Agricultural Engineering
McGill University
Montreal, Quebec
September, 1988

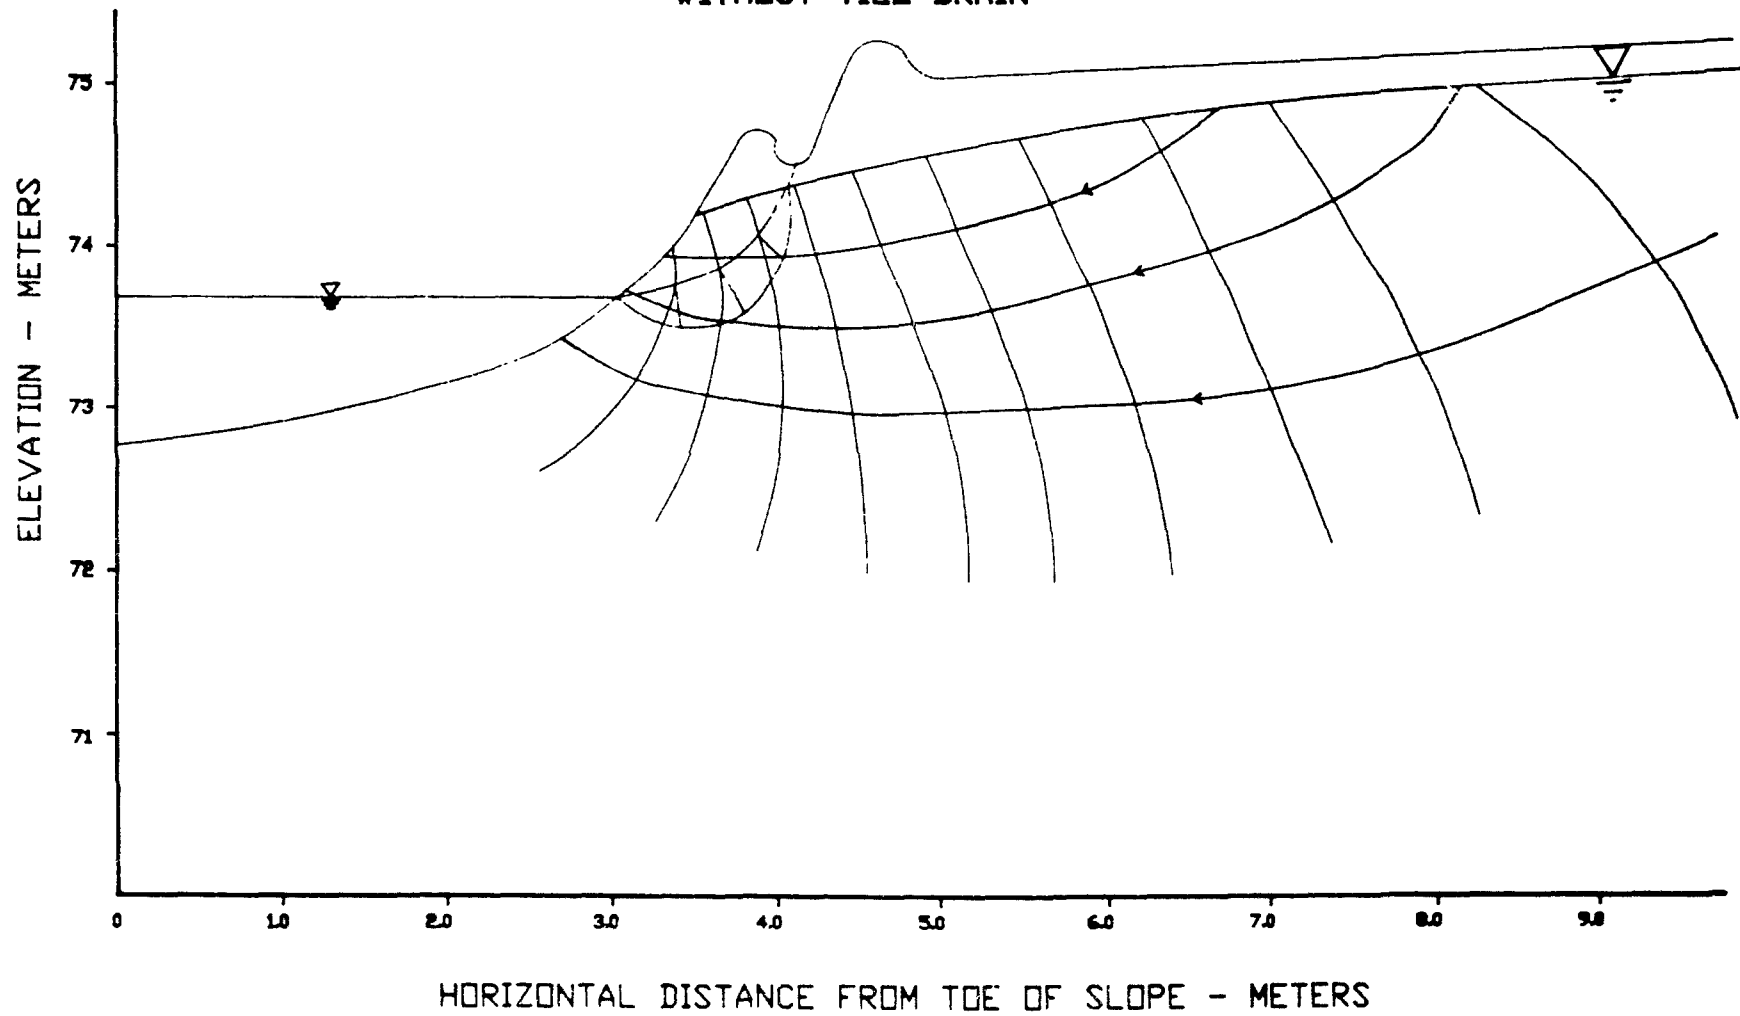
Figure 12a

NORTH MORROW MUNICIPAL DRAIN
WITHOUT TILE DRAIN

Historically, the North Morrow along the test site has always proven troublesome. Continual slumping on both sides of the watercourse has generated large amounts of soil material to be washed away, resulting in a larger than designed channel capacity. The average grade of the channel within the test section is 0.1%, a little steeper than the average slope of the entire drain nevertheless quite flat. Despite the enlarged capacity of the watercourse within the test section, a high water level, approximately 0.75 m, would remain throughout most of the spring. At this water level, flows would remain negligible, indicating a back water problem. Scouring was not observed and is unlikely in the process of rendering the streambank unstable.

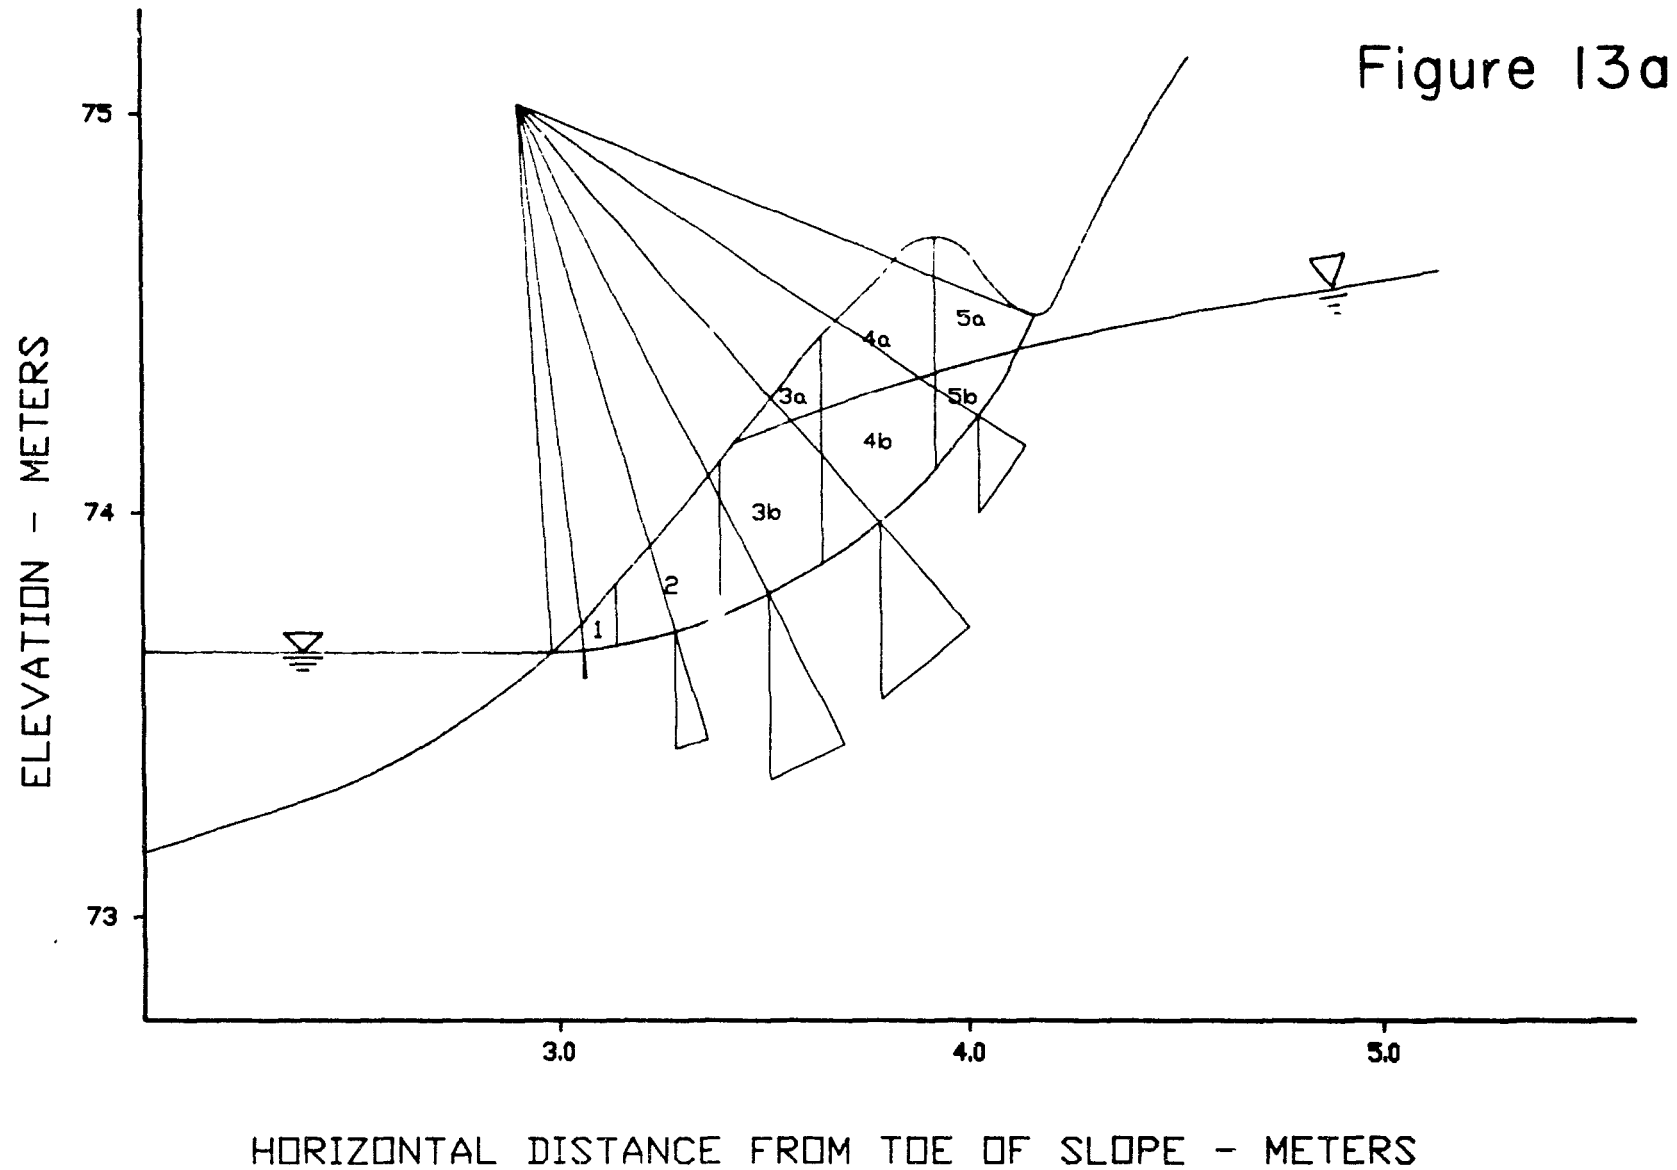
NORTH MORROW M.D. METHOD OF SLICES
WITHOUT TILE DRAIN

Appendix "F" outlines the detailed calculations to determine the safety factor using equation 2. Table F-1 illustrates an increase of 33% in stability for the North Morrow between a tiled and untiled streambank. Table F-2 shows an increase of 28% in stability after the installation of an interceptor tile in the Hammond.

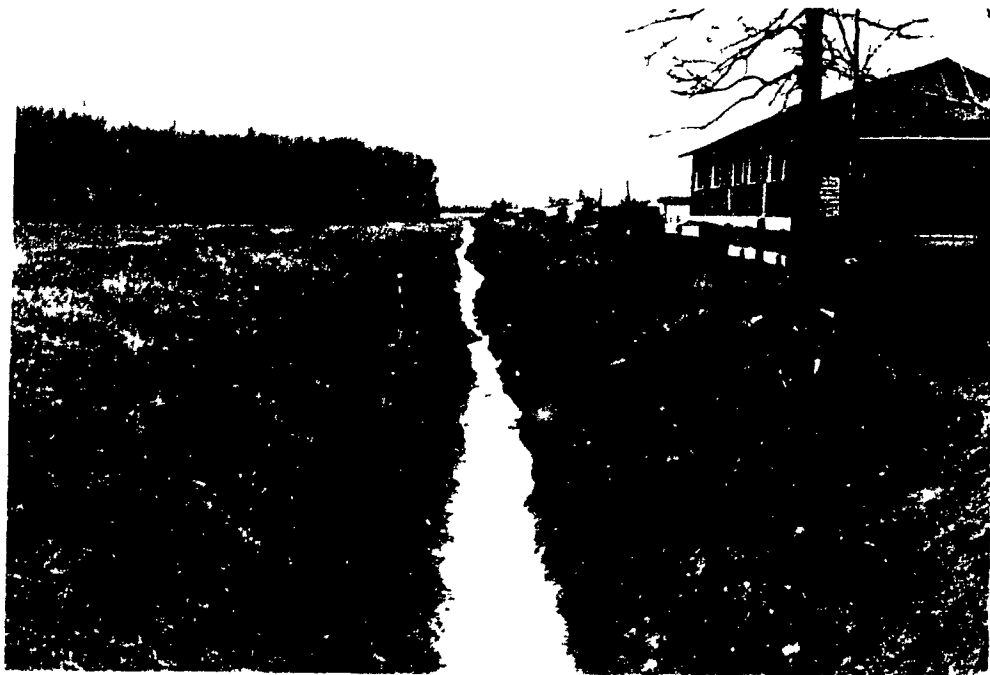
EXHIBIT #1 VARS DRAINAGE OUTLET

View of open channel in Spring, 1984. Sideslopes were constructed 2h:1v and hydroseeded. Lateral interceptor tiles were installed prior to excavation to stabilize ditchbanks.
