# **The dynamics of glacial till erosion: hydraulic flume tests on samples from Medway Creek, London, ON**

Thesis

Department of Civil Engineering and Applied Mechanics

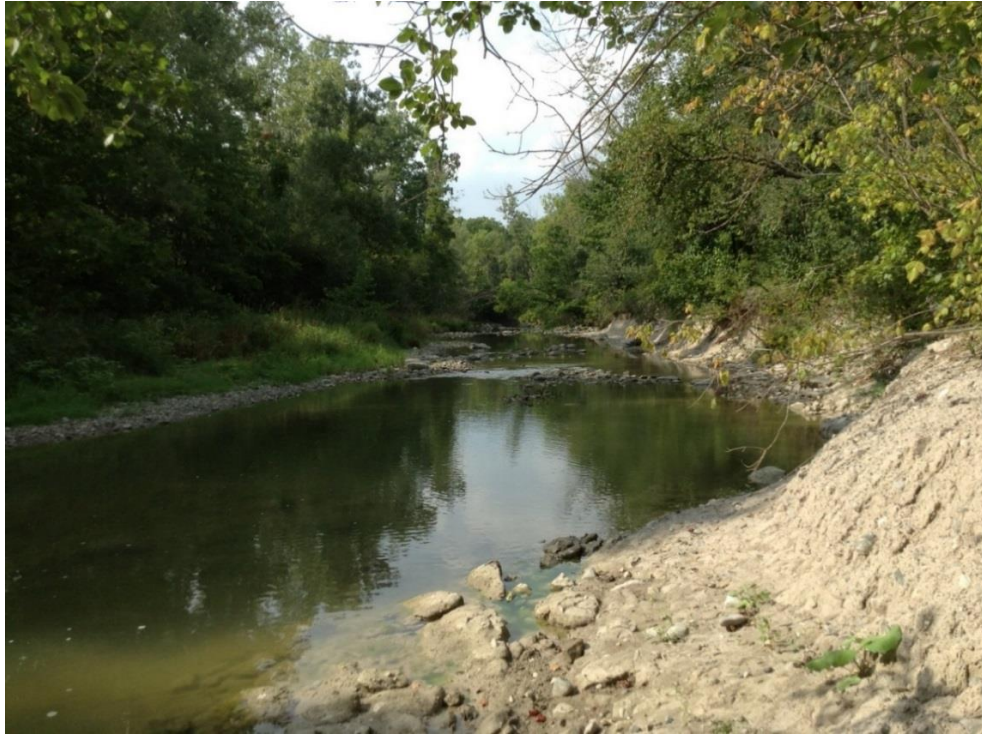
Figure 4: Downstream view of study site on day 1

Samples were collected from Medway Creek to be used in hydraulic flume tests in the McGill University hydraulics laboratory. They were taken from the right bank in the study area outlined in Figure 2, and seen in Figure 4. Samples were collected by hand in the form of large blocks of till that had previously been dislodged from the river bed and were resting on the bed, but still submerged in the river. The river bed material at Medway Creek (Figure 4) is difficult to penetrate with hand tools such as shovels, and the river is an “Environmentally Significant Area” which does not allow any excavating equipment to be used. However, because the samples were collected by hand, they were not subjected to additional stresses from shovels or other extraction equipment and therefore all present damage is assumed due to natural weakness. Care was taken to prevent damage to the samples during extraction and transport.

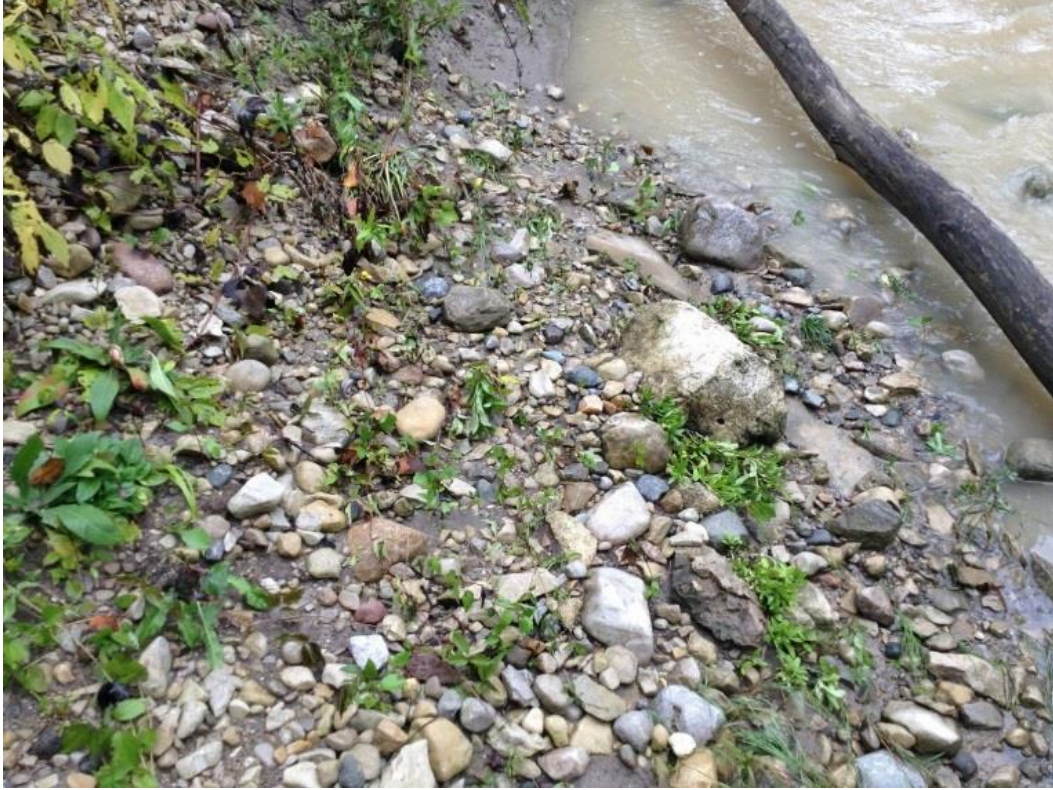
Figure 5: Gravel sample collection site

A sample of the gravel cover was collected from the edge of the river (Figure 5) to be used in the flume studies. The median particle size for the 78 collected gravel particles,  $D_{50}$ , was calculated to be 23 mm (see section 5.2). Bed material samples collected in the reach by Hrytsak (2012), using standard sampling procedures for fluvial gravel, had a  $D_{50}$  of 45 mm. The gravel collected for the flume experiments represents the finer fractions of this river bed material because the larger particle sizes were impractical for the flume and till sample dimensions.

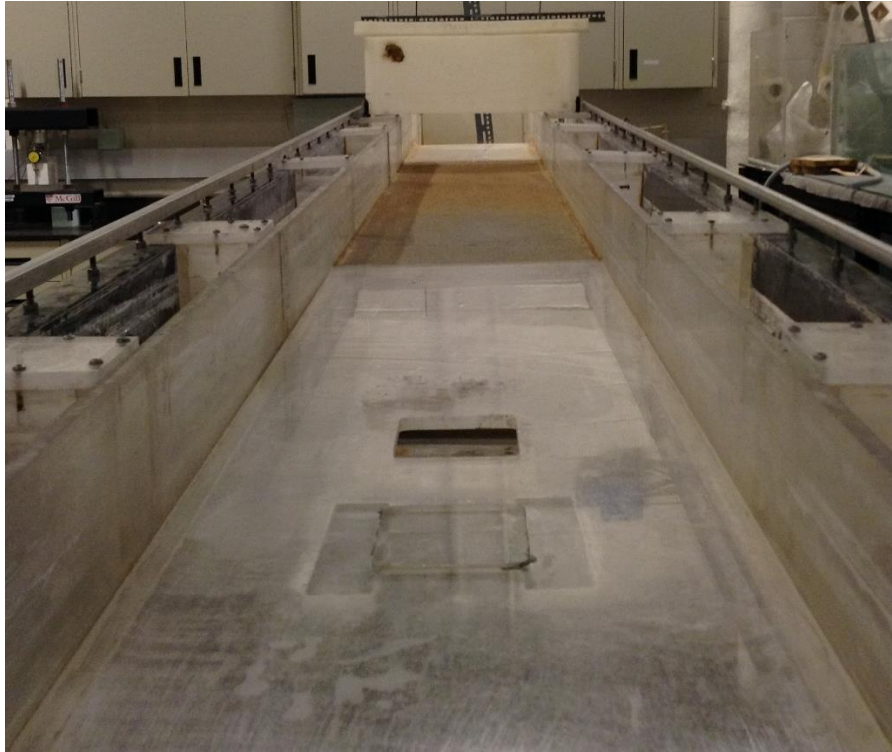
Figure 9: Hydraulic flume channel showing sample location

Each sample was placed in the flume such that the top surface of the sample was flush with the channel floor to ensure no forces were exerted on the sample besides the bottom shear stress of the flow. This was achieved by placing the sample on a height-adjustable platform beneath the flume's plexiglass false floor in a 10 cm x 10 cm hole, located at a distance of 2.5 m from the upstream end of the channel (Figure 9). The platform was adjusted throughout the tests to raise the sample while it eroded so the surface of the sample was level with the flume floor at all times. For some

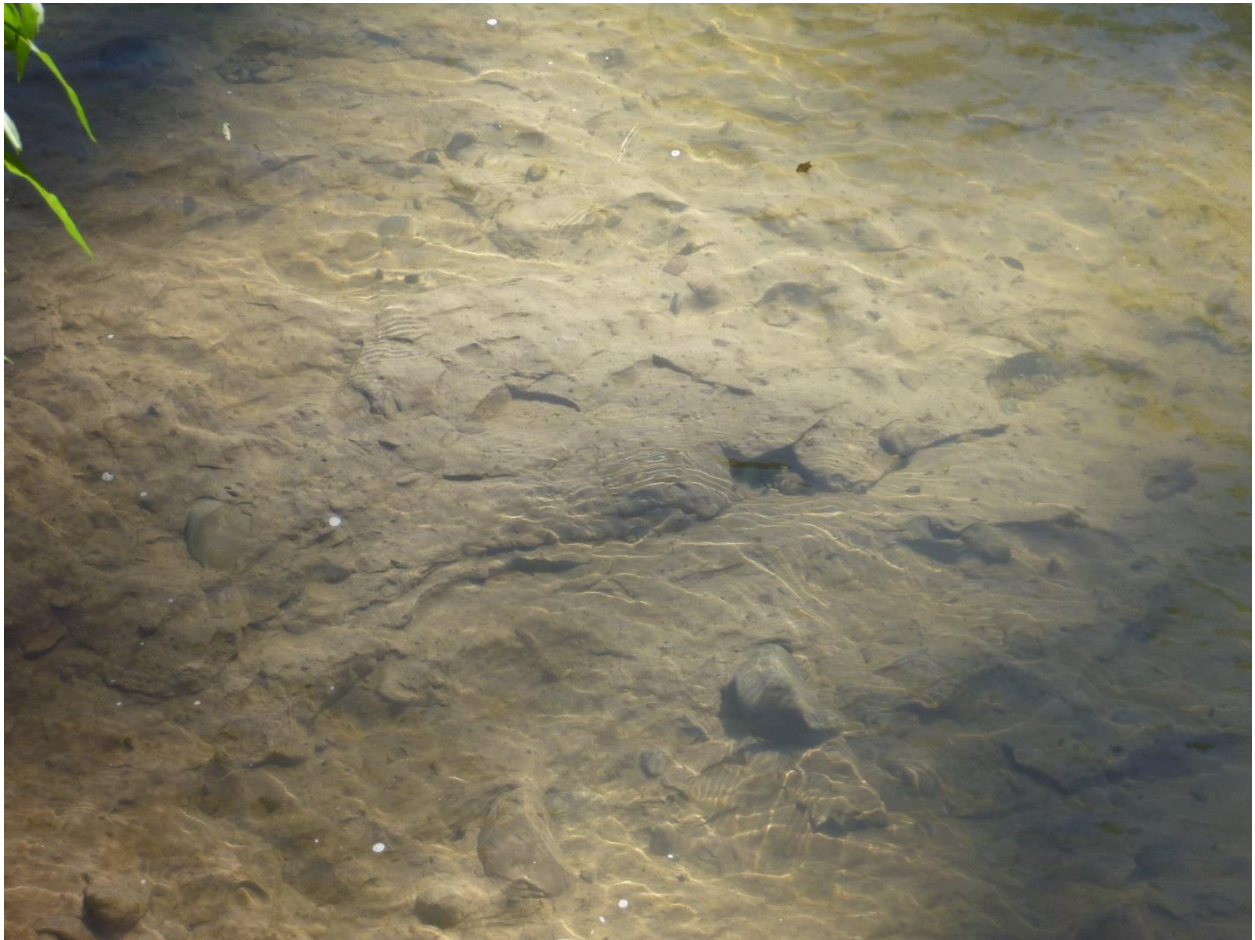
Figure 10: Till bed

The nature of the till in the bed and banks of Medway Creek was examined in the field at the time of sample collection. In-situ observations of the internal structure (joints and bedding), the response of the till under a wetting-and-drying cycle, and the presence of alluvial material in the area were made. Figure 10 is an image of the till bed under water.

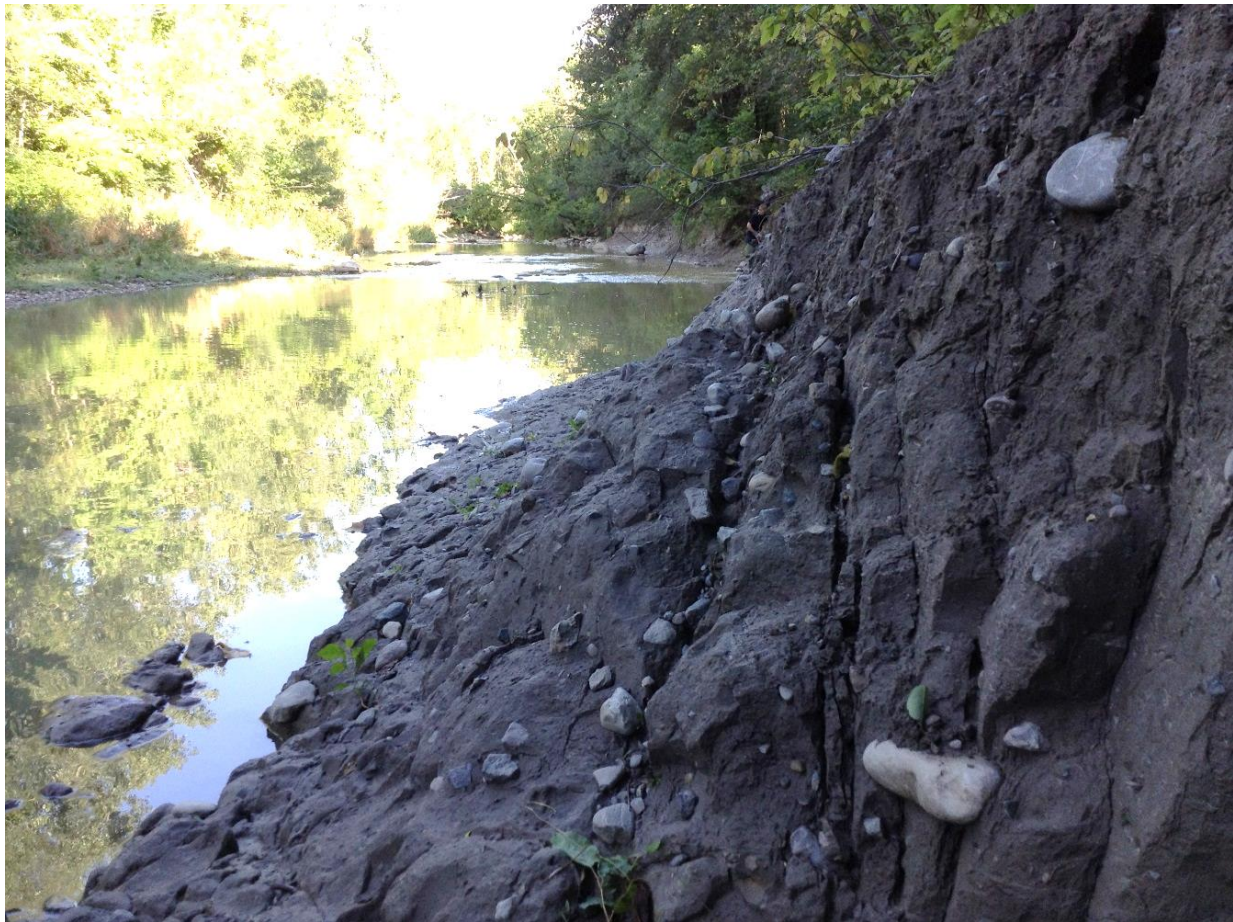
Figure 11: Fractures in till banks

The till was very dense and hard; it could not be penetrated with a shovel by hand and the specific gravity of the samples was later calculated to be an average of 2.36. Observations indicated that the till banks have a natural planes of weakness and defined fractures. In some cases, these fractures were similarly oriented and actual fracture planes were observed (Figure 11). The

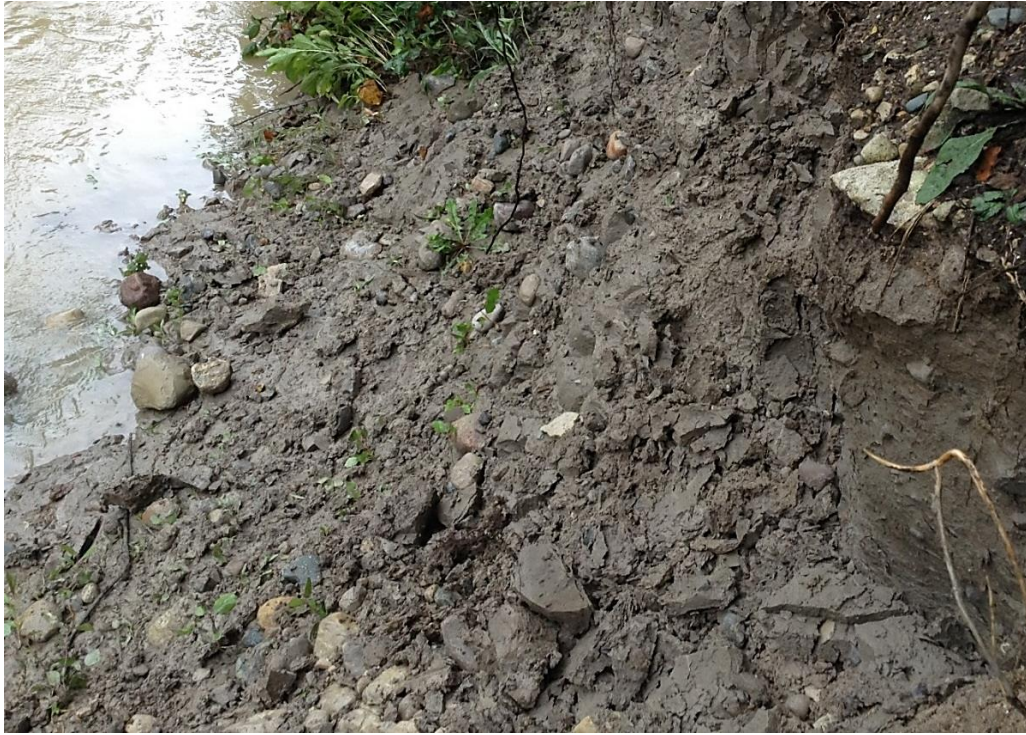
Figure 12: Chunks of till eroded at Medway Creek bank

apparent structure of the material, and the abundance of chunks of till on the bed where erosion had taken place, was evidence of mass erosion (Figure 12). Mass erosion was also observed as block separation under the water (Figure 13). Larger gravel and cobbles could be seen embedded in the till.

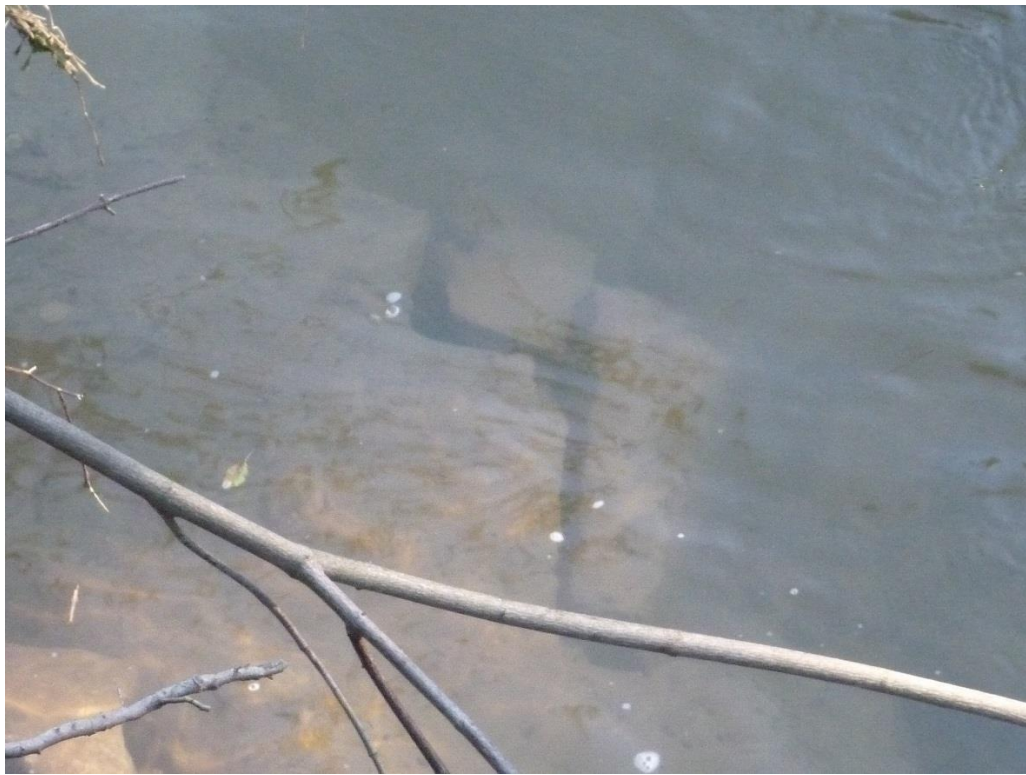
Figure 13: Block separation under water

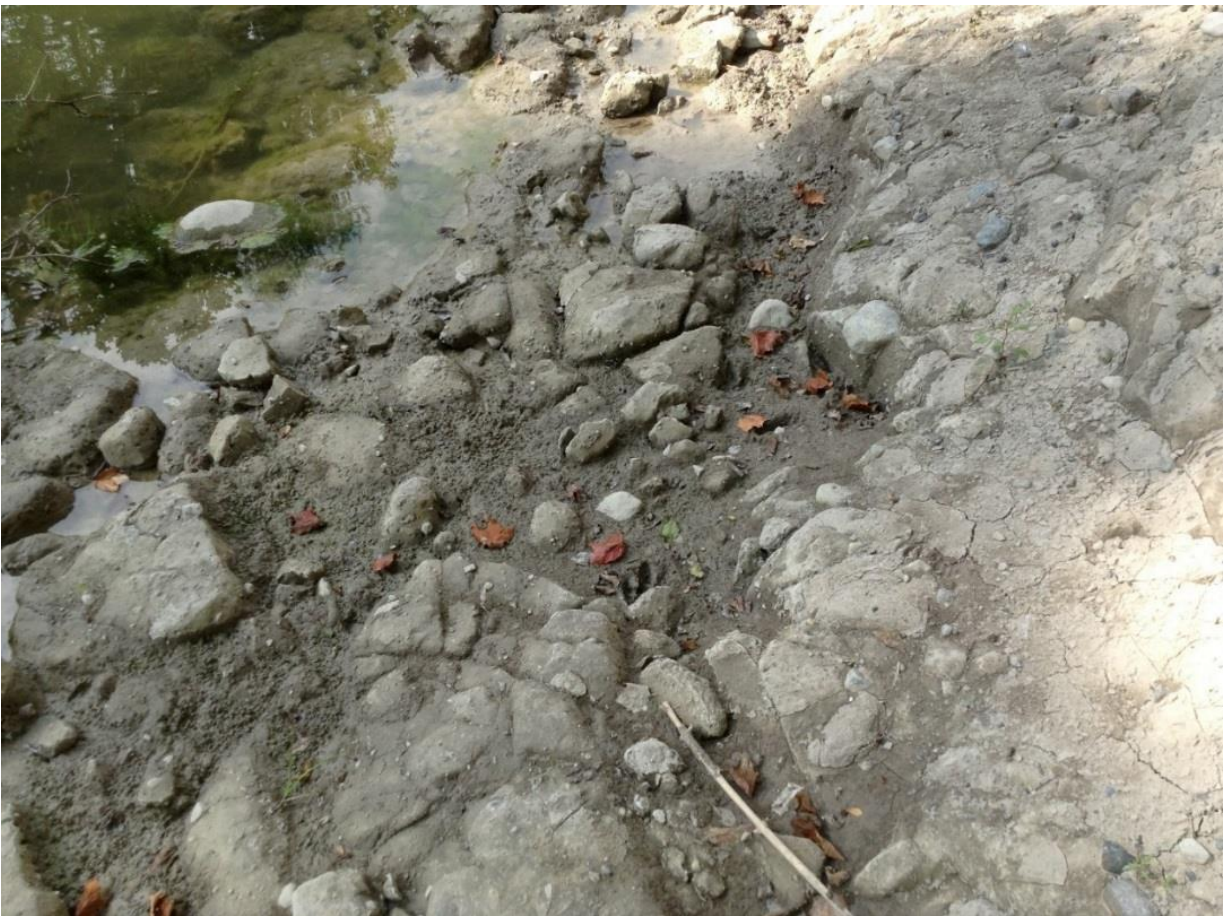
Figure 14: Dry till banks at Medway Creek

The wetting-and-drying cycle appears to weather the material and increase erosion by causing tension cracks during drying and then a break-down of the cohesive structure when re-wetted. This phenomenon was observed during a thunderstorm with intense rains that took place between Day 1 and Day 2 of sample collection (September 10<sup>th</sup> and 11<sup>th</sup>, 2014). On Day 1, the exposed till banks of Medway Creek were dry, with evident tension cracks in many locations. Figure 14 shows the base of a dry river bank where tension cracks are apparent in the till (right corner of the image). The image also portrays the rough and jugged surface of the till itself due to the mass erosion. Figure 15 is a close-up image of a dried section of the bank showing more cracks.

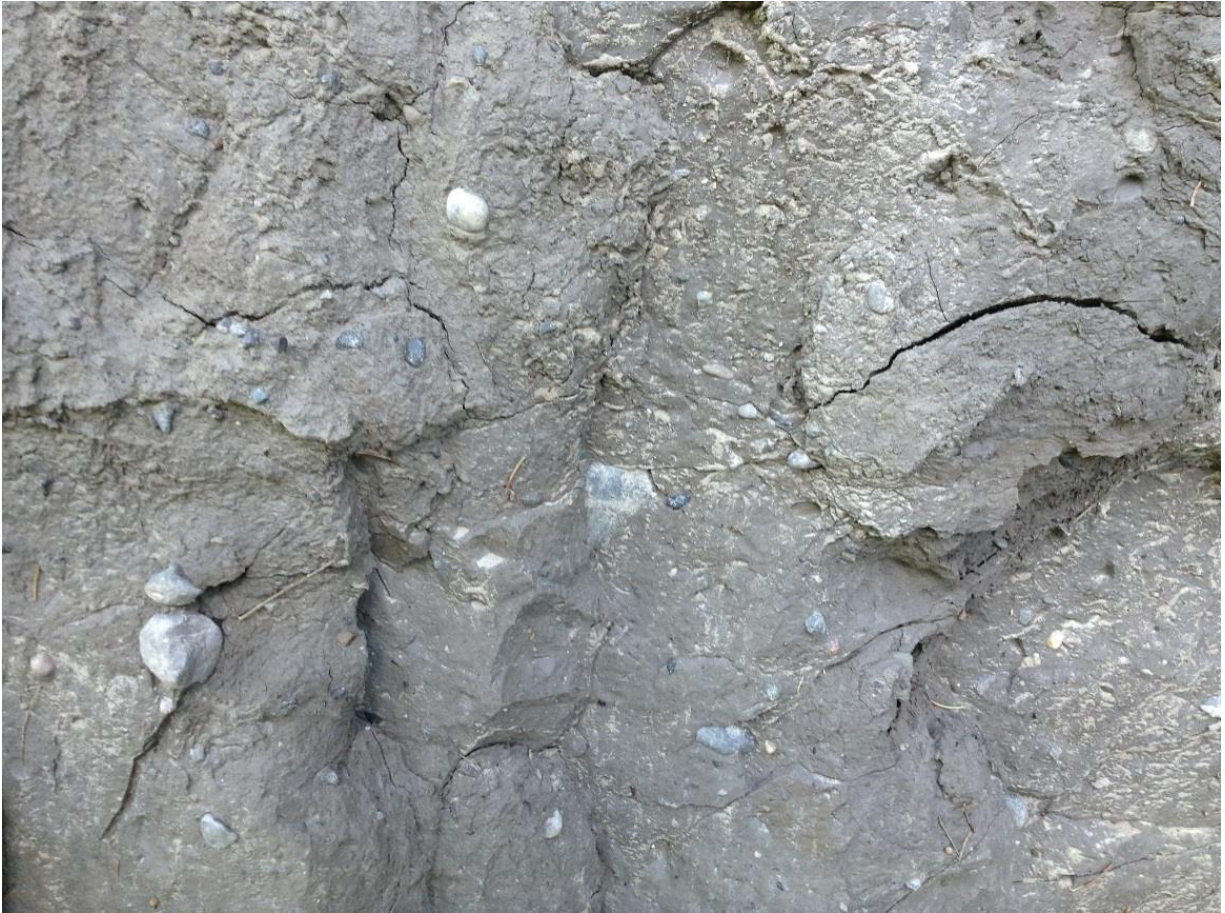
Figure 15: Tension cracks in banks at Medway Creek

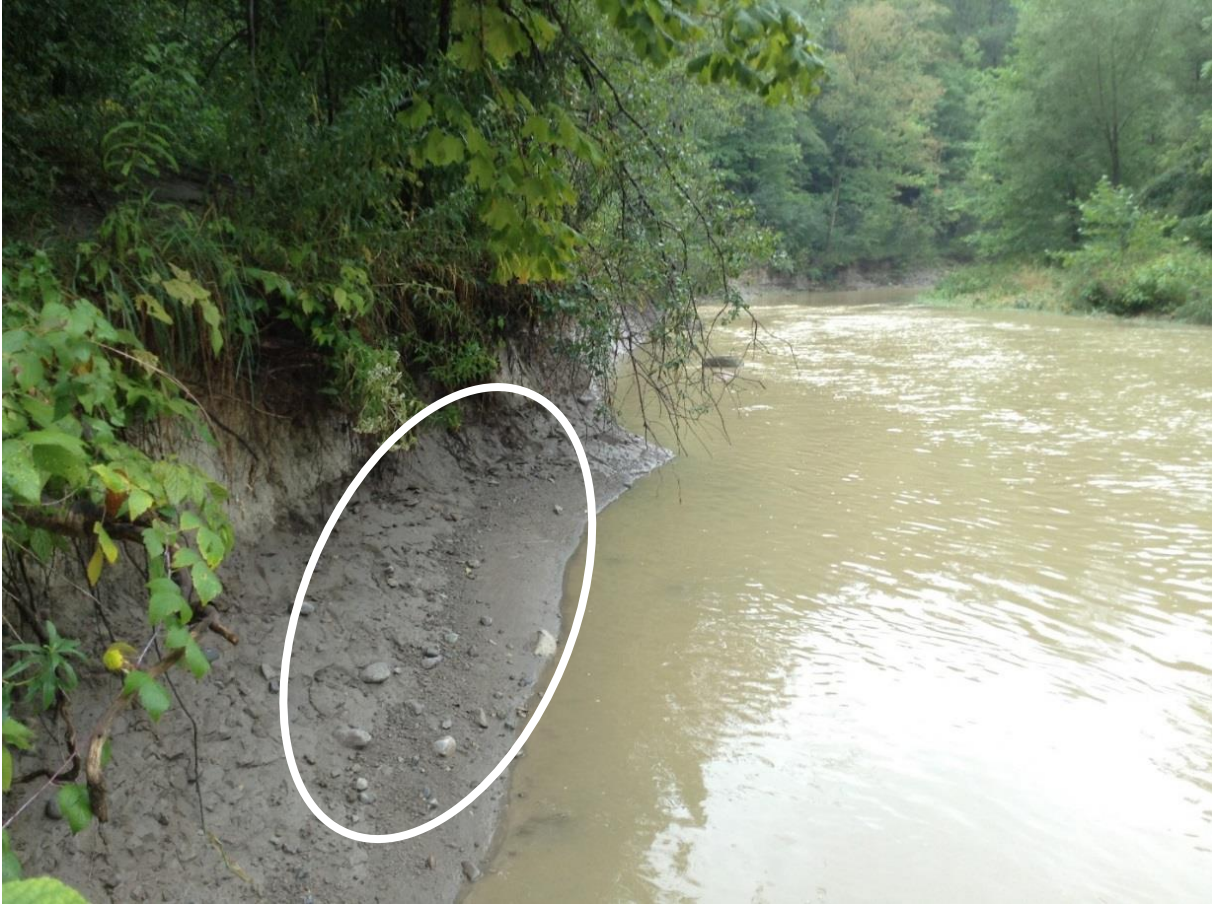
Figure 16: Slumped till bank at Medway Creek

On Day 2, after the intense rainstorm, areas in the river bank that had previously been dry, cracked, and rough on the surface, had become wet and slumped over, having lost material and the surface now being smoother. Figure 16 shows the bank on Day 2, after the rainstorm. The vertical nature of the banks indicate the cohesive nature of the material (the bulk strength) and also the undercutting pattern of erosion, in which the material is eroded at the water level and then the overlying bank falls in. The height the water level reached on the bank was apparent and can be seen in the circled area of the image. The till below the water line, or the material that had been submerged, had a smooth surface, indicative of having lost material and the eroded material slumping down towards the river.

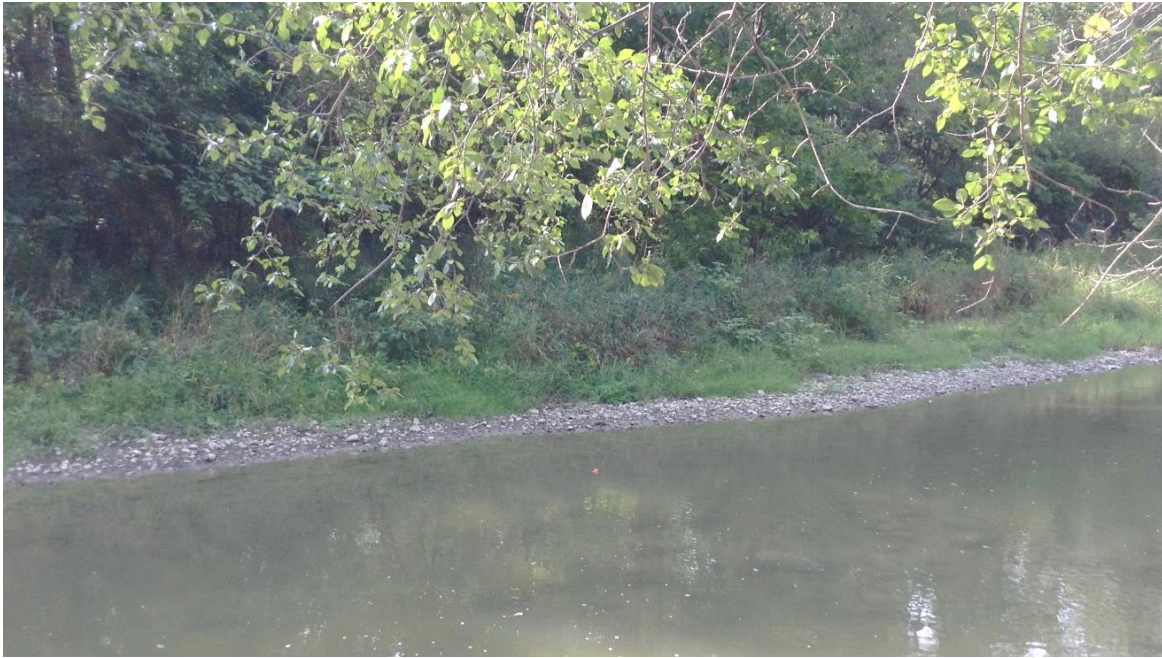
Figure 17: Gravel along bank at Medway Creek

There was a strong presence of alluvial material in the form of large gravel particles embedded within the till itself, intermittently covering the bed, and at the foot of the banks of the river. Gravel embedded in the till and partially exposed can be seen in Figure 11. Figure 17 shows a small lateral bar of gravel on the far bank of the river at the collection site. A discontinuous alluvial cover could be seen on the river bed. Unfortunately, no pictures were taken of the alluvial cover on the bed on Day 1, and the river was too turbid on the following days to see it. However, Hrytsak (2012) studied this particular reach and noted that the alluvial cover varied within the reach and had an overall thickness of 30 cm or less. Figure 18 shows exposed till underneath the alluvial covering and gives a good sense of the extent of alluvial covering in some areas of the river which

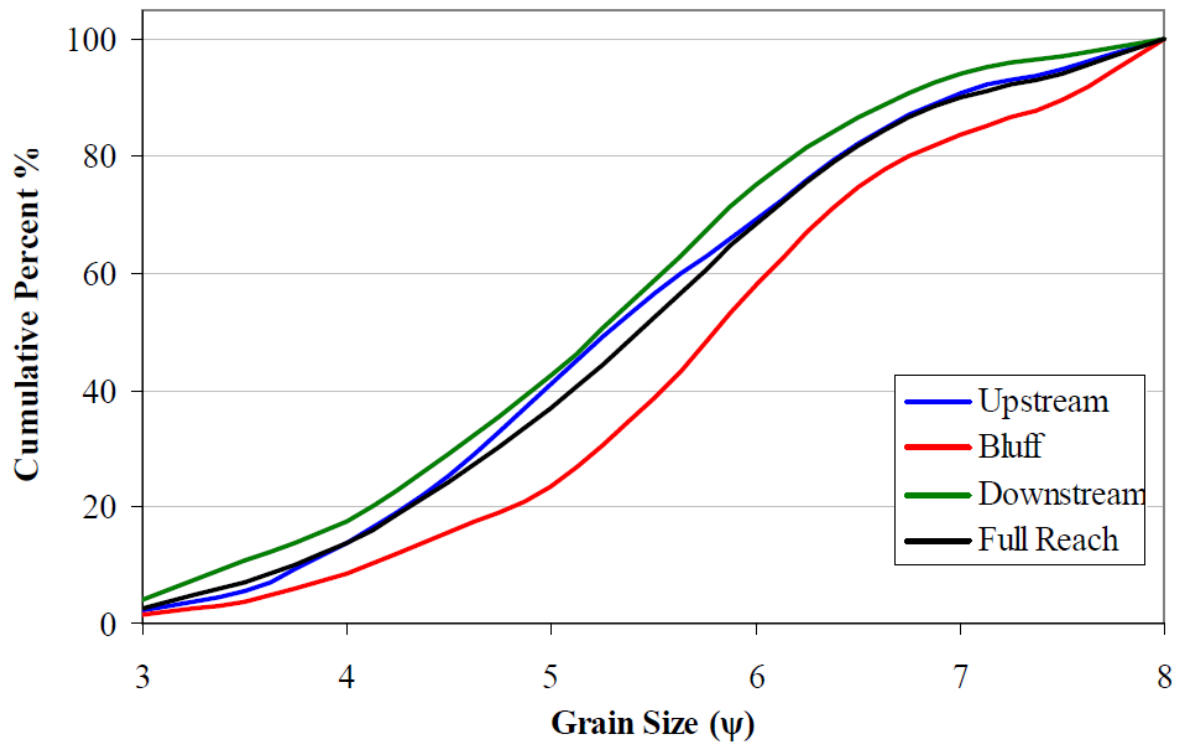
Figure 19: Cumulative grain size by area for Medway Creek (Hrytsak 2012)

Note: horizontal axis is an inverse psi scale, where 3 = 8 mm, 4 = 16 mm, 5 = 32 mm, etc.

is estimated to be between 50-70% by area (Hrytsak 2012). Hrytsak (2012) also determined a particle size distribution of the alluvial cover, and calculated an average grain size of 45 mm (Figure 19).

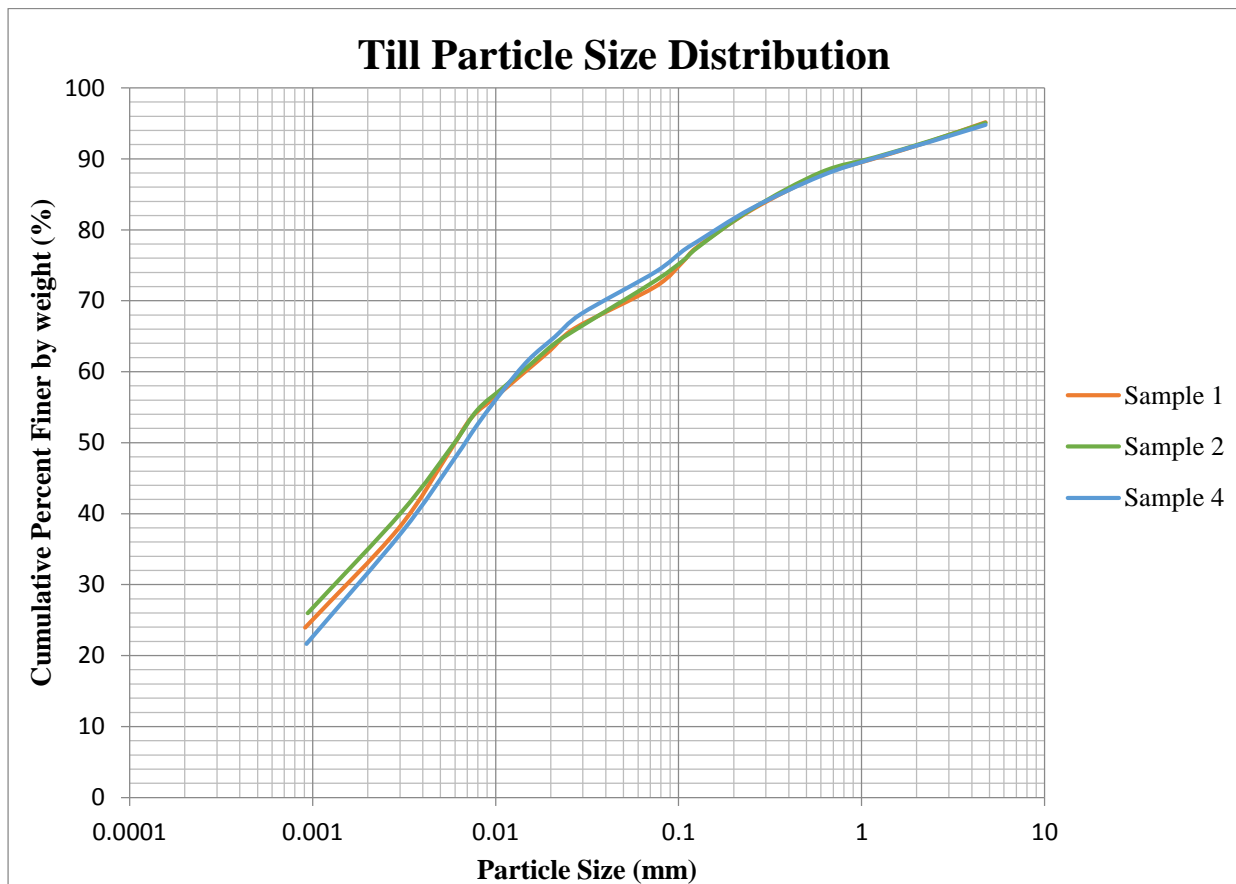
Figure 20: Till particle size distribution

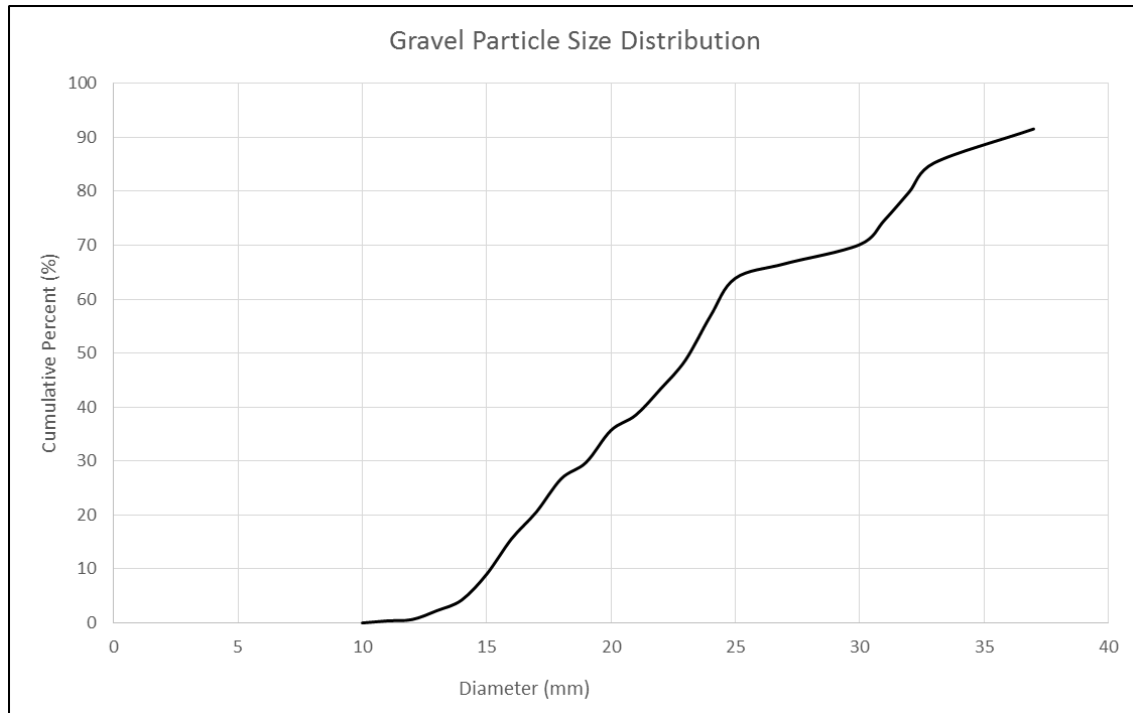
Figure 21: Gravel particle size distribution

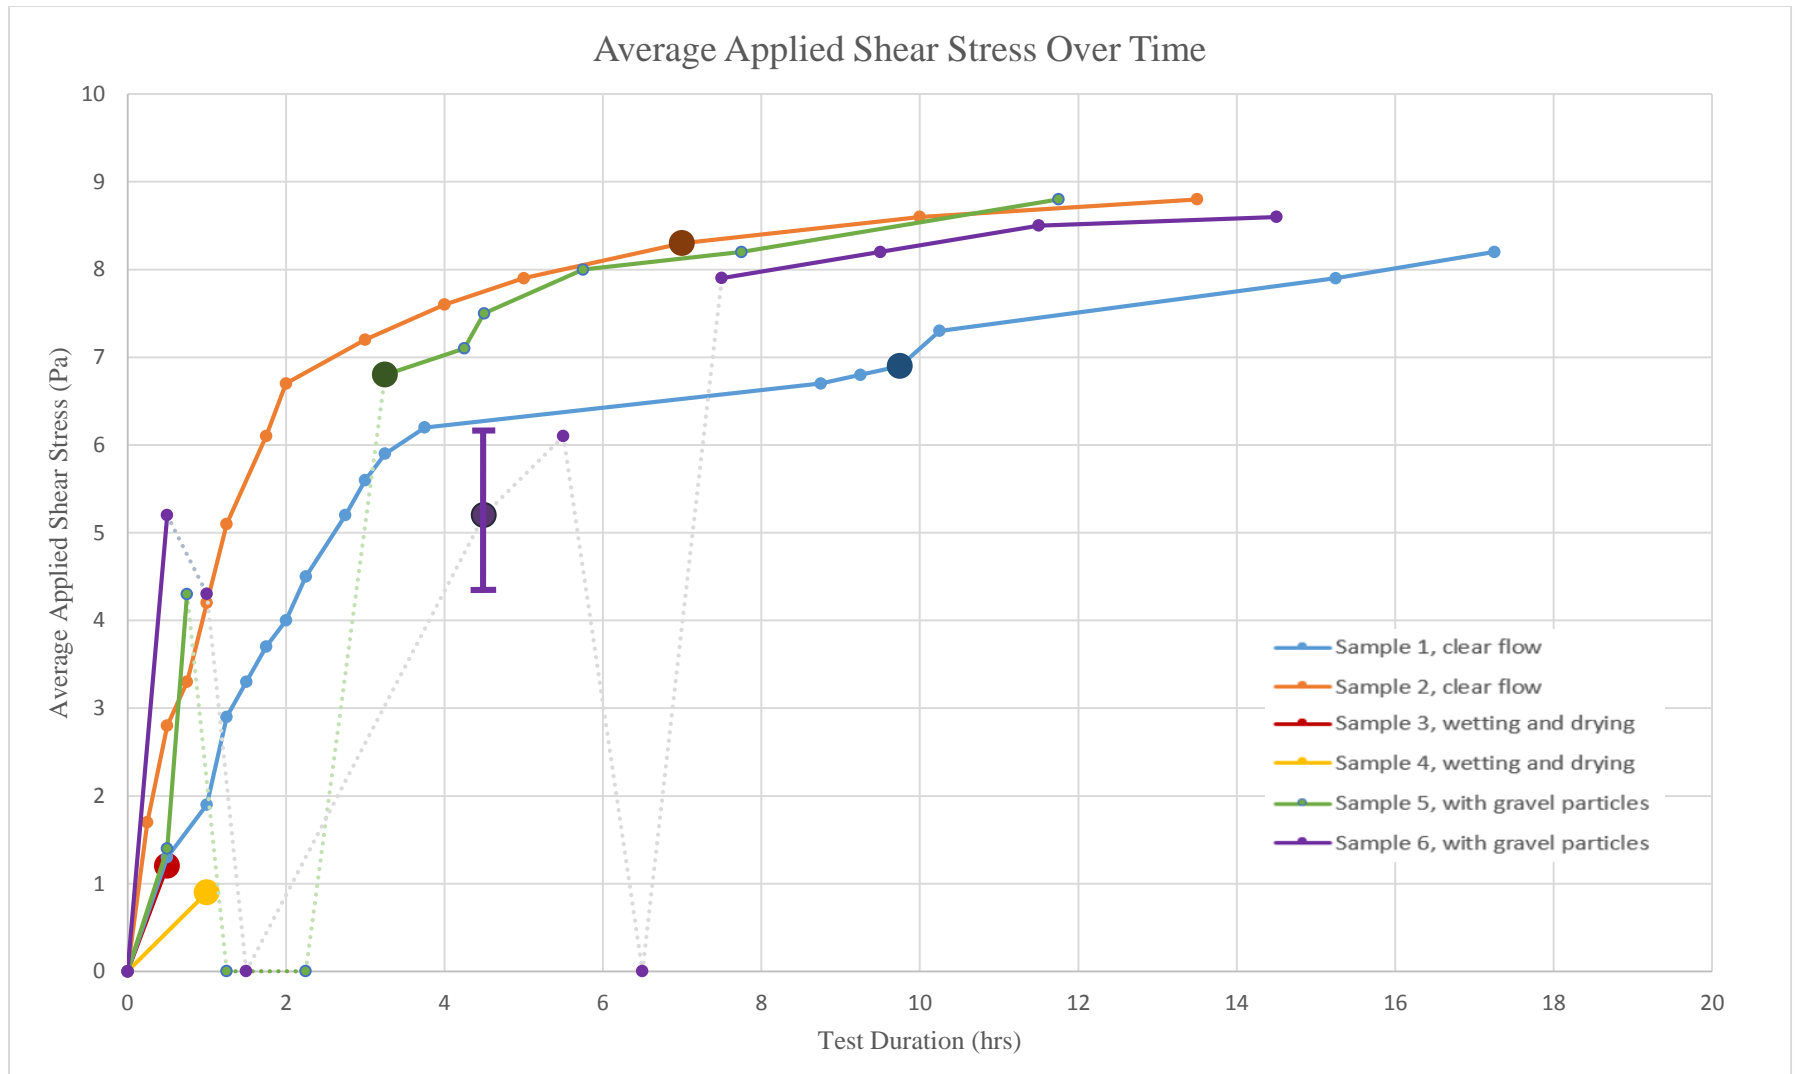
Figure 22: Average applied shear stress over time for each sample, with critical shear stress in bold.

Note<sub>1</sub>: Only the range within which the critical shear stress for Sample 6 lies could be observed (4.3 – 6.1 Pa), as shown in the figure.

Sample	Test Description	Critical Shear Stress (Pa)
1	Normal moisture content	7.9 +/- 1.0
2	Normal moisture content	8.3 +/- 0.9
3	Air dried	1.2 +/- 0.8
4	Air dried	0.9 +/- 0.6
5	Normal moisture content, gravel abrasion	6.8 +/- 0.7
6	Normal moisture content, gravel abrasion	4.3 – 6.1

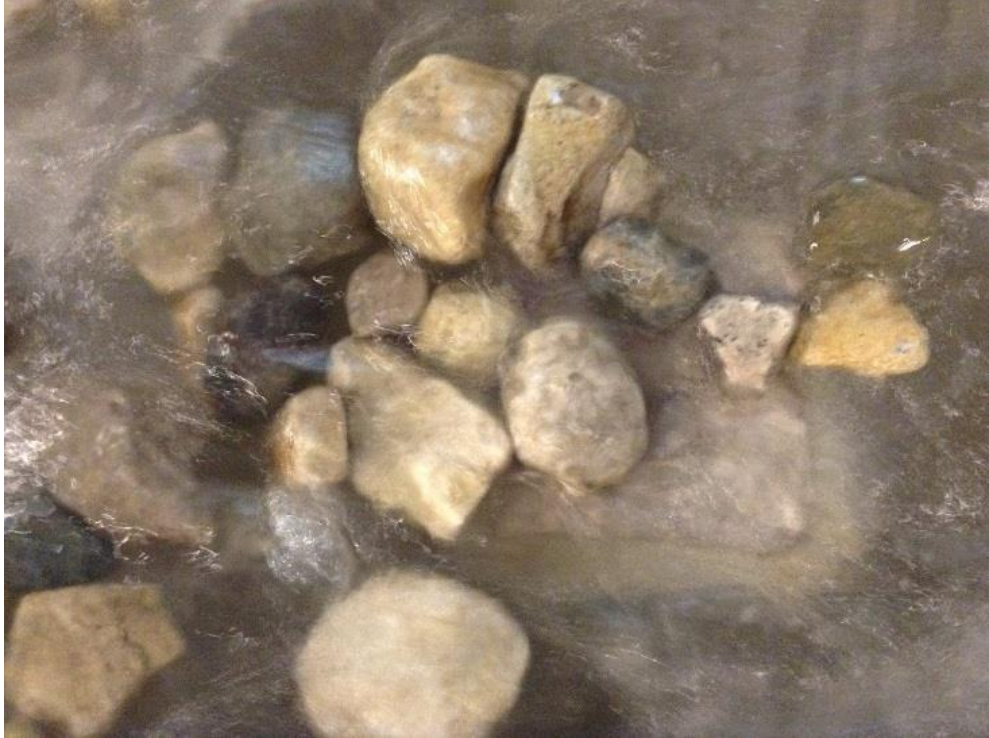
Figure 31: Stationary gravel particles on Sample 5

Sample 5 was tested with 78 large gravel particles in the flow, with diameters ranging from 11 to 37 mm, to see the effect of large particle impact and that of the alluvial cover in the field. The gravel particles remained stationary upstream of the sample under low shear stresses. As the applied shear stress was increased, the gravel particles moved to cover the sample, and then eventually began rolling downstream, causing damage to the sample surface and initiating mass erosion. At first, the stationary gravel upstream of the sample caused increased water depth at the sample location, which increased the applied shear stress on the sample itself. When the applied shear stress was increased to approximately 4 Pa, the gravel particles moved downstream and covered the sample (Figure 31), making the assumed effective average shear stress on the sample unknown but assumed to be close to 0 Pa.

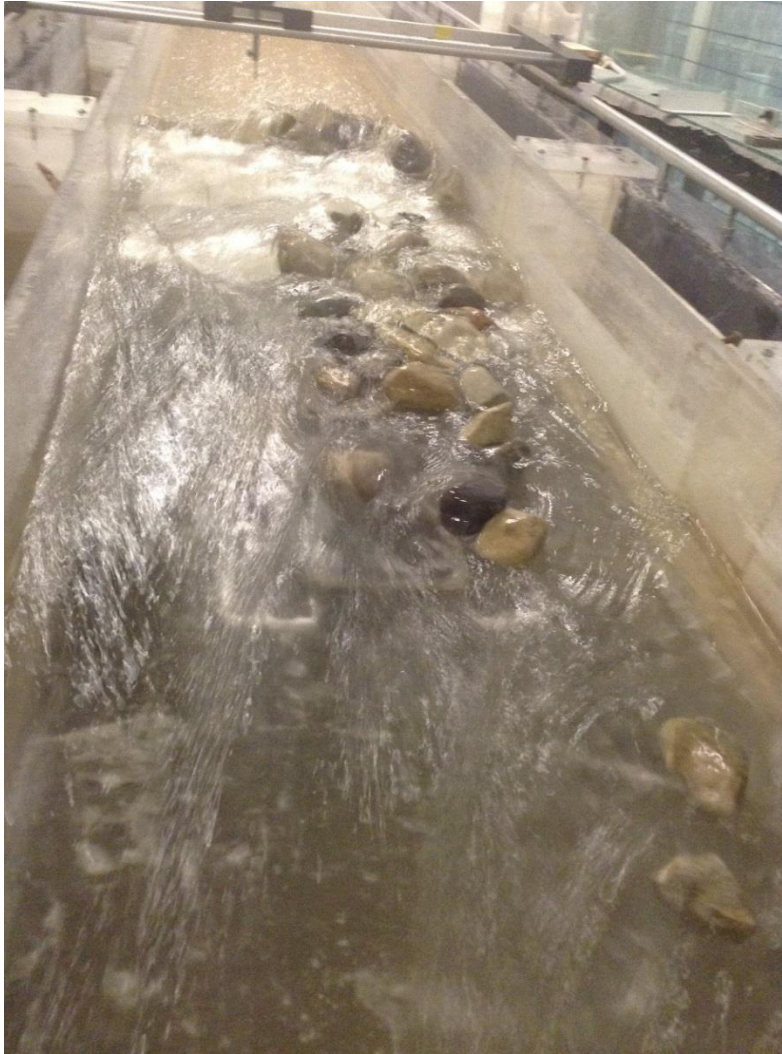
Figure 32: Sample 5 gravel particles moving downstream

Erosion was not observed while the gravel particles covered the sample. When the average applied shear stress was increased to approximately 5 Pa, the gravel pieces moved a small amount on the sample causing corner damage, but then remained stationary. When the flow was increased to an average applied shear stress of 6.8 Pa, the gravel particles started rolling down the flume, and the sample began to form small cracks and erode through surface pitting. This was taken as the critical shear stress. Figure 32 shows an image of the gravel particles moving down the flume.

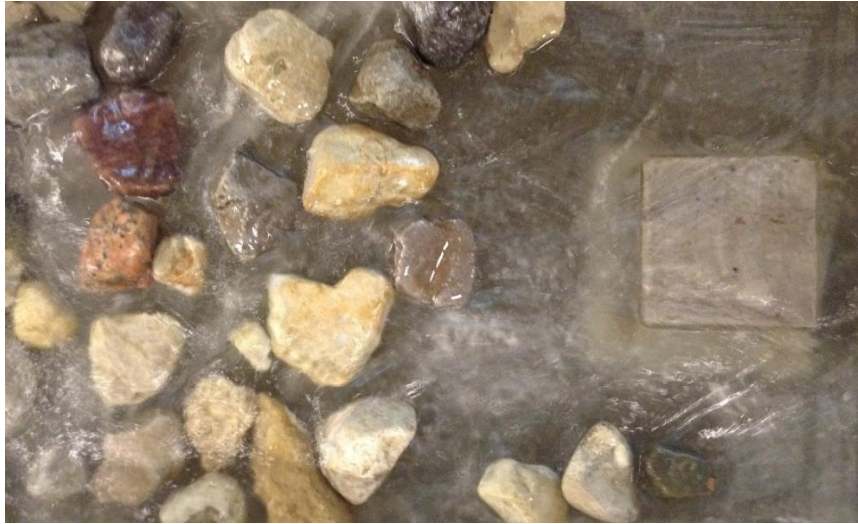
Figure 35: Sample 6 gravel placement with flow  $< 4.5$  L/s

Sample 6 was the second sample tested with the same distribution of gravel particles present in the flume. Similar to Sample 5, the gravel particles remained stationary at first, then moved to cover the sample as flows increased, eventually causing damage due to impacts on the sample surface once the gravel started rolling downstream. When the applied critical shear stress was less than 3 Pa, the gravel particles did not move in the flume and remained upstream of the sample, shown in Figure 35. However, the gravel caused an increase depth of water over the sample, thus, an increase in the applied shear stress on the sample. Erosion was not observed under these flow conditions.

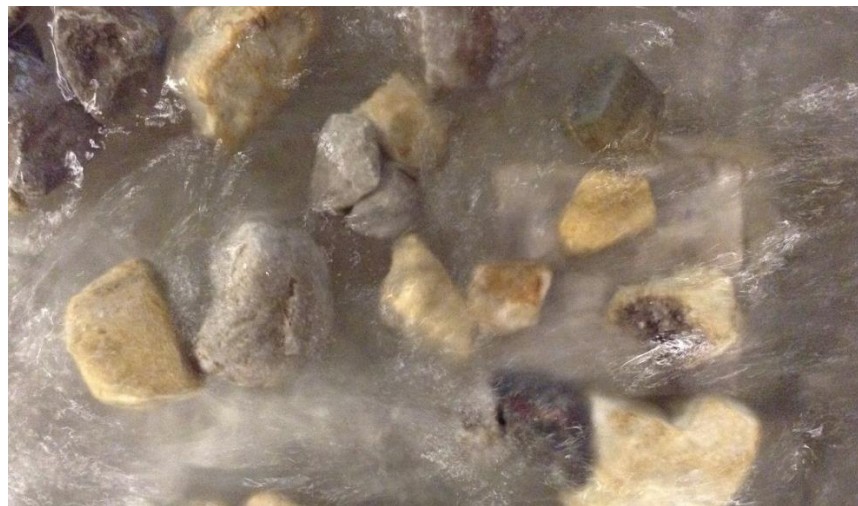
Figure 36: Sample 6 gravel placement with flow  $= 4.5$  L/s

Once the critical shear stress was at approximately 3 Pa the gravel slowly moved down the channel and eventually covered the sample, varying the applied shear stress from an assumed 0 Pa when the sample was covered, to 8.2 Pa, when the sample was uncovered. Figure 36 shows the gravel before it moved downstream and after it moved downstream and covered the sample.

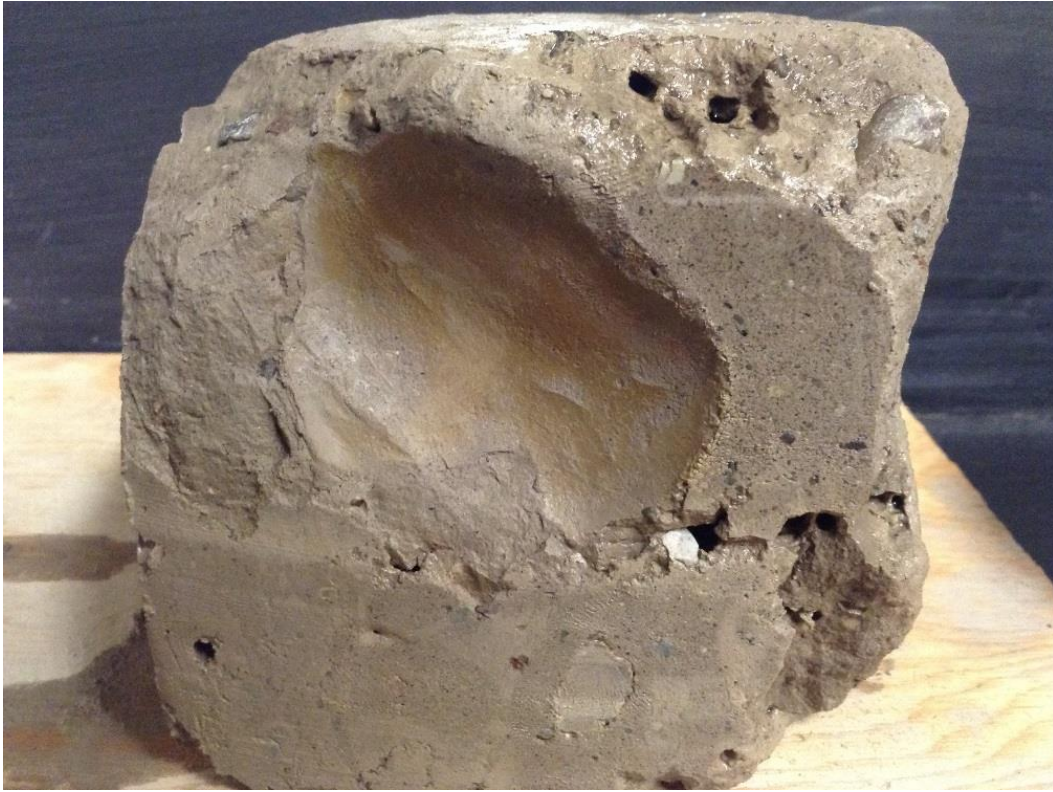
Figure 40: Sample 6 - erosion showing worm holes
