Mechanical and environmental characterization of new and reclaimed brick for use in Canadian masonry construction

Department of Civil Engineering and Applied Mechanics

A thesis submitted to McGill University in partial fulfillment of the requirements of the degree
of Master of Science

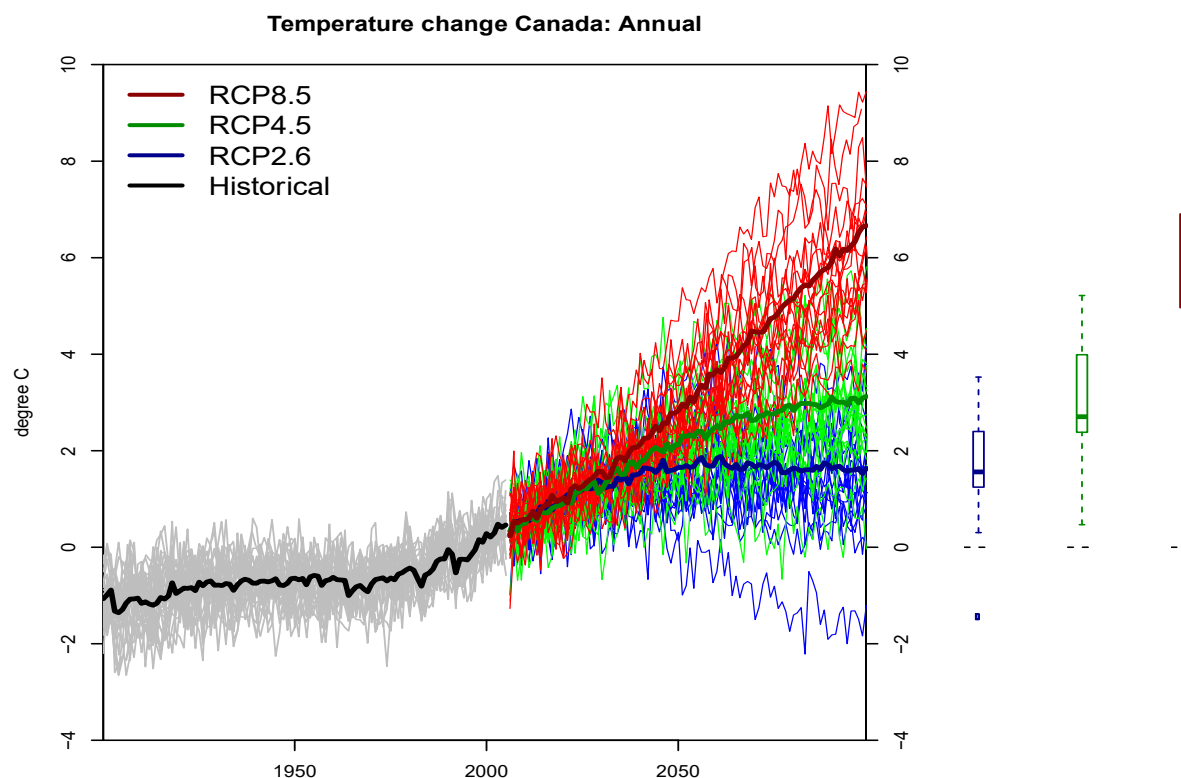
Figure 1.1. Prediction of temperature change in Canada based on three emissions scenarios (Gov. of Canada, 2019)

Unprecedented changes in climate patterns have been observed worldwide since the mid-18th century. The excessive burning of fossil fuels during the First Industrial Revolution caused drastic rises in greenhouse gas emissions, which has been the primary cause of global warming. The annual global mean surface temperature (GMST) has risen by over 1°C between this era and the years 2015–2017. Remarkably, just between 1948 and 2016, the annual GMST has increased by 0.8°C. Within this same time frame, Canada has experienced an increase of 1.7°C in annual mean surface temperature (MST). Hence, surface temperatures in Canada rise at over double the rate compared to global values. Both current data and future projections support this data. In Northern Canada, the annual MST has increased by 2.3°C, nearly triple the global mean. Different regions of the world are subjected to different levels of global warming. High northern latitudes have been observed to experience the highest degree of global warming due to ideal geographic conditions for climate feedback mechanisms. Such mechanisms include the snow/ice albedo feedback, which is when snow and ice melt, the surface reflectivity diminishes due to its darker colour and warming is accelerated. As such, climate change is especially concerning for Canada (Bush & Lemmen, 2019). As for future projections, the annual MST in Canada is expected to rise acutely. Between 2016 and 2035, surface temperatures are predicted to increase by 0.9–1.7°C for a low-emissions scenario (RCP2.6) or by 1.1–1.9°C for a high-emissions scenario (RCP8.5) relative to the 1986–2005 average recorded temperature (Figure 1.1) (Government of Canada, 2019).

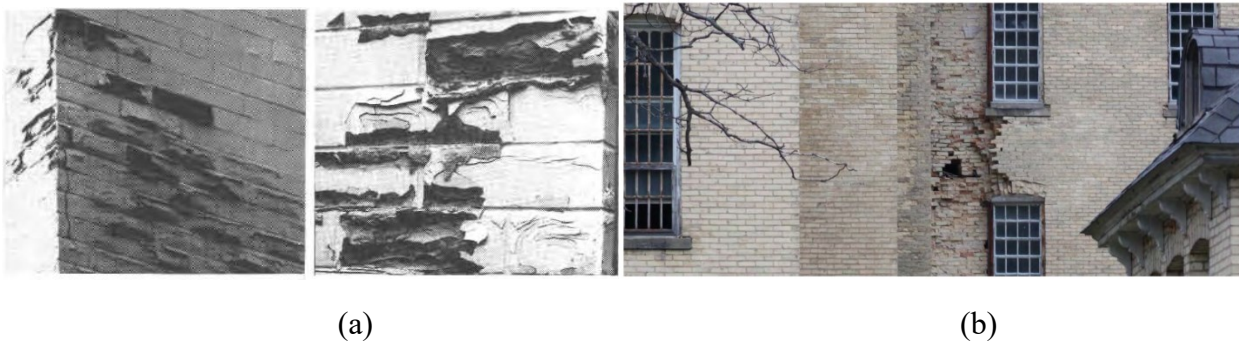
Figure 1.5. (a) Brick spalling caused by freezing and thawing (Maurenbrecher & Suter, 1989); (b) Severe freeze-thaw damage caused by local moisture accumulation (Trainor, 2019)

Although freezing and thawing occurs at the microstructure level, it can still have catastrophic consequences for masonry structures. Damage to infrastructure due to freezing and thawing is not immediately evident and can take months or years for it to become noticeable (Auld et al., 2007). By eliminating either temperature cycles about the freezing point or moisture accumulation, damage from freeze-thaw can be minimized. As it is not possible to control the weather, moisture control is a primary focus in freeze-thaw mitigation strategies. There are several ways that can help prevent moisture from entering the façade such as mortar repointing, localized crack repairs, replacement of damaged bricks, or installing roof overhangs to divert water away from the masonry surface (Moore et al., 2022). Severe freeze-thaw damage is often observed in the form of brick spalling, as shown in Figure 1.5a (Maurenbrecher & Suter, 1989). Without early intervention, Figure 1.5b demonstrates how inadequate water diversion, such as poorly designed gutters, can allow moisture to accumulate and result in life-threatening damage.

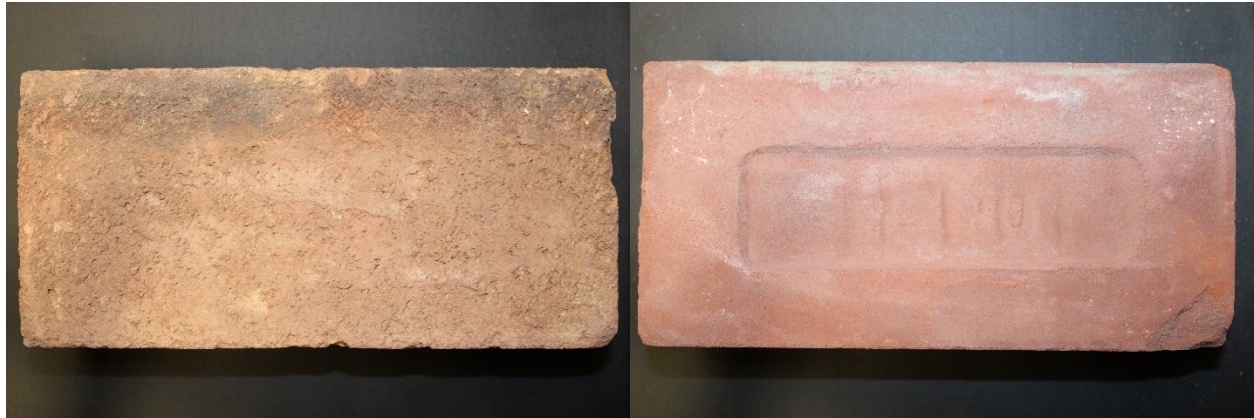
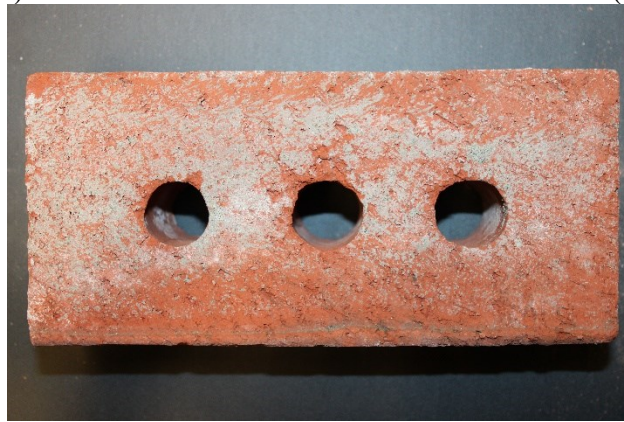
Figure 2.2. Used bricks. (a) MILTON; (b) ORANGE; (c) CORED.

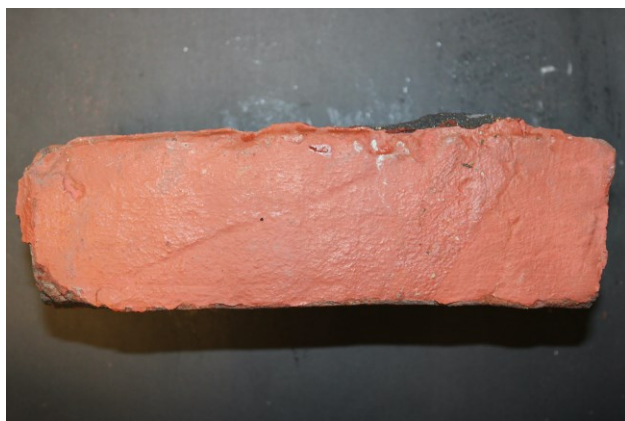
Figure 2.4. Red paint on exposed face of BERRI-NS

In the second trial of the BERRI bricks, an additional sample of five half-bricks was selected but the layer of red paint was not removed for testing. However, there was no considerable difference between the samples with paint and without paint. Since the brick was entirely submerged, all sides were subjected to water intake. However, in a unidirectional freeze-thaw test, the paint is likely to make a bigger difference in the results.

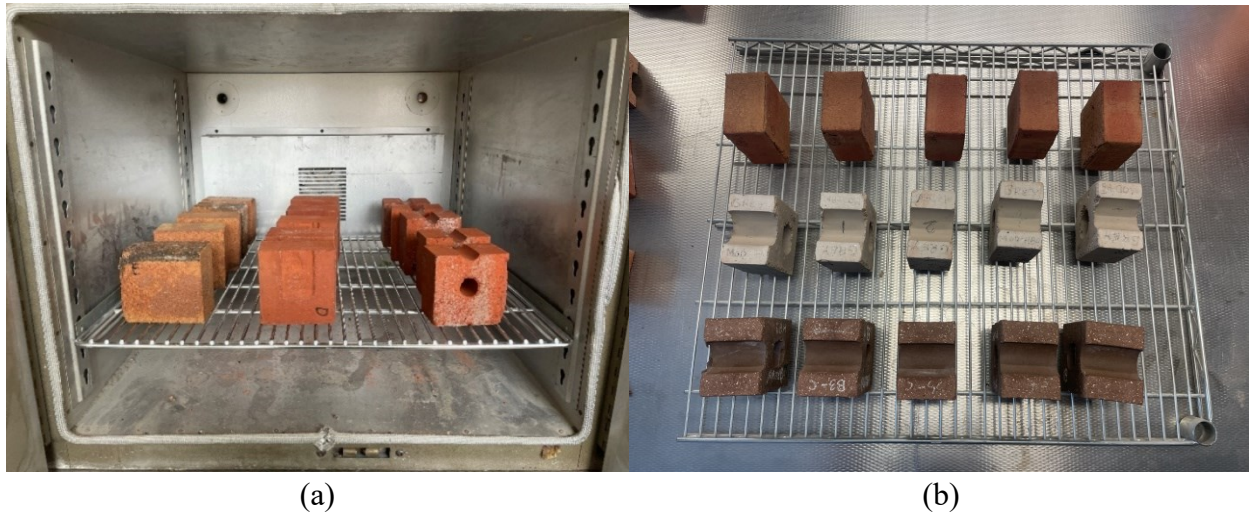
Figure 2.5. (a) Half-bricks drying in the oven at 115°C; (b) half-bricks cooling on a metal rack

The environmental tests performed on all eleven bricks include: (1) the 24-h cold water absorption test; (2) the 5-h boiling absorption test; and (3) the freeze-thaw test, according to the CSA A82:14 standard. For each test, 5 half-brick specimens were sampled and prepared according to Clause 12. Each half-brick was obtained from a different full-size brick. The specimens were dusted with a straw brush and any loose fragments were removed from their surfaces. For the BERRI-NS specimens only, a 1-2 mm thick slice was cut off of the bricks in order to remove the layer of red paint seen in Figure 2.4. The half-bricks were labelled with a china marker to prevent the labels from being removed by water. Next, the specimens were dried and cooled according to Clause 12.5 and 12.6. The samples were weighed after being placed in an oven at 115°C for 24 hours (see Figure 2.5a), and then weighed every subsequent two hours until the difference in mass did not exceed 0.05%. Finally, the samples were cooled on metal racks in a room with an average temperature of 22.8°C and relative humidity of 53% (see Figure 2.5b).

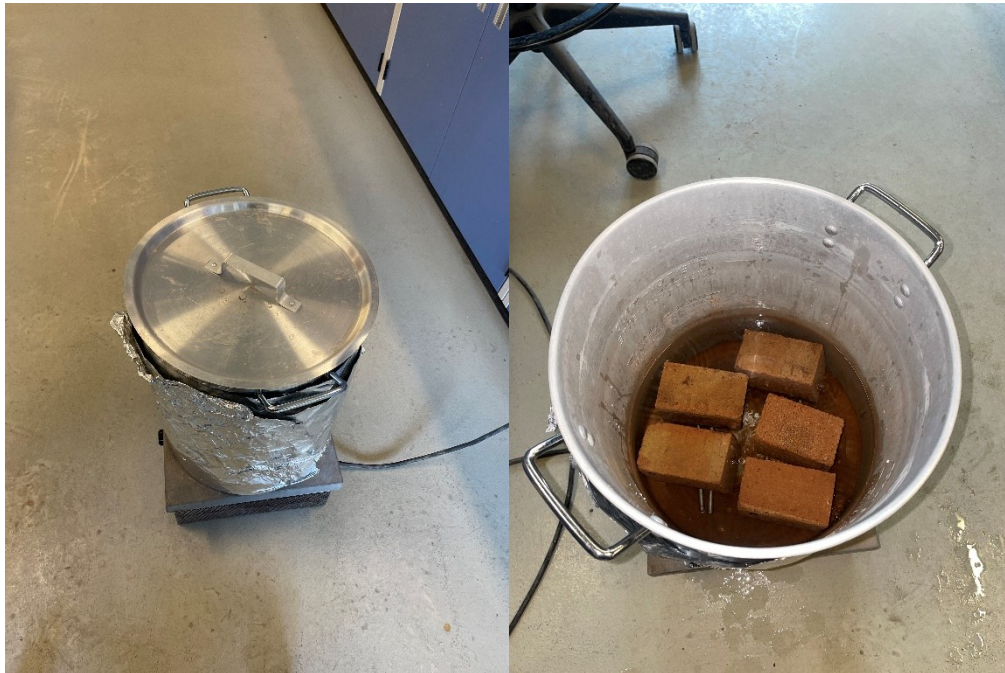
Figure 2.7. 5-h boiling absorption test

The boiling pot was placed on a hot plate set to 400°C and turned on 30 minutes before the start of the test. The half-bricks were placed on 8 mm-diameter stainless steel rods inside the pot and distilled water was poured over the specimens until they were fully submerged. Temperature readings were taken at 15-minute intervals for the duration of the test. The water started to boil at approximately $1\text{ h} \pm 15\text{ min}$ and the bricks were boiled continuously for an additional 5 hours. When the water level dropped below the bricks, boiling water from a kettle was added to the pot. At the end of the test, the hot plate was turned off and the bricks were allowed to cool overnight. After at least 12 hours, the bricks were wiped with damp paper towel and they were weighed.

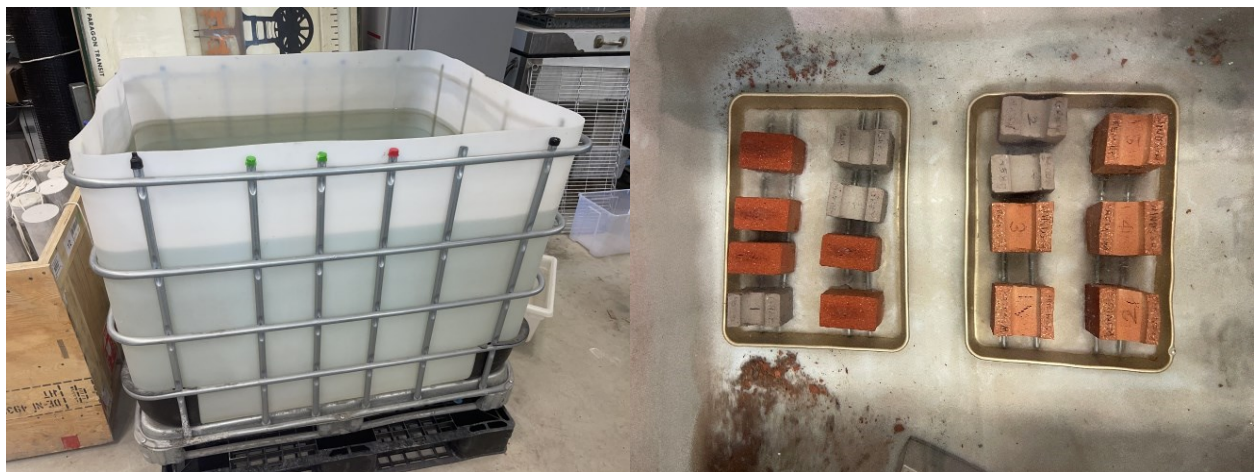
Figure 2.8. Thawing tank used for the freeze-thaw test

The freeze-thaw test, performed according to Clause 15 of CSA A82:14, complements the 24-h cold water absorption test and the 5-h boiling absorption test. The freeze-thaw test is optional, as long as the bricks pass the requirements of Clause 7.2.2 (Table 1). Otherwise, the results of the freeze-thaw govern over the absorption tests. The prepared half-brick specimens were first submerged in a water tank for $4\text{ h} \pm 15\text{ min}$ at an average temperature of 21.5°C (Figure 2.8). The specimens were then placed end face down (the face with the smallest area) on 8 mm-diameter stainless steel rods in a stainless-steel tray with an inside depth of 50 mm. The tray was filled with enough water such that the specimens stood in $12 \pm 1\text{ mm}$ of water. The trays were placed in a freezer (Figure 2.9) such that the air temperature of the fridge reached at most $-9 \pm 1^\circ\text{C}$ in $1\text{ h} \pm 5\text{ min}$, reached at most $-20 \pm 2^\circ\text{C}$ in $14\text{ h} \pm 30\text{ min}$, and stayed at $-20 \pm 2^\circ\text{C}$ for the next 6 hours. After 20 ± 1 hours, the trays were placed in the water tank for $4\text{ h} \pm 30\text{ min}$ to thaw. Hot water was added during the thawing phase to ensure that the water temperature remained above 19°C (Clause 15 requires that the water temperature remains at $24 \pm 5^\circ\text{C}$). Bluetooth-powered temperature monitors continuously recorded the temperature in the freezer and in the water tank to ensure compliance with CSA A82:14. The freeze-thaw cycle was repeated daily, five times a week, for ten weeks. Once 50 cycles were completed, the test was over. The specimens were dried and cooled according to Clause 12.5 and 12.6. The mass loss as a percentage of the original mass was calculated, and if it exceeded 0.5%, the test failed. However, the test can fail before the 50 cycles have been completed if the specimens do not meet the acceptance criteria of Clause 7.2.3.1: 5% mass loss is observed by visual inspection, a crack develops that is at least as long as the minimum dimension of the brick, or if the specimen breaks in two or more pieces.

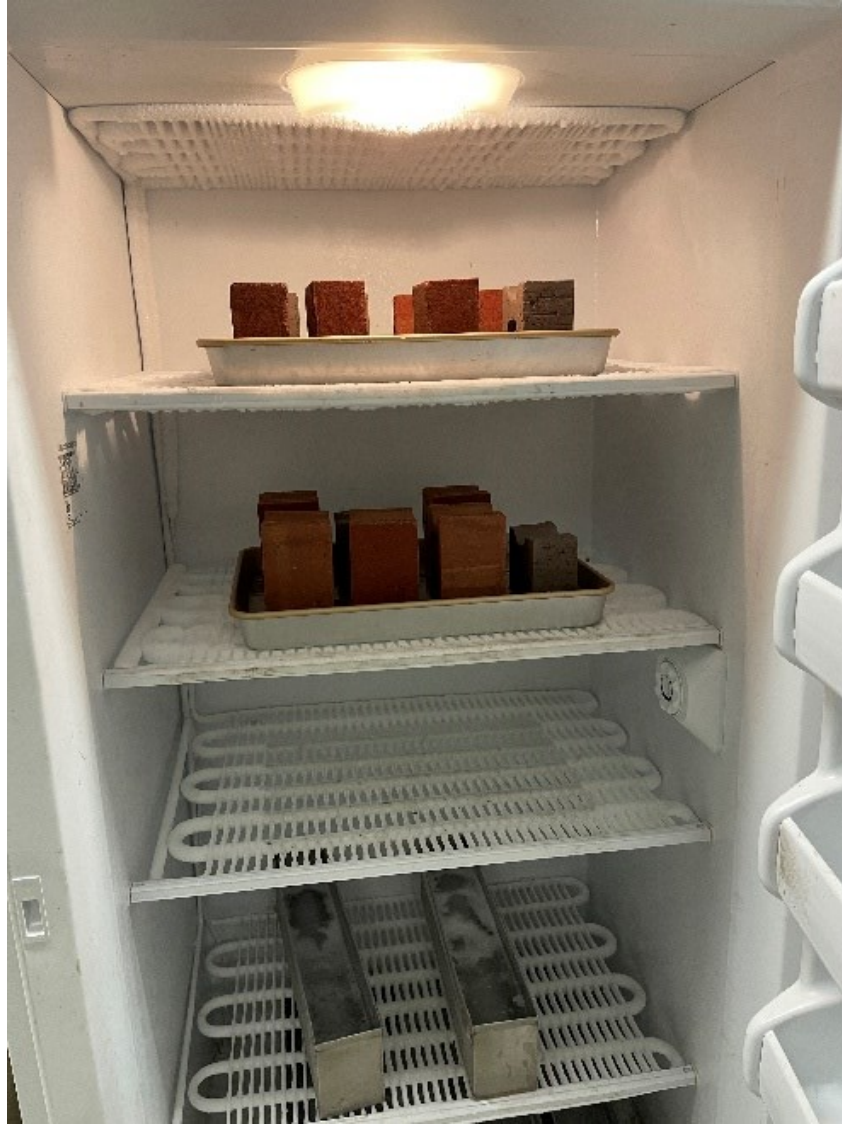
Figure 2.9. Freezer used for the freeze-thaw test

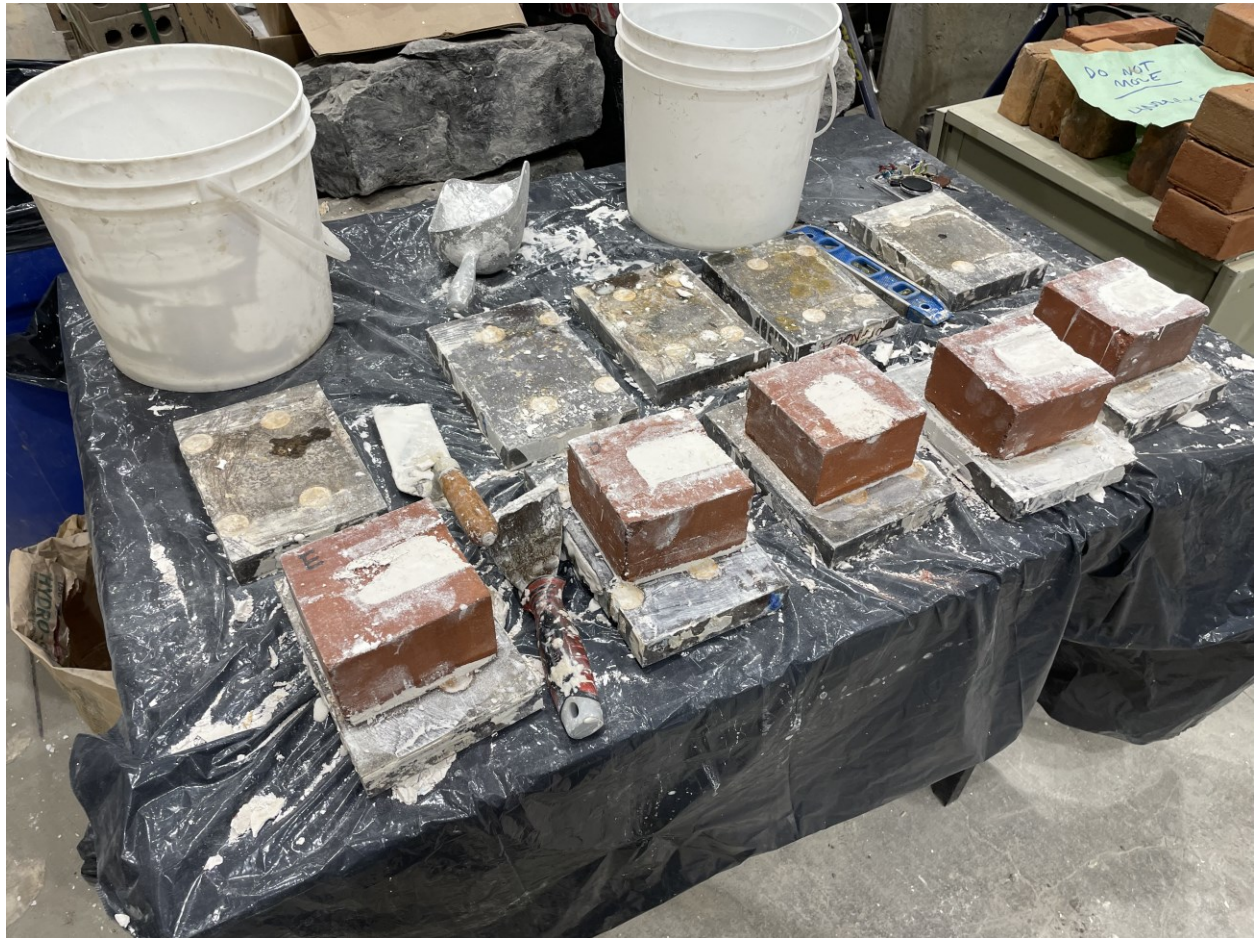
Figure 2.10. Filling the frogs of the MILTON bricks with gypsum cement during the capping process

Clause 7.2.1 of CSA A82:14 states that all EG bricks must satisfy a minimum compressive strength (see Table 1). Uniaxial compression tests were performed for all eleven brick types according to Clause 13. Full bricks were used for the tests, except in the case of the used bricks where half-bricks were selected due to limited supply. Five bricks were tested for each brick type except for three of the old brick types in order to minimize the COV. The average of 60 bricks was taken for the BERRI-S and BERRI-NS bricks, and the average of 40 bricks was taken for the CRAIG bricks. The specimens were capped using Hydro-Stone gypsum cement, with a water to cement ratio of approximately 0.25. Both the top and bottom of the brick were capped using 1.5" thick steel plates as shown in Figure 2.10. A spirit level was used to ensure that the steel plates were properly aligned and levelled. Once all specimens were capped, they cured for a minimum of 24 hours. A final capped brick can be seen in Figure 2.11.

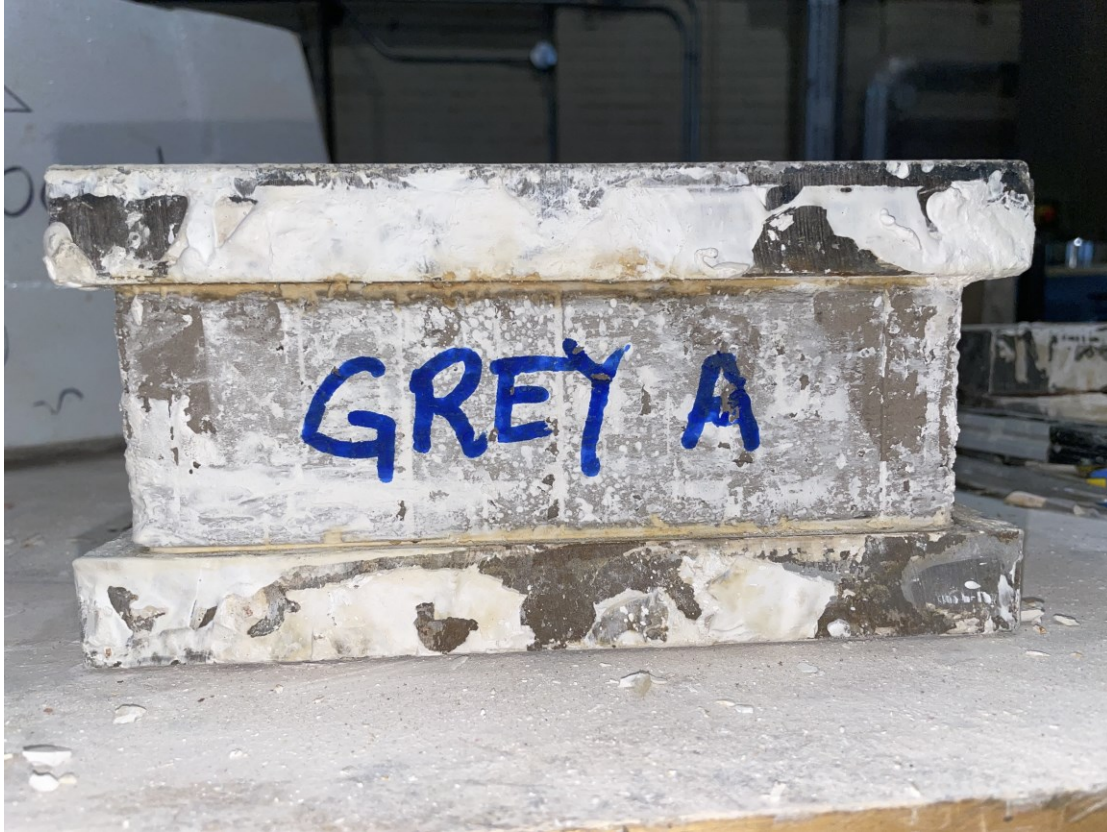
Figure 2.11. Capped brick

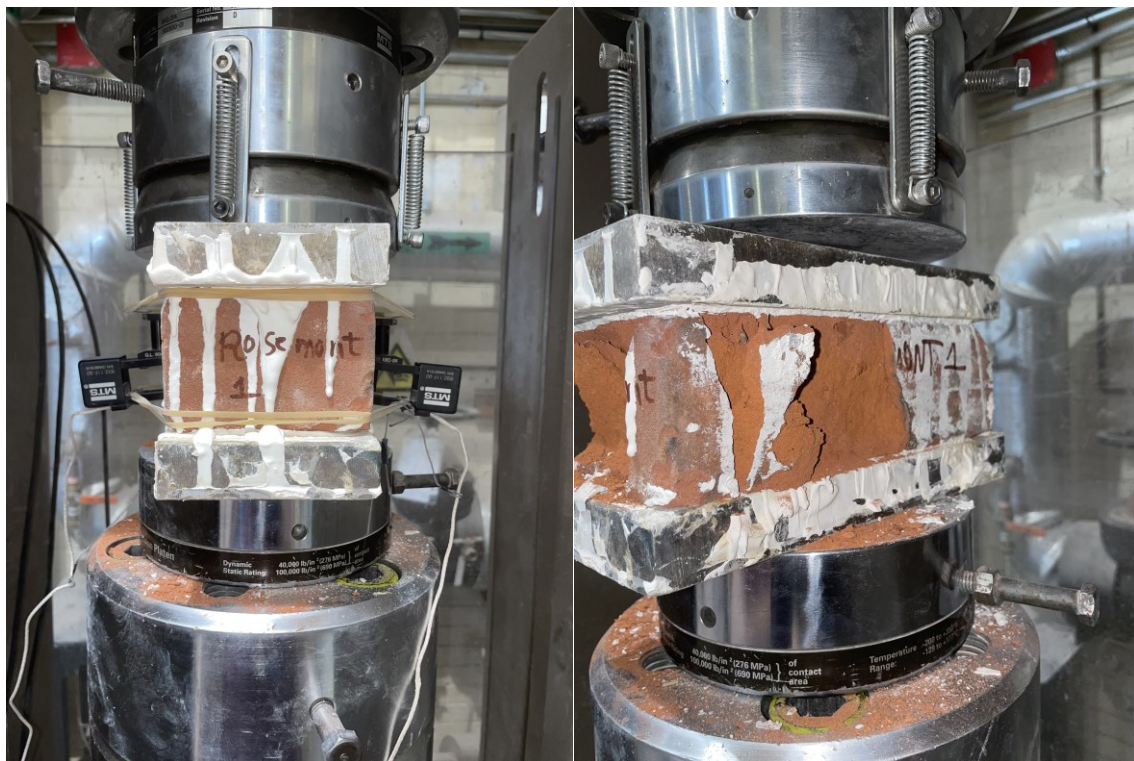
Figure 2.13. Before and after the compression test

The specimens were tested using the MTS rock frame, a hydraulic press with a 4,600 kN capacity and accuracy of ± 5 kN. Before testing began, the top and bottom areas of the bricks were measured using a digital caliper. Afterwards, 50 mm-gauge length extensometers were placed on both of the long faces of the brick, as shown in Figure 2.12. The final setup of the brick in the MTS rock frame, as well as the crushed brick once the test was over, can be seen in Figure 2.13. The loading rate was determined through a trial-and-error process, such that once half of the expected load has been reached, the remaining load is applied between 1 and 2 minutes. This flexible requirement allowed for a loading rate of 0.0085 mm/s for all eleven brick types. The results of all the compression tests are displayed in Table 8. The minimum individual compressive strength is the minimum compressive strength of the five bricks tested for each brick type. COV values are indicated in parentheses. The values highlighted in green are those that have passed the acceptance criteria in Table 1 and the values highlighted in red are those that have failed the acceptance criteria in Table 1. The values highlighted in yellow are those that were close to meeting the acceptance criteria, which are considered a “marginal pass”.

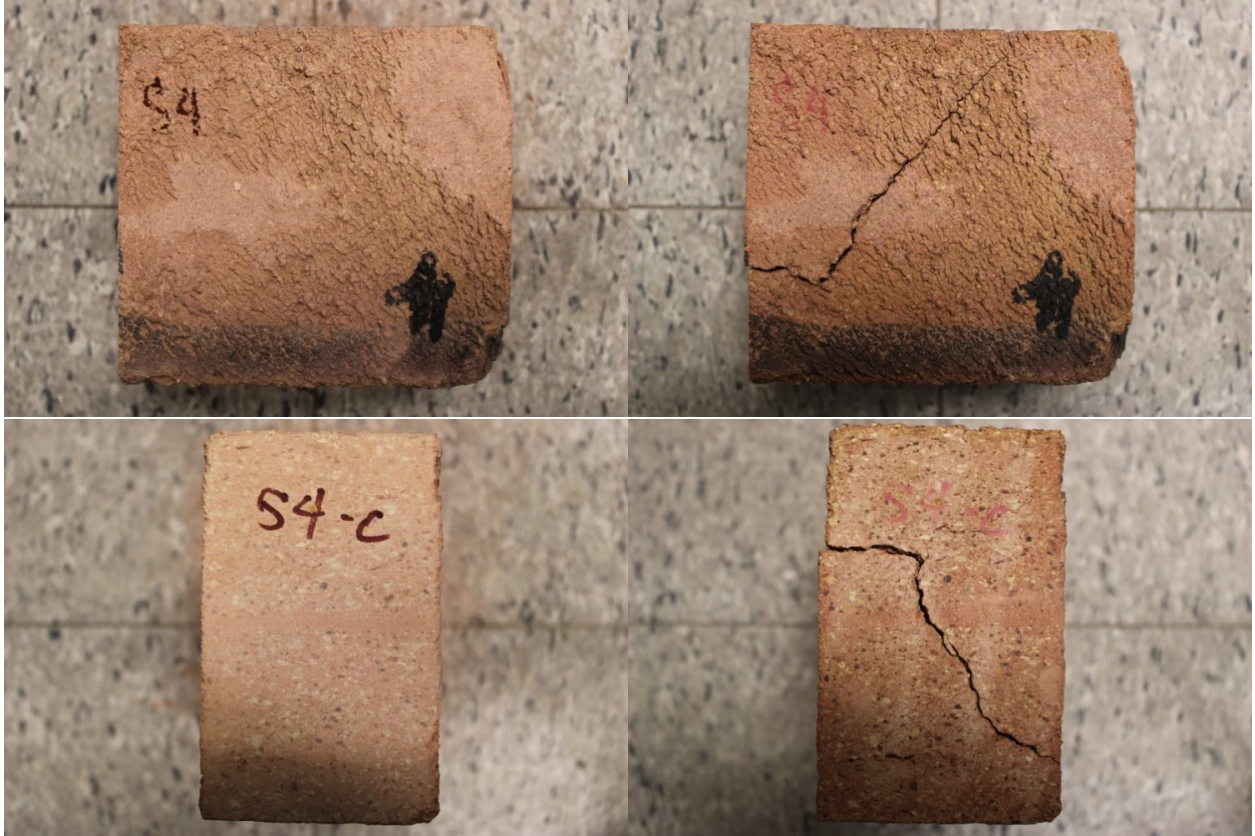
Figure 3.1. ORANGE-4 before and after the freeze-thaw test

Interestingly, the failure mode for the used bricks was cracking whereas the failure mode for the old bricks was spalling. Bricks produced in the early 1900s were manufactured differently than those in the mid 1900s. They were manufactured using the “soft-mud” method, where clay and sand were mixed with water to create a material in a plastic state that could be moulded into the shape of a brick. These bricks were generally more porous and less smooth than the extruded bricks that became popular in later years. It is understandable that the bricks produced from these different processes behave differently under freezing and thawing (Ritchie, 1971). The before and after photos from the freeze-thaw tests are shown from Figure 3.1 to Figure 3.7.

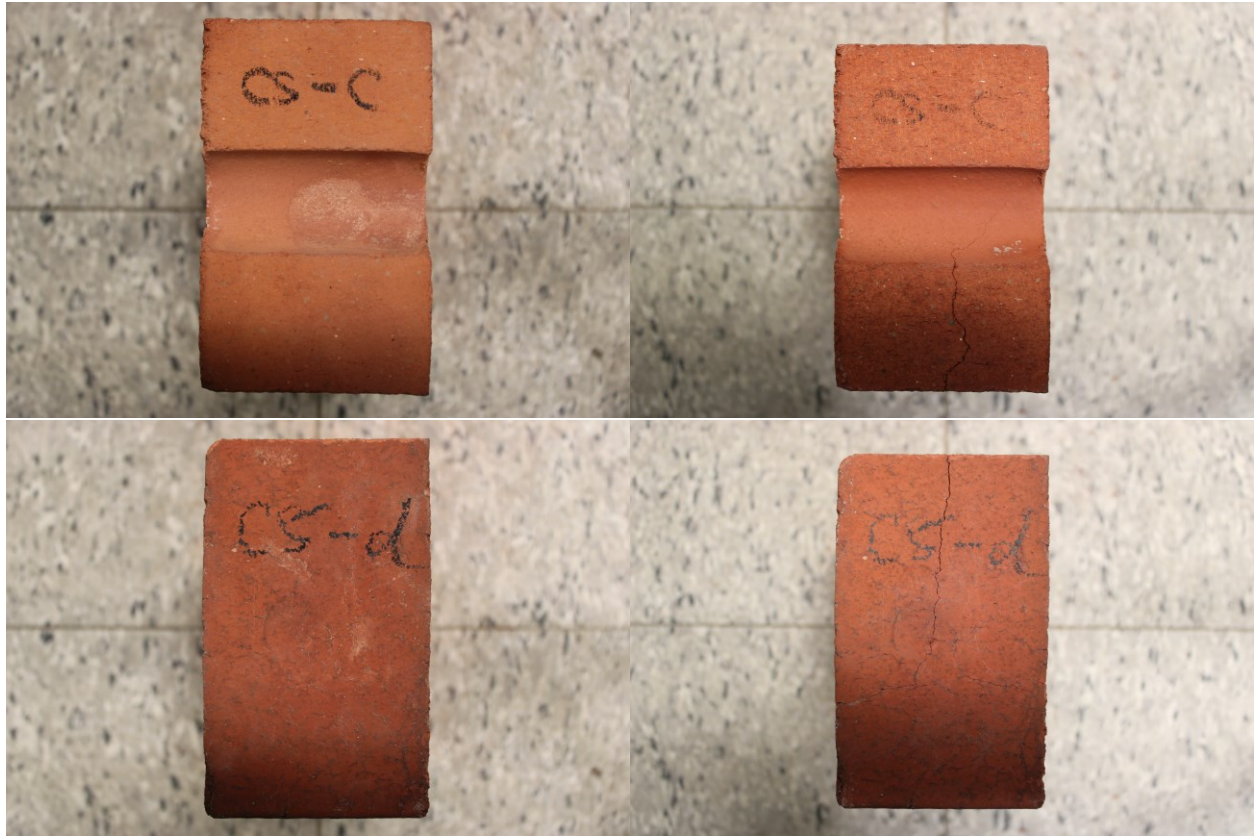
Figure 3.3. CORED-5 before and after the freeze-thaw test

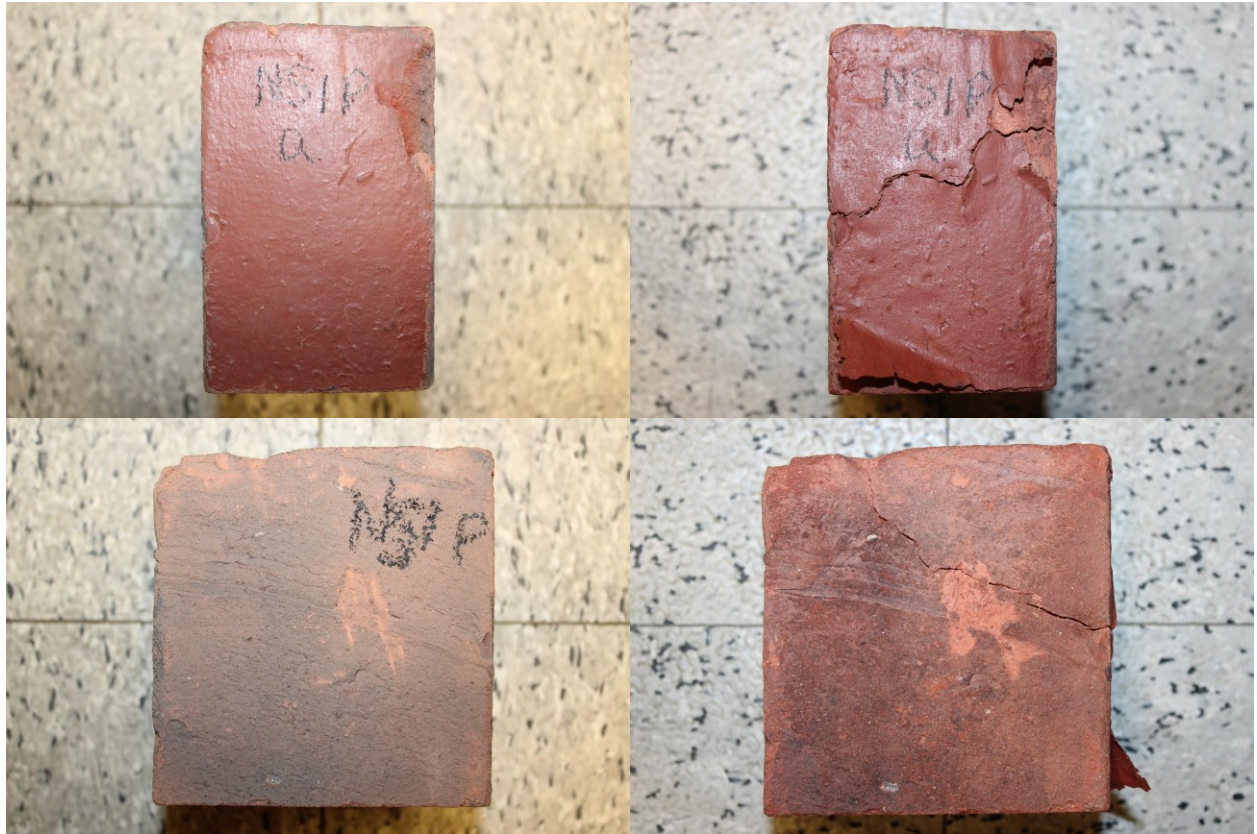
Figure 3.5. BERRi-NS-IP before and after the freeze-thaw test

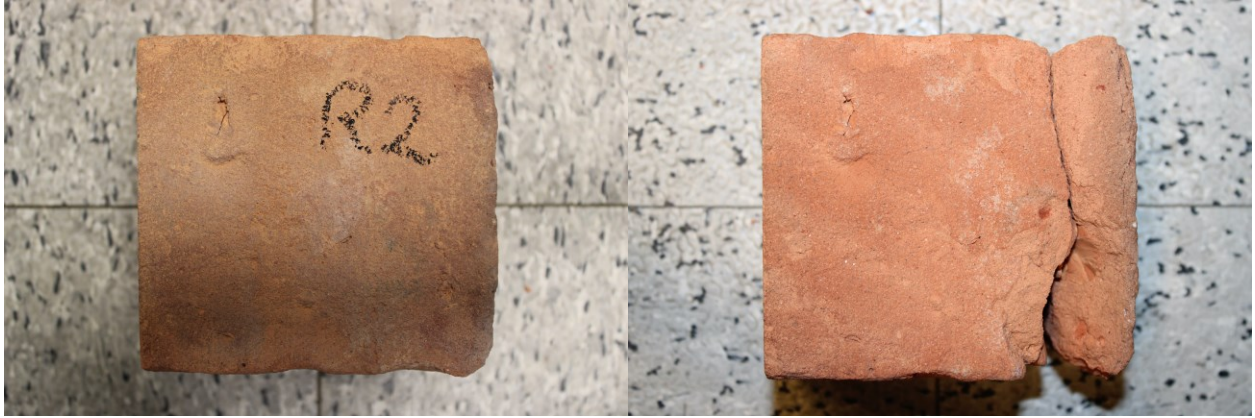
Figure 3.6. ROSEMONT-2 before and after the freeze-thaw test

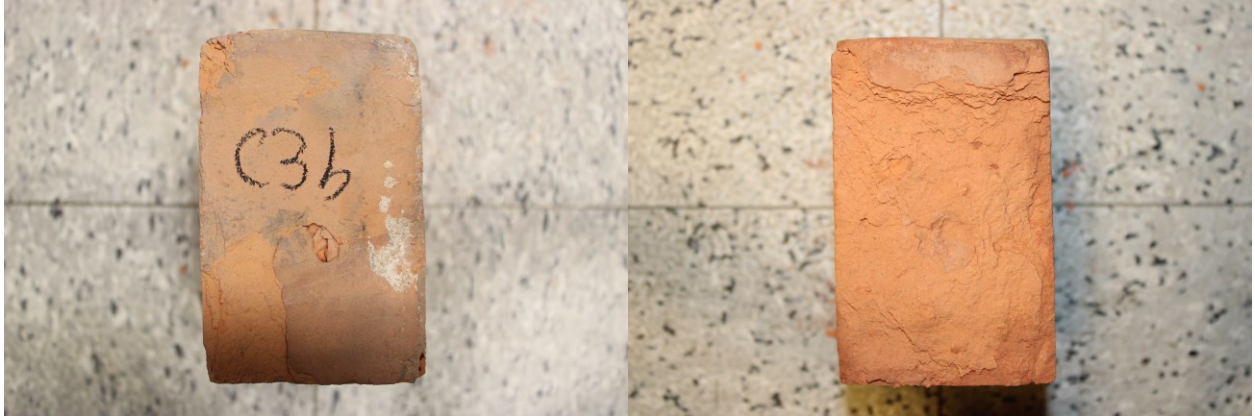
Figure 3.7. CRAIG-3 before and after the freeze-thaw test
