# **INFLUENCE OF DETAILING ON RESPONSE OF DAPPED END BEAMS**

Ting Peng

April 2009

A thesis submitted to the Faculty of Graduate Studies  
and Research in partial fulfillment of the requirements  
for the degree of Master of Engineering

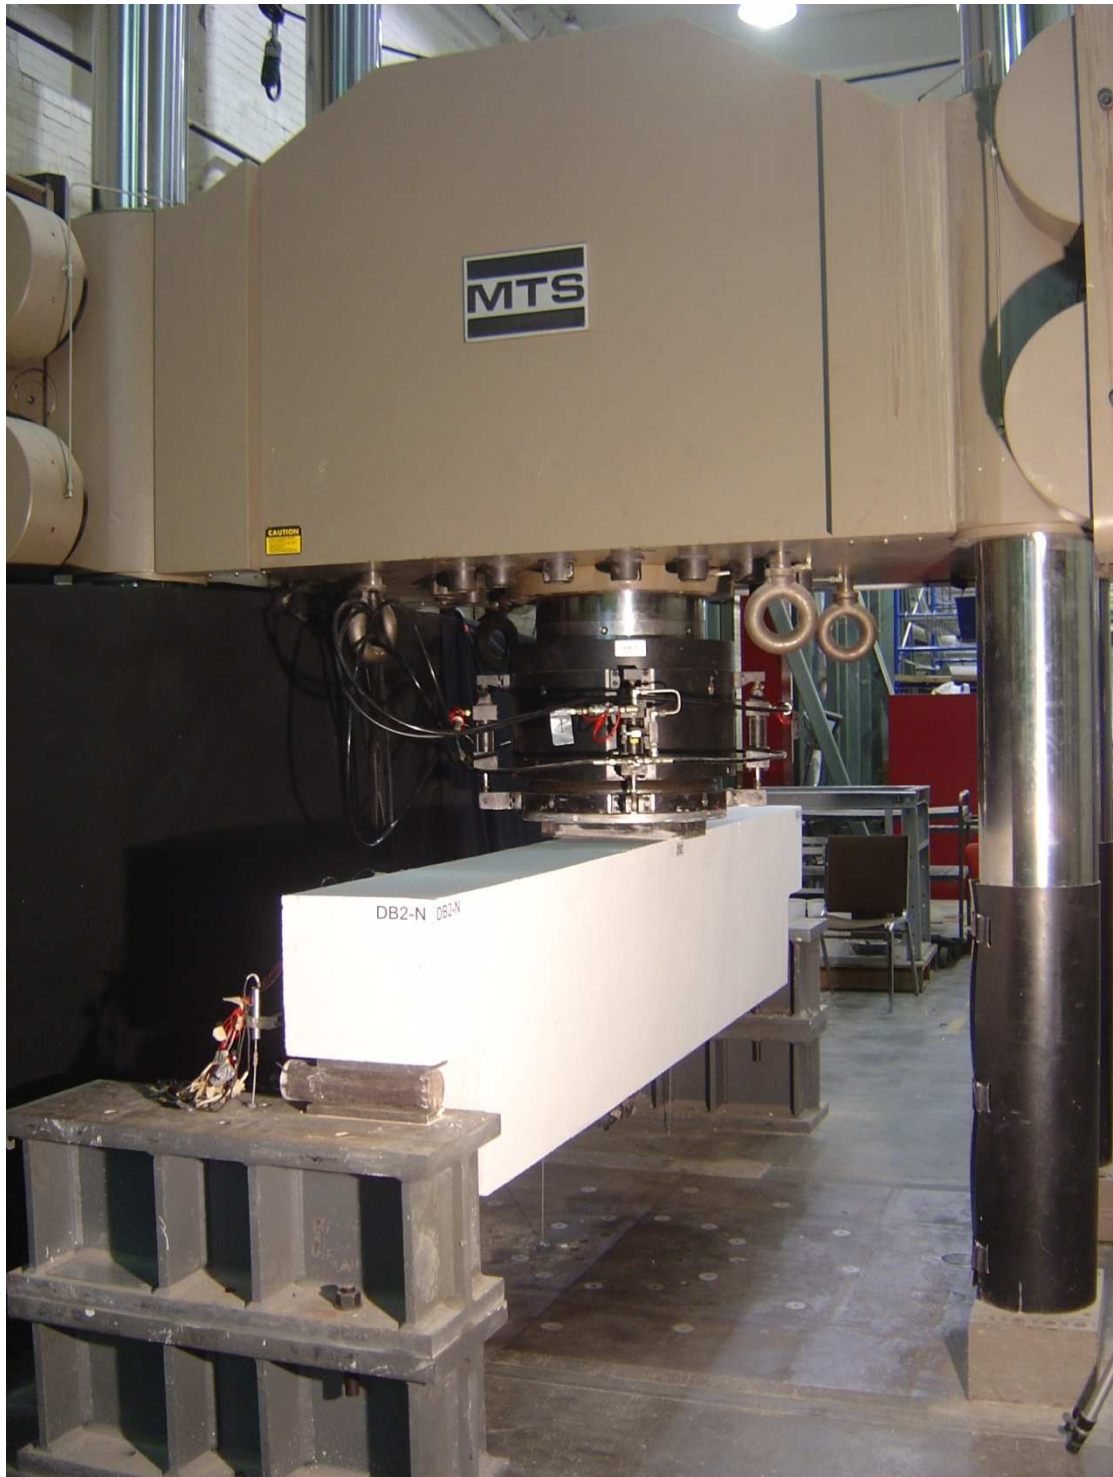
**Figure 2.10** Overview of specimen under MTS machine

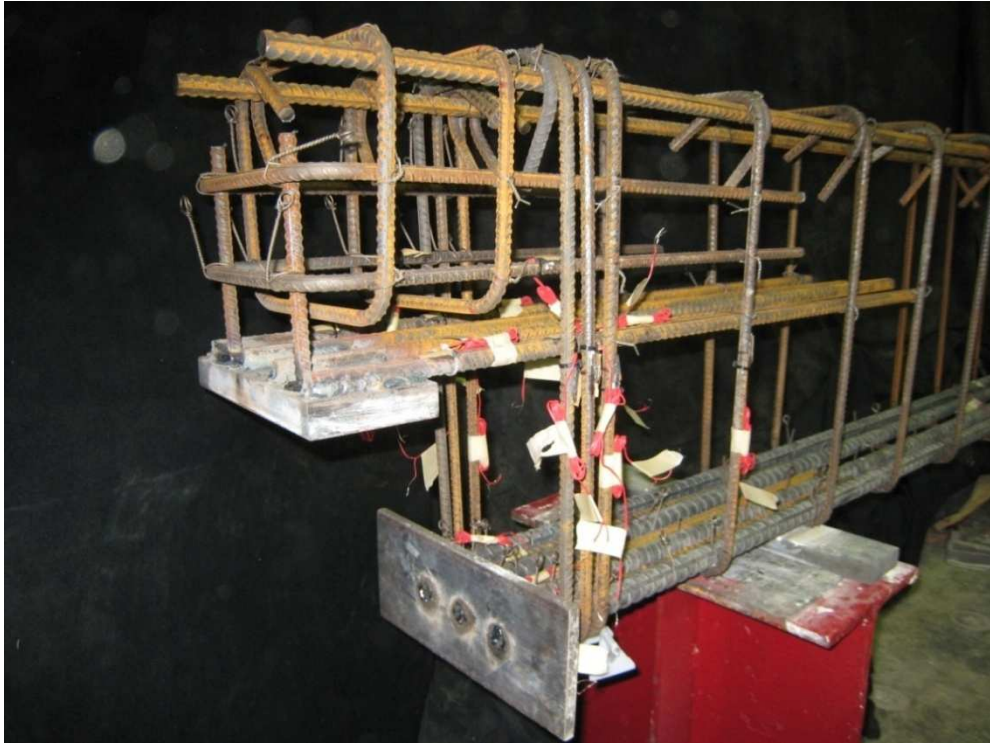
**Figure 2.21** Reinforcement details at north side dapped end of DB2

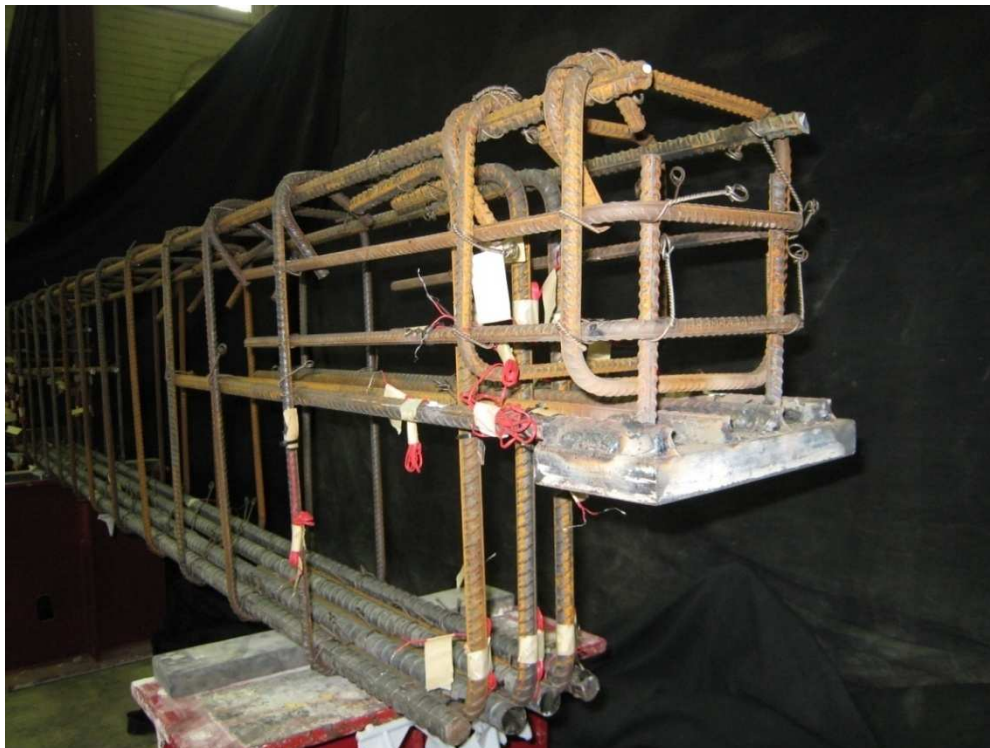
**Figure 2.22** Reinforcement details at south side dapped end of DB2

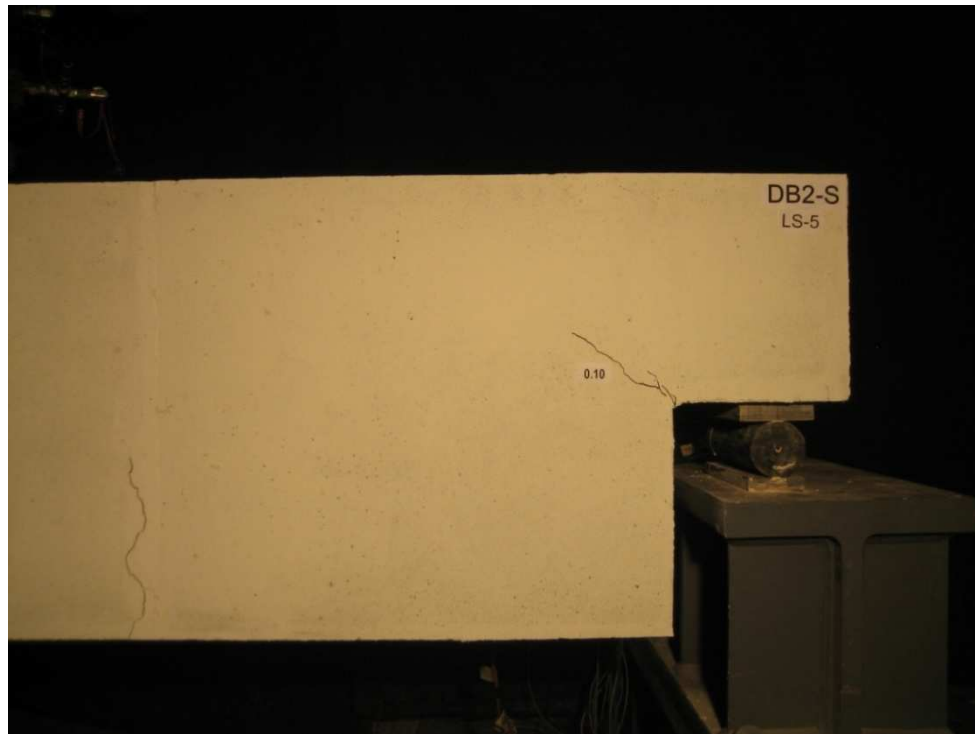
**Figure 3.267** Photo of crack pattern at LS-5 for DB2-S

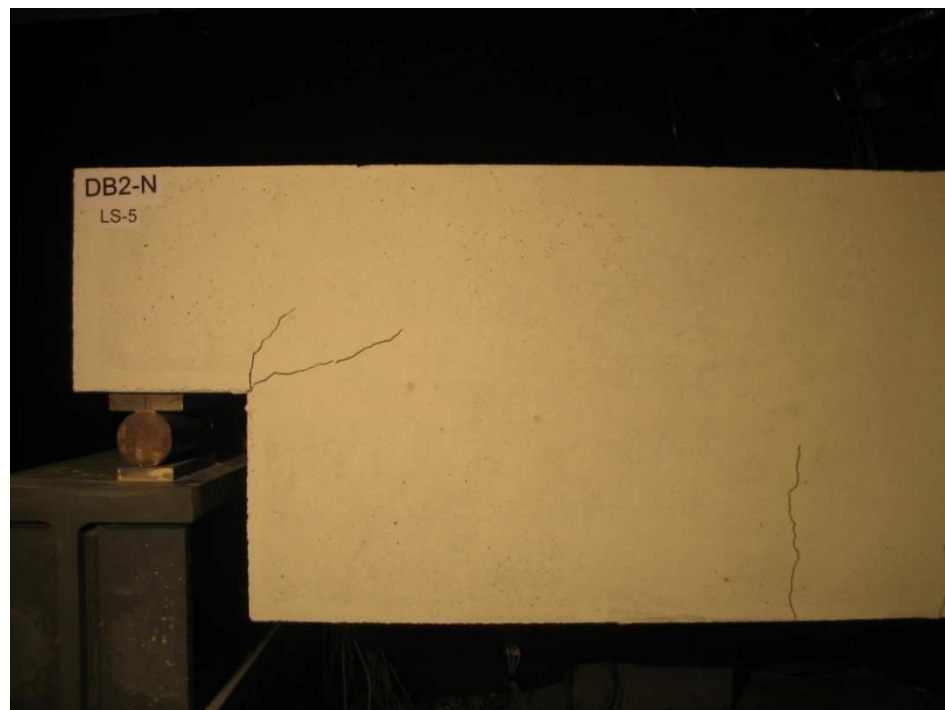
**Figure 3.35** Photo of crack pattern at LS-5 for DB2-N
