**UPGRADING SANITARY SERVICES**

**IN SQUATTER SETTLEMENTS**

A thesis submitted to the Faculty of  
Graduate Studies and Research of  
McGill University, in partial  
fulfillment of the requirements for  
the degree of Master of Architecture.

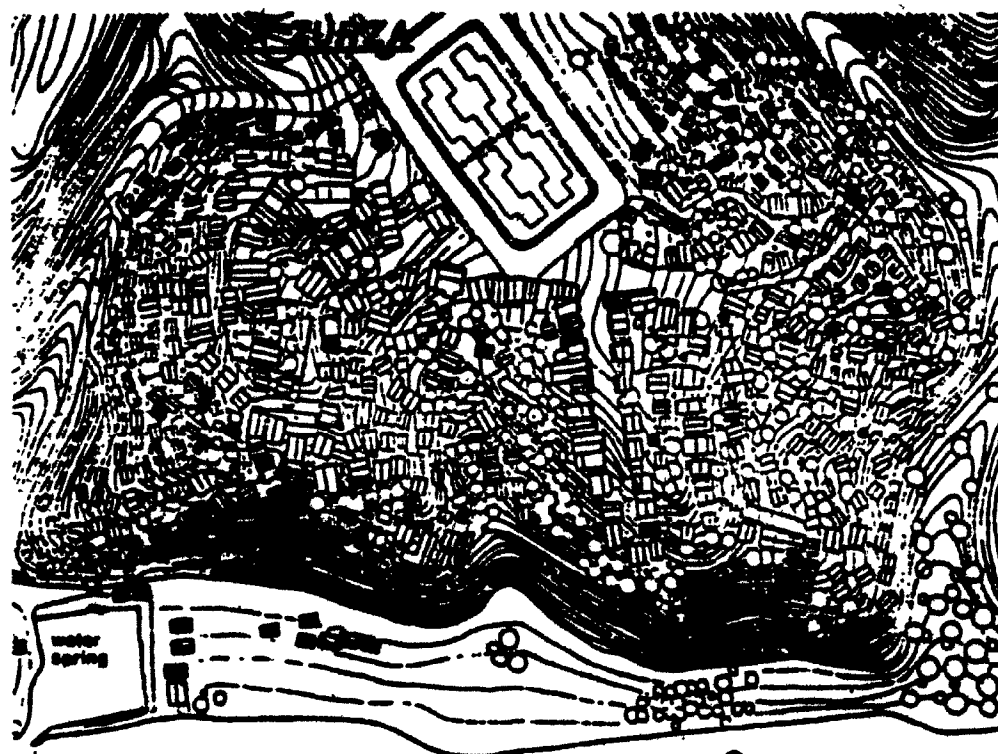
**Map 4**

● water tanks  
○ water tanks not in use

**Water Resources**

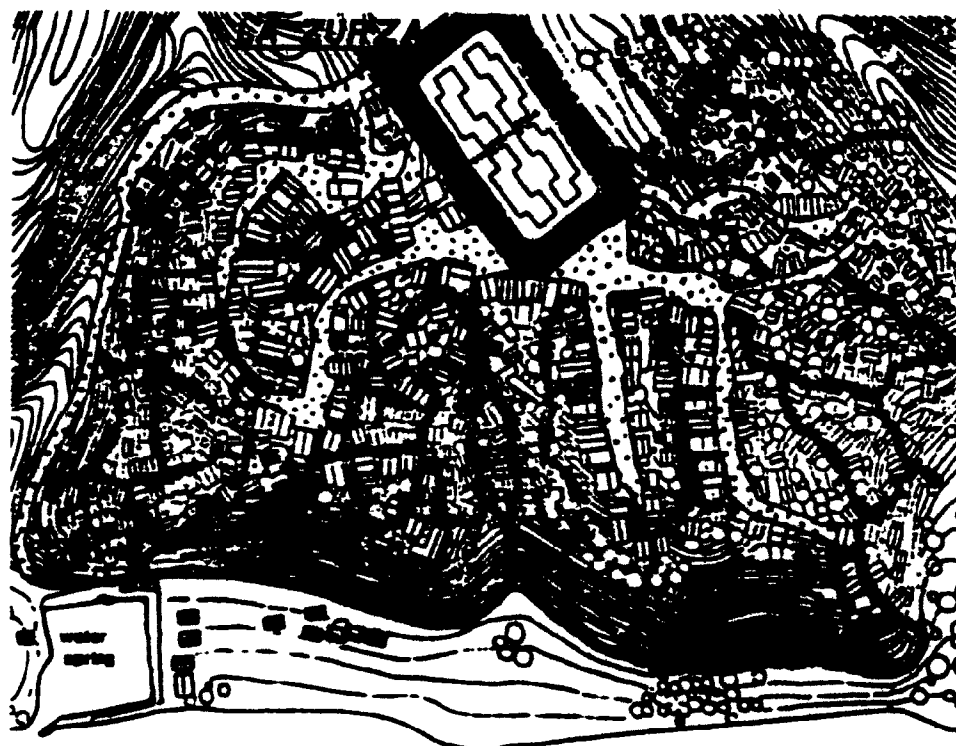
Map 5  
Road System

street  
dirt-road  
path
