# **Post-Punching Shear Behaviour of Full-Scale Slab Structure with Edge and Corner Columns**

A thesis submitted to McGill University in partial fulfilment  
of the requirements of the degree of Master of Engineering

## ABSTRACT

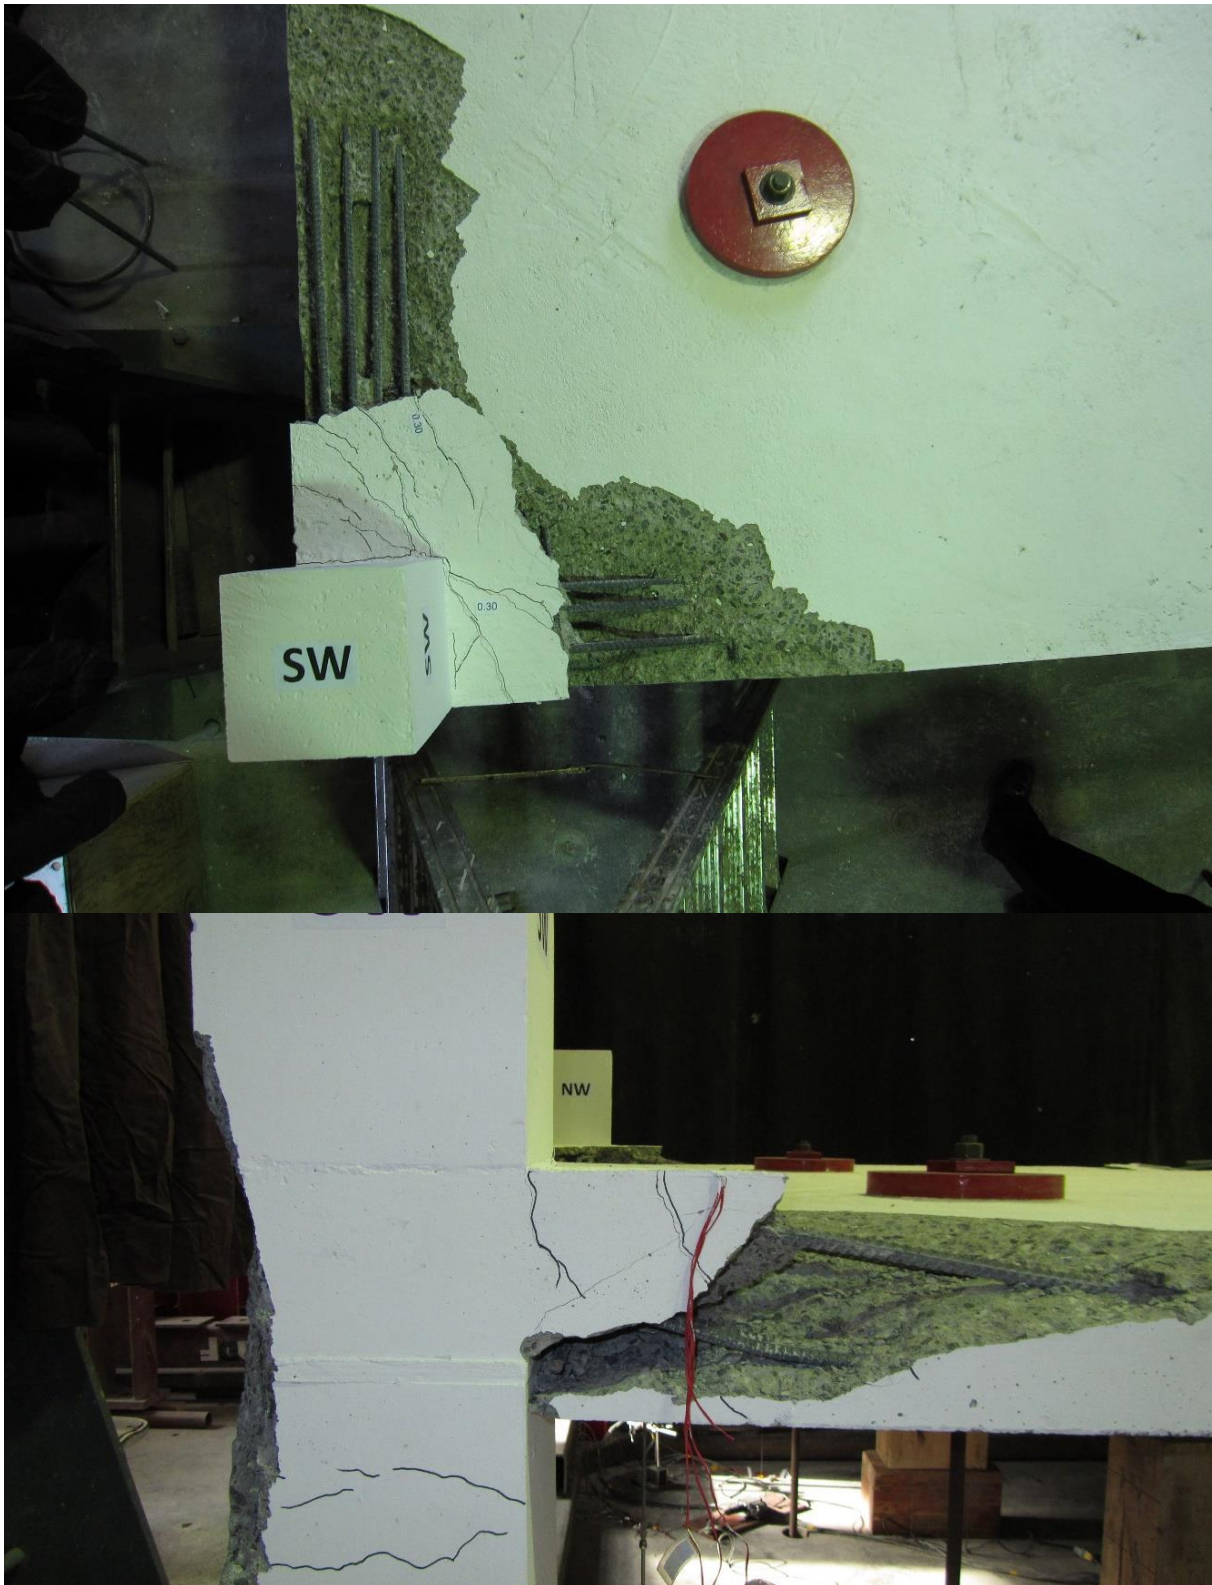
**Figure 3-35: Post-punching shear condition of the corner slab-column connection SW at the end of testing**

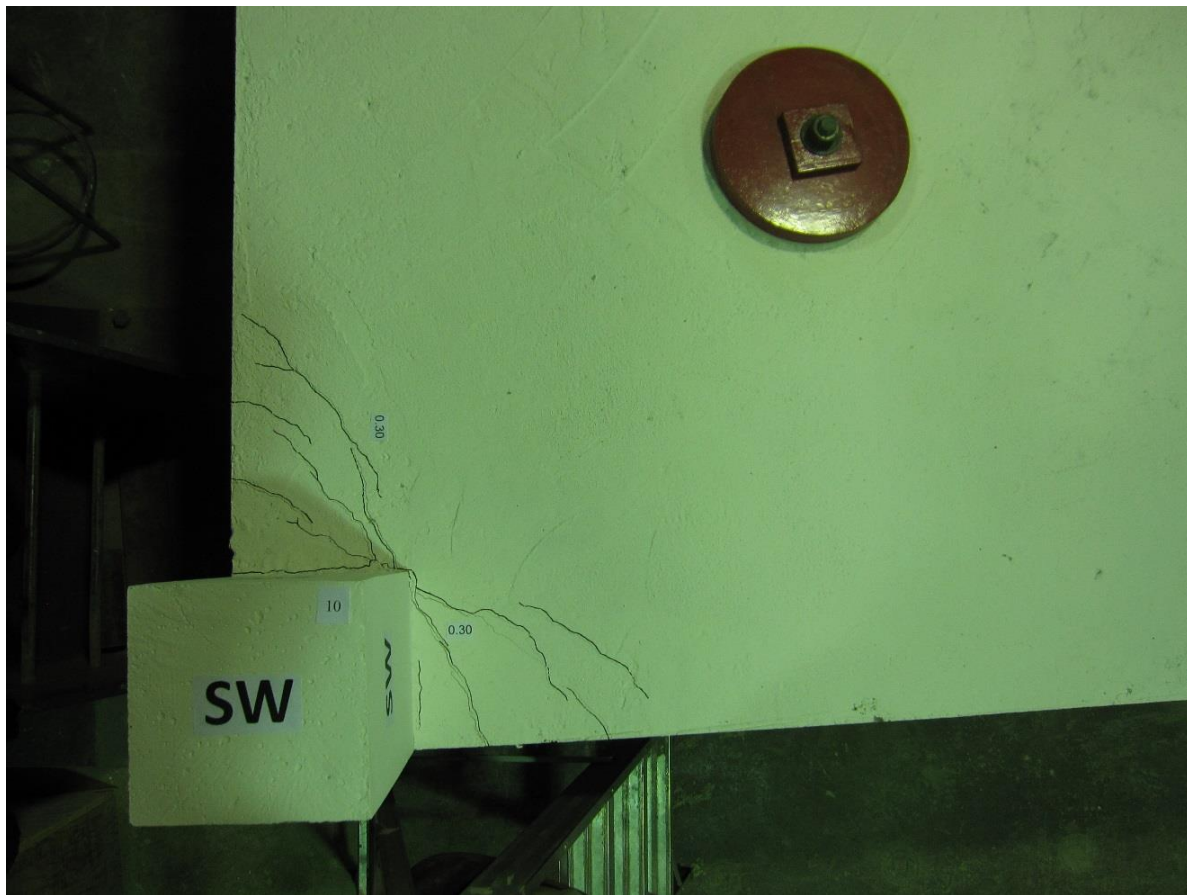
**Figure 3-36: Crack pattern around corner slab-column connection SW at load stage 10**

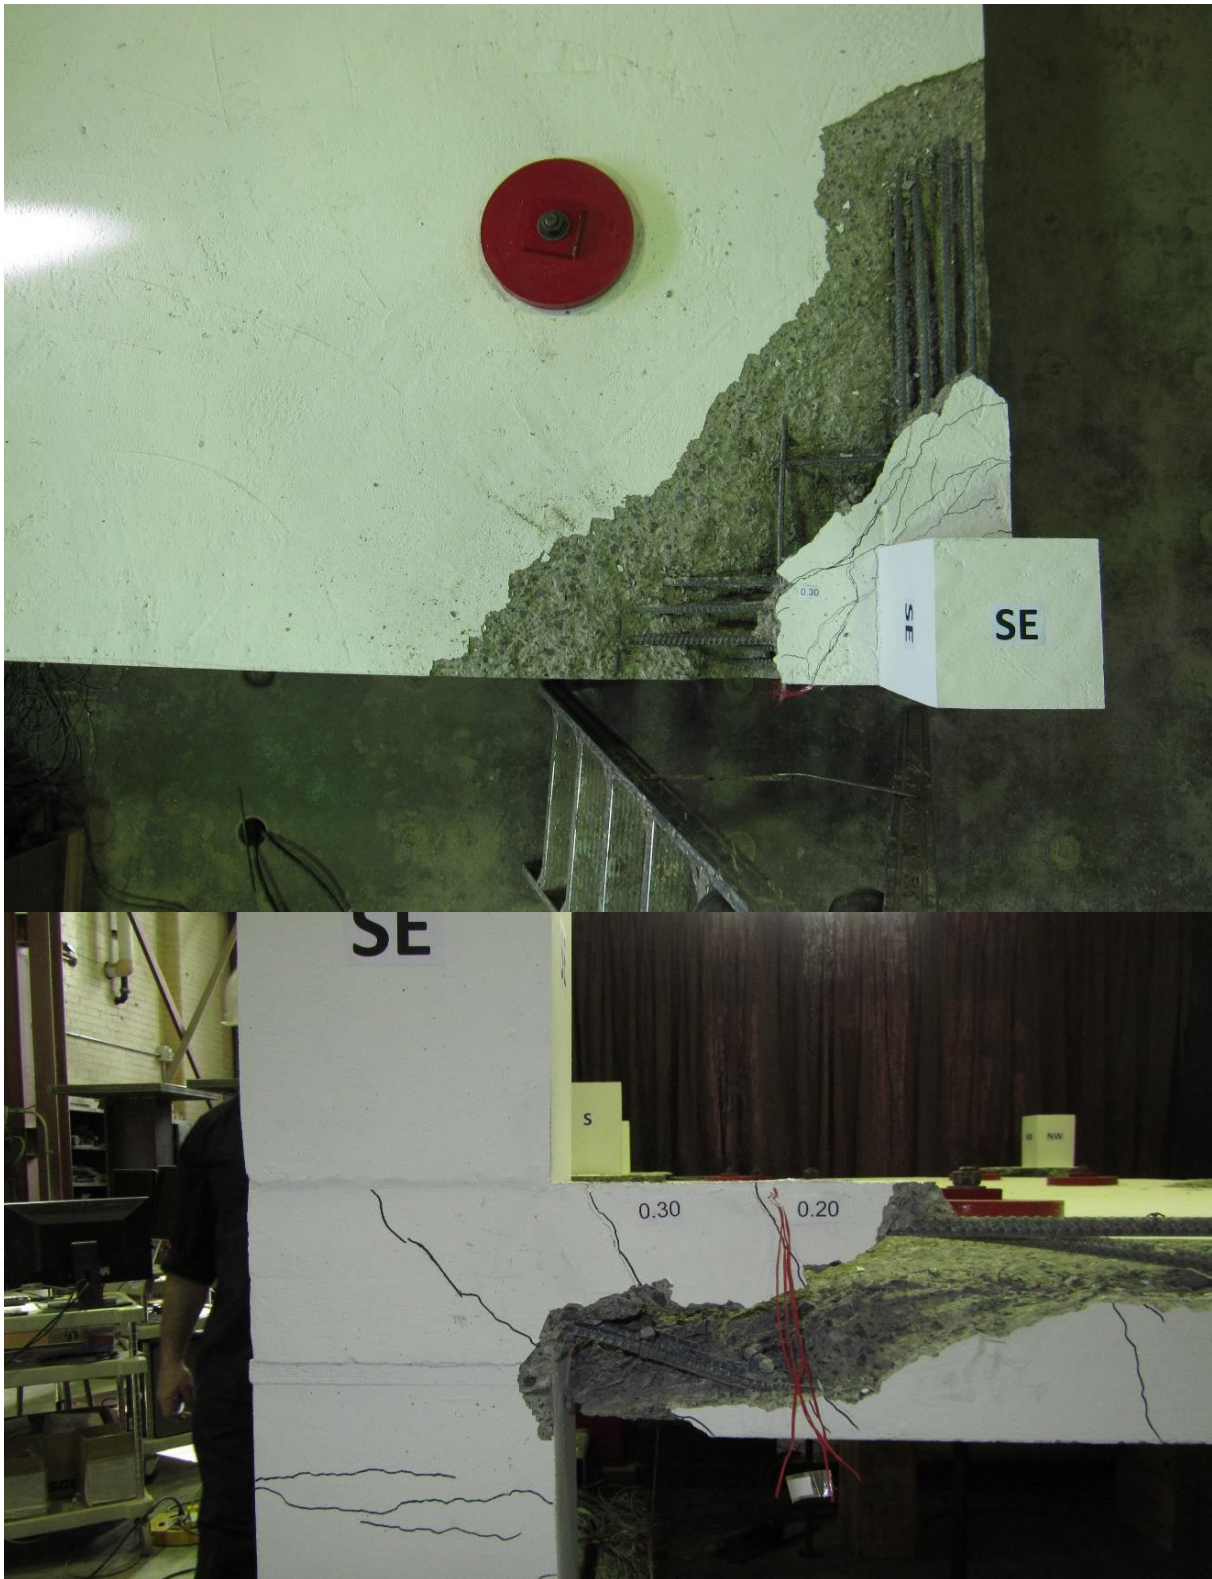
**Figure 3-51: Post-punching shear condition of the corner slab-column connection SE at the end of testing**

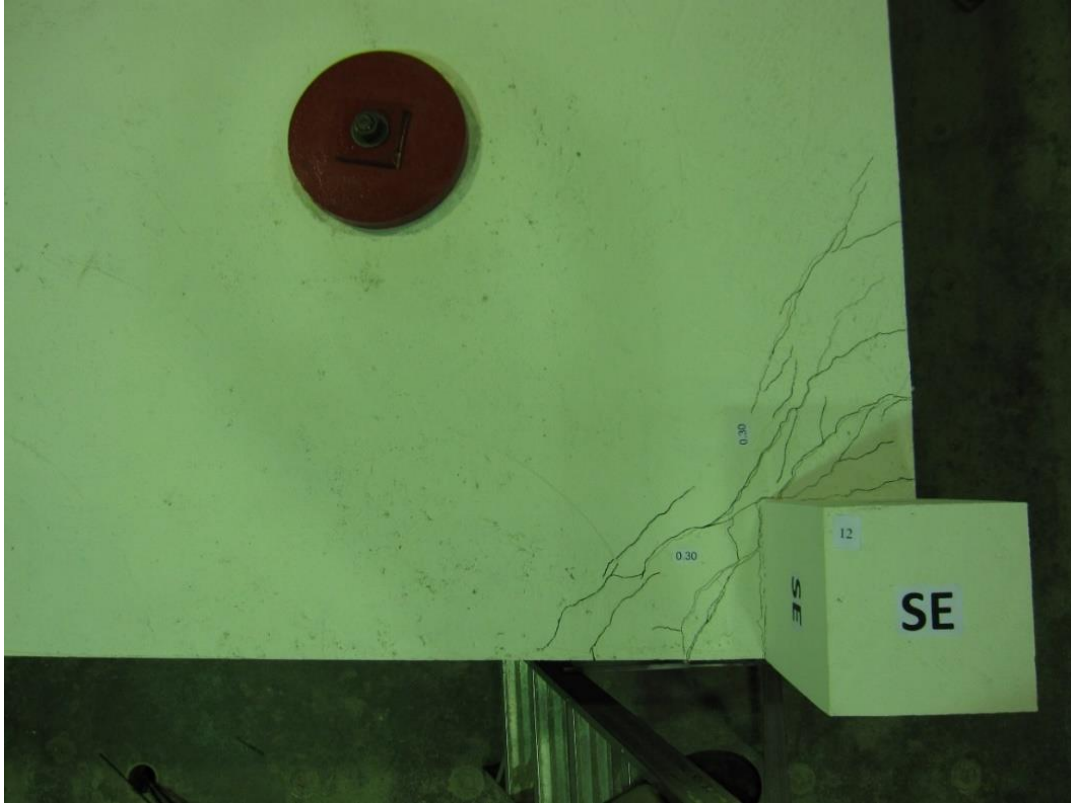
**Figure 3-52: Crack pattern around corner slab-column connection SE at load stage 12**
