NON-LINEAR RESPONSE OF REINFORCED CONCRETE
COUPLING SLAB WITH DROP PANEL IN EARTHQUAKE-
RESISTING SHEAR WALL STRUCTURES

ALBERT KEE WAH LIM

McGill University

A thesis submitted to the Faculty of Graduate Studies
and Research in partial fulfillment of the requirements
for the degree of Master of Engineering

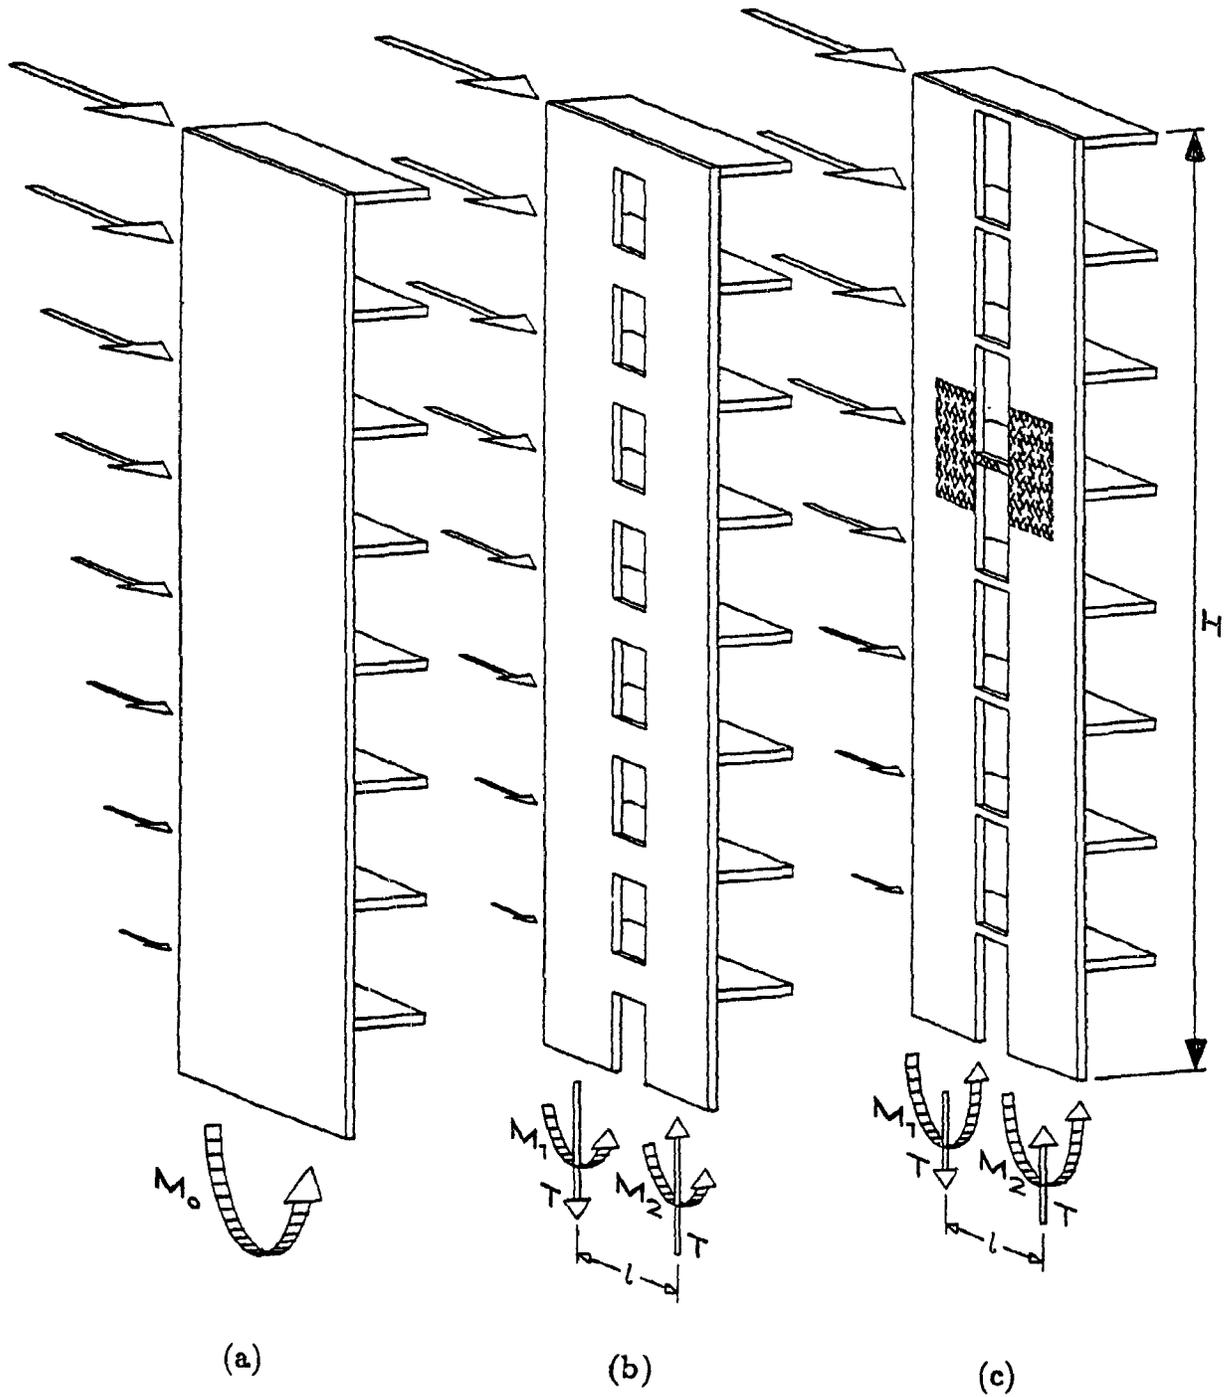
Figure 1.1 Types of Earthquake-Resisting Shearwalls
 (a) Cantilever Walls
 (b) Two Walls Coupled by Beams
 (c) Two Walls Coupled by Floor Slabs.

One desirable feature in a shear wall structure subjected to earthquake forces is its hysteretic response - the ability of the structure to dissipate energy. For a single, plain, solid cantilever shear wall, such energy dissipation takes place when inelastic deformations caused by an overturning moment, M_o , (Figure 1.1a) occur due to a single plastic hinge in the bottom storeys of the wall. For a coupled shear wall, the overturning moment, M_o , is resisted at the base of the coupled shear walls by moments in each of the two walls, M_1 and M_2 , and by axial forces, T , forming a couple with a significant internal lever arm l as shown in Figures 1.1(b) and 1.1(c). The equilibrium

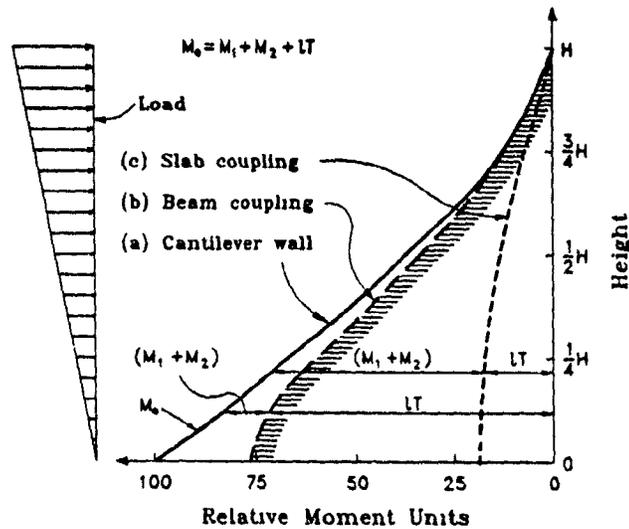
Figure 1.2 Contribution of Internal Coupling to the Resistance of Overturning Moments in Coupled Shear Walls. (Ref. 3).

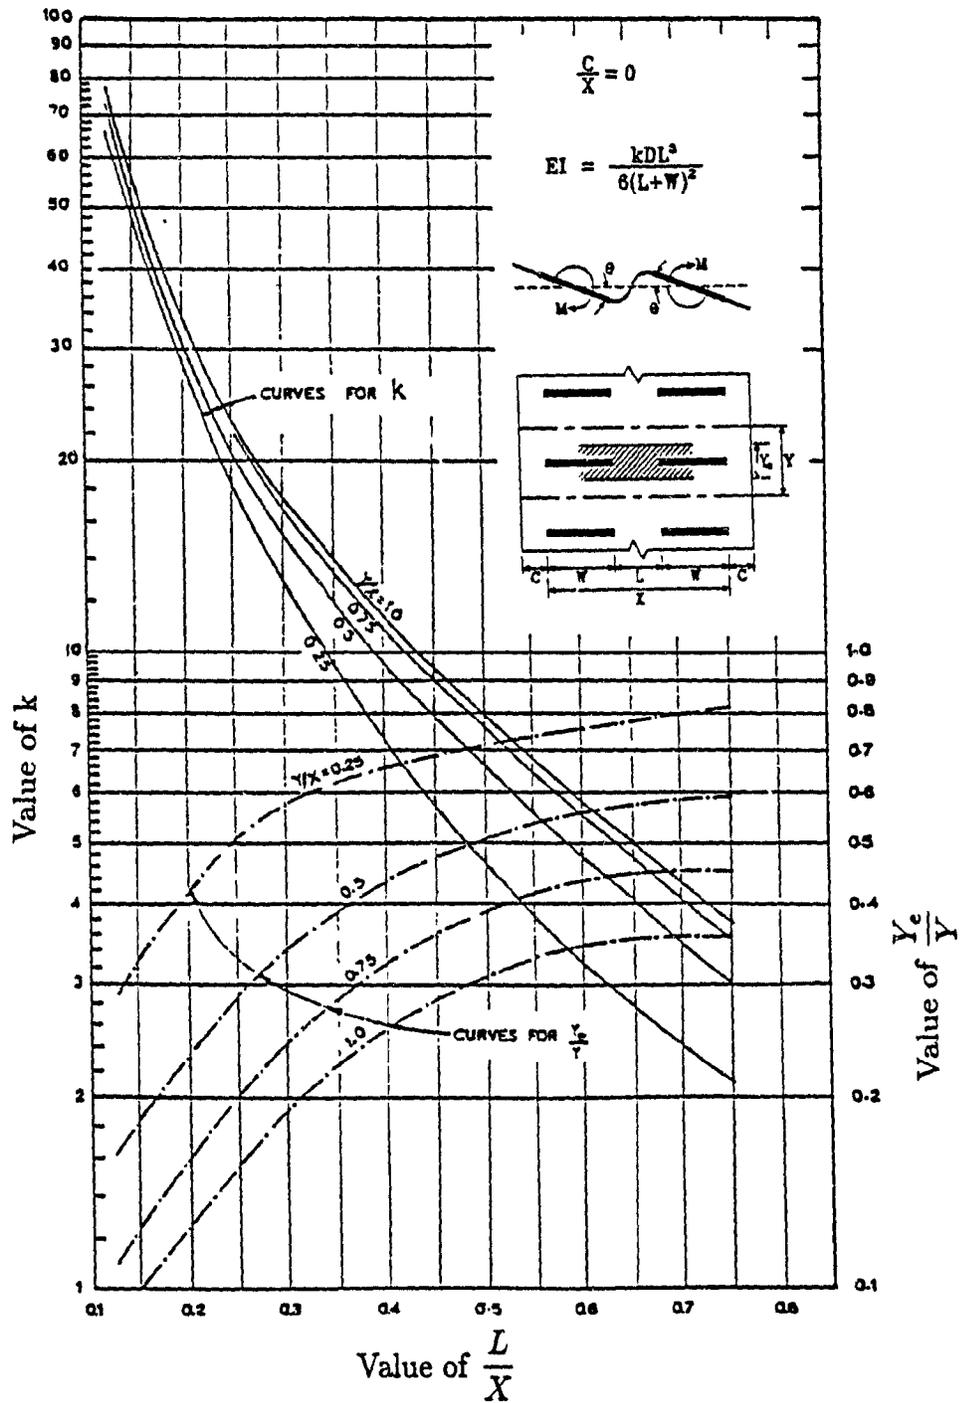
Figure 1.3a Value of Slab Stiffness Number k and $\frac{Y_c}{Y}$ as a Function of $\frac{L}{X}$ for $\frac{C}{X} = 0$ (Ref. 7).

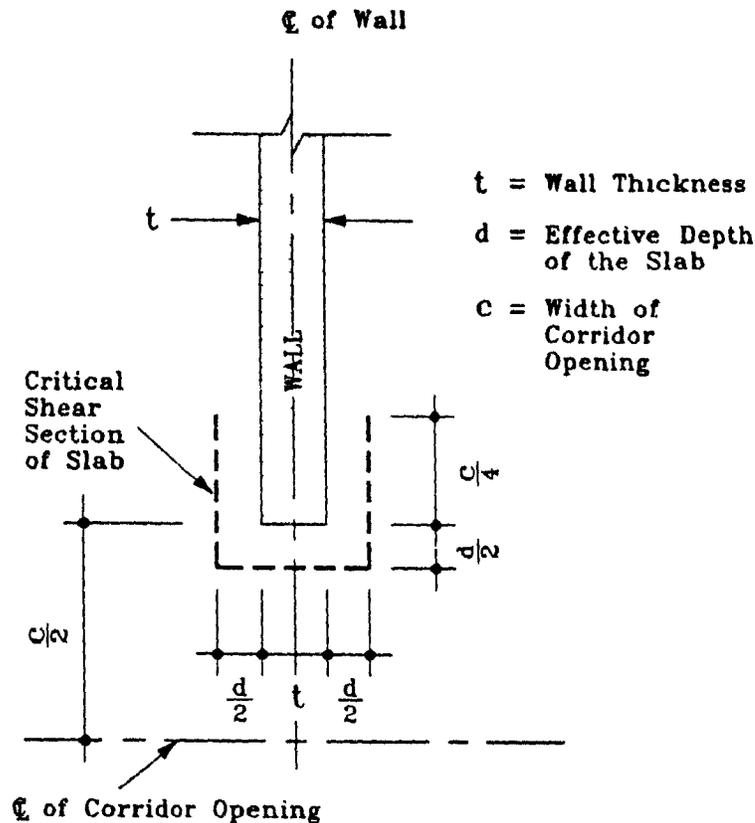
Figure 1.4 Critical Section for Shear Suggested by Chang (Ref. 8).

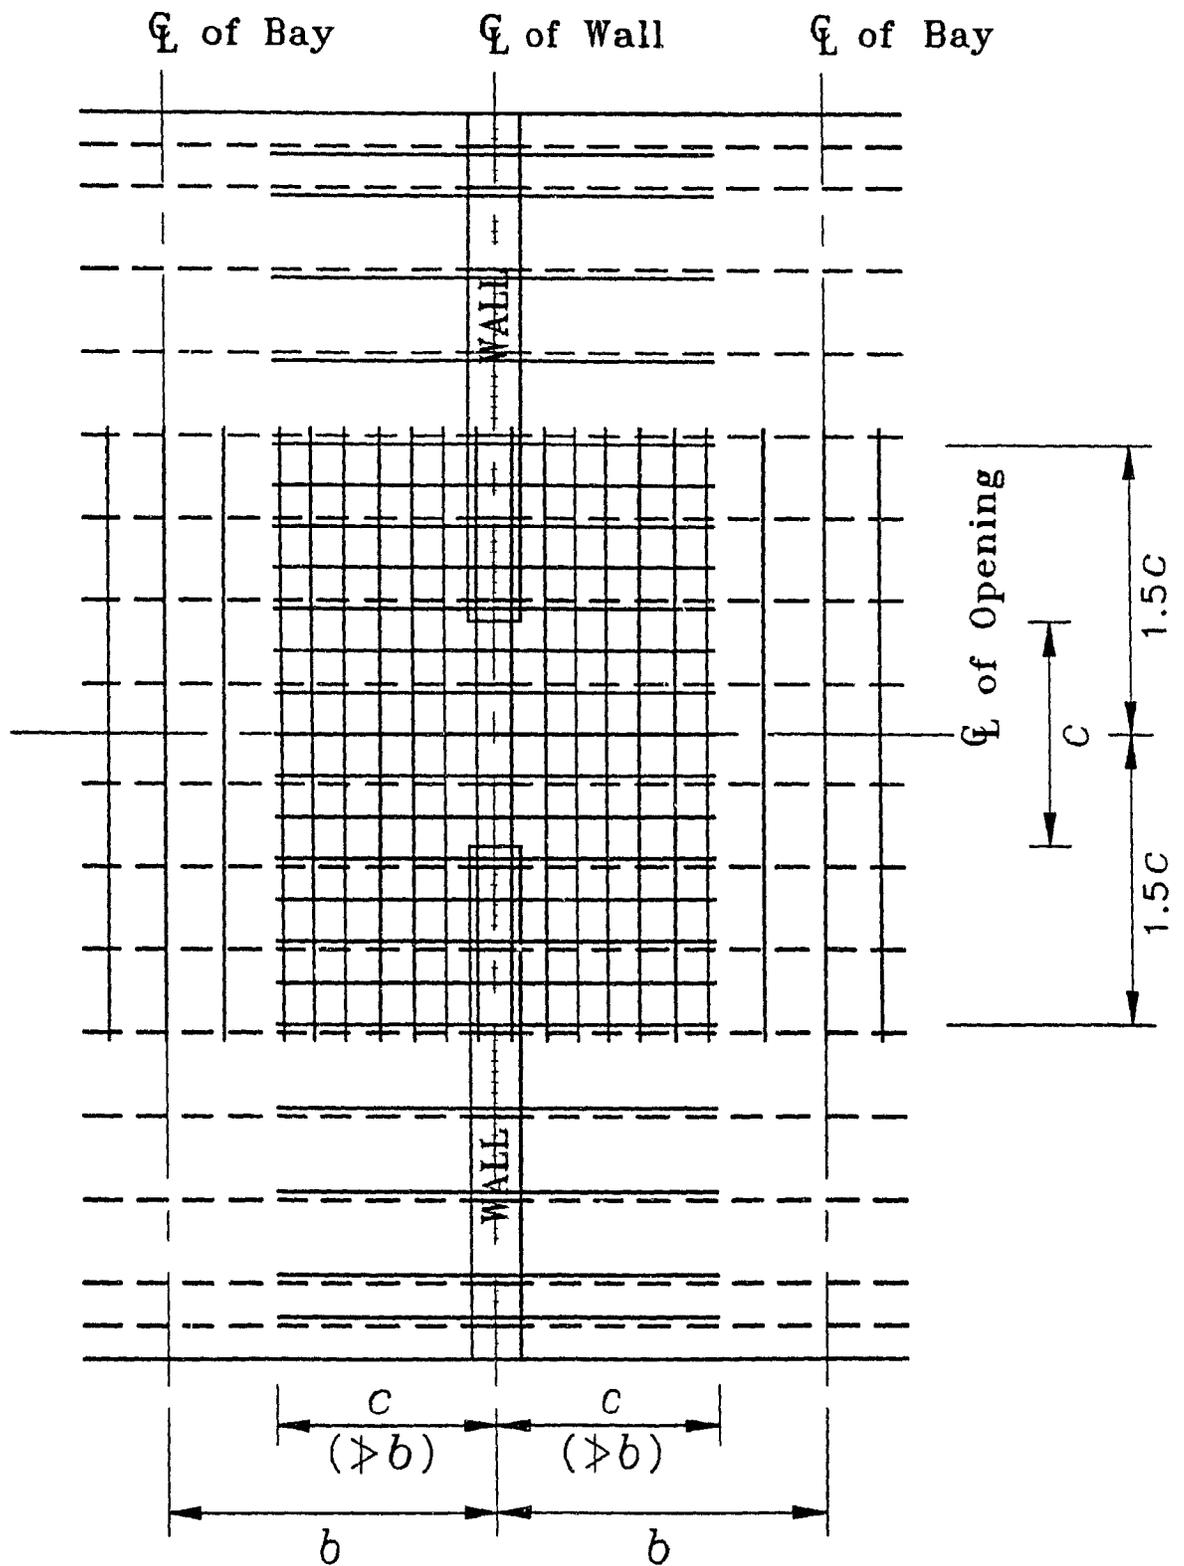
Figure 1.5 Reinforcing Layout Suggested by Chang (Ref. 8).

During the same year, Chang⁸ carried out parametric studies using the finite difference method on the distribution of bending moments in the slabs of slab-shear wall structures for various bay, corridor and wall widths. He recommended that the critical section for shear should be confined to one-fourth of the corridor width from the toe of the wall at a distance equal to half the effective depth of the slab from the wall faces, as shown in Figure 1.4. He also recommended that the effective width of the slab be one corridor width on either side of the walls and that the concentrated transverse and longitudinal reinforcements should extend a distance of at least one corridor width beyond the shear wall toe. This reinforcing pattern is shown in Figure 1.5.

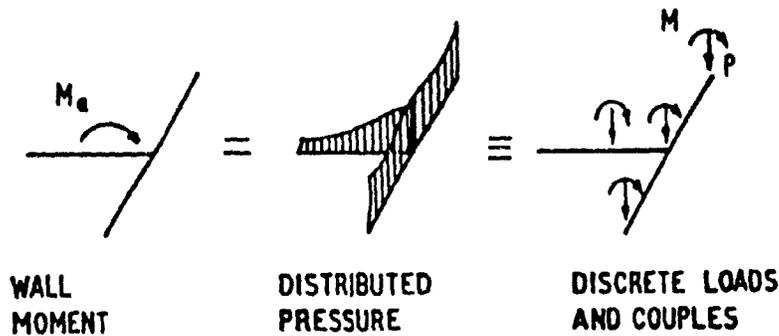
Figure 1.7 Representation of Moment Transfer Between Wall and Slab by Discrete Forces (Ref. 29).

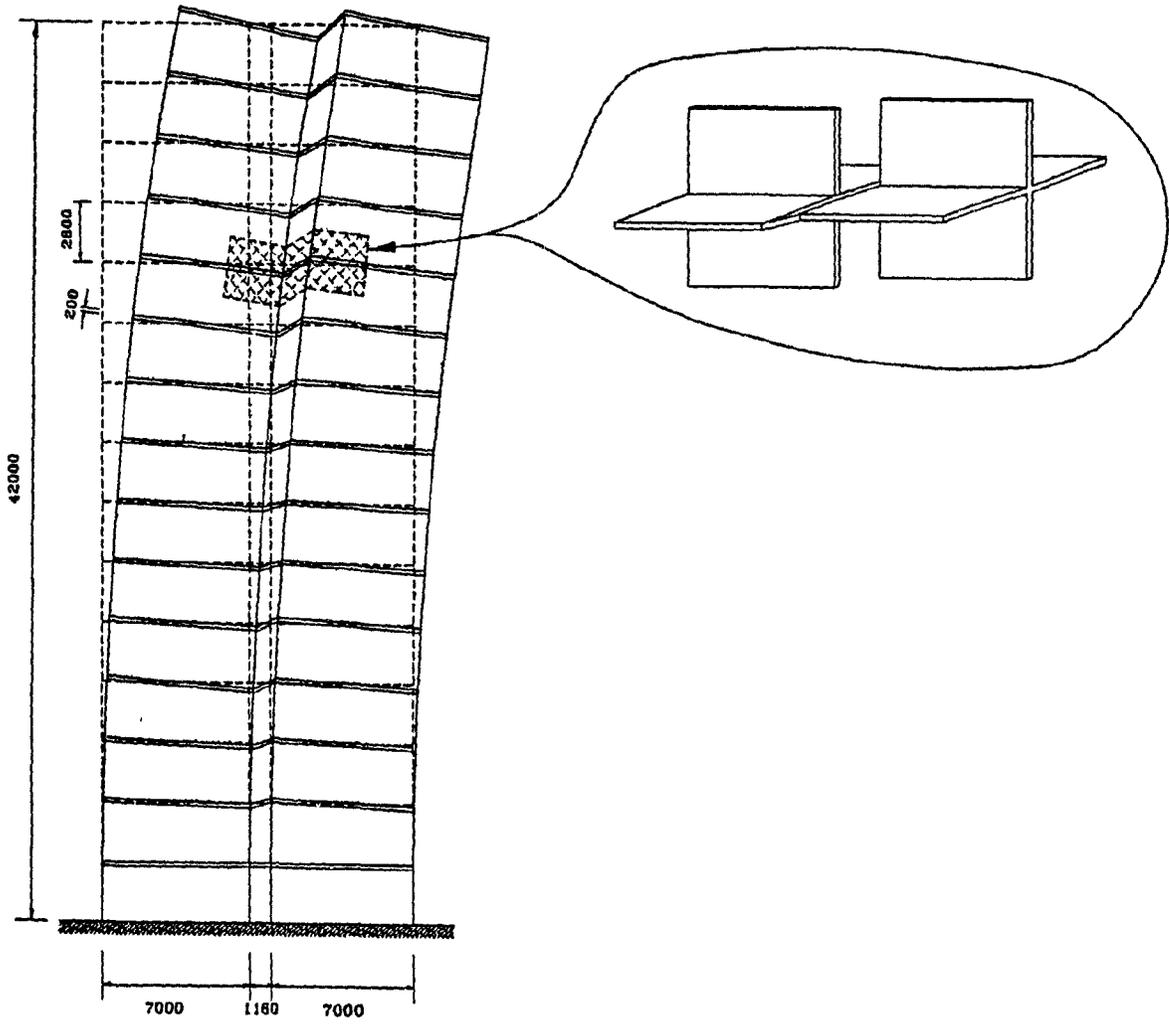
Figure 1.8 15 Storey Prototype Structure Adopted by Taylor and Schematic View of a Typical Interior Bay Section (Ref. 14).

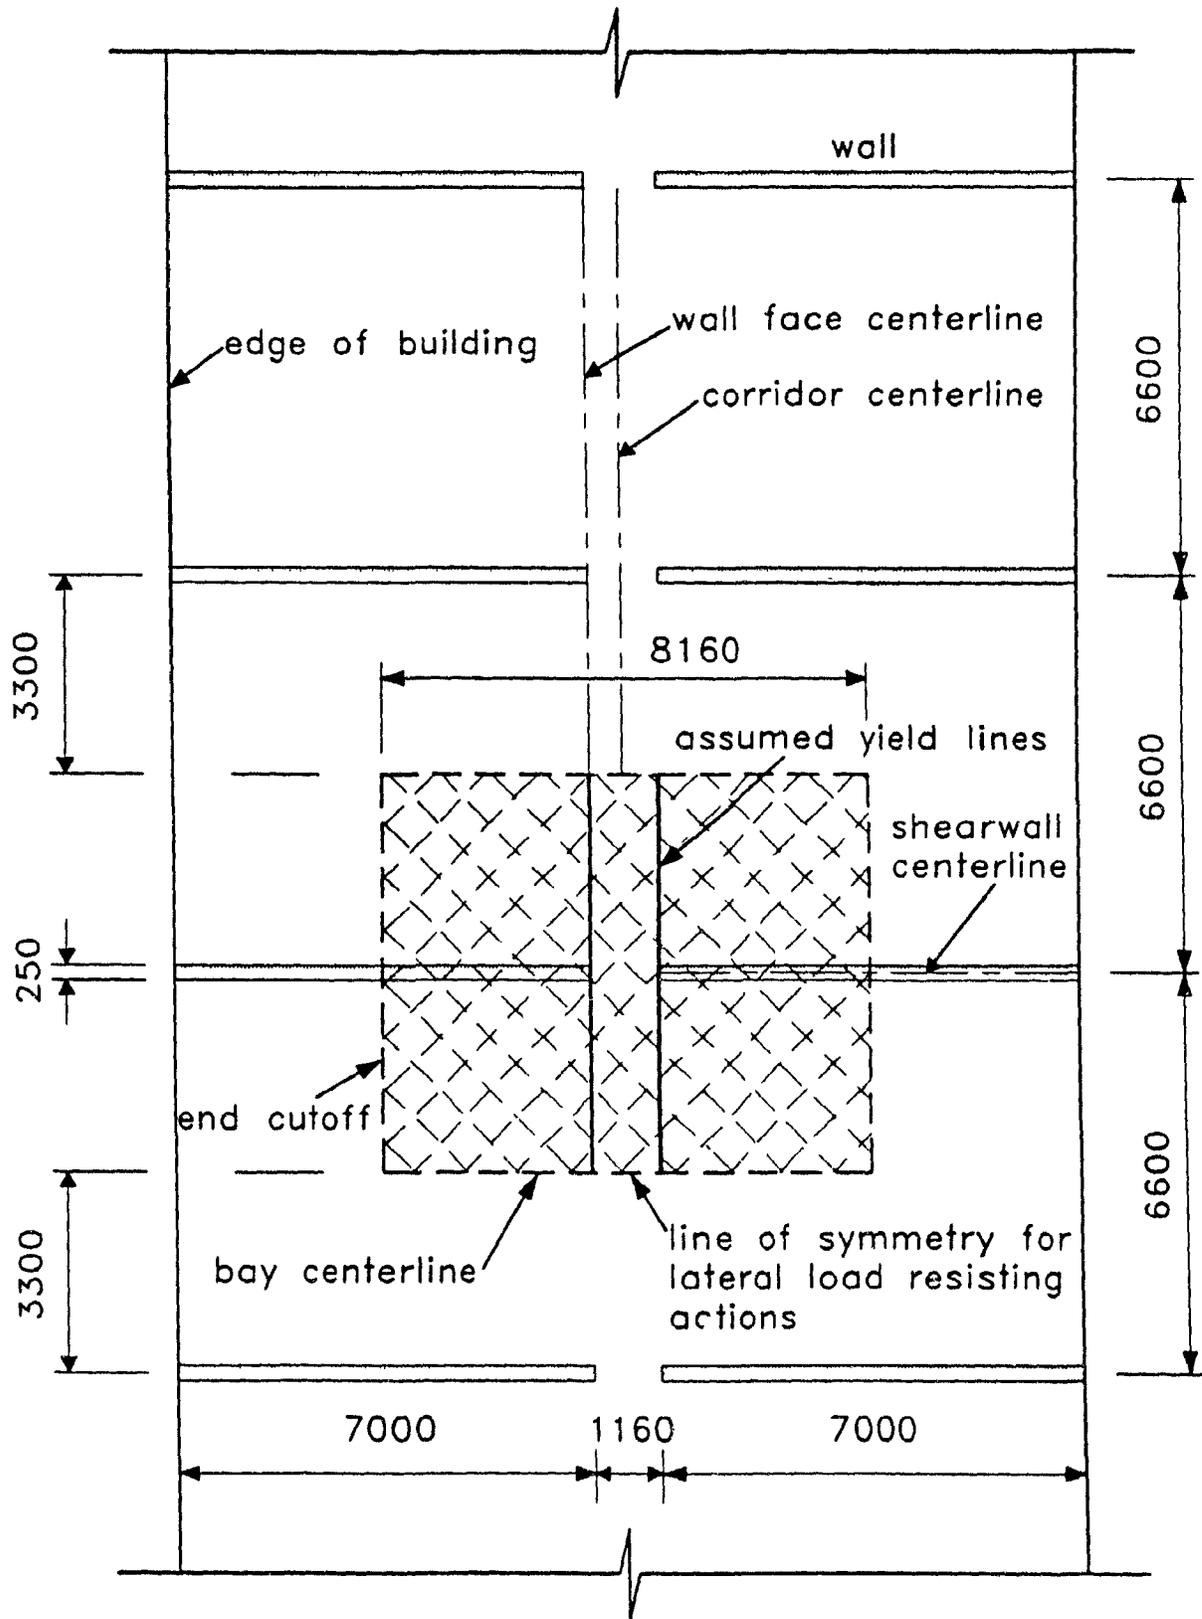
Figure 1.9 Typical Plan View of Prototype Structure by Taylor (Ref. 14).

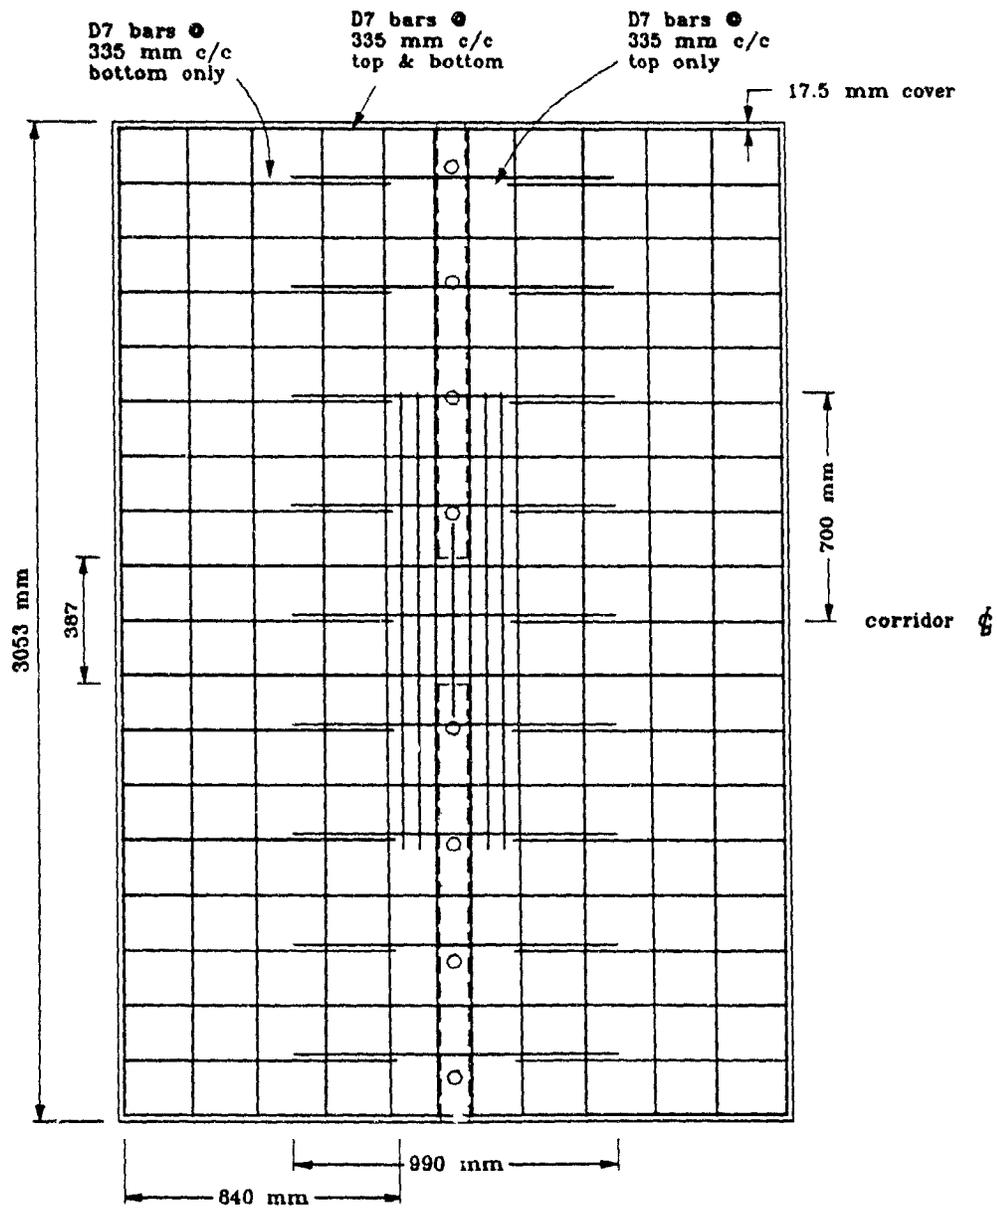
Figure 3.10 Slab Flexural Reinforcement Detail of Specimens D1 and D2.

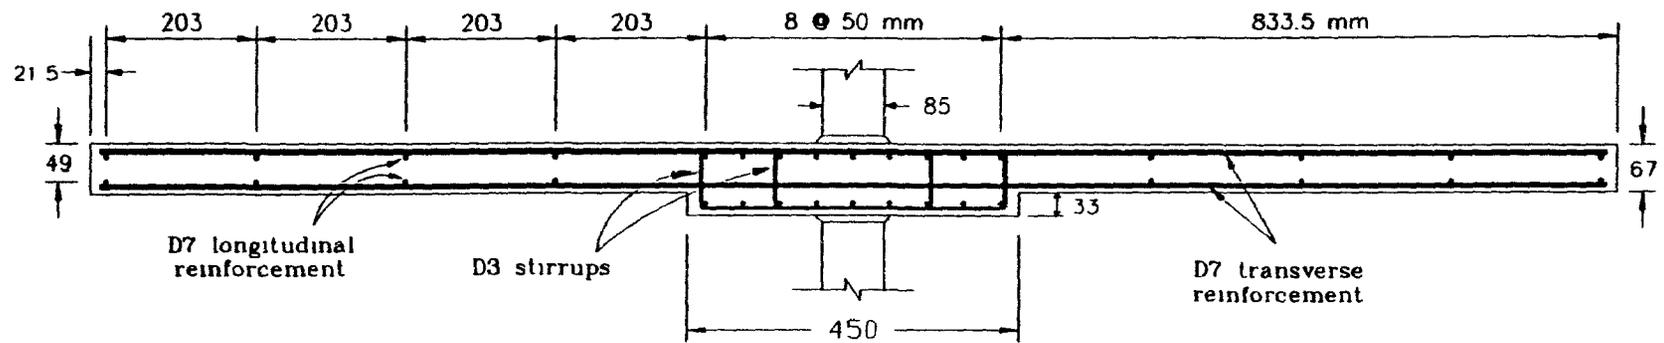
Figure 3.13 Cross-Section of Slab Reinforcement at Wall Toes of Specimens D1 and D2.

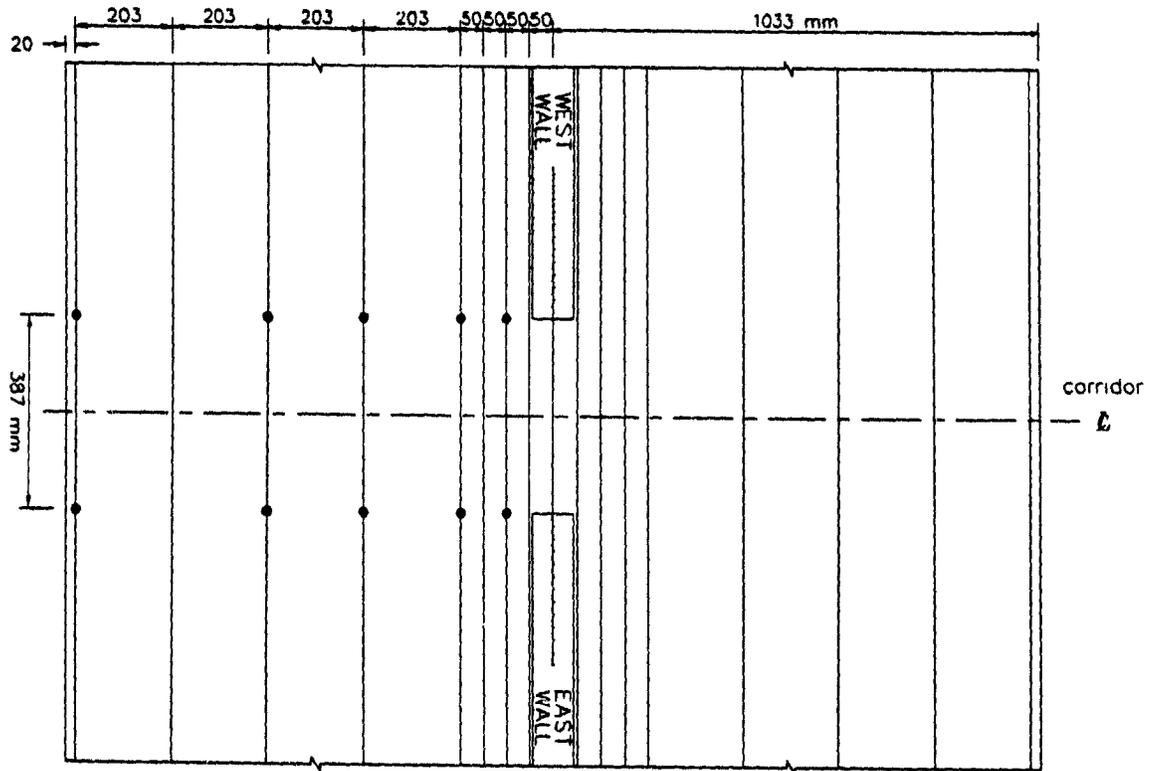
Figure 3.19 Demec Stud Locations on Top and Bottom Longitudinal Slab Reinforcement of Specimens D1 and D2.

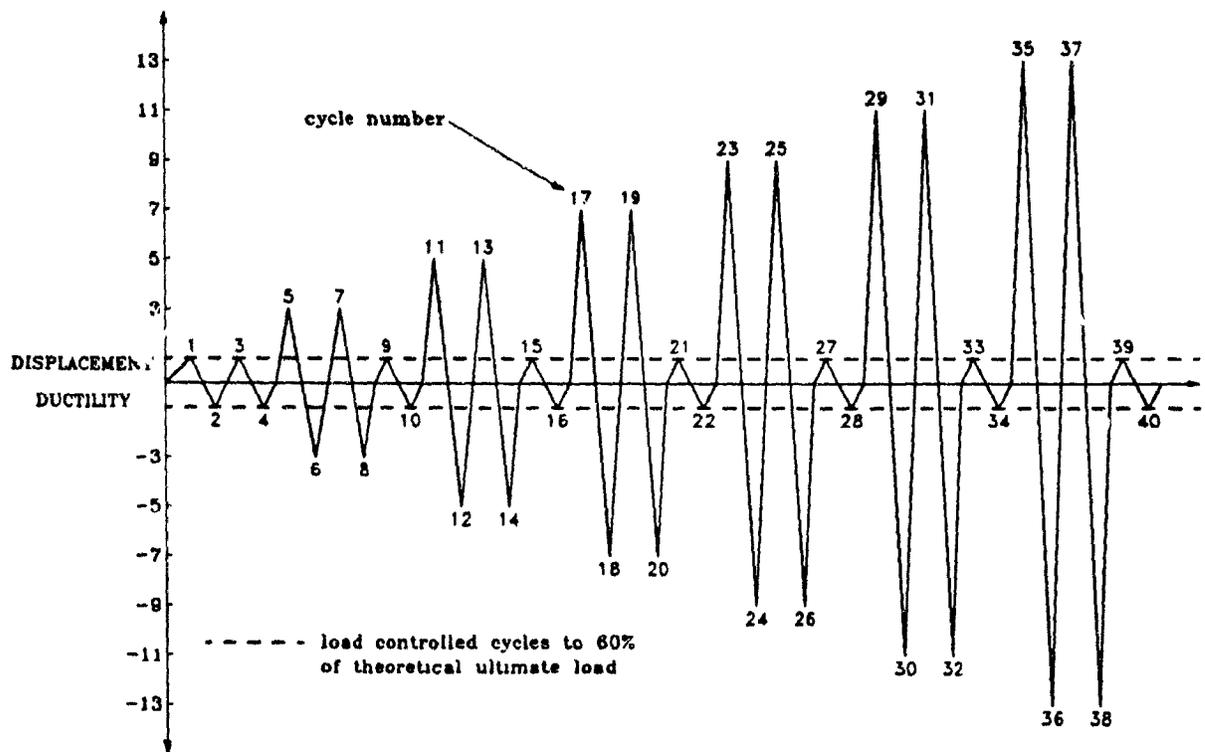
Figure 3.23 Loading History.

The intermediate “elastic” load cycles were included to observe the effect of each “inelastic” displacement amplitude cycle on the slab coupling stiffness. The 20 kN peak value for these “Cycles to 60% of the Theoretical Ultimate Load” is not equivalent to 60% of the theoretical ultimate load predicted by the yield line theory ($P_{ult} = 86.1$ kN).

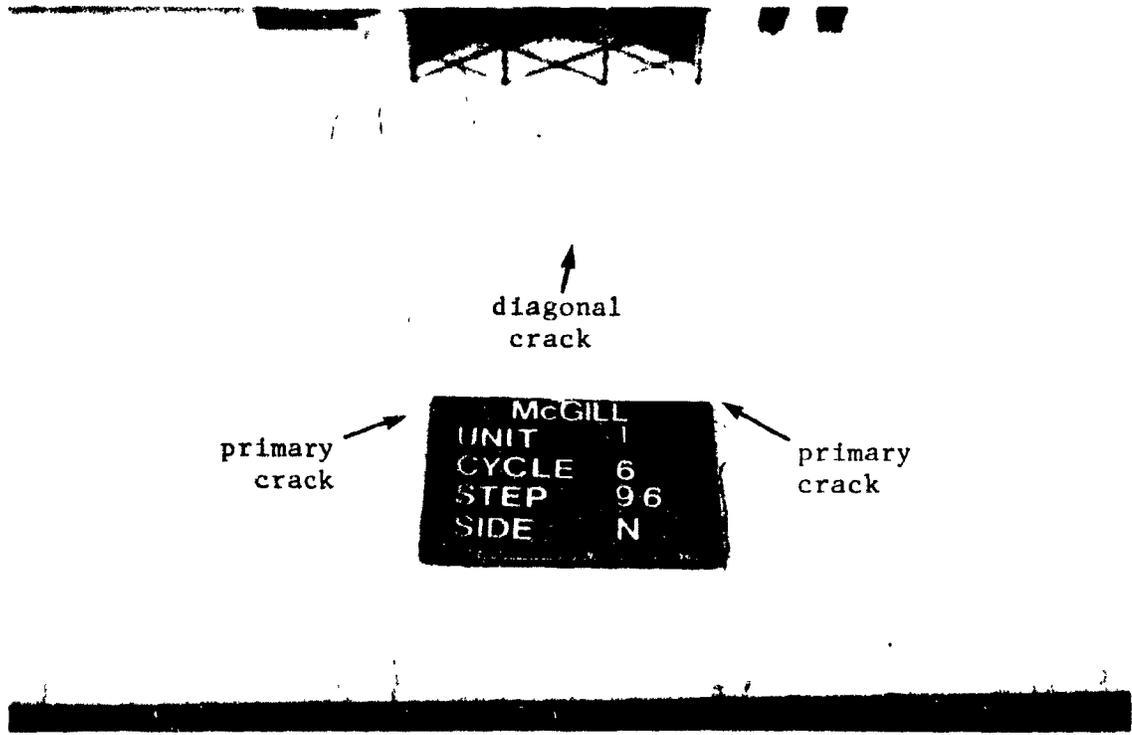
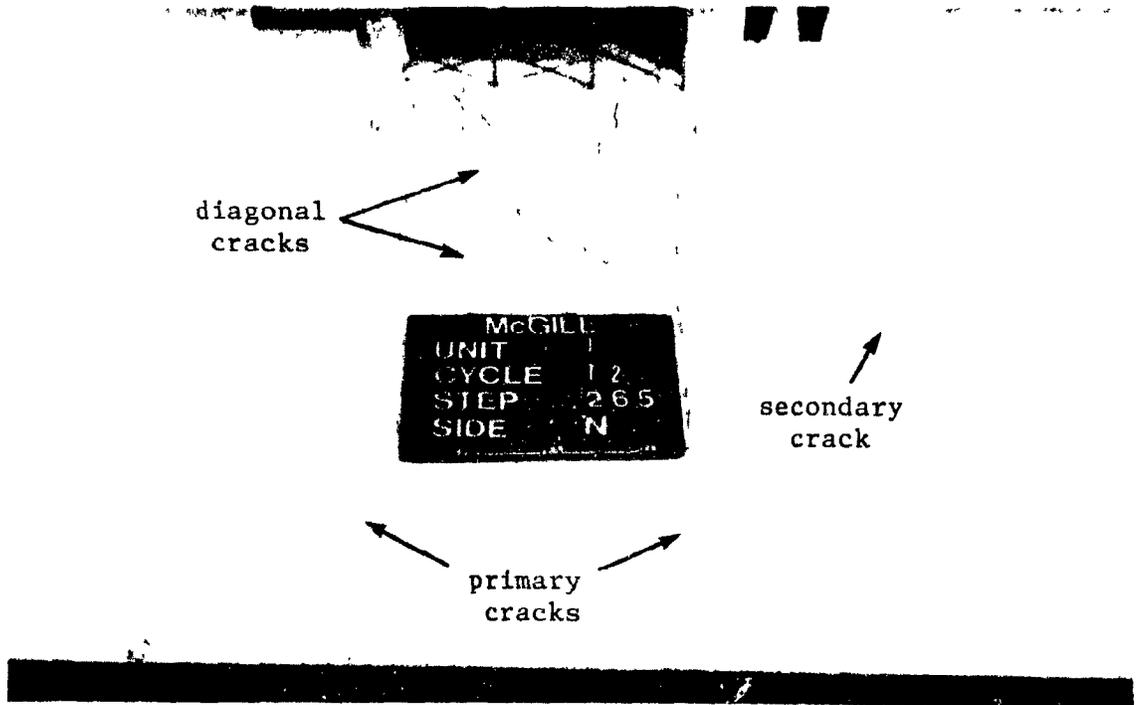
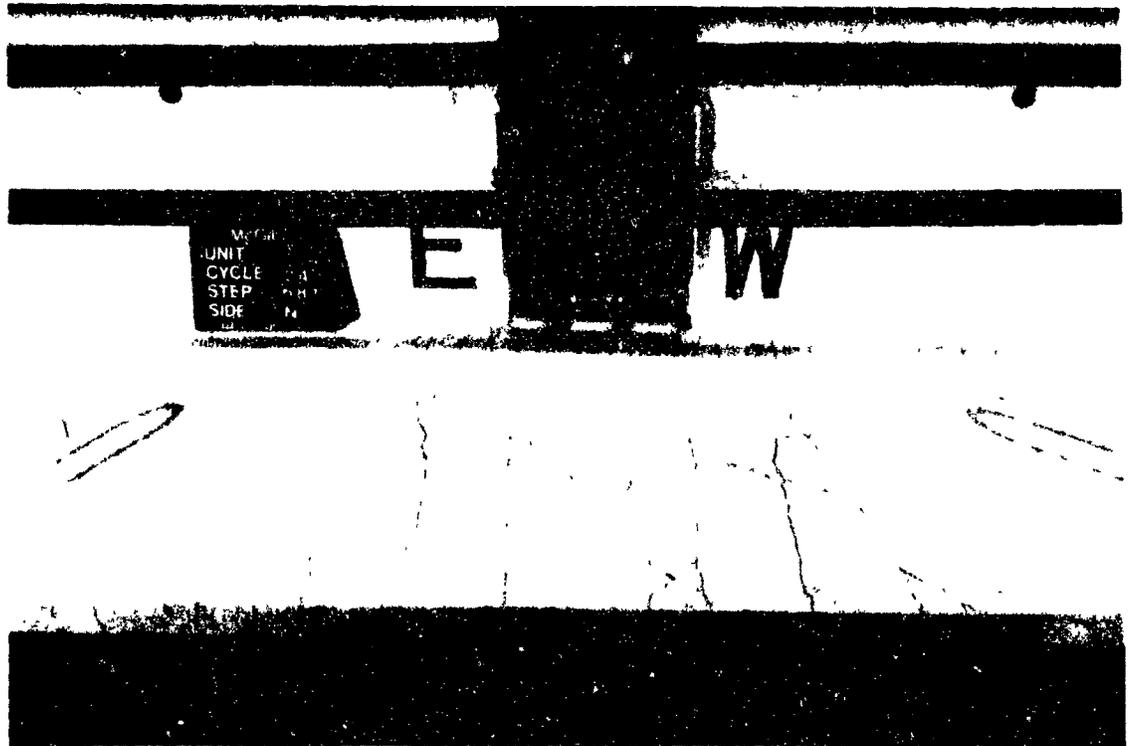
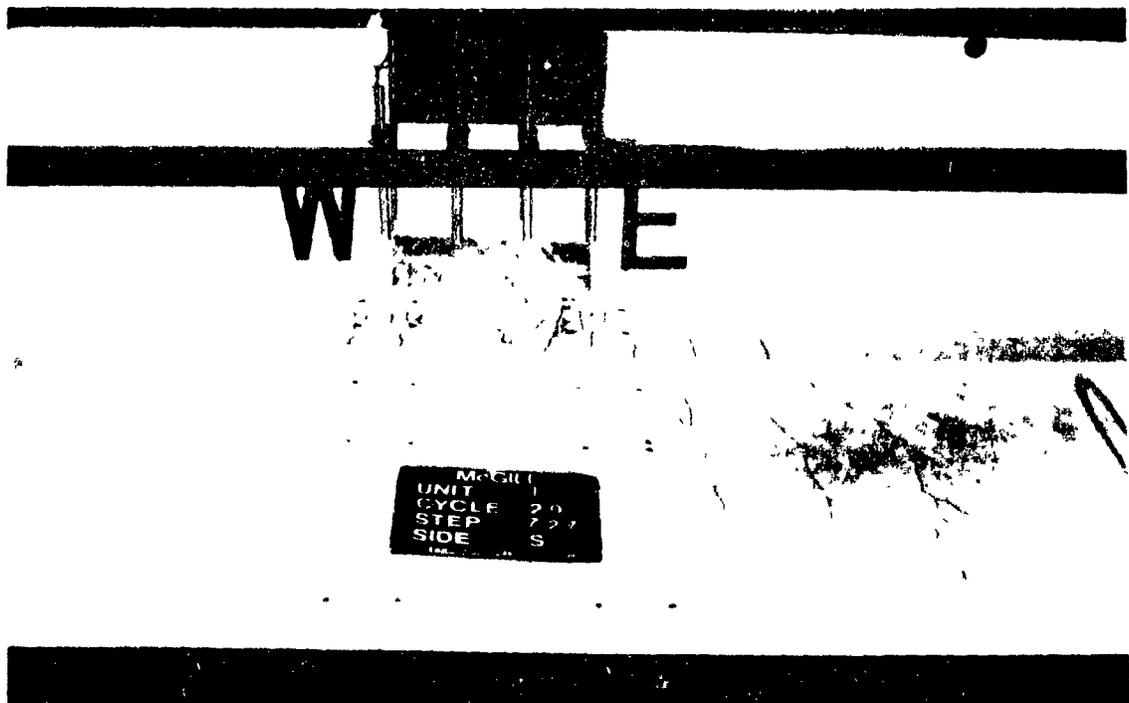
Figure 4.1 Crack Pattern for Specimen D1 at Cycle 6, $\Delta = -4.02$ mm.

Figure 4.2 Crack Pattern for Specimen D1 at Cycle 12, $\Delta = -4.91$ mm.

Figure 4.3 Crack Pattern for Specimen D1 at Cycle 24, $\Delta = 8.61$ mm

Figure 4.4 Crack Pattern for Specimen D1 at Cycle 29, $\Delta = 9.58$ mm.

Figure 4.5 Crack Pattern for Specimen D1 at the Onset of Punching Shear Failure.

Figure 4.6 Crack Pattern on the Underside for Specimen D1 at Cycle 24. $\Delta = -8.61$ mm

At subsequent larger imposed relative vertical displacements, more secondary cracks formed behind the wall toes in a manner similar to the first secondary crack. The diagonal cracks, which formed in Cycle 6, emanated from the corners of the wall toes as more cracks near the wall toes appeared in Cycle 24, as illustrated in Figure 4.3. Secondary diagonal cracks also appeared at about one corridor width from the wall toes (near the ends of the initial diagonal cracks) at the primary cracks and propagated toward the opposite primary crack near the edge of the slab. Concurrently, cracks parallel to the shear wall centerline and midway between the shear wall centerline and the edge of the slab ($\frac{1}{4}$ bay width) appeared from and behind the primary cracks. Figure 4.3 shows the extent of these cracks at the peak of Cycle 24 ($\Delta = 8.61$ mm). Similar crack patterns were observed on the top of the slab on the south side and on the underside of the slab, as shown in Figures 4.6 and 4.7. Figure 4.8 shows the crack pattern at the onset of crushing at the peak of Cycle 29 ($\Delta = 9.58$ mm) near the wall toe areas. The absence of radial cracks at this stage is noted, and no prominent signs of punching

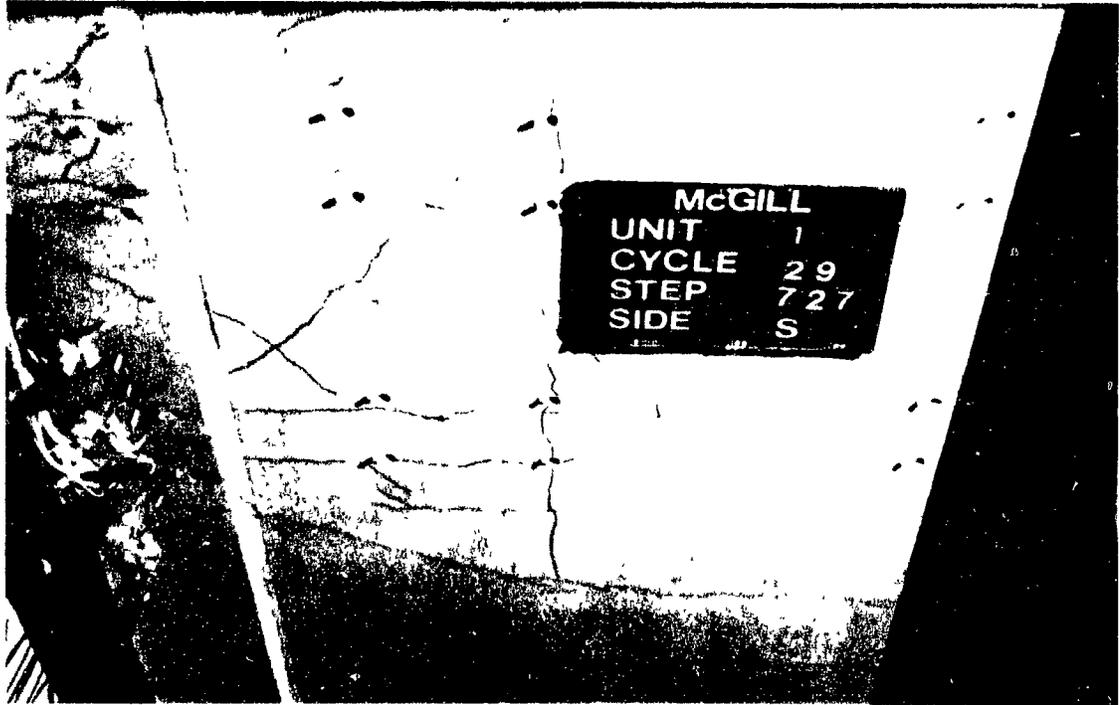
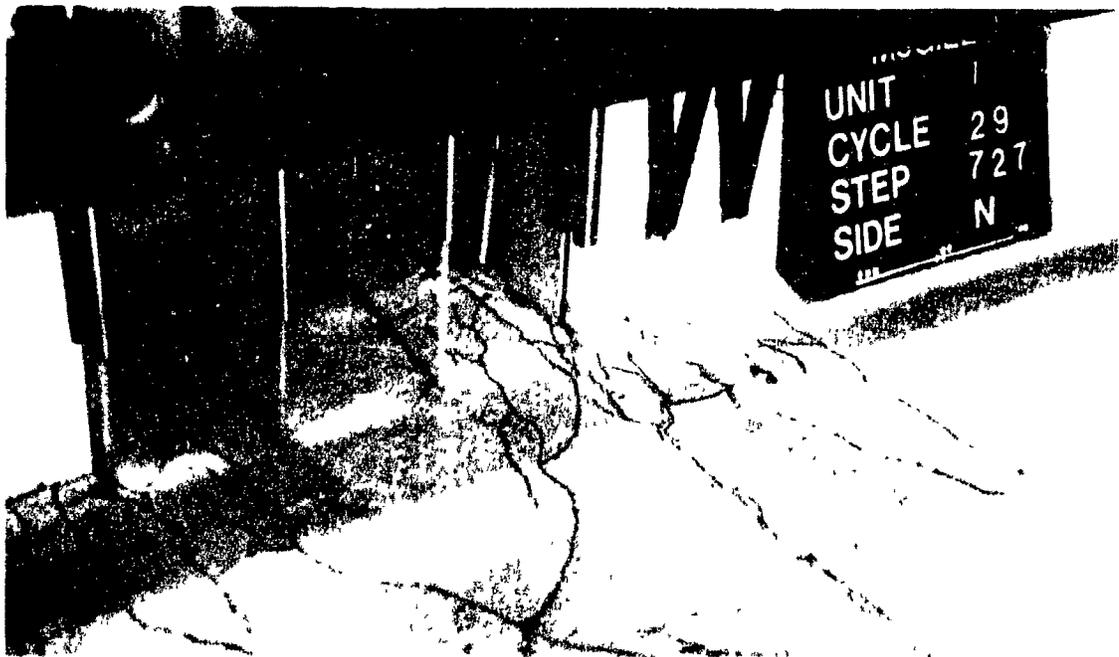
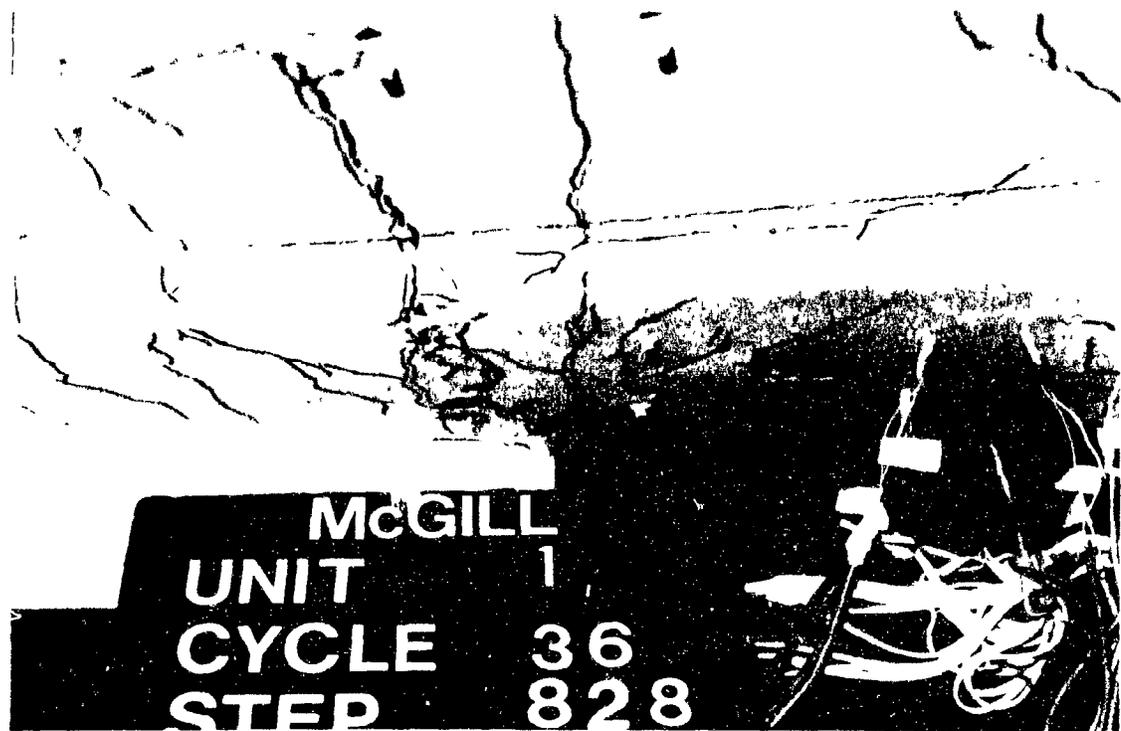
Figure 4.7 Crack Pattern on the Underside for Specimen D1 at Cycle 29, $\Delta = 9.58$ mm

Figure 4.8 Close Up View on the Crack Patterns for Specimen D1 Near the Wall Toes at Cycle 29, $\Delta = 9.58$ mm.

Figure 4.9 Crack Pattern for Specimen D1 Near the Wall Toes at Failure.

Figure 4.10 Close Up View of the Underside for Specimen D1 Near the Wall Toe Region at Failure (South-East side)

Figure 4.11 Close Up View of the Underside for Specimen D1 Near the Wall Toe Region at Failure (South-West side).
