NON-LINEAR RESPONSE OF REINFORCED CONCRETE
COUPLING SLAB WITH DROP PANEL IN EARTHQUAKE-
RESISTING SHEAR WALL STRUCTURES

ALBERT KEE WAH LIM

McGill University

A thesis submitted to the Faculty of Graduate Studies
and Research in partial fulfillment of the requirements
for the degree of Master of Engineering

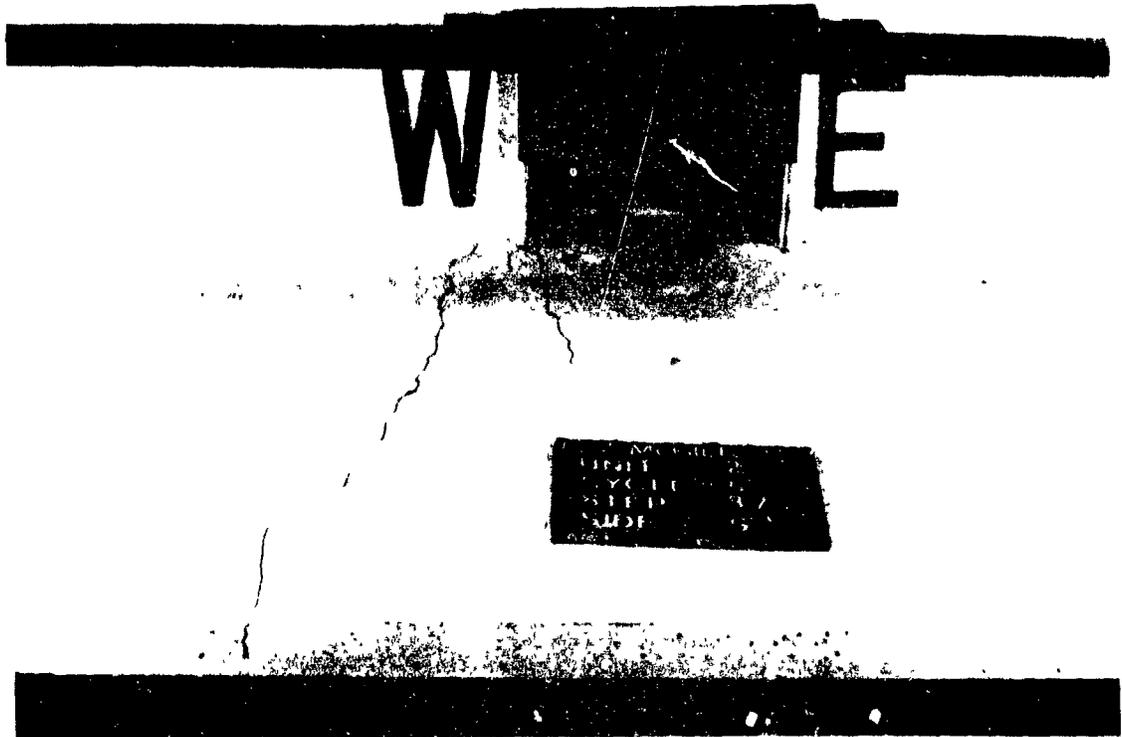
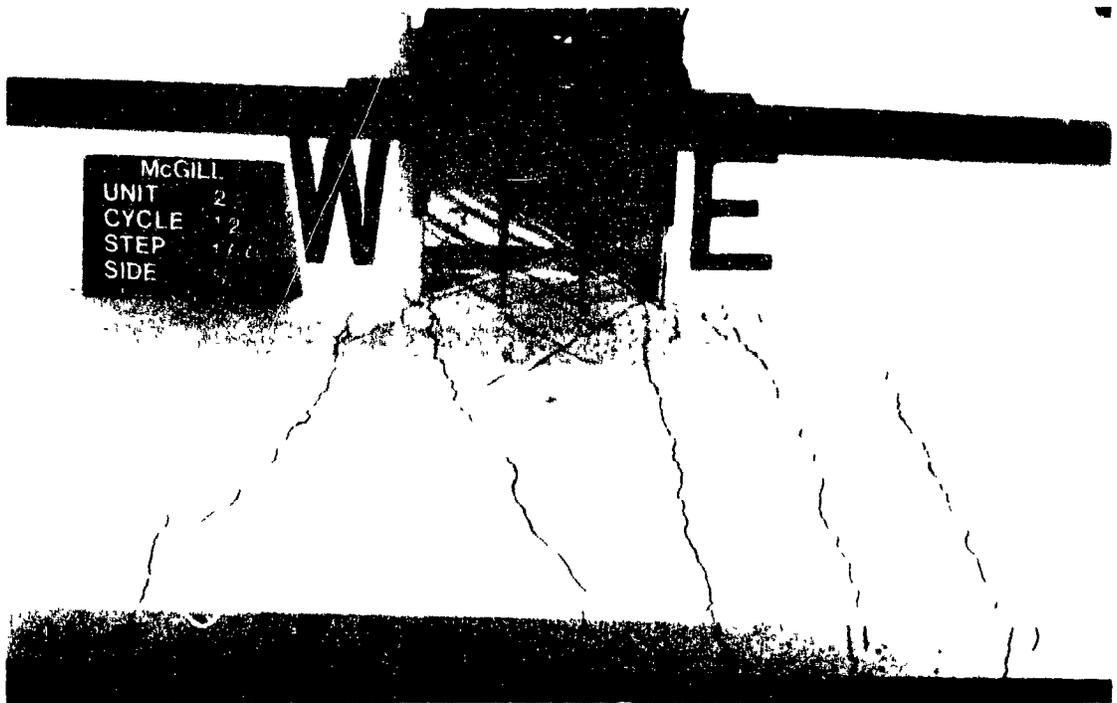
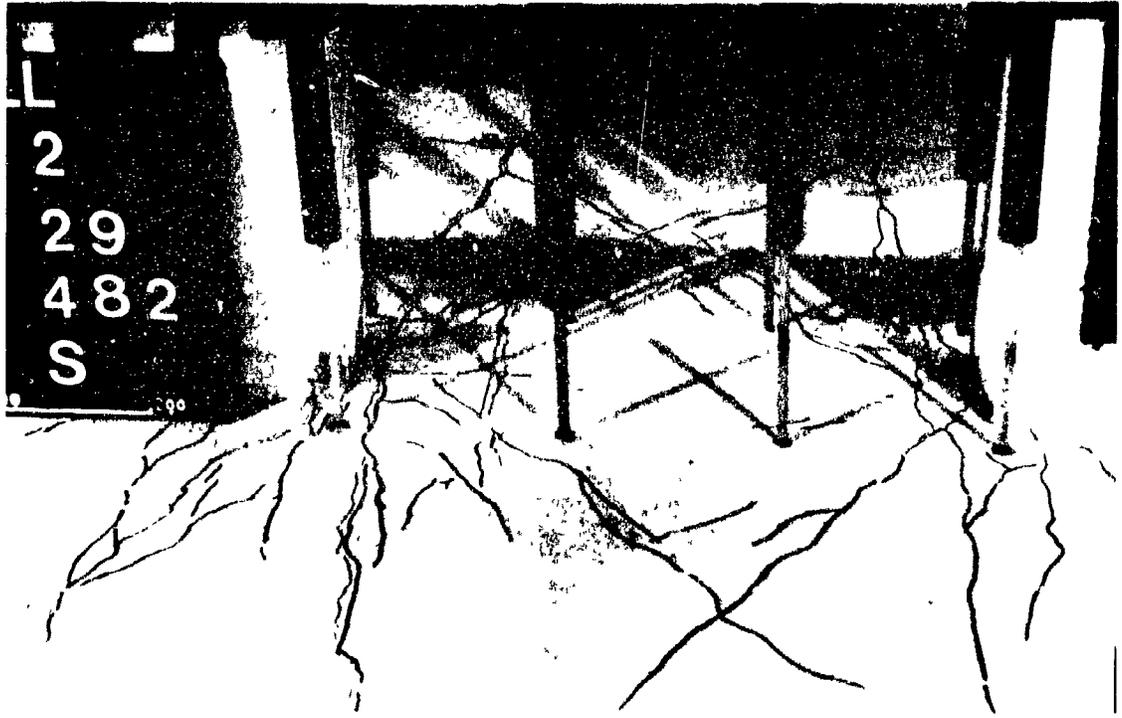
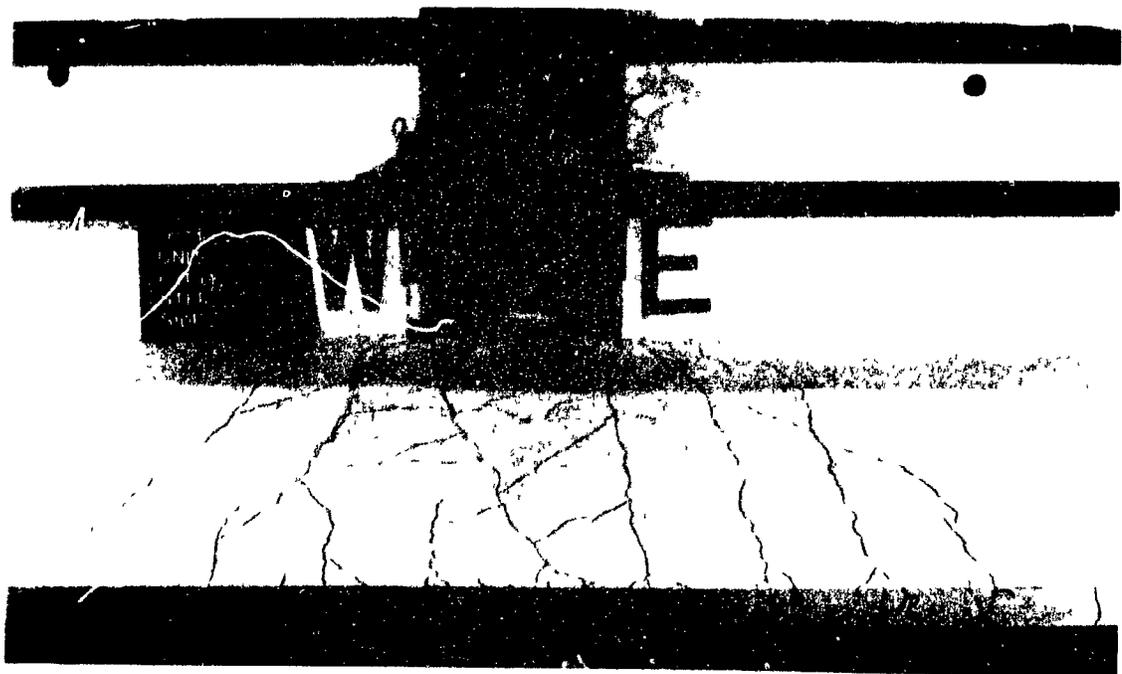
Figure 4.12 Crack Pattern for Specimen D2 at Cycle 5, $\Delta = 1.67$ mm.

Figure 4.13 Crack Pattern for Specimen D2 at Cycle 12, $\Delta = -5.09$ mm.

Figure 4.14 Close Up View of Crack Pattern in Specimen D2 Near the Shear Wall Toes at Onset of Punching Shear Failure.

Figure 4.15 Crack Pattern for Specimen D2 at Cycle 31, $\Delta = 14.73$ mm.

Figure 4.16 Close Up View for Specimen D2 Near the Wall Toes at Failure ($\Delta = 18.07$ mm)

Figure 4.17 Plan View of the Crack Pattern for Specimen D2 at Failure.

Figures 4.12 through 4.23 shows the sequence of crack formation of Specimen D2. The crack formation on the east side of the corridor centerline were similar to that of Specimen D1 with two notable exceptions. The cracks in Specimen D2 formed at a faster rate than those in Specimen D1, and more cracks were observed near the wall

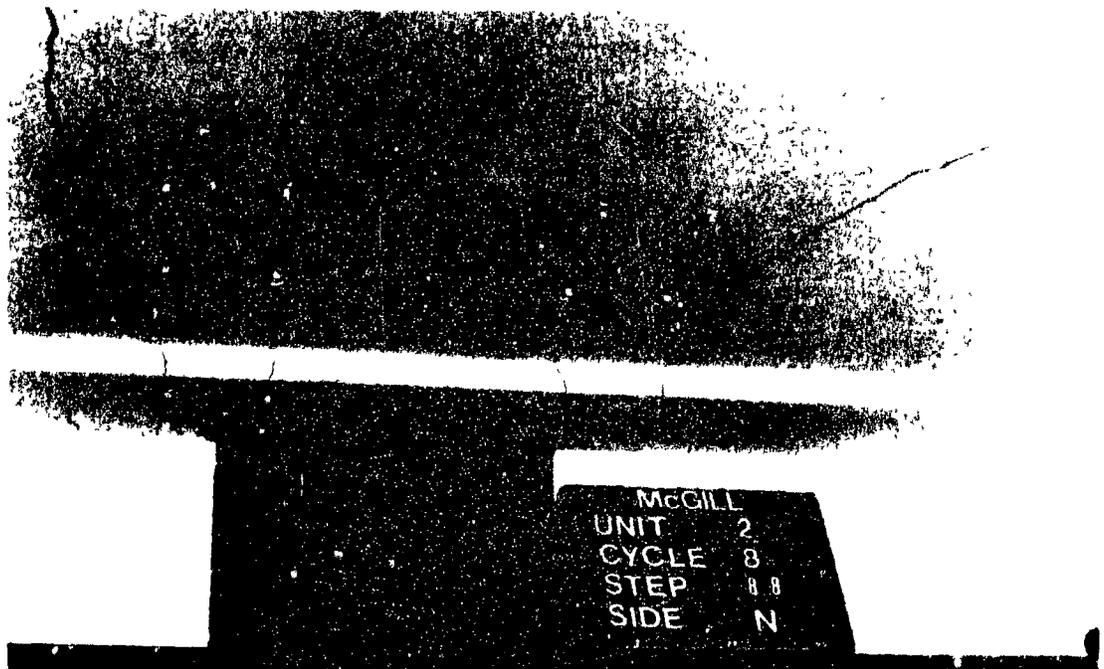
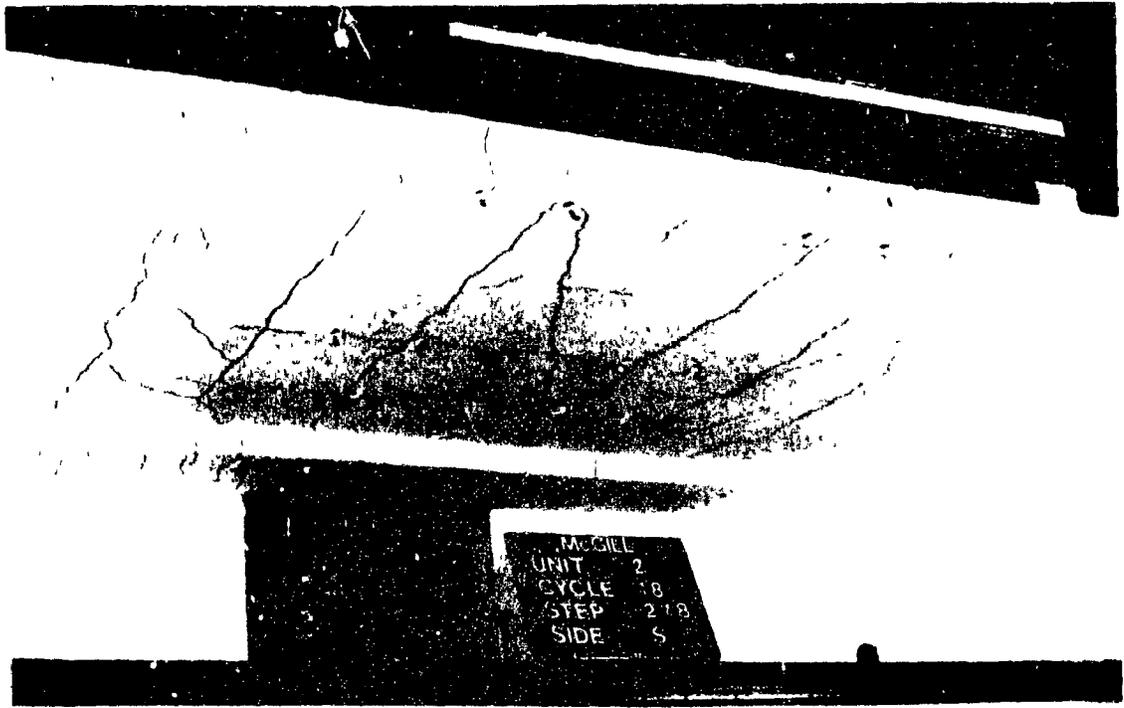
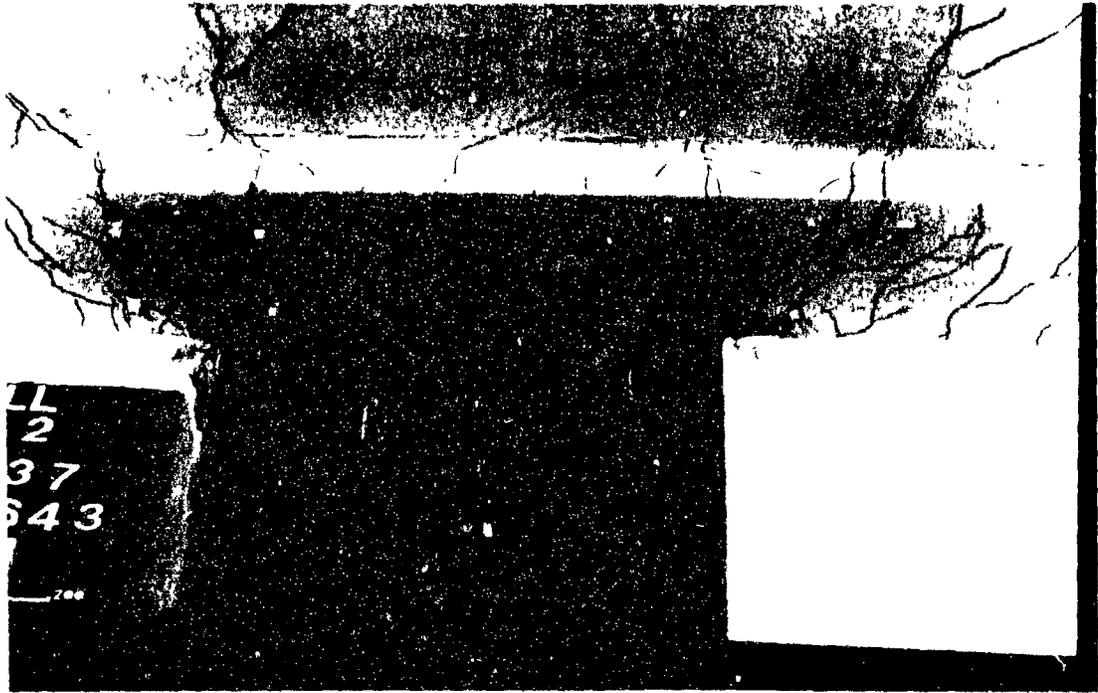
Figure 4.18 Close Up Top View for Specimen D2 Near the West Wall Toe After Failure.

Figure 4.19 Crack Pattern on the Underside for Specimen D2 at Cycle 8. $\Delta = -1.62$ mm.

Figure 4.20 Crack Pattern on the Underside for Specimen D2 at Cycle 18. $\Delta = -8.26$ mm

Figure 4.21 Close Up View of Drop Panel for Specimen D2 at Onset of Punching Shear Failure

Figure 4.22 Close Up View of Drop Panel for Specimen D2 at Cycle 37, $\Delta = 18.07$ mm

Figure 4.23 Close Up Bottom View for Specimen D2 Near the Wall Toe Regions After Failure

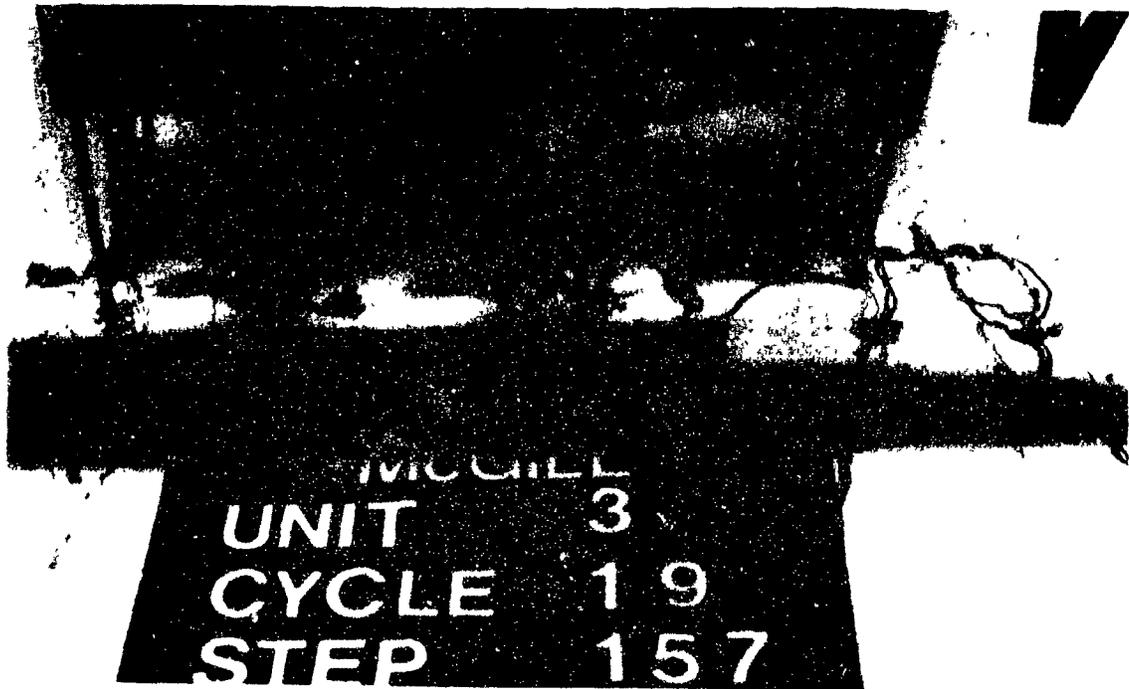
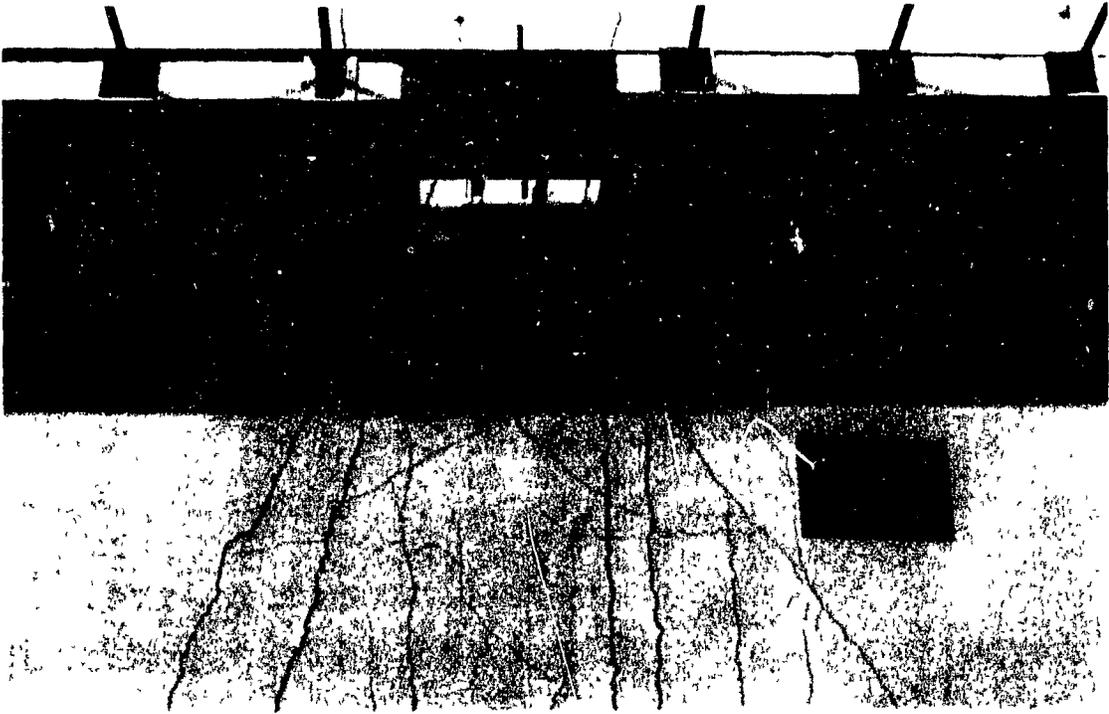
Figure 4.24 Crack Pattern for Specimen D3 at Cycle 1, $\Delta = 3.12$ mm.

Figure 4.25 Crack Pattern for Specimen D3 at Cycle 5, $\Delta = 12.30$ mm

Figure 4.26 Crack Pattern on the Drop Panel for Specimen D3 at Cycle 14, $\Delta = -19.30$ mm

Figure 4.27 Close Up View for Specimen D3 Near the Wall Toes at Onset of Punching Shear Failure ($\Delta = 27.99$ mm)

Figure 4.28 Crack Pattern for Specimen D3 at Cycle 20, $\Delta = -26.85$ mm.

Figure 4.29 Crack Pattern for Specimen D3 at Failure ($\Delta = -34.70$ mm).

The crack formation in Specimen D3 was, in general, similar to that of Specimens D1 and D2. As expected, the secondary cracks that developed in Cycle 5 ($\Delta = 12.30$ mm, Figure 4.25) were influenced by the concentrated transverse reinforcement. Figures 4.24 to 4.29 illustrate the sequence of crack formation for Specimen D3. Punching of the slab at the wall toe was preceded by the formation of radial

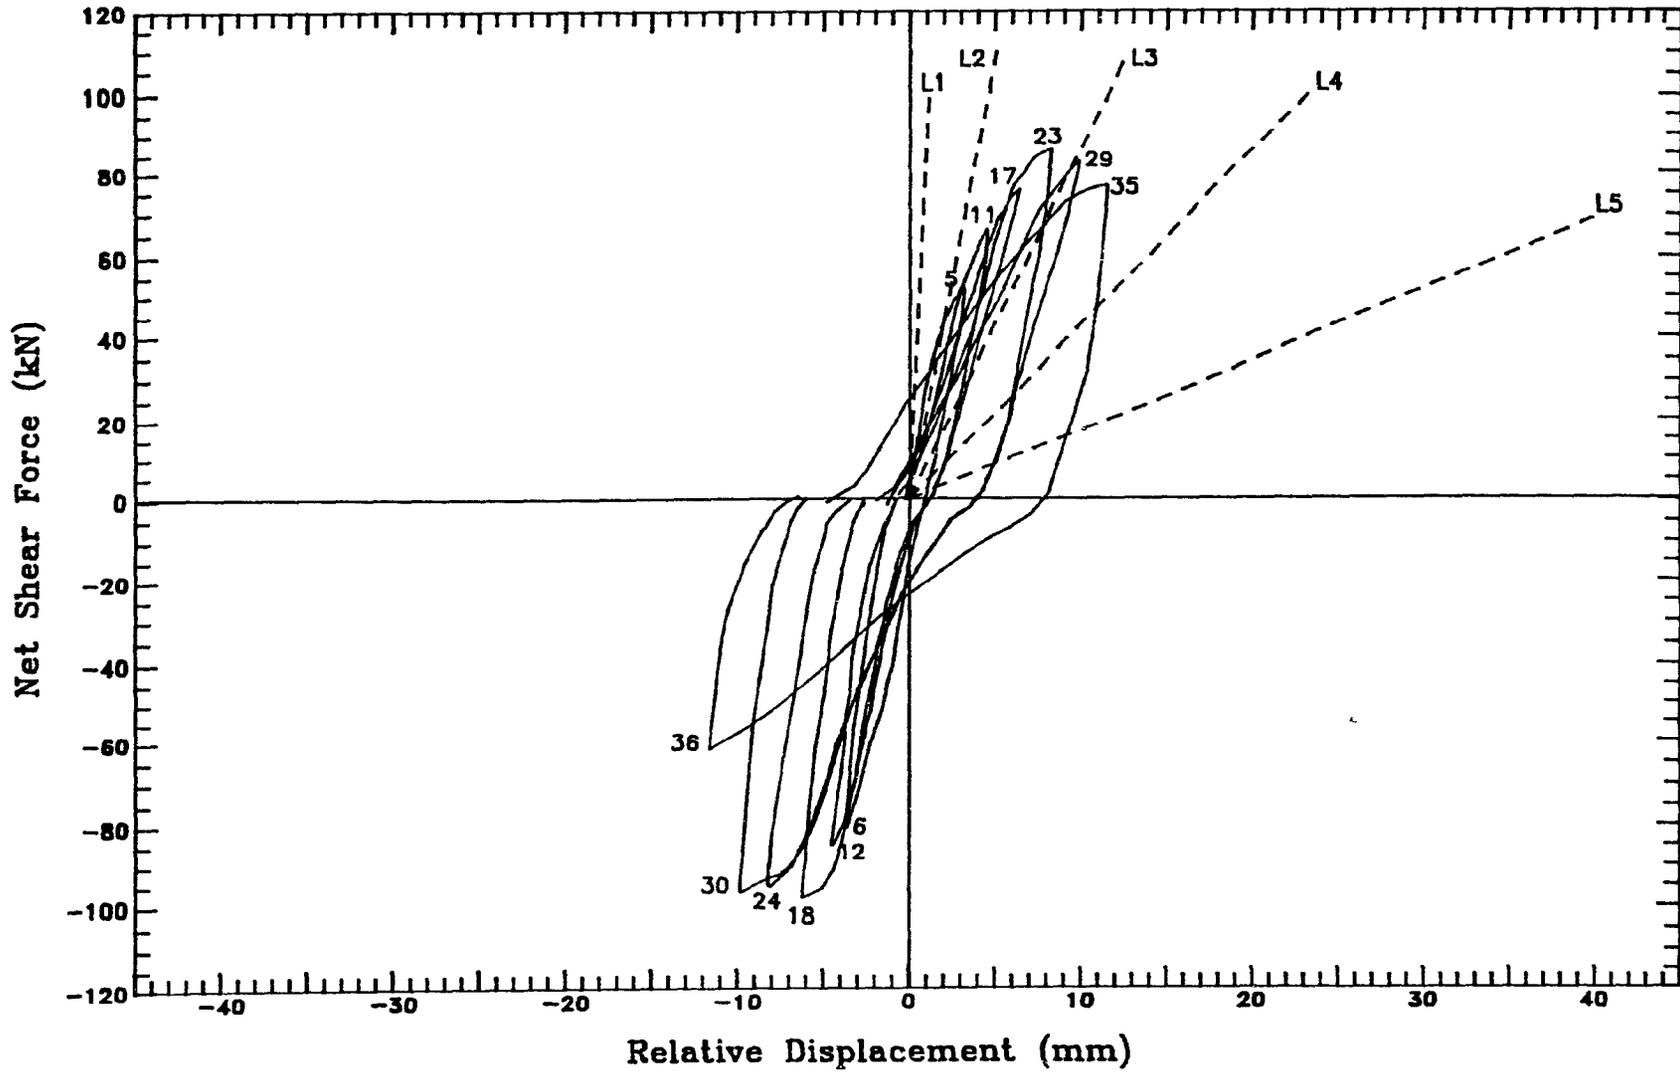
Figure 4.37 Load-Deformation Characteristics for Specimen D1.

The ultimate load achieved by the first three specimens, Specimens D1, D2 and D3, were 93.81 kN, 86.50 kN and 90.51 kN, respectively. Specimen D4 exhibited a marked increase in the maximum load achieved (107.18 kN) over the other three specimens. These loads were achieved at displacement levels of -6.25 mm ($\mu = -1.61$), -11.65 mm ($\mu = -3.01$), -11.18 mm ($\mu = -2.89$) and 13.45 mm ($\mu = 3.47$) for Specimens D1, D2, D3

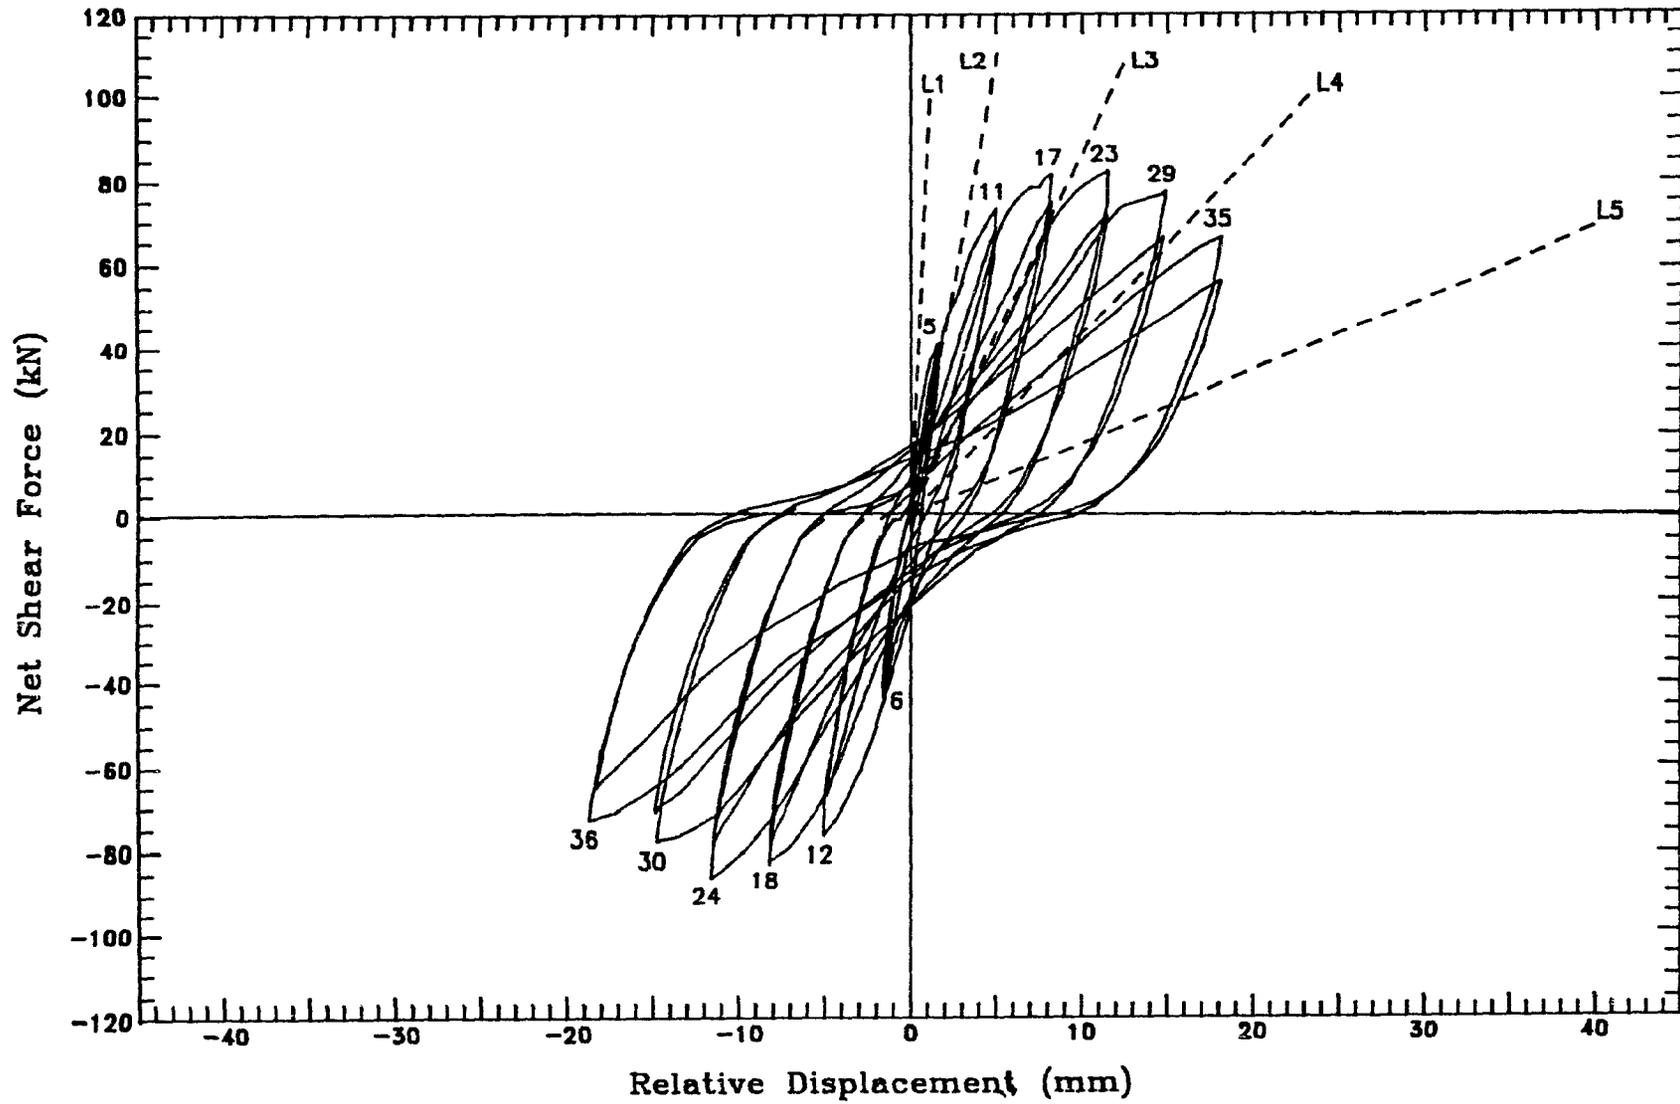
Figure 4.38 Load-Deformation Characteristics for Specimen D2.

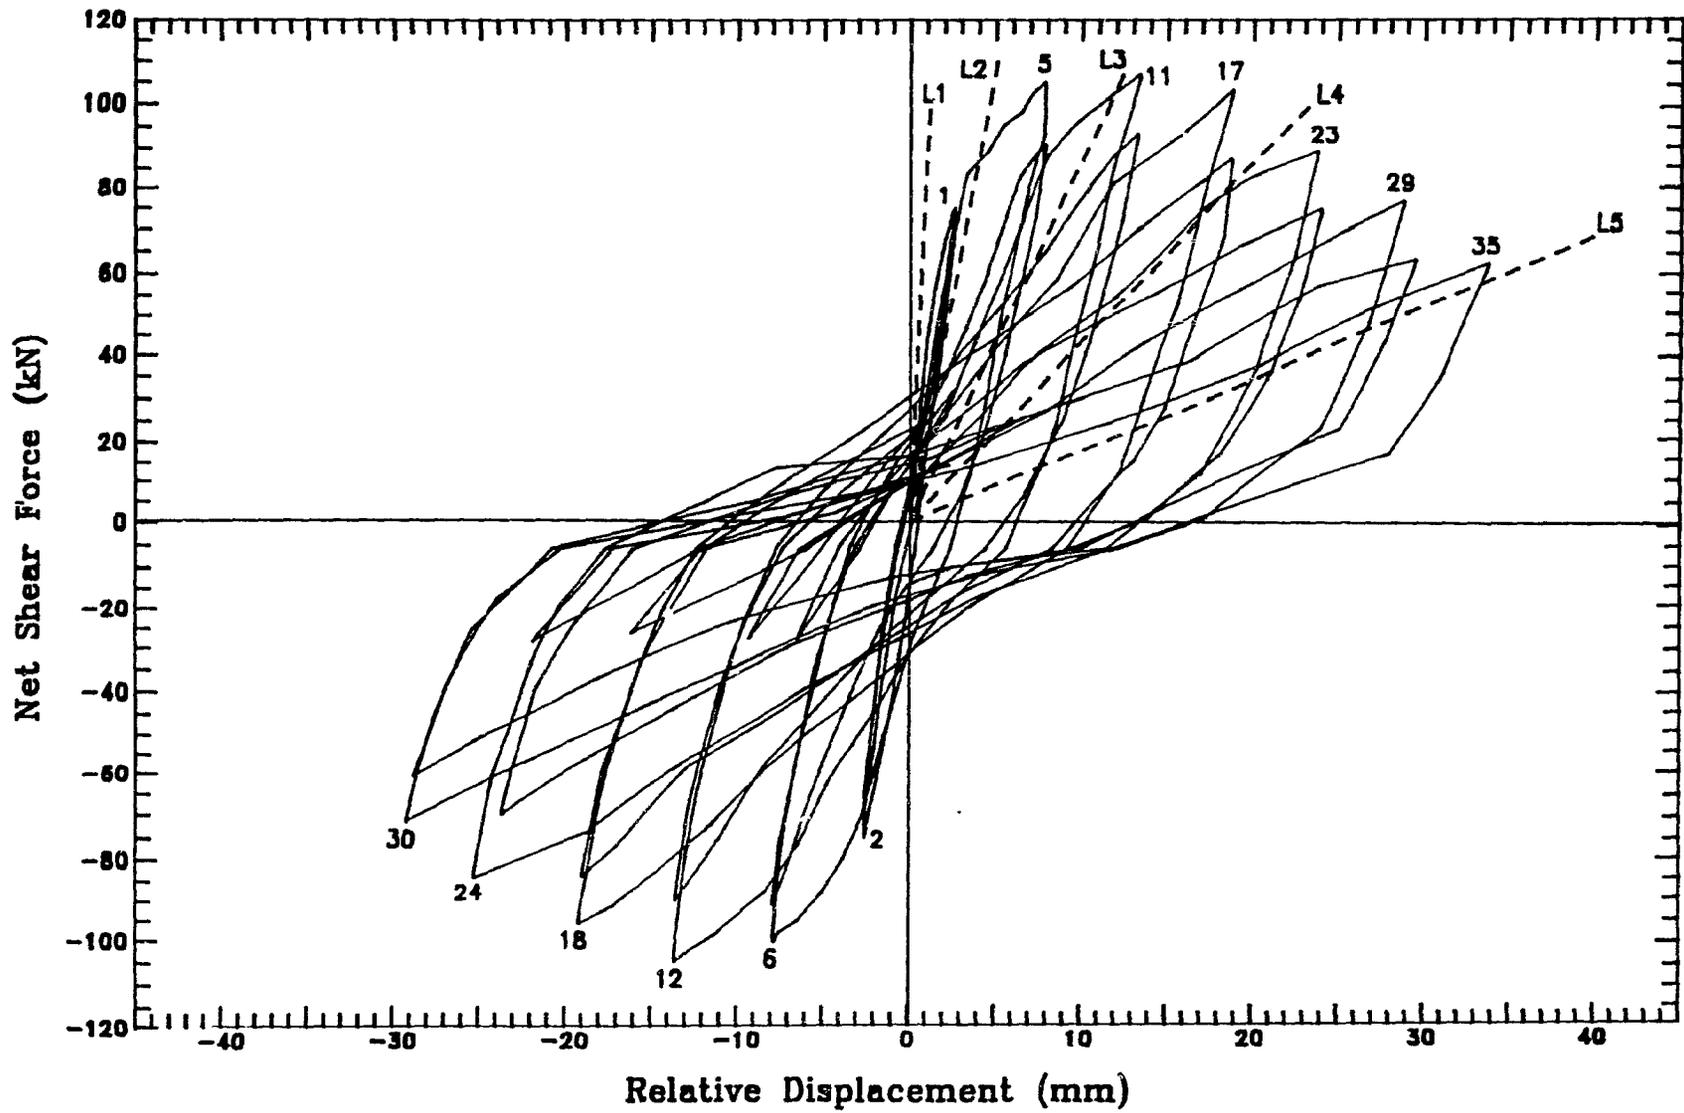
Figure 4.40 Load-Deformation Characteristics for Specimen D4.

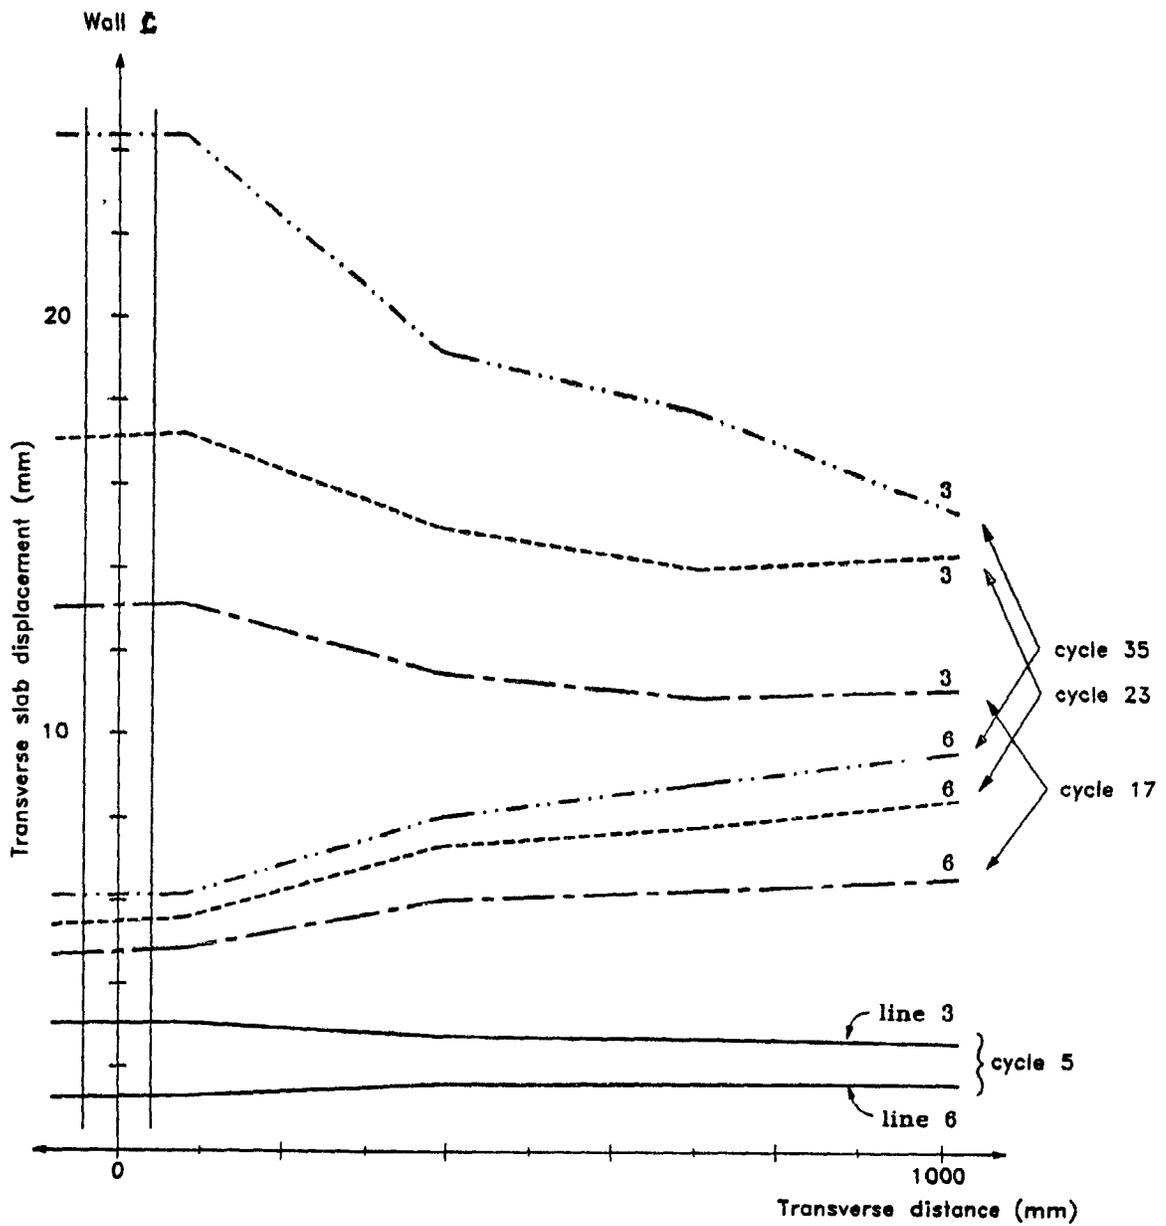
Figure 4.44 Transverse Slab Displacement Profiles for Specimen D2.

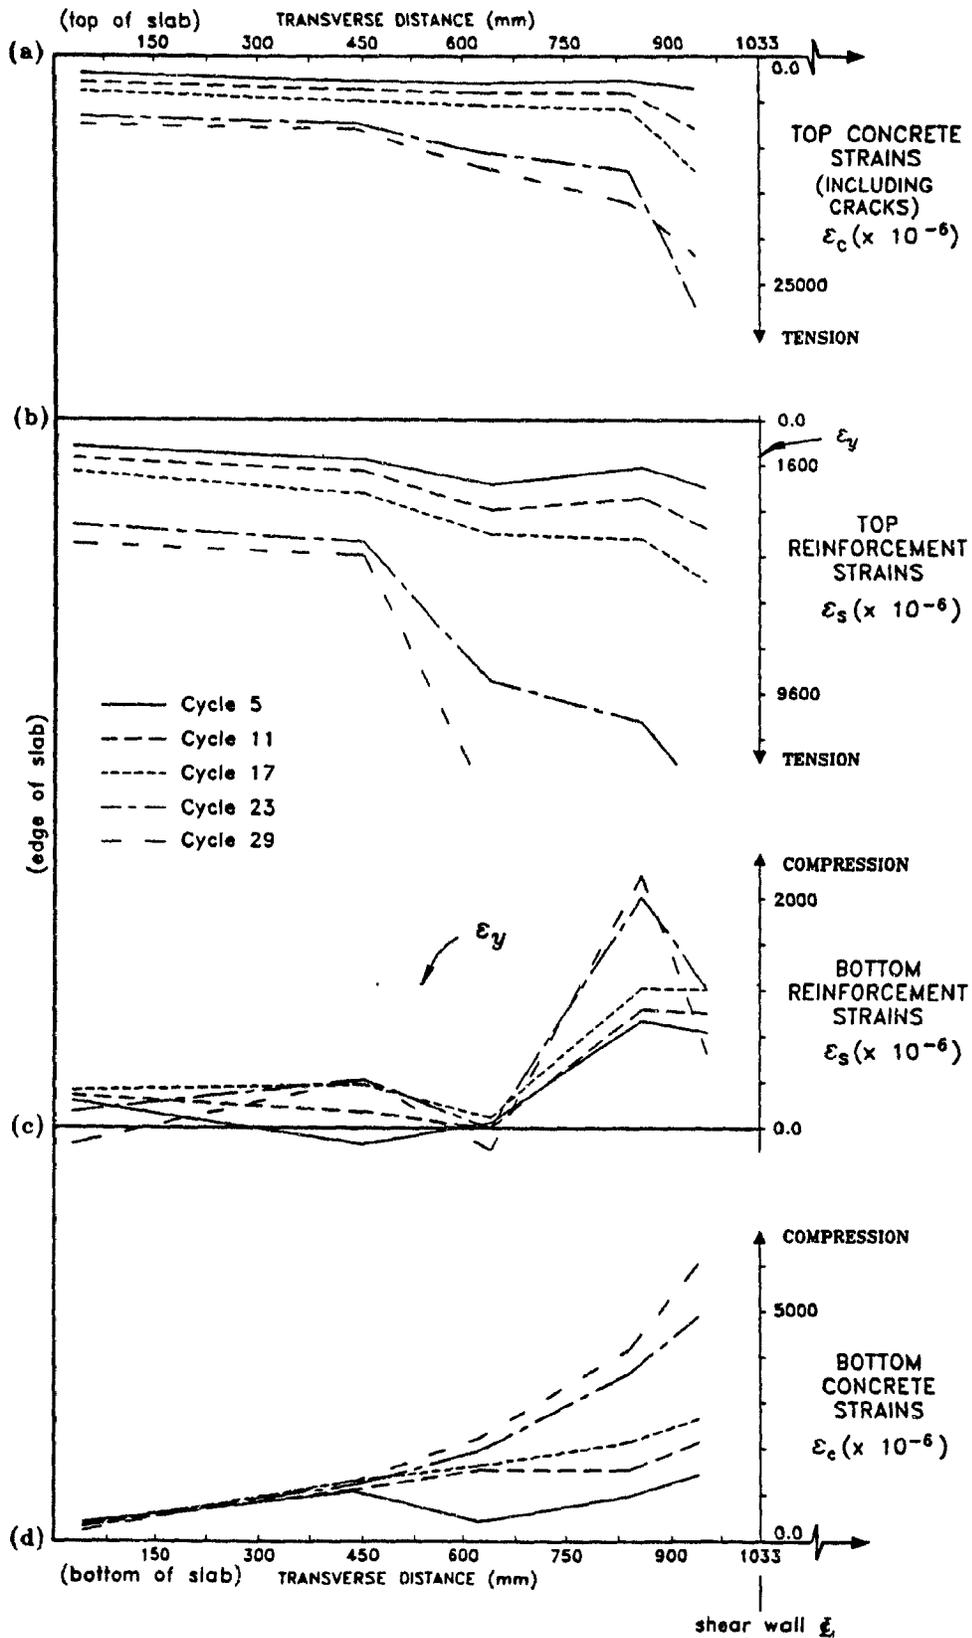
Figure 4.45 Longitudinal Strains for Specimen D1.

In both Specimens D1 and D2, the steel and concrete strains near the shear wall centerline were higher than at the slab edges. Most of the top longitudinal reinforcement in Specimens D1 and D2 yielded at relative displacement levels of 2.85 mm and 5.01 mm, respectively, corresponding to displacement ductility ratios of 0.74 and 1.29. As shown in Figure 4.46, at a displacement ductility ratio of about 3, it was observed that the

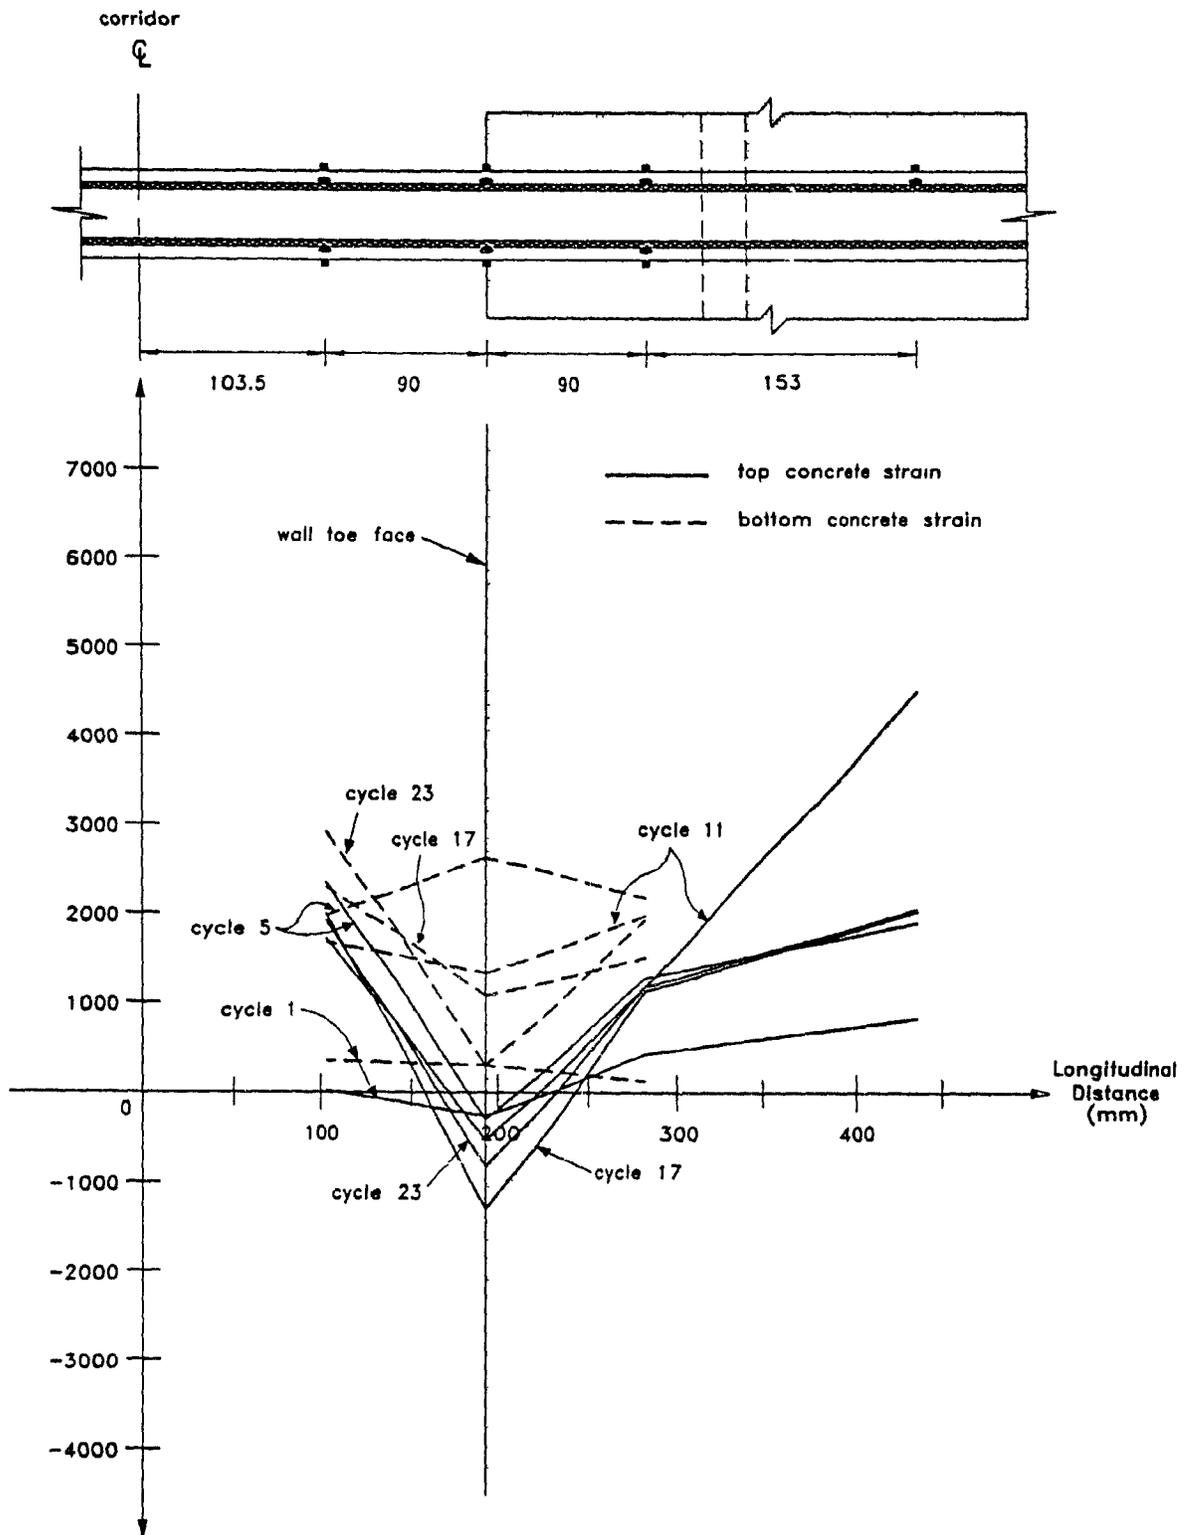
Figure 4.50 Longitudinal Variation of the Concrete Strain of Specimen D3 in the Transverse Direction.

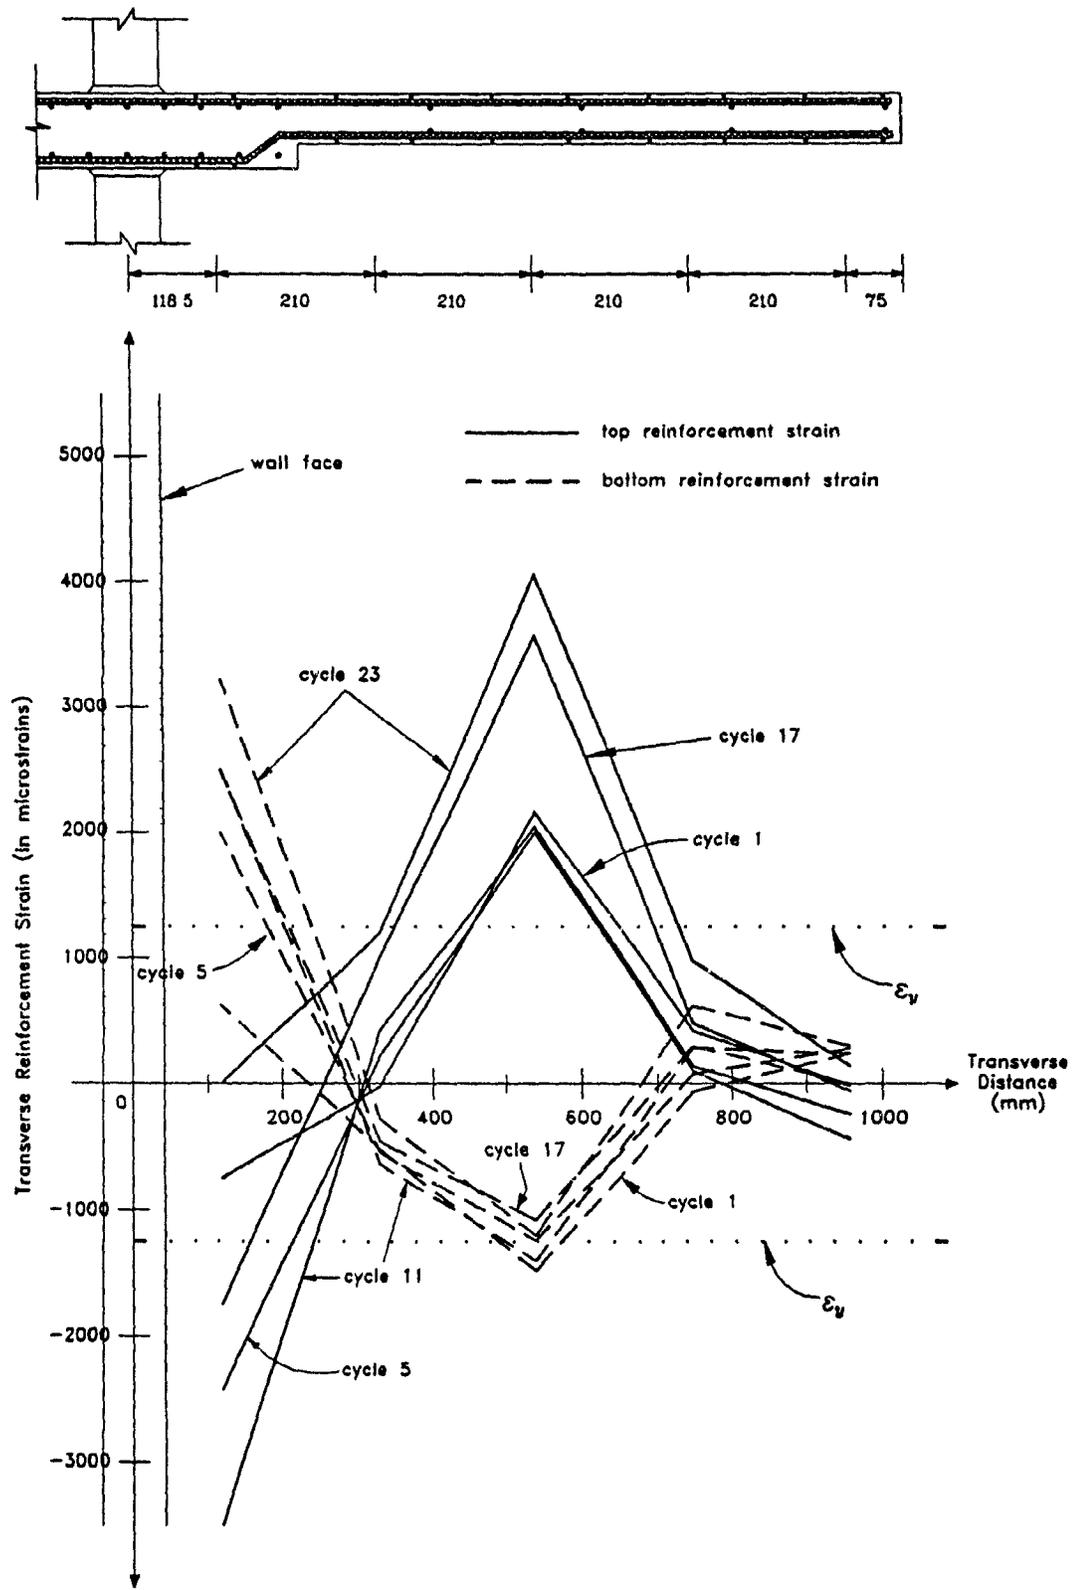
Figure 4.51 Transverse Variation of the Concentrated Transverse Reinforcement Strain for Specimen D4.

The strain variations in the transverse direction of the concrete and transverse reinforcement strains for Specimen D4 are shown in Figures 4.51 through 4.54. The concentrated transverse reinforcement strain variation of Specimen D4 in the transverse direction (Figure 4.51) was similar to that of Specimen D3 (Figure 4.47) with one notable exception. The strains in the bottom concentrated transverse reinforcement for Specimen D4, at a distance of 540 mm from the shear wall centerline, were approximately equal to the yield strain of the reinforcement while that of Specimen D3 was negligible. However, the results of the strains in the transverse concentrated reinforcement in Specimens D3 and D4 show that these reinforcements contributed significantly to the distribution of forces up to 750 mm from the shear wall centerline. Although the concrete transverse strain variation in the transverse direction in Specimen D4 (Figure 4.52) was similar to that of Specimen D3 (Figure 4.48), much lower transverse concrete strain values were observed within the drop panel region in Specimen D4 than in Specimen D3. However, it should be noted that the variation of the transverse strain in Specimen D4 in the transverse direction was measured along a line which was at a distance of approximately 30 mm in front of the wall toe face (Figure 3.21), instead of along a line directly underneath the shear wall toe as was the case in Specimen D3 (Figure 3.20). In the longitudinal direction, the concentrated transverse reinforcement strain variation of Specimen D4 (Figure 4.53) near the wall face showed that much of

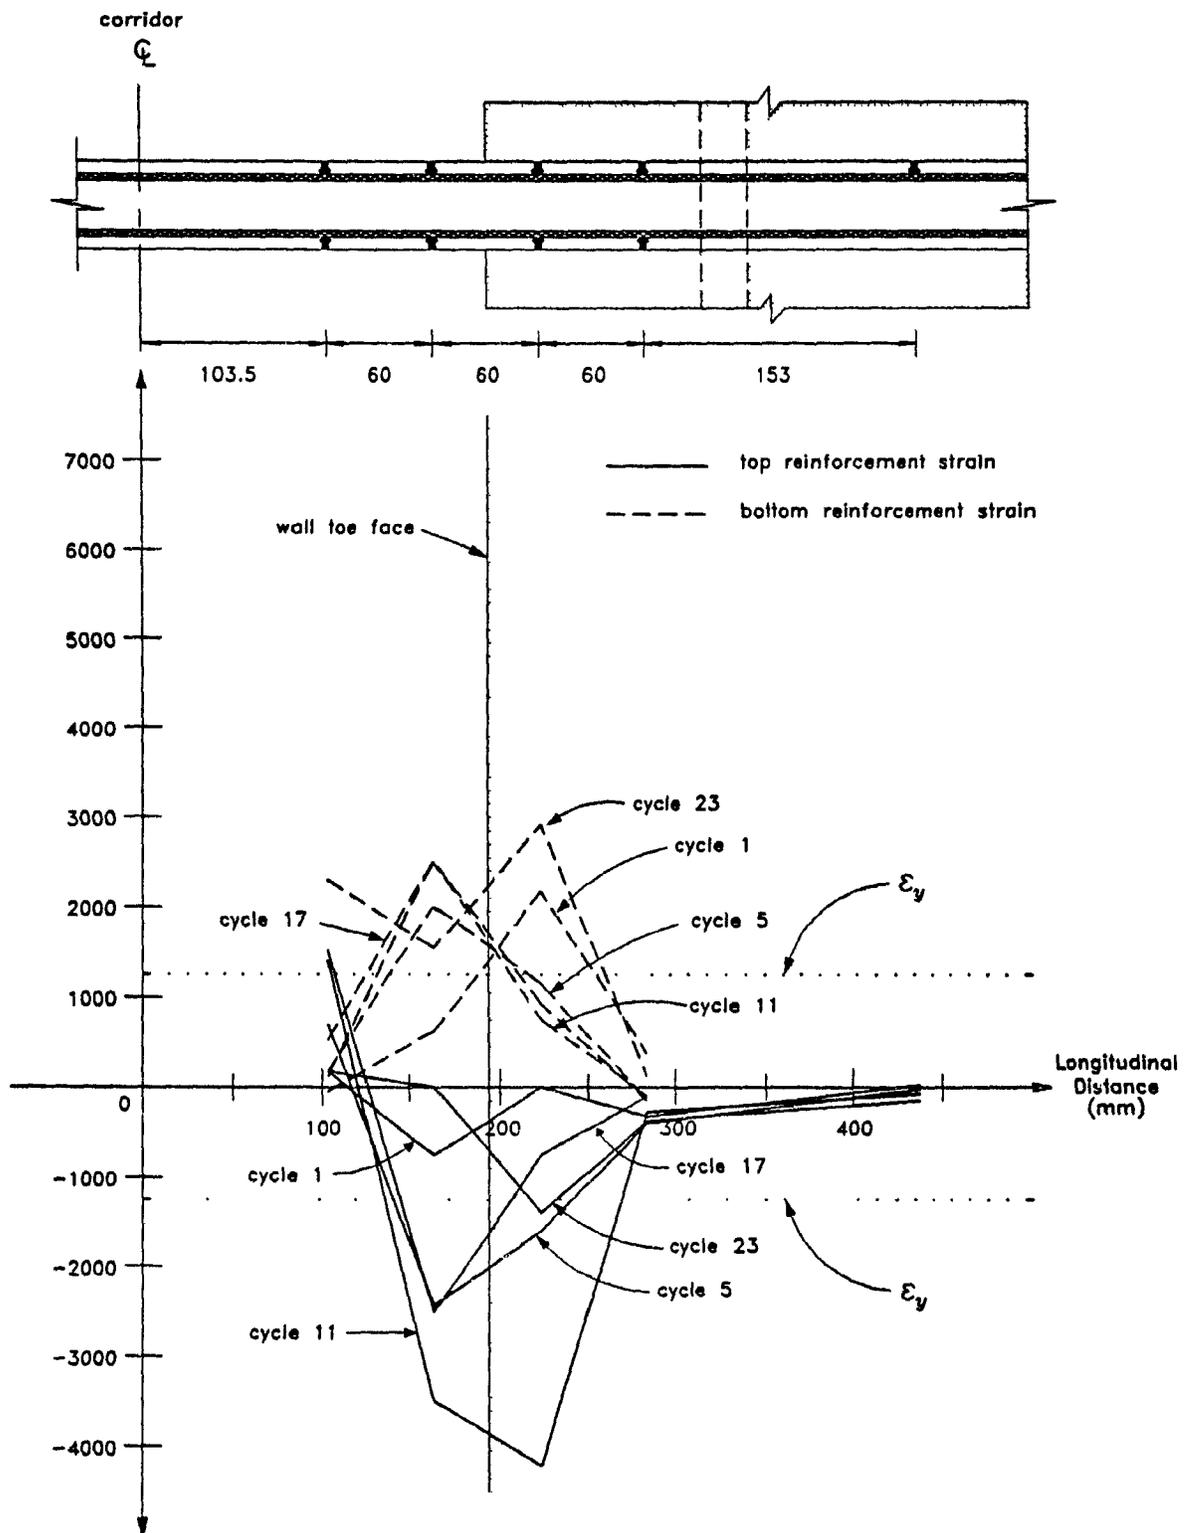
Figure 4.53 Longitudinal Variation of the Concentrated Transverse Reinforcement Strain for Specimen D4.
