NON-LINEAR RESPONSE OF REINFORCED CONCRETE
COUPLING SLAB WITH DROP PANEL IN EARTHQUAKE-
RESISTING SHEAR WALL STRUCTURES

ALBERT KEE WAH LIM

McGill University

A thesis submitted to the Faculty of Graduate Studies
and Research in partial fulfillment of the requirements
for the degree of Master of Engineering

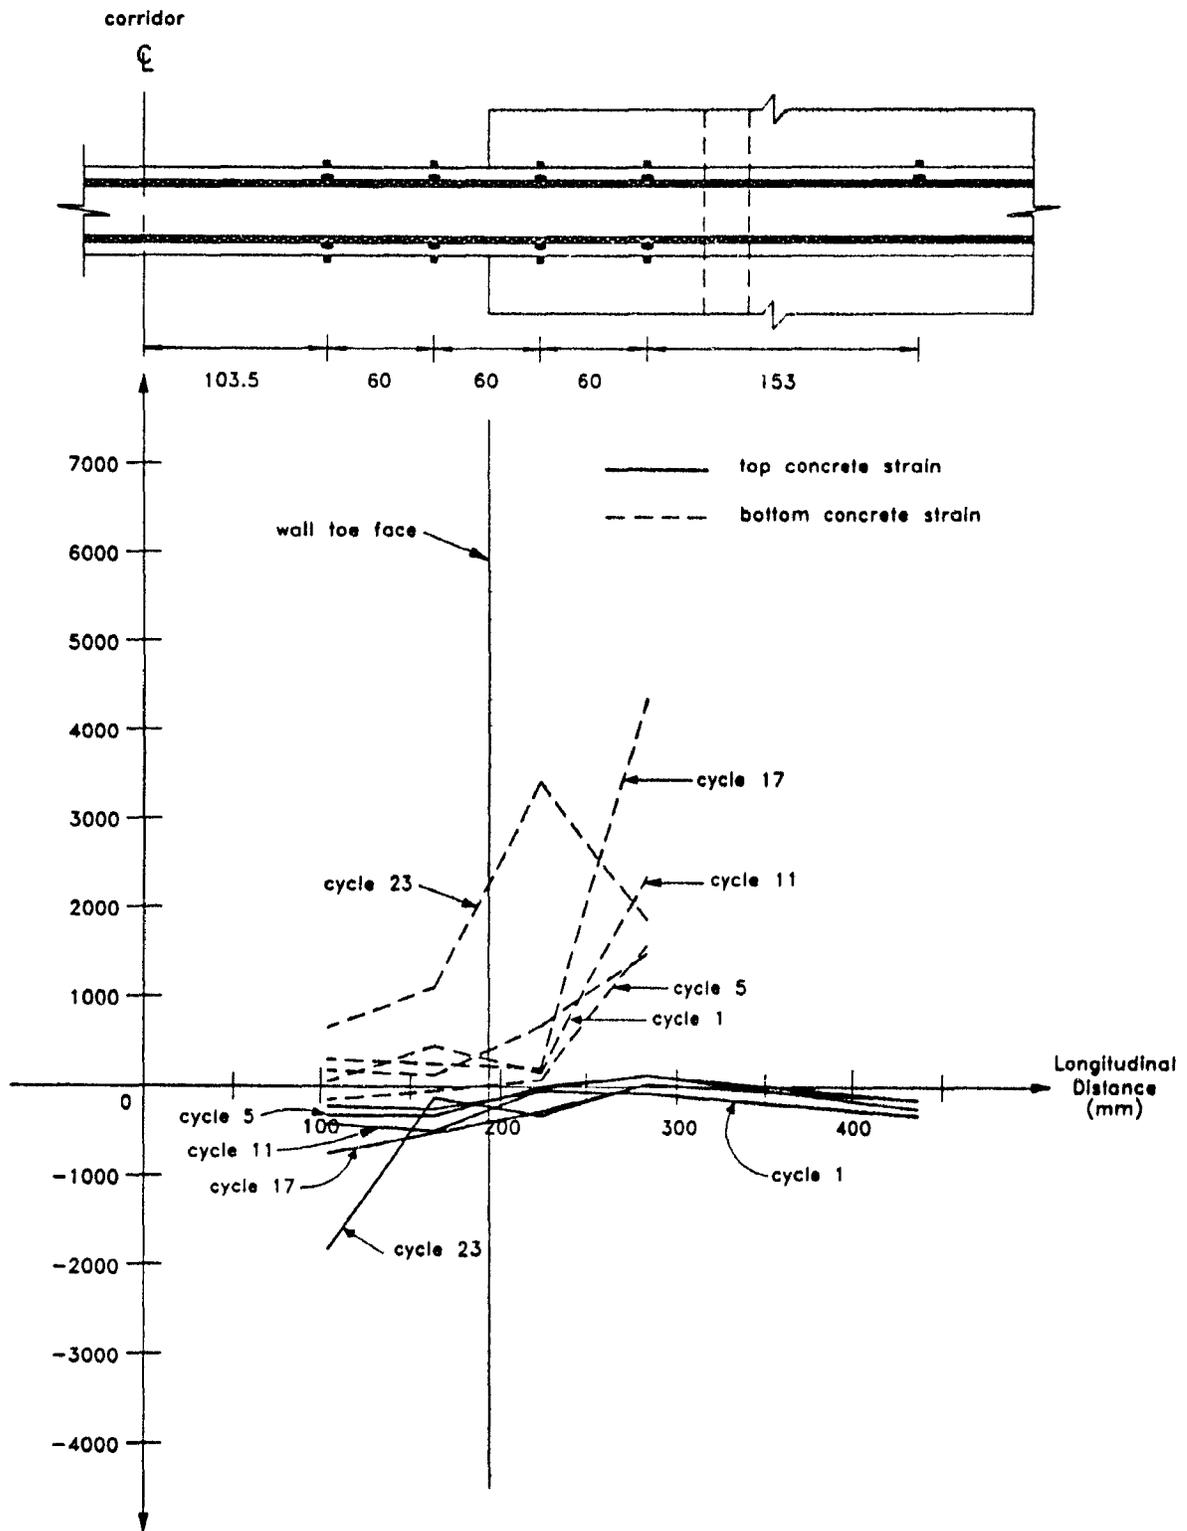
Figure 4.54 Longitudinal Variation of the Concrete Strain for Specimen D4 in the Transverse Direction.

The strain variations in the transverse direction of the concrete and transverse reinforcement strains for Specimen D4 are shown in Figures 4.51 through 4.54. The concentrated transverse reinforcement strain variation of Specimen D4 in the transverse direction (Figure 4.51) was similar to that of Specimen D3 (Figure 4.47) with one notable exception. The strains in the bottom concentrated transverse reinforcement for Specimen D4, at a distance of 540 mm from the shear wall centerline, were approximately equal to the yield strain of the reinforcement while that of Specimen D3 was negligible. However, the results of the strains in the transverse concentrated reinforcement in Specimens D3 and D4 show that these reinforcements contributed significantly to the distribution of forces up to 750 mm from the shear wall centerline. Although the concrete transverse strain variation in the transverse direction in Specimen D4 (Figure 4.52) was similar to that of Specimen D3 (Figure 4.48), much lower transverse concrete strain values were observed within the drop panel region in Specimen D4 than in Specimen D3. However, it should be noted that the variation of the transverse strain in Specimen D4 in the transverse direction was measured along a line which was at a distance of approximately 30 mm in front of the wall toe face (Figure 3.21), instead of along a line directly underneath the shear wall toe as was the case in Specimen D3 (Figure 3.20). In the longitudinal direction, the concentrated transverse reinforcement strain variation of Specimen D4 (Figure 4.53) near the wall face showed that much of

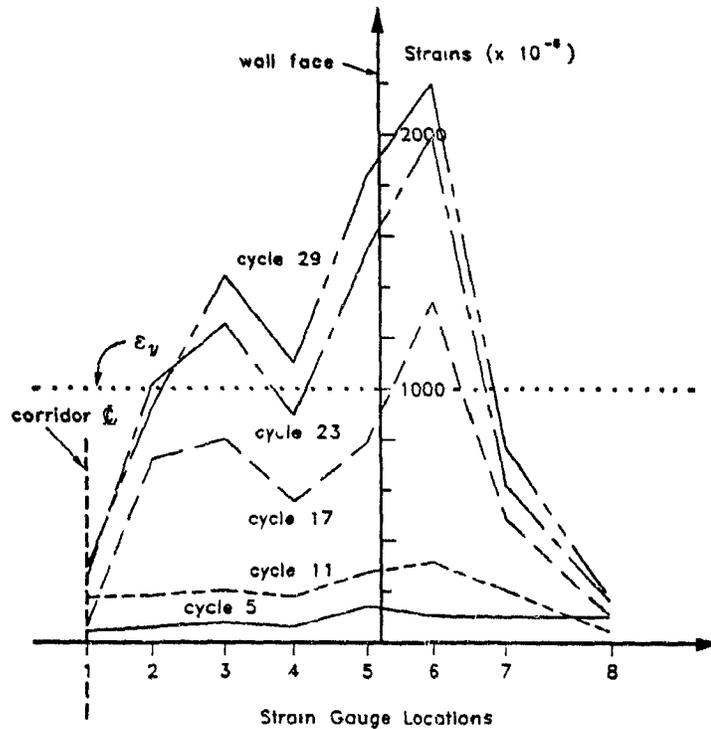
Figure 4.55 Strains in Inner Vertical Stirrup Legs for Specimen D1.

Electrical resistance strain gauges placed on the inner and outer vertical stirrup legs of all four specimens provided limited but useful data. The locations of these strain gauges were described in Section 3.4.3. The results of the strains in these vertical stirrup legs are presented in Figures 4.55 through 4.61. The strains in the outer vertical stirrup legs of Specimen D1 were not available due to the damage during casting to most of the strain gauges locations at these outer vertical legs.

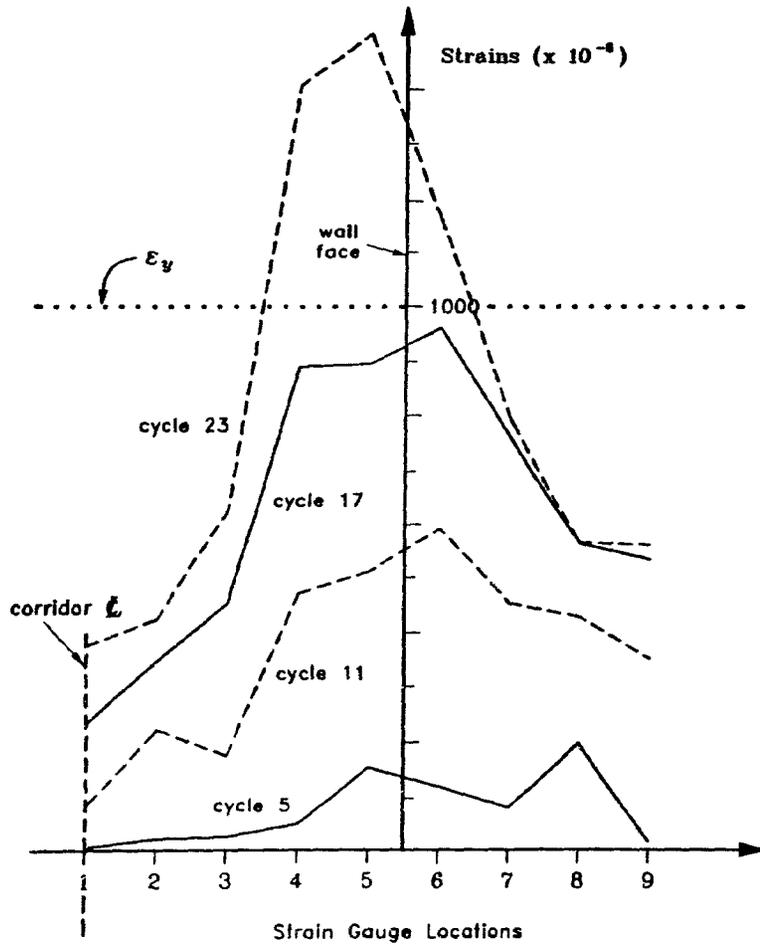
Figure 4.56 Strains in Inner Vertical Stirrup Legs of Specimen D2.

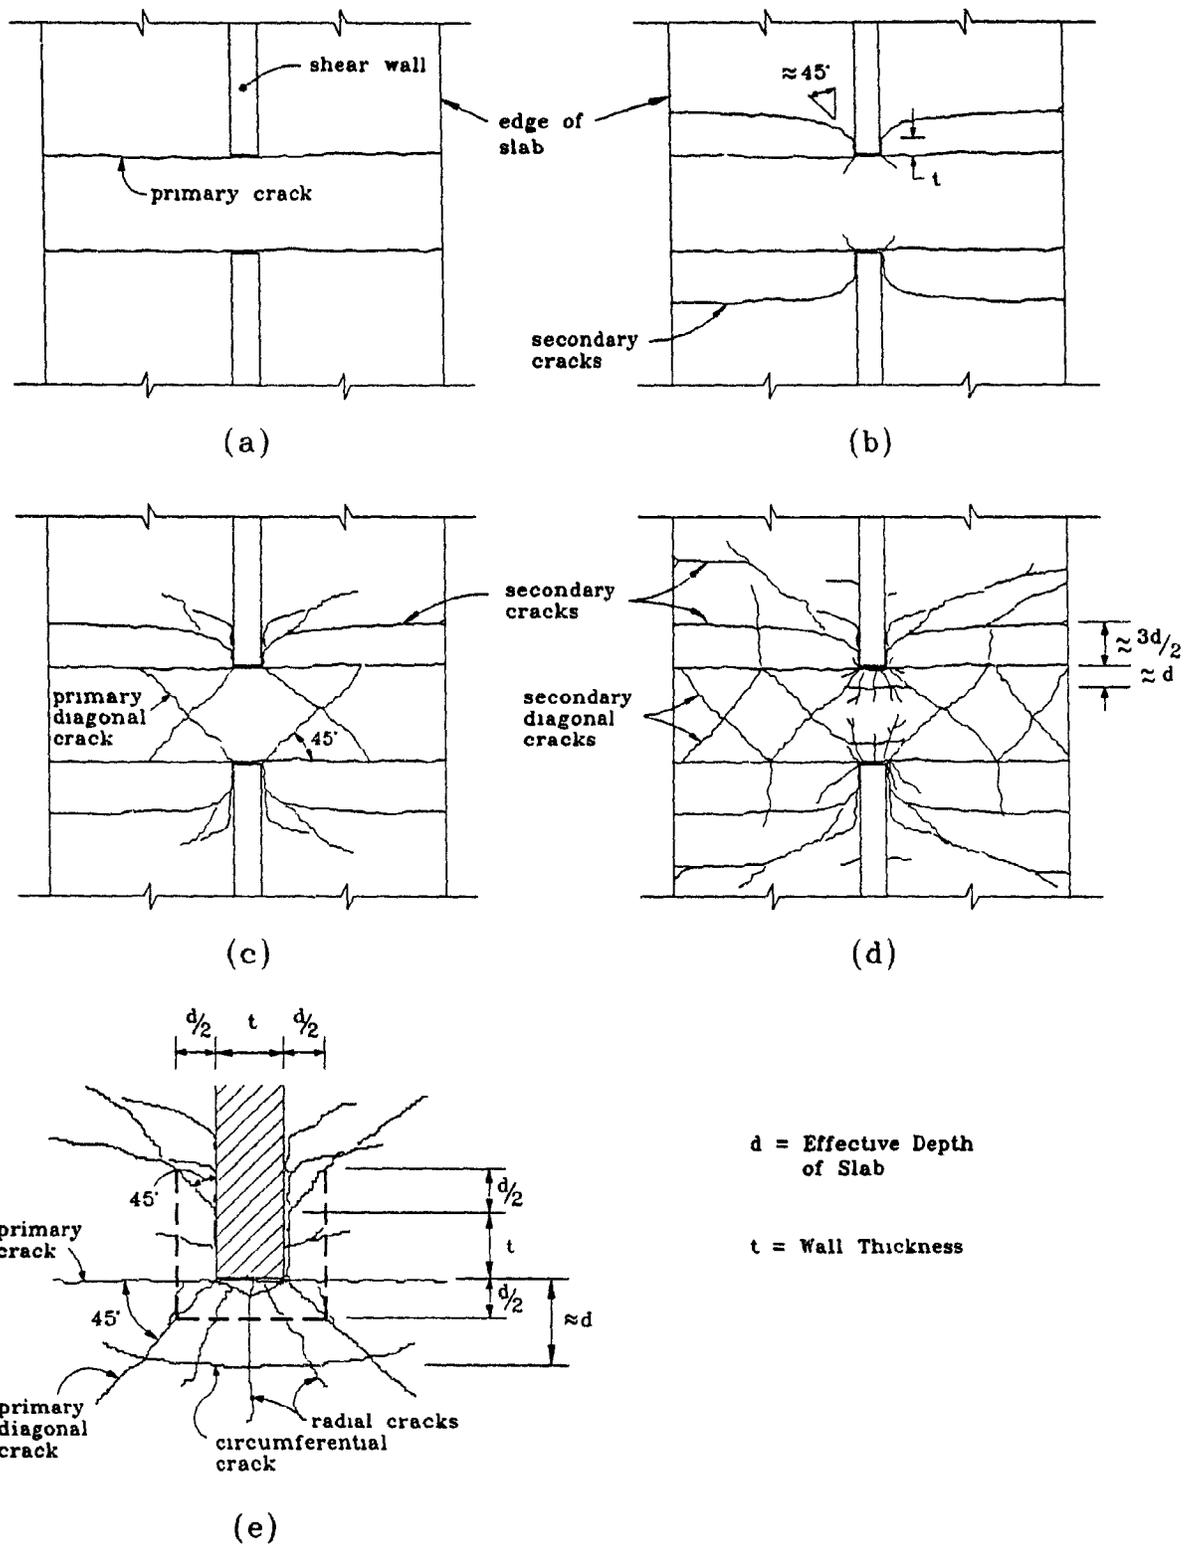
Figure 5.1 Schematic Diagrams of Crack Propagation.

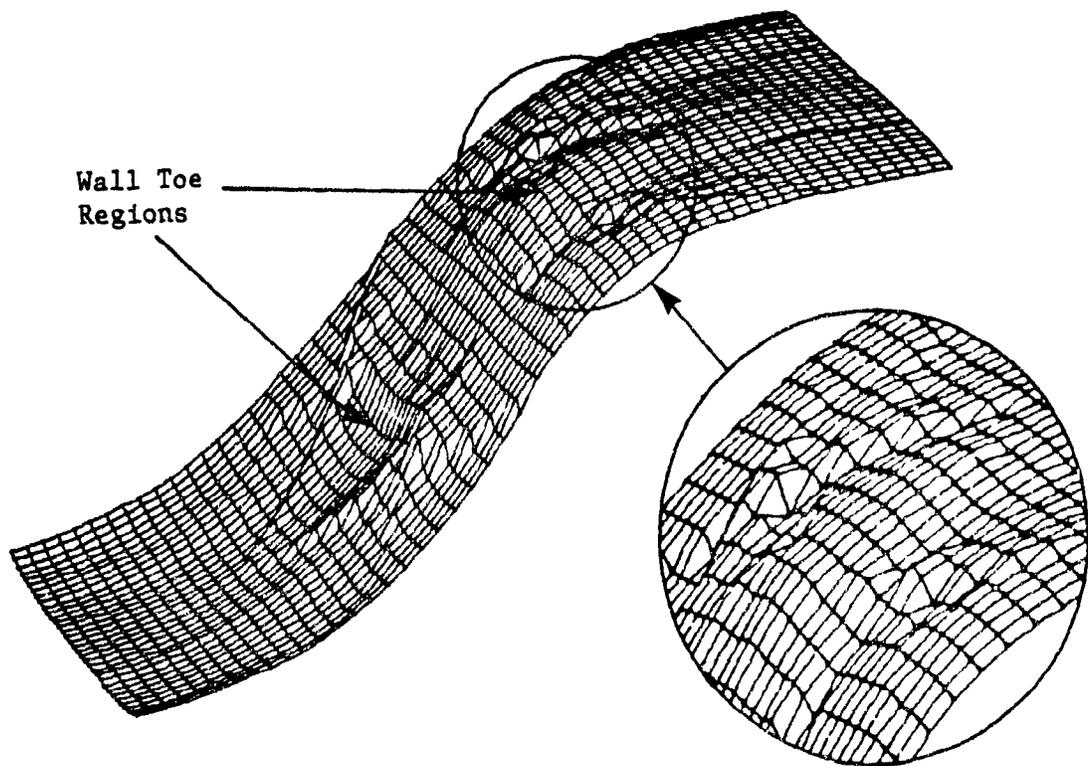
Figure 5.2 Deformed Shape of Coupling Slab at Failure (Specimen D2).

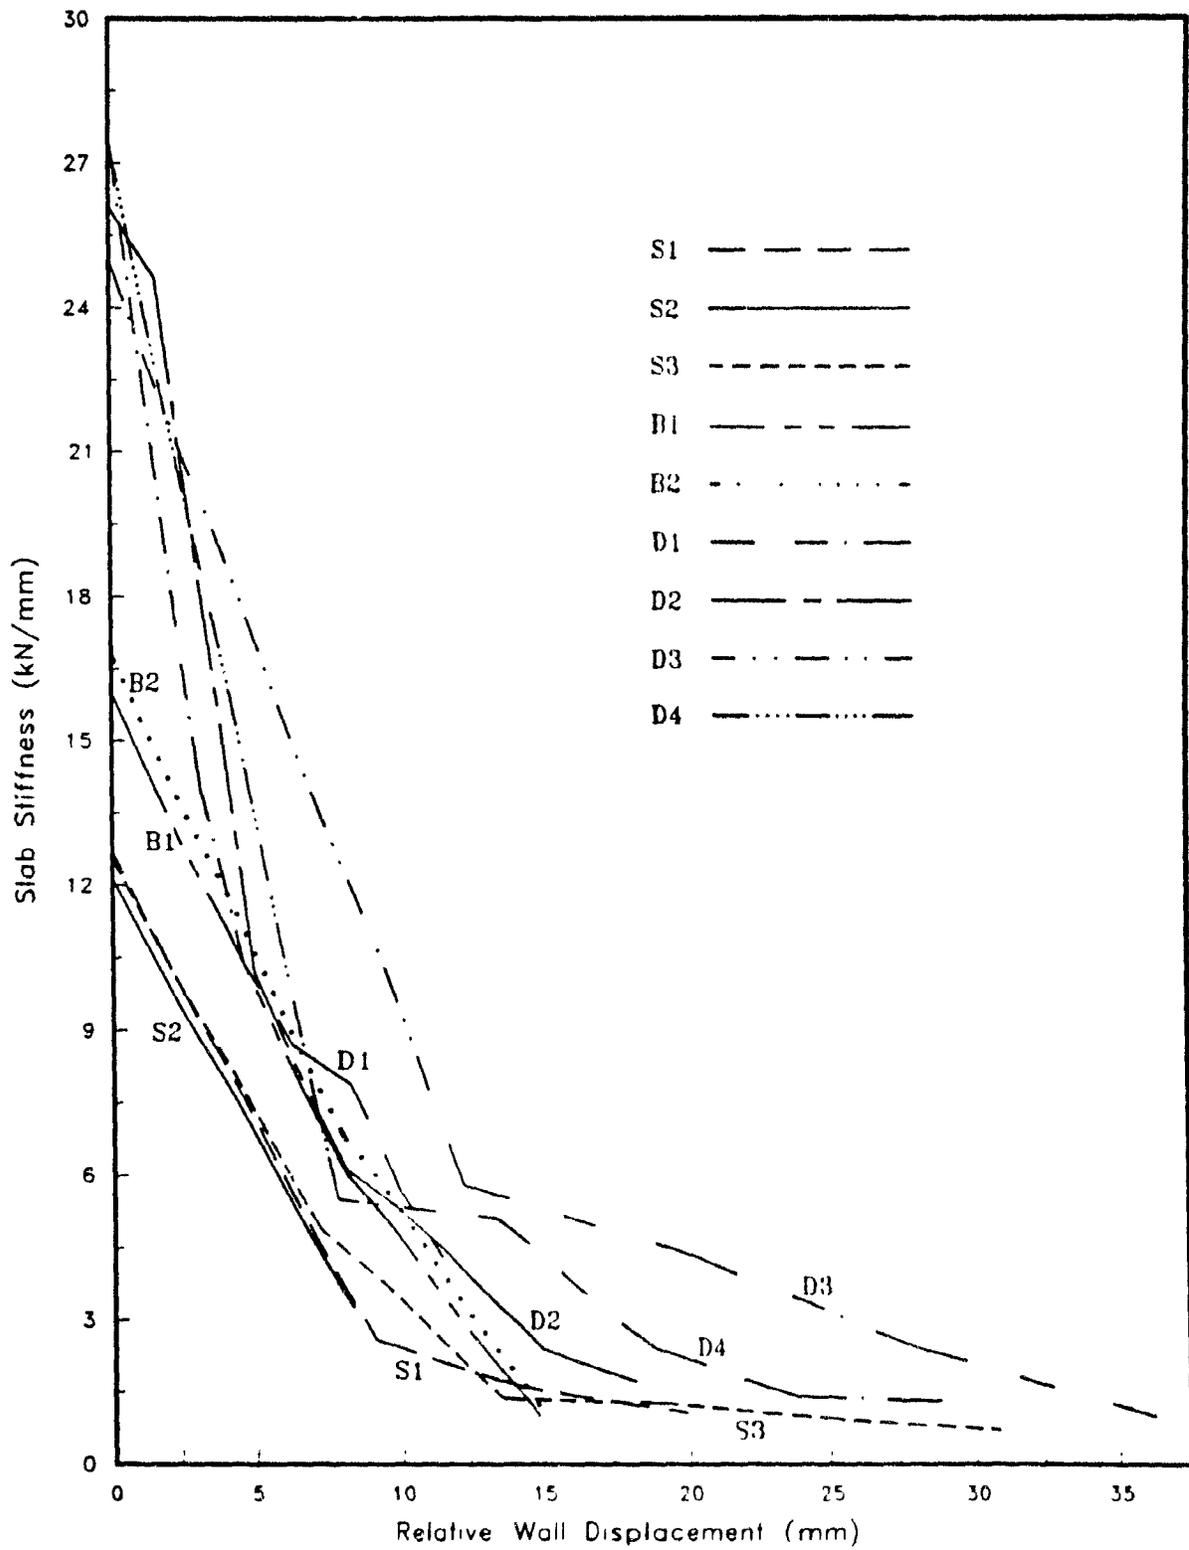
Figure 6.2 Variation of Coupled Slab-Shear Wall System Stiffness with Relative Wall Displacement.

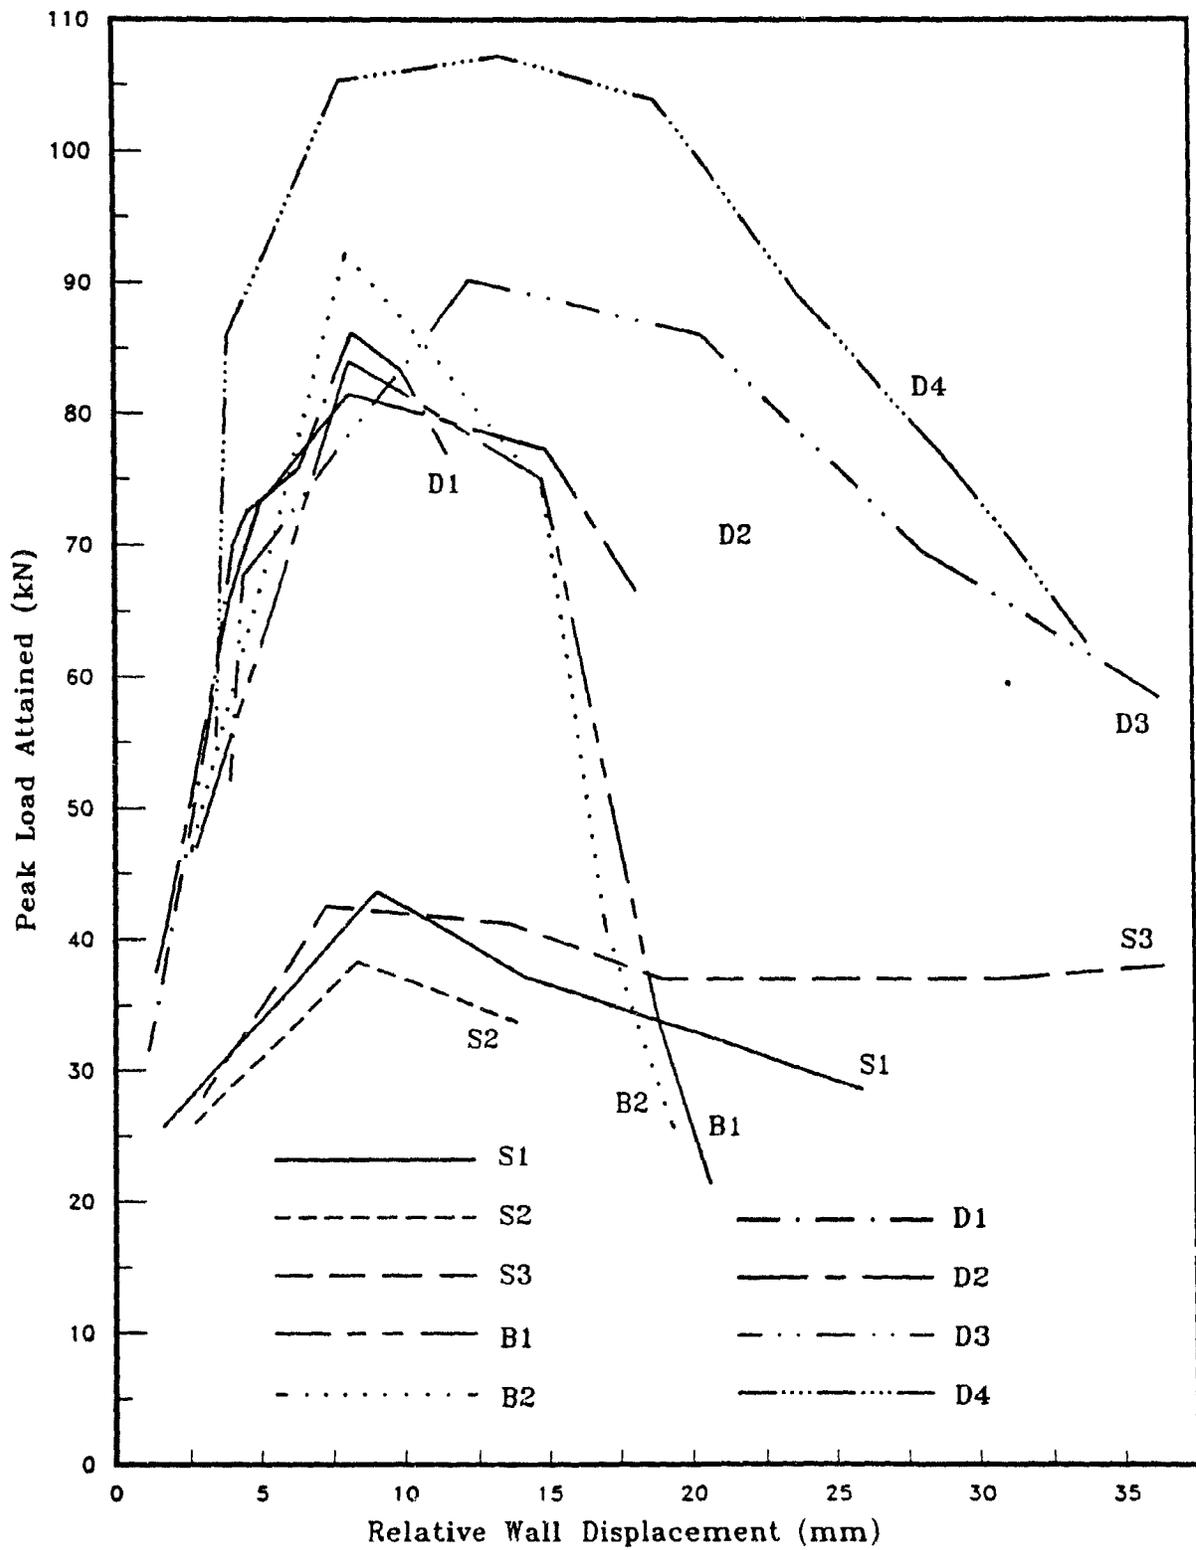
Figure 6.3 Variation of Coupled Slab-Shear Wall System Strength with Relative Wall Displacement.

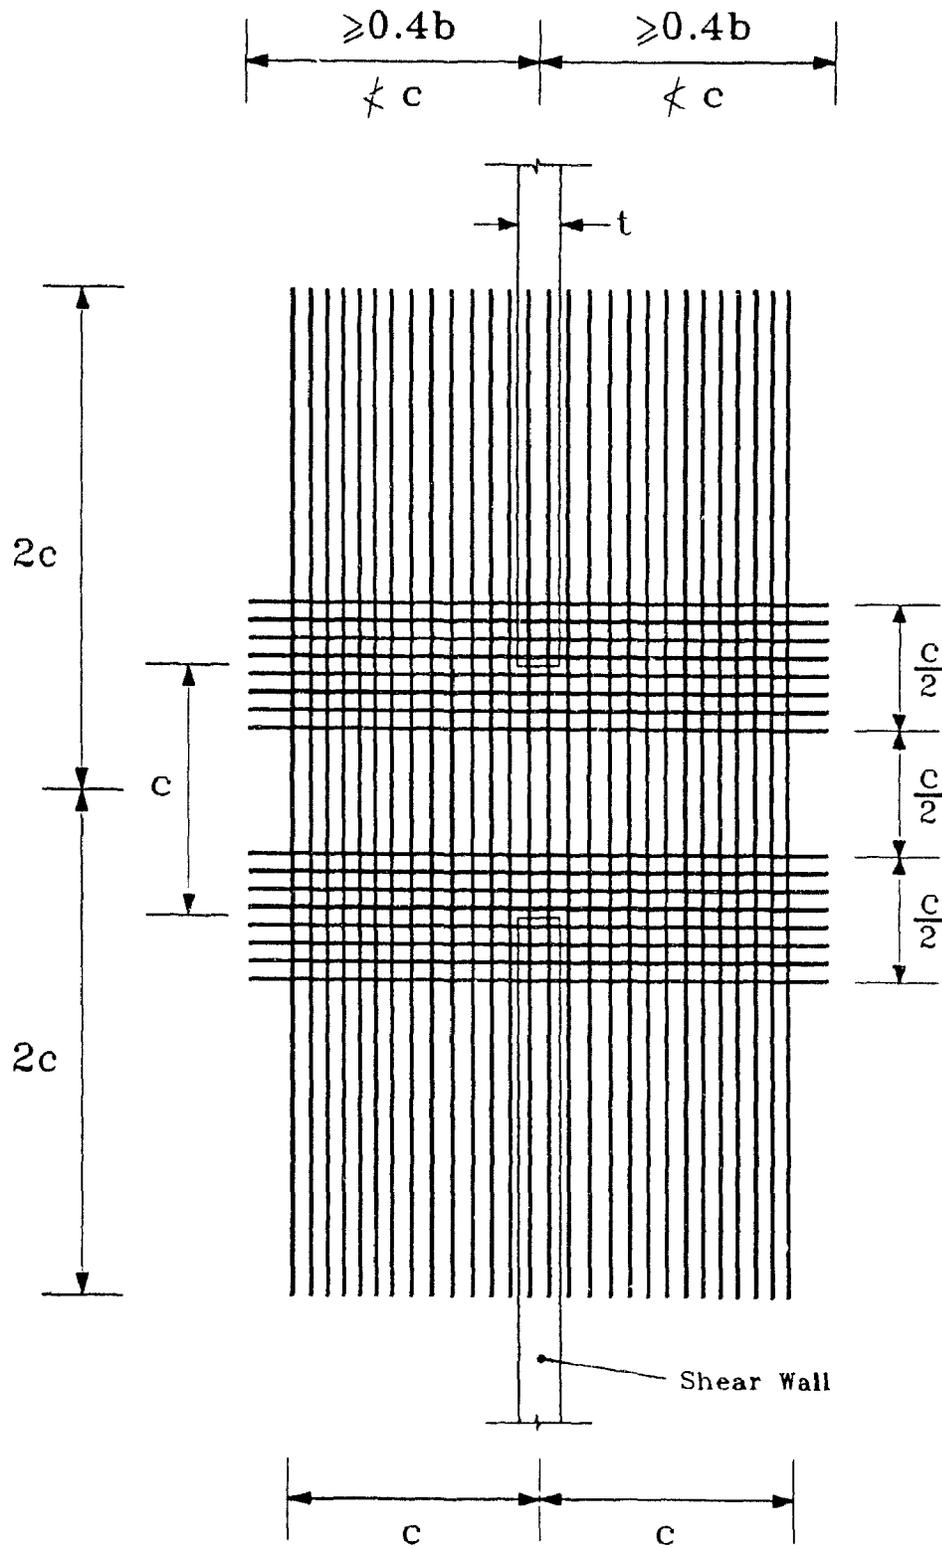
Figure 6.5 Longitudinal and Transverse Reinforcement Detail.

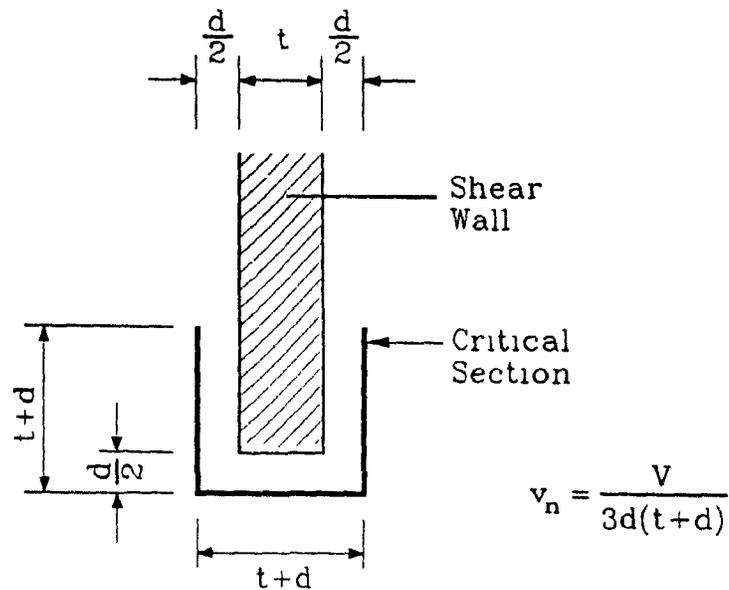
Figure 7.1 Critical Section for Punching Shear Around the Wall Toe.

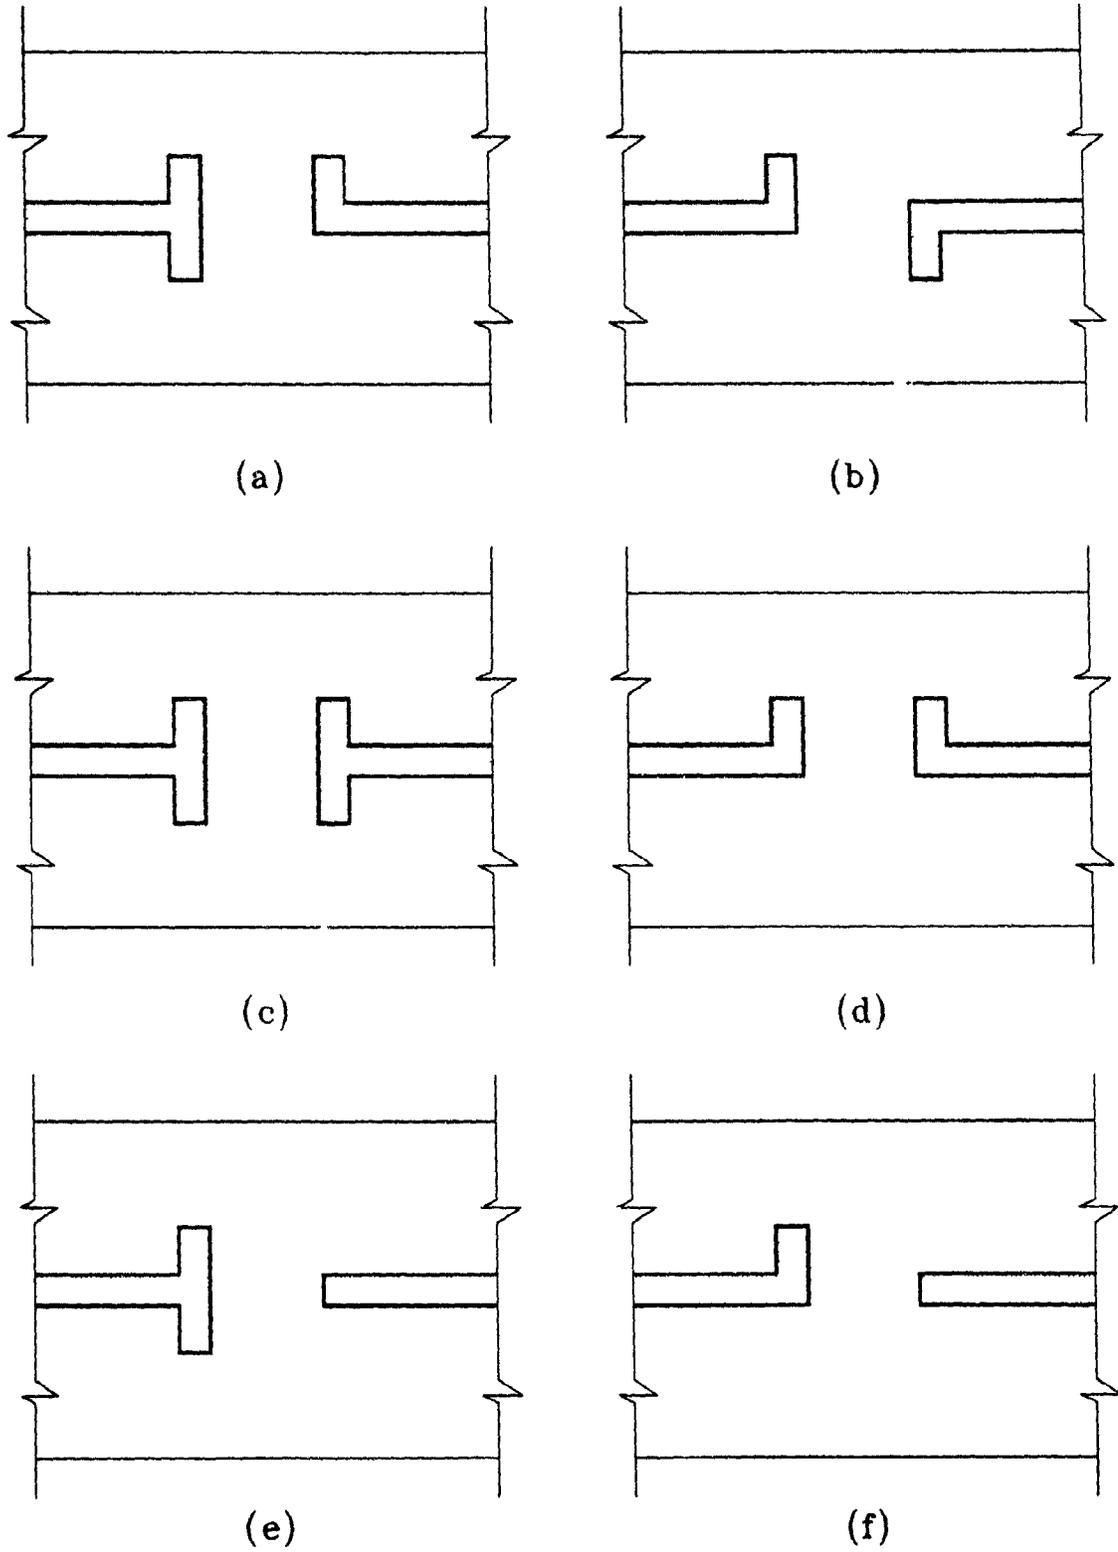
Figure 7.2 Possible Wall Configurations for Future Studies.
