# **Self- Help Housing for Rohingya Refugees in Bangladesh**

A Report Submitted to the Faculty of Graduate Studies and Research in Partial Fulfillment of  
the Requirement of the Degree of Master of Architecture

Urban Design and Housing Program  
Peter Guo-hua Fu School of Architecture  
McGill University  
Montreal, QC  
August 2020

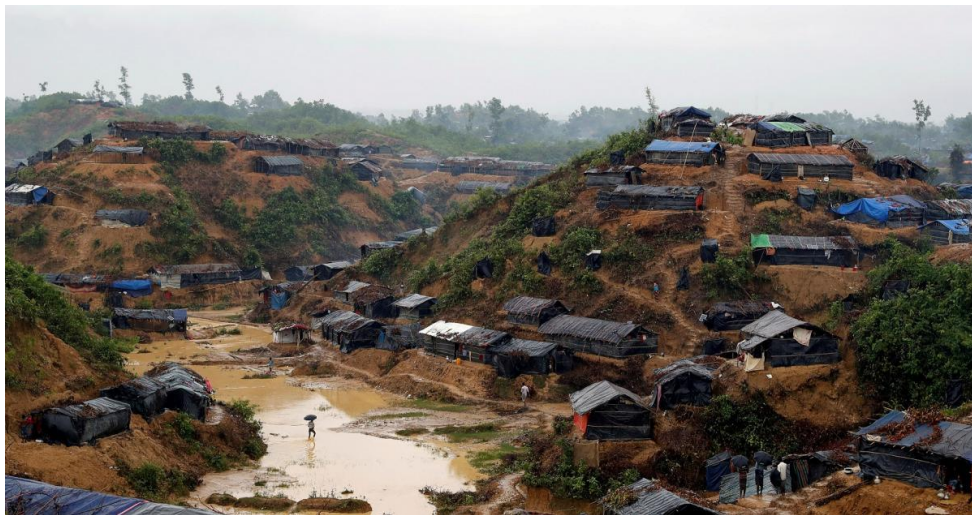
Figure 2.6: Condition of Rohingya camps during the monsoon.

The hilly site of Cox's Bazar is very prone to flooding and landslides during the monsoon season. When the refugees arrived in 2017, the site planning teams from leading agencies started drawing masterplan. But they faced extremely unregulated camps where the refugees led decision-making on where to live, where to pave new footpaths and bridges, and how to build a shelter for their families. The vulnerable site was worsened as there was a need to quickly settle the refugees. This resulted in impoverishing the hills, removing natural drainage and infiltration capacities, and increasing the likelihood of severe flooding. With the annual monsoon season, this becomes especially important. Figure 2.6 demonstrates the condition of Rohingya camps during rainy seasons. The complexity of the context emphasizes the value of site planning for the refugees' long-term protection. It highlights the need to enhance the position of site planners and lift their voices within the planning process. Their early decisions would improve the communication system within the site and the lives of people impacted by forced displacement (Global Shelter Clusters, 2018).

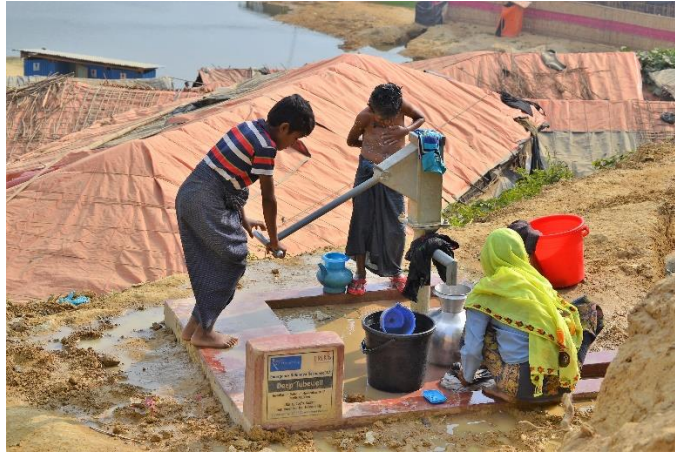
Figure 2.7: Deep tube wells in the refugee camp for drinkable water

The main sources of drinkable water in all Rohingya camps are tube wells and hand pumps (Figure 2.7). Both male and female key informants raised questions about their access to drinkable water during the interviews. Long wait times (male KI: 55%; female KI: 62%), lack of adequate water points (male KI: 44 %; female KI: 39%), and distance to water points (male KI: 38%; female KI: 48%) were the most frequently identified water access issues. To cope with these challenges, they used to go further away to fetch water (male KI: 50%; female KI: 59%), which resulted in unhygienic water consumption (male KI: 31%; female KI: 41%) (IOM Bangladesh, 2019).

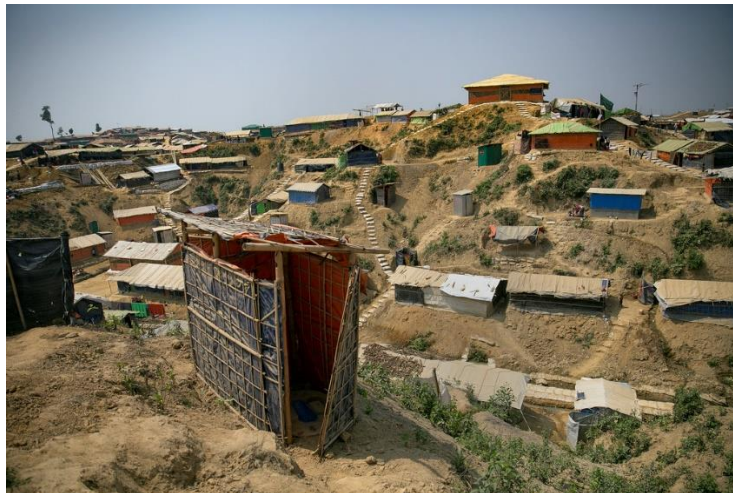
Figure 2.8: A common type of toilet in the refugee camp.

Generally, the Rohingya camps have 4 types of latrines and bathing practices; they are, public toilet facilities, private toilets in their shelters, showering outdoor and no bathing and toilet facilities. Figure 2.8 and figure 2.9 illustrates the usual scenario of toilets in the refugee camps. Lack of segregation between female and male facilities was the most frequently recorded problem about accessing latrines and bathing facilities and a higher percentage of female KIs reported the problem than the male KIs. The second most frequently recorded problem with male KIs was inadequate lighting in toilet areas (48%), whereas the female KI recorded unhygienic latrines (54%). The third most widely identified problem with both male KIs (42%) and female KIs (46%) was toilets being completely or partially non-functional. A substantial gap could be found between male KI and female KI responses on the issues regarding the toilet and bathing facilities located in too far away distances. The explanation for this may be that females are more likely to have

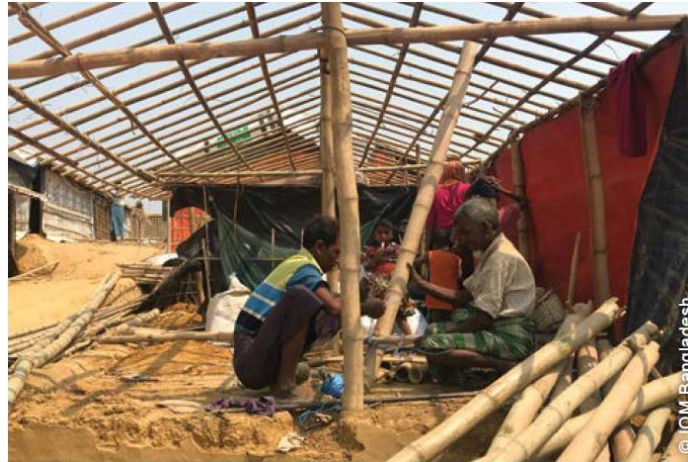
Figure 2.12: Self-help shelter construction process by the refugees.

Despite having training, they faced several challenges, such as limited durability of material and insufficient quantities of shelter kits. The organizations suggested that bamboo can be a durable building material if properly picked and handled (Martin, 2017). Therefore, bamboo posts were used by inserting directly into the earth. Additionally, the refugees did not provide support using bracings. It was primarily due to cultural preference, limitation of the number of bamboos, as well as the small covered space (since bracing decreases internal space if bamboos are mounted within the frame). Additionally, the language barrier was also a problem to understand the construction materials and process properly. But the high involvement of the refugees in the building process created a sense of ownership over their shelters (Global Shelter Clusters, 2018). Figure 2.12 below demonstrates the refugees building their own houses with bamboo.

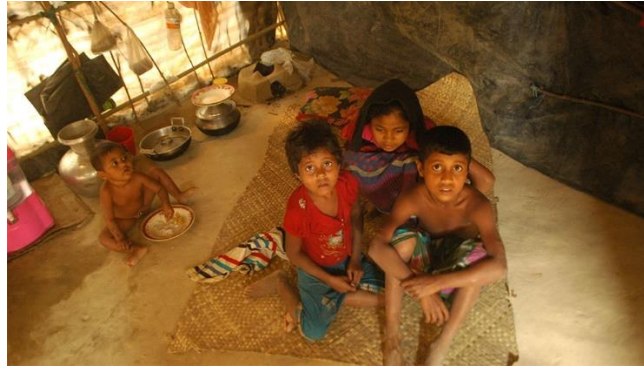
Figure 2.16: Unhygienic living conditions inside a Rohingya shelter.

In the upgraded shelters, the average area per house is 14 square metres and the average area of shelter per person is 3.4 square metres. Moreover, most of these houses have no attached toilet. The cost of material of these upgraded shelters is \$155US per household, where \$103US for materials, \$12US for tools and \$40US for supporting cost. The total cost per project is \$208US per household (Global Shelter Clusters, 2018). Most of these shelters do not provide any privacy and people live within a very congested room. Figure 2.16 demonstrates the unhealthy living environment inside the shelters.

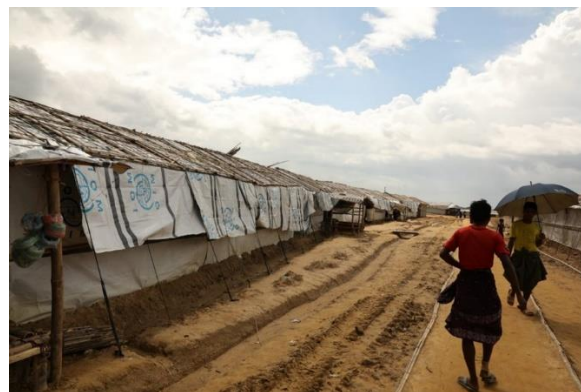
Figure 2.17: Emergency Rohingya shelters.

During the beginning of heavy influx in 2017, the Shelter / NFI Sector has carried out extensive distributions of emergency shelter kits (primarily tarpaulins and rope) and with these materials, the refugees have established their shelter using materials either obtained or procured from the local market. Figure 2.17 shows emergency houses built with Tarpaulins. The purpose of Tarpaulin was to provide protection from water, wind, sand and to give privacy and dignity (Martin, 2017). Shelter-grade Tarpaulins were procured from numerous sources, including regional stockpiles of the agency, foreign procurement and in-kind donations (Global Shelter Clusters, 2018).

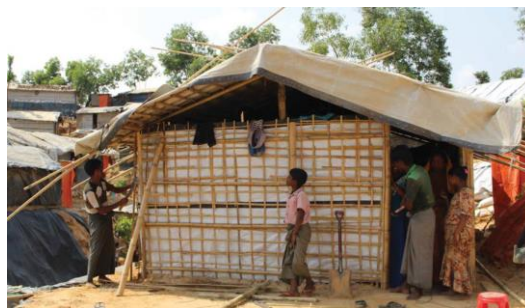
Figure 2.18: Upgraded shelter made of bamboo structure and tarpaulin.

Two months after the initial flux it became clear that bamboo was the only viable building material if procured from the local markets. Bamboo was economically feasible and accessible to the Rohingyas and was familiar as well. This was used as shelter materials, for projects of community buildings, facilities and other accessible infrastructures (bridges, stairs, paths). As an acknowledgement of this, a study was commissioned by the Shelter-NFI Sector to understand the market capacity to supply bamboo. The study reported that the construction needs of the world's largest refugee camp could not be met without sufficient and high-quality supply of bamboo. About 23 million pieces of bamboo were distributed via the shelter kits. Following the emergency process, the focus was on reinforcing and stabilizing the existing shelters, which were constructed in direct contact with the ground with untreated bamboo, creating the ideal conditions for pests and rot, resulting in failure during heavy winds and rains. Significant measures have been taken to resolve those problems by the end of 2018 (Global Shelter Clusters, 2018). A technical note and report on the durability and treatment of bamboo were prepared. Technical requirements were accepted for bamboo treatment, and Sector Partners gained a deeper understanding of the entire bamboo supply chain and key recommendations for sourcing, processing, handling, treatment and design (Hodgkin & Prideaux, 2018). Figure 2.18 illustrates the upgraded shelters for the refugees. The Sector developed key messages and diagrams about shelter improvements, such as bamboo ties and connections, to support training activities (Figure 2.19).

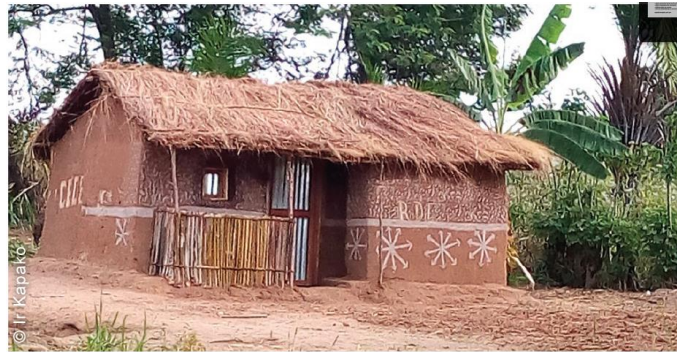
Figure 3.1: Shelters built by the communities

The shelters were designed based on local building techniques using accessible local materials and were constructed by the beneficiaries. This process brought about two advantages: firstly, because of a simpler execution, target households could buy the materials from local markets which ensured cash flow into the local economy. Secondly, it also reduced the possibility

of conflicts with neighbouring host populations as they worked in a group that developed unity among them. Aside from these, vernacular building techniques also made these structures usable for many years.

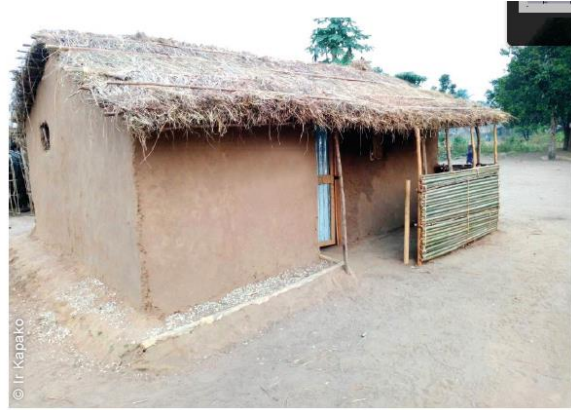
Figure 3.2: A typical refugee shelter designed by the community  
Source: (Global Shelter Cluster, 2019)

The basic plan of each shelter included a shaded cooking and storage veranda, connecting to a living area and an additional sleeping space accessible only from the living room. The average size of these shelters was 20 square meters, where the average area per person was 4 square meters. Figure 3.3 illustrates the plan of the shelters.

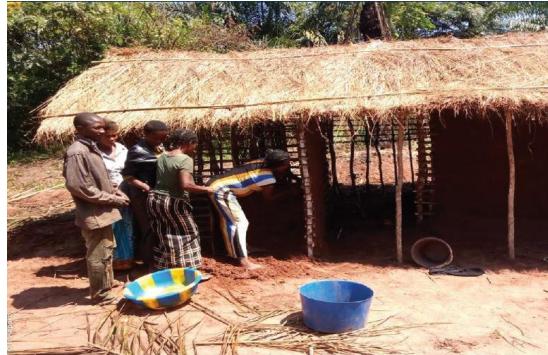
Figure 3.5: Construction process of a shelter by the refugees

Women were found to be more active than men (even though housing construction is generally a male-led activity), which was the reason behind more women were included in the committees. Women played a leading role in collecting local materials, such as sticks, ropes, palm

leaves, soil and reeds, while men also assembled the materials before construction. Both men and women performed shelter-building or retrieval activities (Figure 3.5).

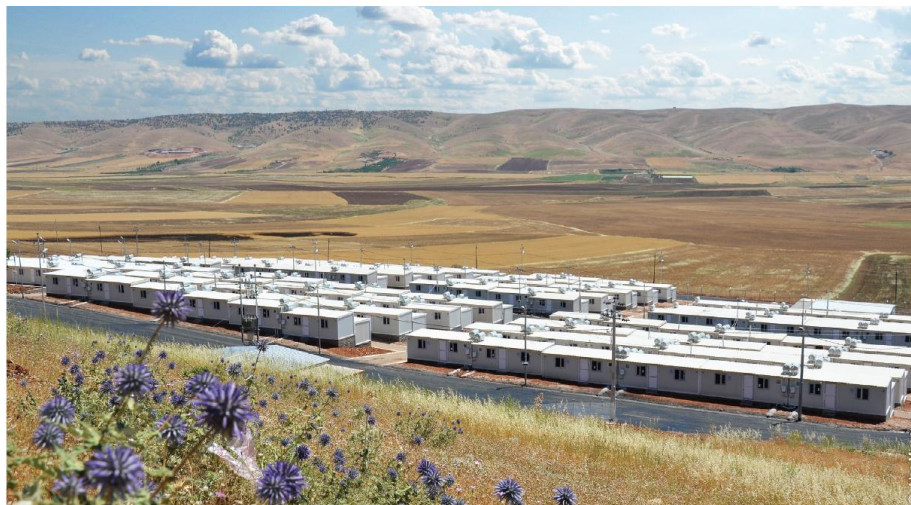
Figure 3.8: Shelter for the IDPs after completion  
Source: (Global Shelter Cluster, 2017)

The project fulfilled its aims by developing four prefabricated shelter sites and facilities. It considered both social and economic vulnerabilities and cultural differences. The prefabricated shelters had one living room and one bedroom, with a partition for women and girls to ensure privacy (Figure 3.7).

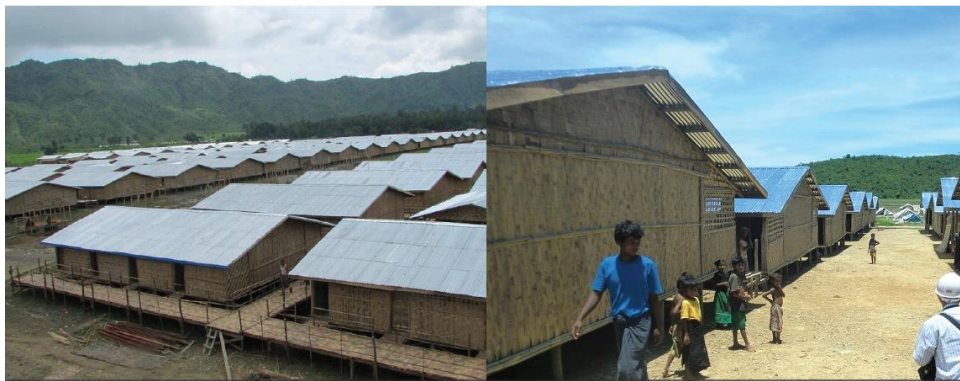
Figure 3.13: Elevated shelters for the IDPs after completion

The shelters were lifted from the ground in some settlements, and walkways were constructed across the shelter. Besides, firewood was in such low supply that the survivors cut up the wooden walkways for fuel in some situations. Therefore, instead of wooden walkways, rammed earth walkways had to be built (Figure 3.13).

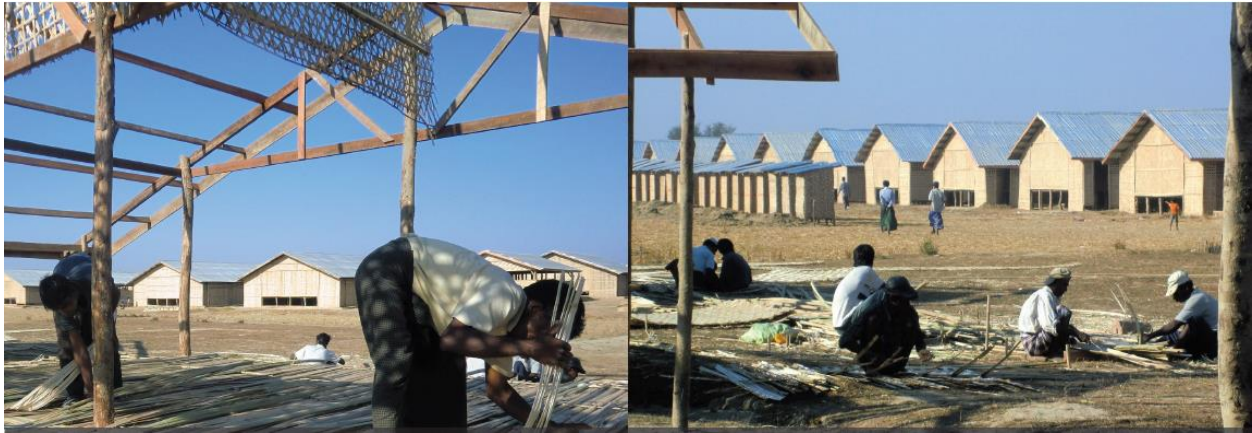
Figure 3.15: Shelter construction by the IDPs

Shelters were constructed by recruiting local building contractors authorized by the RSG. The contractors recruited IDP labour (skilled and unskilled) to ensure cash flows into the vulnerable microeconomies developed in the IDP camps. Workers were paid at government standard rates. The leading organization conducted site planning in partnership with three government departments. The camp infrastructure was also built to provide the basic amenities. After that, maintenance and repair programmes were implemented through CCCM Cluster partners, which allowed a community-driven approach. However, the RSG opposed the distribution of toolkits to beneficiary households, as they believed these could be used as weapons.

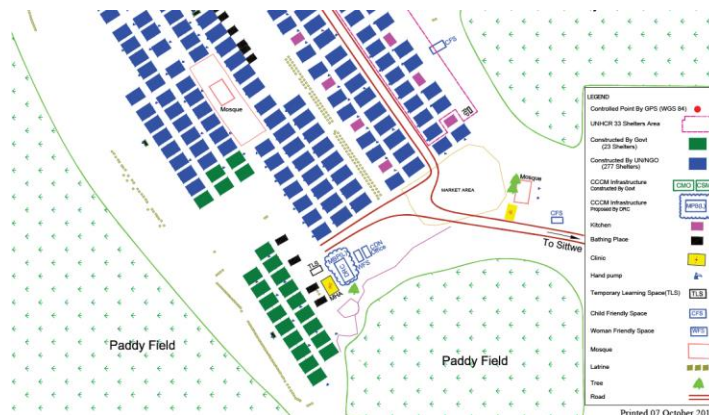
Figure 3.16: The site plan of the camp showing the shelters and the infrastructure

Besides shelters for the IDP community, other infrastructures were also built within the project. The camp included an outdoor common water pump, kitchen and bathroom. Additionally, it had temporary learning space, child-friendly space, women-friendly space, health centres and mosques. The following figure 3.16 shows the site plan of the shelters and the infrastructures.

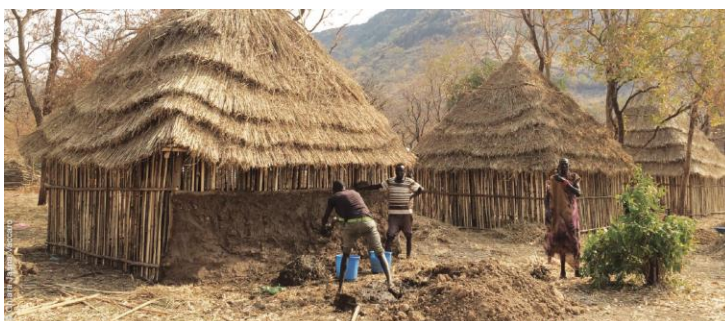
Figure 3.18: Construction of tukul houses by the beneficiaries.

The shelter design chosen for the refugees was mud tukul house, which is a traditional form of house design in the region. This form of shelter is very resilient against heavy winds and heat (UNHCR, 2016). It can be built using timber, bamboo or brushwood structure. The form, as well as the dense layer of mud, protect the structure from the weather and help sustain a cooler temperature in the interior. The following figure 3.17 shows the plan of the tukul house:

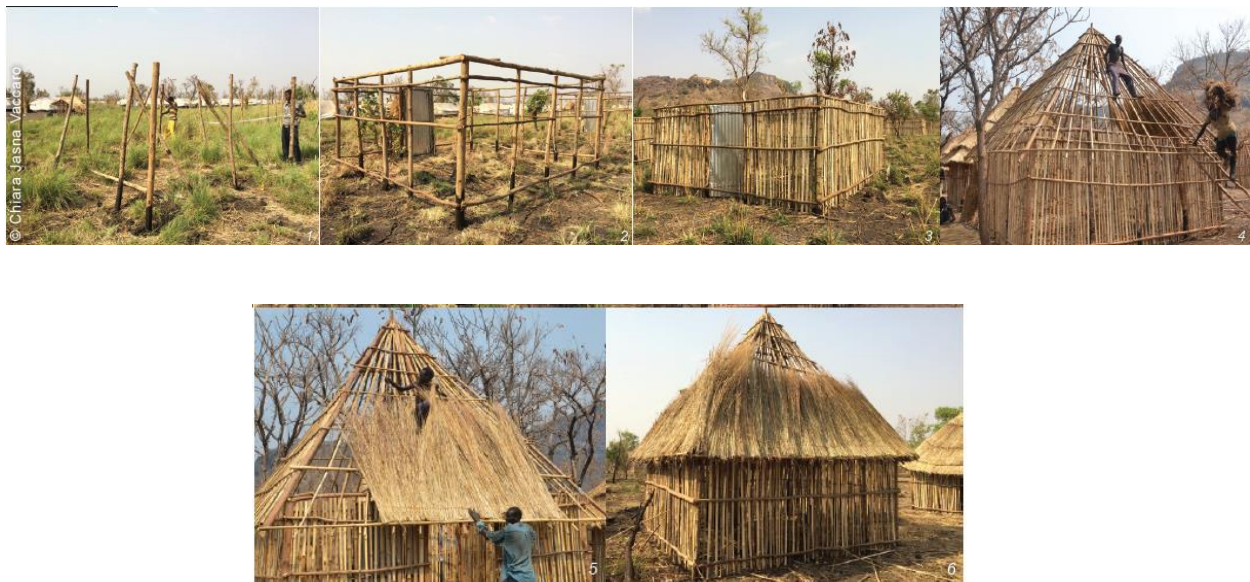
Figure 3.20: Shelter construction by the refugees

- A team of trained refugee staffs built the grass thatch roof. Due to some parts of the roof being deteriorated relatively quickly, the thatching technique was improved in the second phase of the project.

- The shelters were then handed over to the family of the designated beneficiaries.
- Appropriate locations for soil quarrying were agreed with the host community to ensure compliance with safe practices and mitigate conflicts with the host community. The soil was obtained by the refugees themselves, with the aid of field officers.

- Then, the beneficiaries were supplied with the requisite local materials, tools and technical assistance to conduct mud rendering and elevate embankments to protect against flooding.
- Regular technical help and guidance were provided, according to the design and accepted requirements.
- Coordination and supervision of the project were provided with the staff of the agency, and other implementation partners to resolve any problems that might arise.
- The organization conducted a post-implementation evaluation among the refugees to understand whether they were satisfied with the shelter. Most beneficiaries reported being satisfied with the shelter design and materials (over 80%) or very satisfied (over 10%).

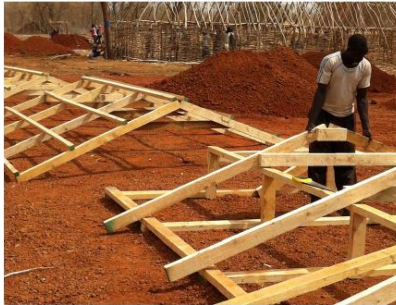
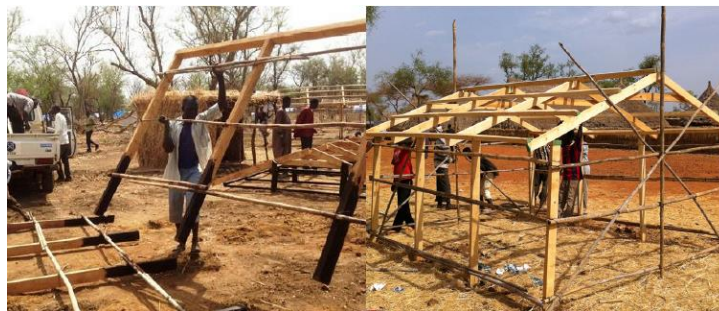
Figure 3.24: Construction of the shelters by the beneficiaries

Beneficiaries received construction training to develop their skills for shelter construction. They were also trained in carpentry to make prefabrication units and installation of the structure.

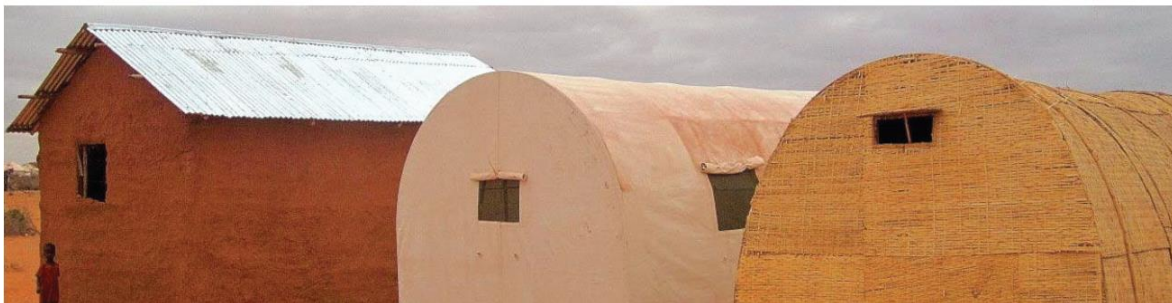
Figure 3.26: Different prototypes of shelters

In February 2010, the first camp opened at Dollo Ado. After 7 months in September, criteria for transitional shelters were adopted. Then, in March 2011, the shelter prototypes were evaluated by the organizations, government and refugees.

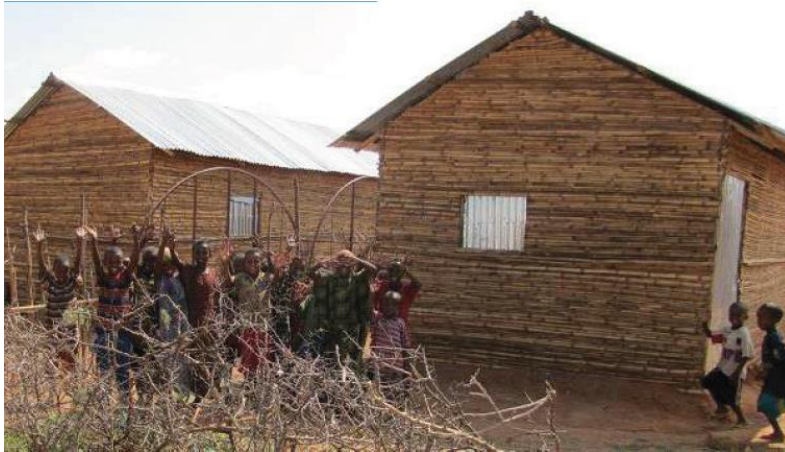
Figure 3.28: Shelter for the beneficiaries

Essential training was provided for skilled labourers involved in building on site. Activities on-site included digging holes for foundations, erecting structures, installing the roofing, lining the walls with bamboo slats and repairing windows and doorways. The training was provided in rendering mud for walls where the mud was available.

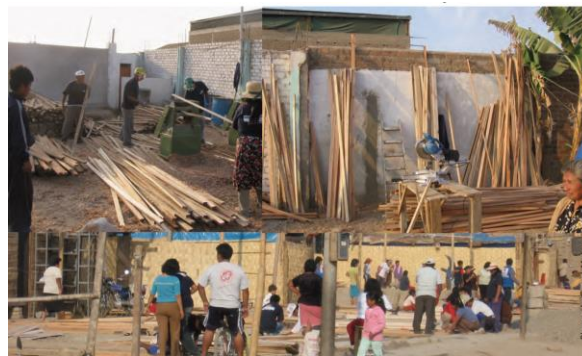
Figure 3.32: Construction process of the prefabricated shelters

Homeowners transported the products from their 'factory' to their homes. Then, they installed the wall sheeting of the tongue and groove onto the six wall framing panels. Employees

of the company and qualified members of the group then assembled the side frames (two for the sidewalls and four for the front and back walls) with the help of company advisors. Families hammered together the frames and fixed the doors and windows. The staff of the contractor performed monitoring and quality assurance. The contractor had one project manager and one technician whose main responsibility was to supervise and 5 skilled workers for cutting wood. Monitoring was carried out by a team of about 30 volunteers, 15 of them were involved regularly in the field. Among them, five to six worked regularly with the contractor and recruited volunteers from the neighbourhood. The rest of them worked in the community for assisting with registration, property rights and other developing problems.

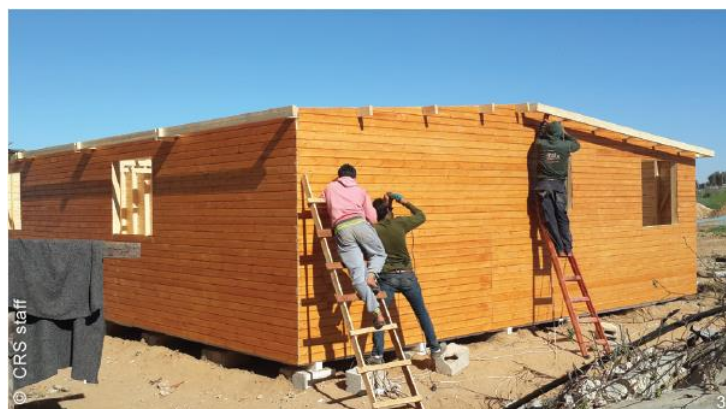
Figure 3.38: Shelters made by the communities

Shelters were designed in different sizes to match the various family groups. The shelters included a living or bedroom area, a bathroom, a kitchen and an open veranda that could be used by adding walls to extend the covered space.

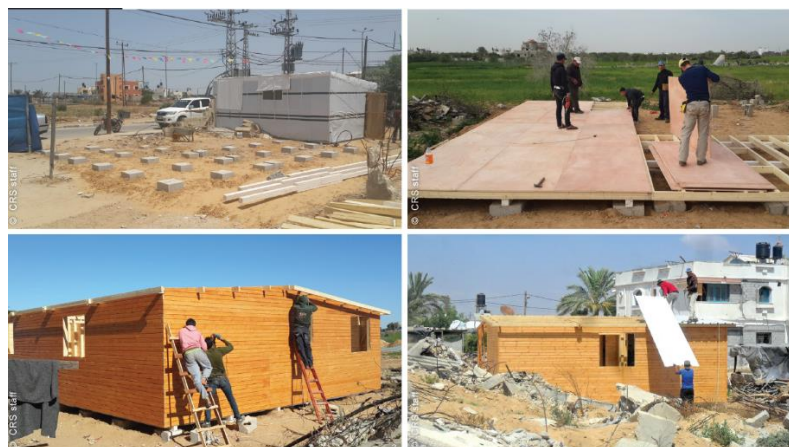
Figure 3.41: Construction Process of the shelters

The organization decided to use a wood-frame construction because of the embargo on other building materials other than timber. The company then hired a contractor having timber building expertise, to help with the project's sourcing and execution. Timber construction was not usual in Gaza, so the wooden panels were prefabricated off-site. Due to the time shortage and for quality assurance, the installation was performed by the contractor. This was chosen through a competitive tender process. The timber frames were made in a factory and transported to the site by truck. When erected, the materials for the cladding, flooring, and roofing were supplied and fitted to the frames. The house was installed by other construction technicians, such as electricians, plumbers, and dry-lining wall fitters. A mixture of on-site and off-site working methods permitted higher speed, greater productivity and better quality control.

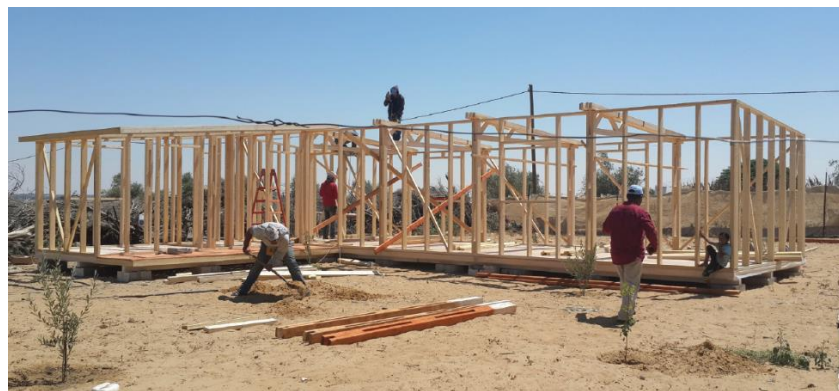
Figure 3.42: Experienced workers built the structure as timber construction was new in the country

Necessary training was given to reduce hazards associated with unexploded war objects and even radioactive waste, such as asbestos. The timber frame construction was done by the skilled workers hired by the organization. The beneficiaries were responsible for the construction of the septic tank and connect the plumbing fixtures. They were provided with a manual to develop the skills needed.

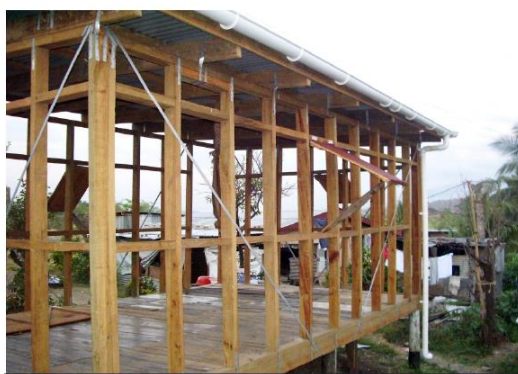
Figure 3.46: Construction process during a prefabricated shelter

Procurement and construction were the responsibility of the organization, with families contributing in terms of labour. Once selected, beneficiaries within the project became "home partners." These involved beneficiaries agreeing to contribute to shelter building ("sweat equity") and undergoing basic construction training. Family members became part of the construction team from beginning to end.

Four teams were formed, each comprising four technical persons. The shelters were built in batches of three or four at a time, with each structure taking three days to complete. A temporary warehouse was set up on-site using supplies that would later be used for the last T-shelters. In the depot, two teams worked to make seven sets of wall frames a day.

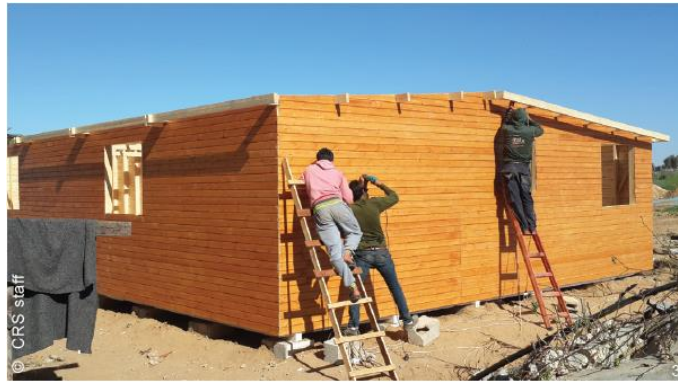
Figure 4.3: A prefabricated refugee shelter in Gaza assembled by the beneficiaries themselves.

After a crisis, it is very significant to build the structure within a very short period on an immediate basis, at the same time making it usable for the long term. Considering these criteria, a prefabricated shelter structure can be a very good option for the refugee shelters, even for the Rohingya refugees. Furthermore, it makes the self-help construction process easier and minimizes waste of material. Additionally, in the cases where shelter kits are needed to be transported by

UNHCR or other humanitarian organizations due to the emergency needs in the conflict or disaster zone, prefabricated shelter kits could be a viable option because of its easy transportability and convenient assembly process within less time.

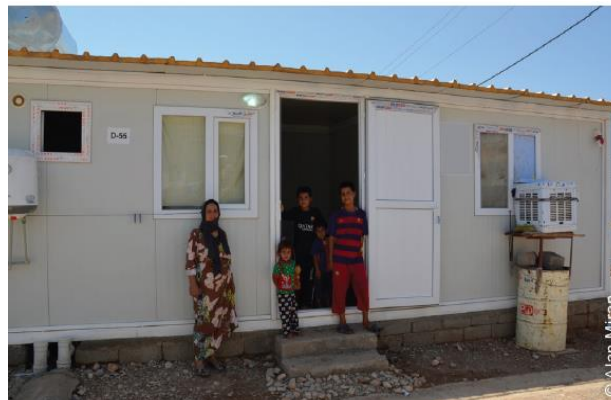
Figure 4.5: A prefabricated wood shelter for refugees in Iraq.

For any type of refugee housing including Rohingya refugees, the major criteria for selecting materials for the structure and exterior envelope are durability, construction time, availability and cost of the material. Also, for self-help construction, the material should have the compatibility to be handled by the refugees themselves to avoid unwanted injuries.

any hassle at the same time ensuring durability and protection for a longer period (Figure 4.5). However, if the materials are collected by contractors from the surrounding markets in Cox's Bazar, bamboo is a good solution for the Rohingya refugees' shelters for self-help construction (Figure 4.6). Additionally, prefabrication of the shelter materials according to design can ease the self-help construction process and reduce construction time.

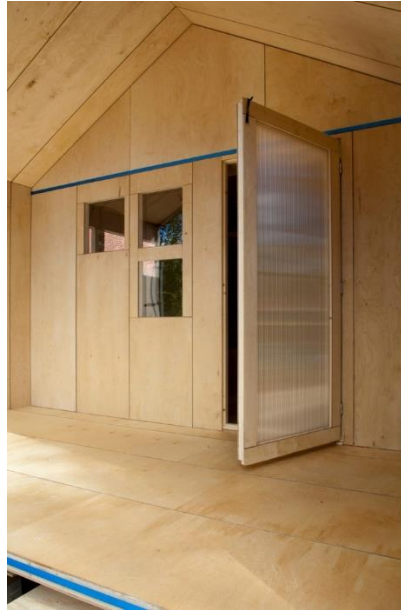
Figure 4.7: Prefabricated wood panels used for the interior of a refugee shelter.

While selecting materials for the interior, such as for walls, floors, doors and windows; prior attention should be given to durability, protection from the adverse climate, construction time and availability. Also, the materials should be prefabricated in the workshop for the ease of construction. In Cox's Bazar, bamboo framed door and windows and mud floor are available interior materials. Moreover, if the shelter kits are transported by the organization, prefabricated wood floors, timber-framed doors and windows are sustainable materials for the immediate constructions ensuring the permanence of the structure (Figure 4.7).

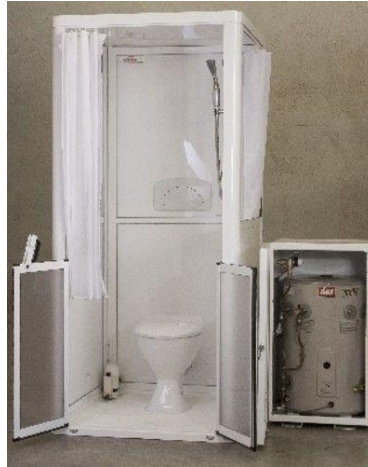
For the sanitation system for the refugees' Pod toilets are an easy solution for self-help construction due to its easy and quick installation process. These toilets can also be transferred easily and they solve many of the existing problems that the Rohingya refugees are facing in the existing camp; such as hygiene issues, inaccessibility, inefficient and faulty fixtures.

Figure 4.8: A typical POD toilet.

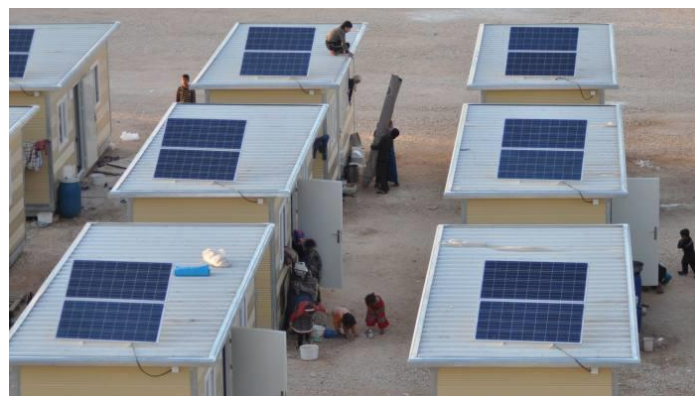
Renewable energy sources are very sustainable sources of energy for the refugee camps. In many refugee camps around the globe including Rohingya camps, renewable power is used for electricity, heating and other purposes. Therefore, the design of the shelters and masterplan of the site should include a solar panel on top of the roof or in any other suitable location in the camp (Figure 4.9). Other types of renewable energy sources such as wind power and hydropower can also be used in other contexts if available.

Figure 4.9: Solar panel on refugee shelters in a refugee camp in Syria.
