Geometrical and material characterization of old industrial masonry buildings in Eastern Canada

Abstract. The benefits of repurposing existing constructions are recognized by provincial legislation for their potential in achieving sustainable development goals. In recent years, adaptive reuse projects in Eastern Canada targeting seismically vulnerable old buildings, especially those once used by local industries and featuring unreinforced masonry members, have significantly increased. When major renovations are planned, however, the objectives set by the National Building Code of Canada require old buildings to achieve the same seismic performance of modern ones. As a result, and because of the lack of ad-hoc guidelines and the limited knowledge of traditional construction methods, local engineers are prompted to design overly invasive retrofits or demolish/reconstruct entire sub-structures. To avoid such unsustainable practices, preserve the integrity of Eastern Canada's built environment and enable its responsible reuse, this research aims to increase knowledge about the response of old unreinforced brick masonry industrial buildings. These results can aid in the classification

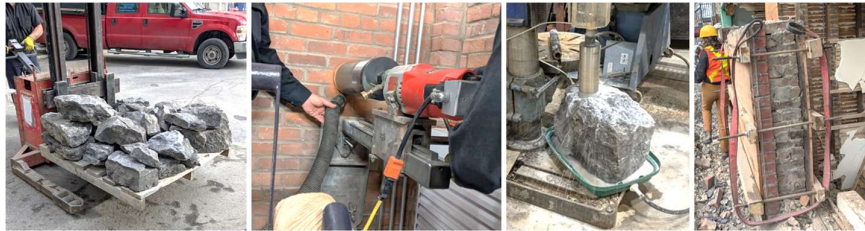
Fig. 1: Examples of specimens extracted onsite to be tested mechanically in the lab

At this early stage of the project, evaluation of the geometrical and material properties involves onsite non-destructive evaluation (NDE) as well as lab destructive testing on original samples (units, masonry prisms/cylinders or walls) extracted via minimally invasive (e.g. core drilling) or targeted demolition techniques (**Fig. 1**). We plan to use destructive test data of key materials to calibrate NDE tools as well as to better understand features of old units, mortar and URM in controlled conditions.

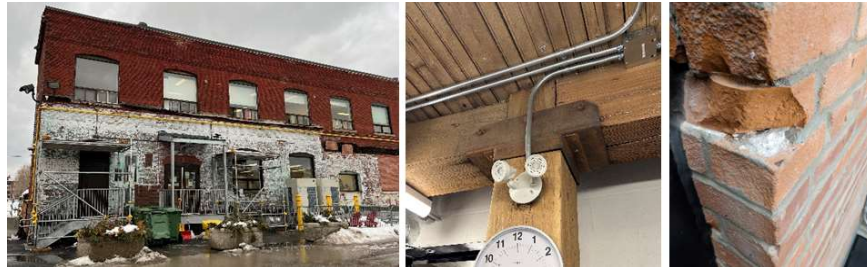
Fig. 5: Rue St. Patrick's building exterior (North facing) and interior timber frame/URM details

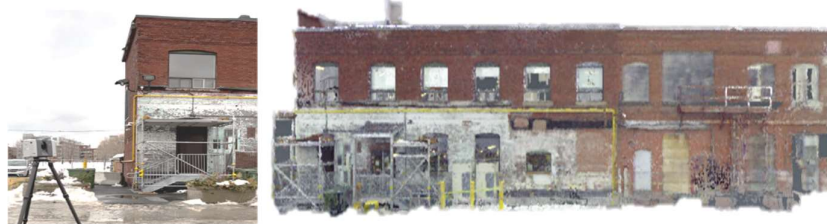
Fig. 7: Laser scan setup (left) and point cloud results (right) of Rue St. Patrick's building

In the geometrical survey of the Rue St. Patrick's building, a laser scan of the structure was completed using our Leica RTC360. Laser scans were registered with scan-to-scan recognition and links to create a geometric network. The medium-density point cloud from the laser scan was post-processed to create an accurate geometrical model of the structure. **Fig. 7** depicts the setup of the Leica RTC360 and the resulting point cloud. The resulting precision of the point cloud is about ± 0.006 m. Further processing of these point clouds will inform accurate geometrical models for seismic evaluation.
