# **Condition Assessment of Concrete Bridge Girders Using Modal Testing – A Preliminary Study**

October 2009

A Thesis submitted to the Department of Civil Engineering and Applied  
Mechanics in partial fulfillment of the requirements for the degree of Master of  
Engineering

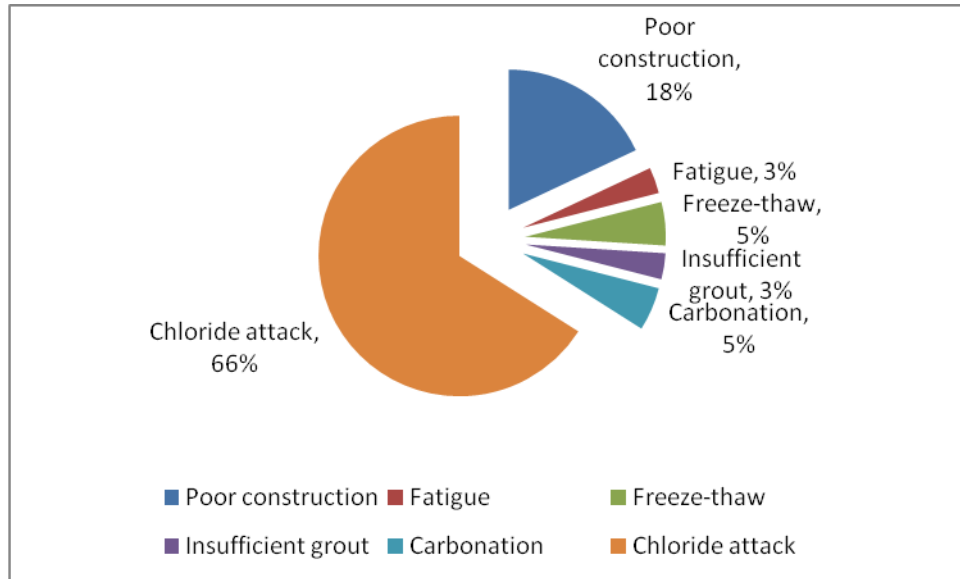
Figure 3.3 Cause of spalling (Gaal et al. 2002)

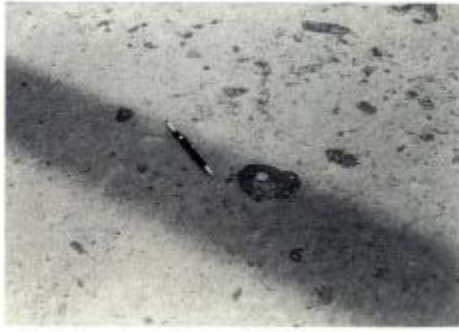
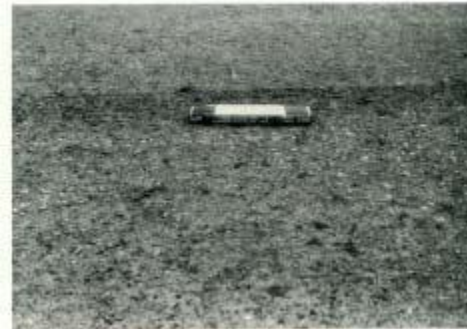
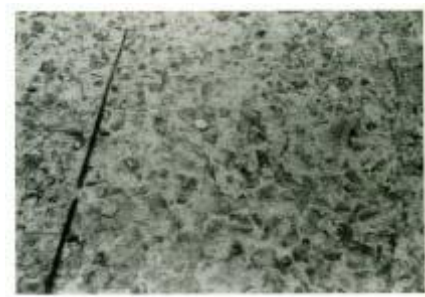
Figure 3.17 Types of scaling

**Manifestation:** Scaling is a surface defect, observed on the outermost concrete layer. This is a gradual process in which cement mortar and aggregate disintegrate. It starts from outer layer and progresses inwards. Initially, it starts in the form of small patches that merge and extend over time and transform in larger areas. Depending up on the depth of scaling, scaling are classified in three categories (Figure 3.17).

(2) **Moderate scaling:** Loss of surface mortar between 3 to 10 mm depth with exposure of coarse aggregates.

(3) **Severe scaling:** Loss of surface mortar between 5 -10 mm; in addition, there is complete loss of mortar between 10 to 20 mm around coarse aggregate that result in loosening of coarse aggregate.

Light scaling

Moderate scaling

Severe scaling

**Causes:** Scaling of the concrete surface occurs mainly due to freezing-thawing cycles and the presence of de-icing salt ( $\text{NaCl}_2$  or  $\text{CaCl}_2$ ). Other causes of scaling are:

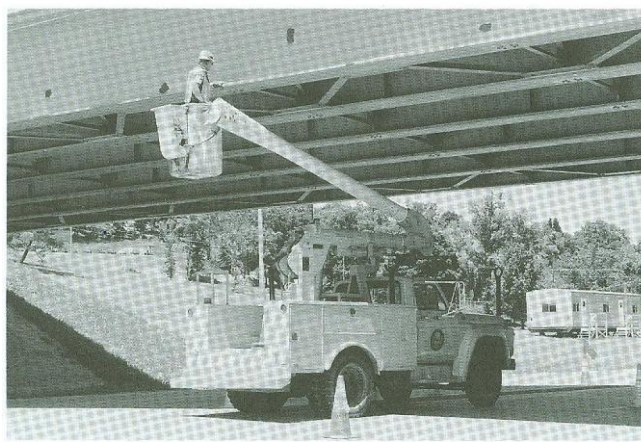
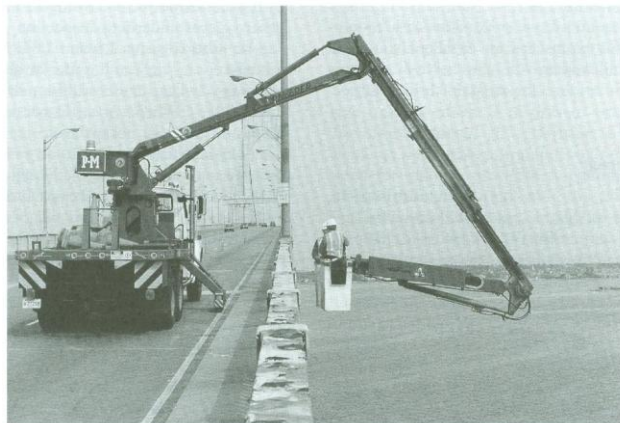
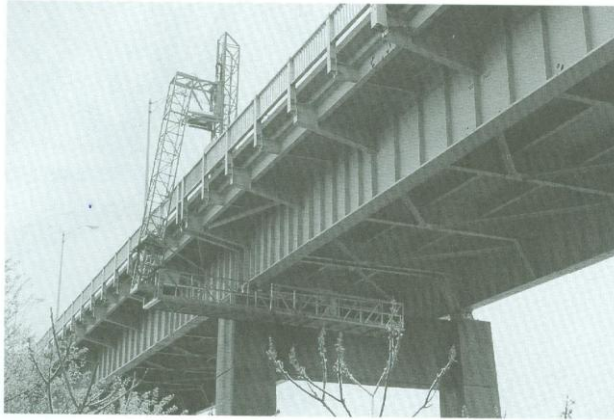
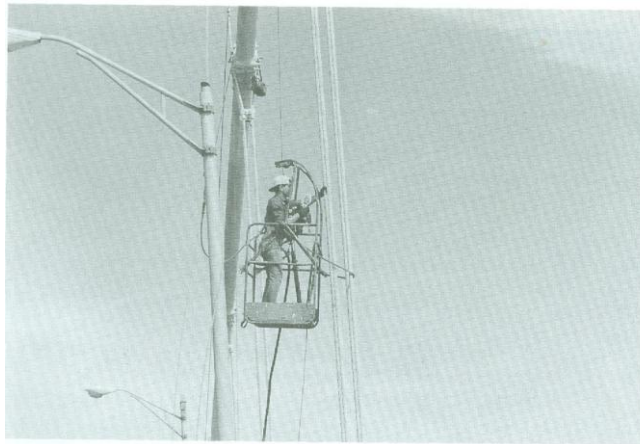
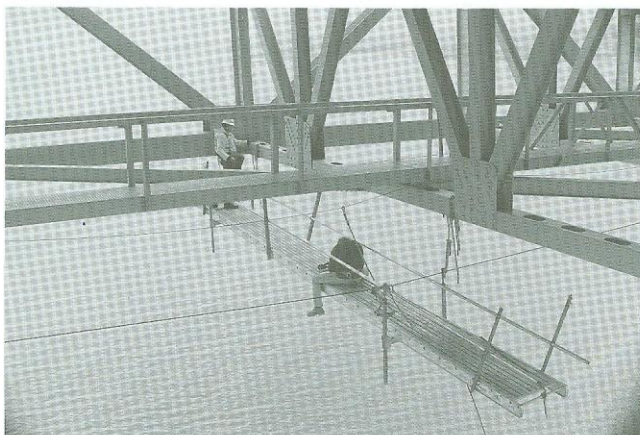
Figure 4.1 Special lifting equipments (Silano 1993)

(a) Cherry picker

(b) Bucket snoopers

(c) Inspection Platform

(d) Spider

(e) Scaffolding

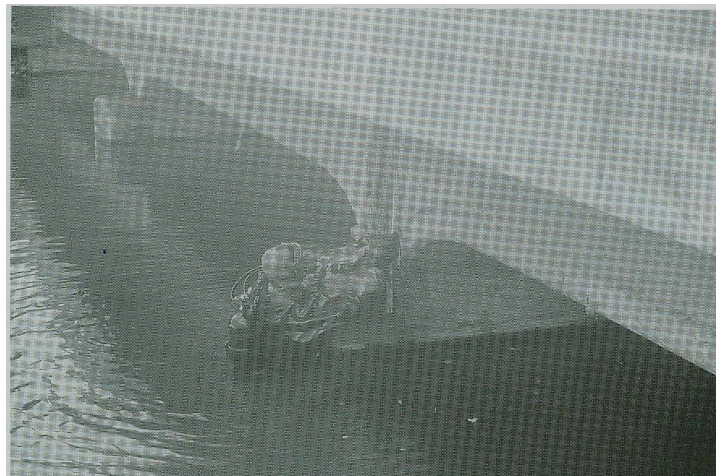
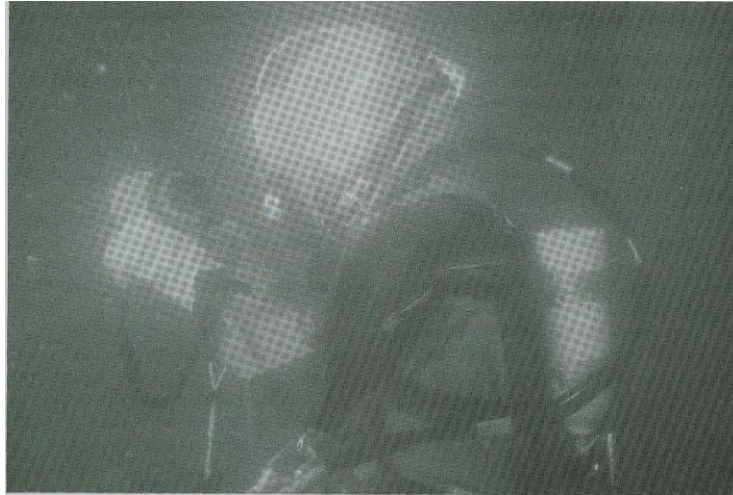
This inspection is carried out to supplement mainly the in-depth or damage inspection. Special equipment and advanced NDT techniques may be needed. Diving underwater inspection is a type of special inspection (Figure 4.2). According to FHWA, underwater members should be inspected at least once every five years. FHWA has published Bridge Inspector's Training Manual\90 (FHWA 1991) which provides guidelines for underwater inspection of bridges.

Figure 4.2 (a) Scuba diving for under water inspection, (b) Underwater photography  
(Silano1993)

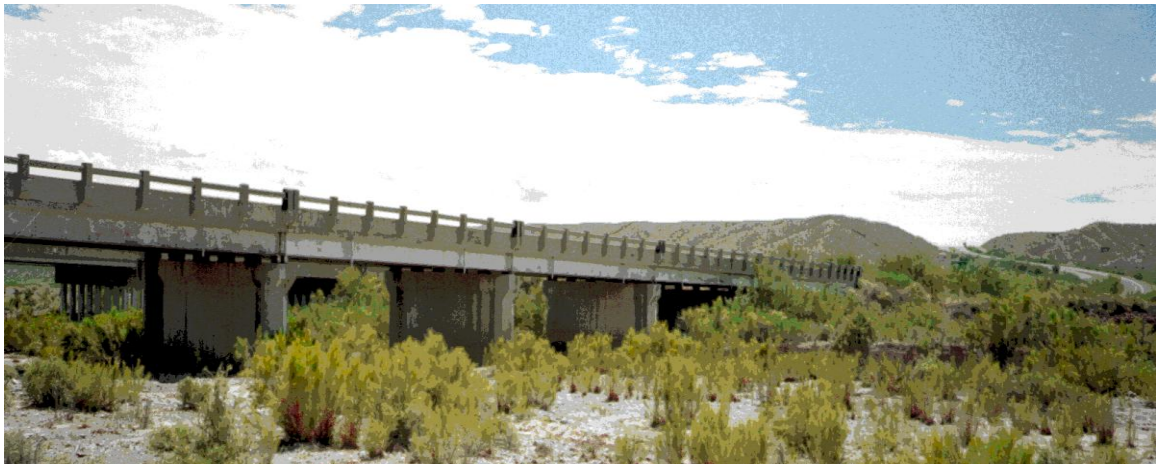
Figure 6.3 Alamosa Canyon Bridge (Farrar et al.1997)

**Farrar et al (1997)** studied the influence of change in day time temperatures, sources of excitation and service conditions, such as extent of the traffic load on natural frequency and mode shape of the **Alamosa Canoy Bridge** - a two-lane, seven-span, composite slab- on-girder bridge (Figure 6.3). They reported about 5% variation in frequencies during 24 hours time period. Ambient vibration test and impact test were conducted at the same time of day to minimize the temperature effects. Variation in the natural frequencies and the value of the damping ratio were recorded. No difference was noted in the mode shapes. The difference in modal frequency was also observed due to added mass of traffic vehicle. Moreover, without any specific analysis, the authors reported from their own experience that the type of algorithm that was applied for modal parameter identification and the analyst, who was applying it, may influence the data

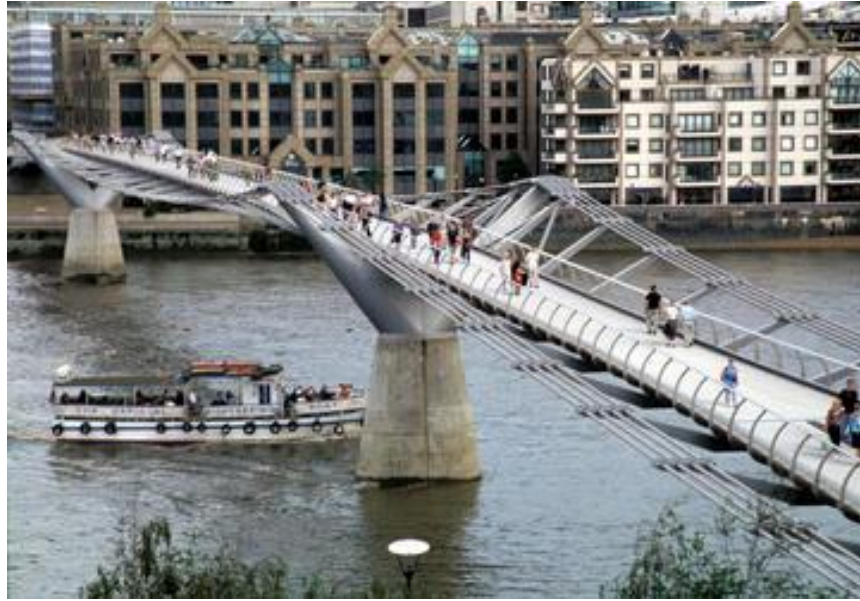
Figure 6.7 Millennium Bridge, London

**Pavic et al (2002)** described the problem created with the newly constructed **Millennium Bridge, London**; a shallow suspension foot bridge (Figure 6.7), and the methodology based on modal testing applied as a retrofitting solution of the excessive lateral sway vibration of deck. Measurement of FRF's on the Millennium Bridge, London, was the key part of the retrofitting solution to identify the cause of this excessive lateral sway of the bridge deck and to quantify its dynamic excitation. Modal testing was also used in design and verification of the system that was going to be installed on the bridge to control the vibration to acceptable levels. The test showed that it was possible to measure good quality FRFs around a frequency as low as 0.5 Hz that was the natural frequency of first lateral mode of vibration.

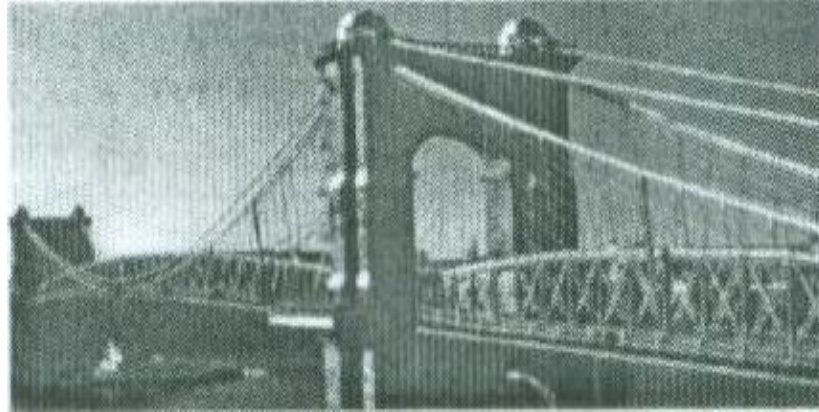
Figure 6.12 Roebling Suspension Bridge (Ren et al 2004)

**Ren et al (2004)** present the methodology for evaluation of load carrying capacity of the historical **Roebling Suspension Bridge** (Figure 6.12) over the Ohio River between Covington, Kentucky, and Cincinnati, Ohio, relative to current safety standards. Dynamic properties were determined using ambient vibration testing and used to modify the three dimensional finite element model by adjusting the FE model stiffness parameters to correlate the FE model frequencies with ambient test frequencies to represent current bridge properties; material properties, cross sectional properties and additional extreme live loading. The cable area was also reduced by 10 to 40% to estimate the safety margin against future deterioration and corrosion of the cables. The test results demonstrated that even though cross-sectional area of cable was reduced by 40%, safety of main cables and forces in the truss member remained within the range of maximum load carrying capacity.

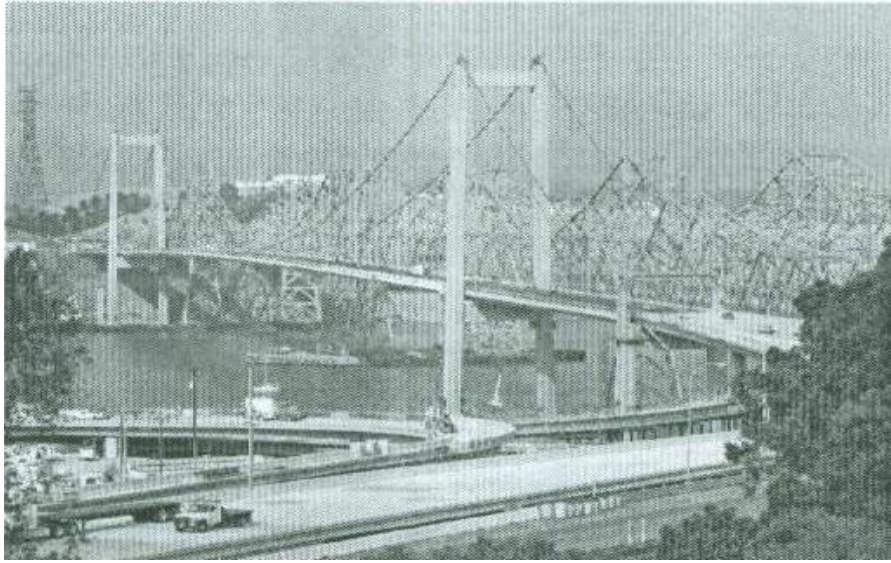
Figure 6.13 Alfred Zampa Memorial Bridge (Conte et al. 2008)

**Conte et al. (2008)** described in detail the set of dynamic field tests conducted on the **Alfred Zampa Memorial Bridge** (Figure 6.13), The Carquinez Strait, 32 km northeast of San Francisco; the first suspension bridge in the U.S. with an orthotropic steel deck, reinforced concrete towers and large diameter drilled shaft foundation. Both ambient vibration tests and forced vibration tests were conducted just before the opening of this new suspension bridge to traffic in 2003. Ambient vibration tests were mainly wind induced, whereas forced vibration tests were based on controlled traffic loads and vehicle-induced impact loads. Since the bridge was not affected by previous traffic loads, or seismic excitation, the test result data available are in an “as –built condition”. This test data can be used to validate and/or update the finite element model used in bridge design and also to use as reference for future condition assessment, or health monitoring of this bridge. The test result showed that ambient vibration test provide more practical information than the forced vibration tests; as forced vibration can excite only vibration mode with natural frequencies above 1 Hz (higher modes of vibration),

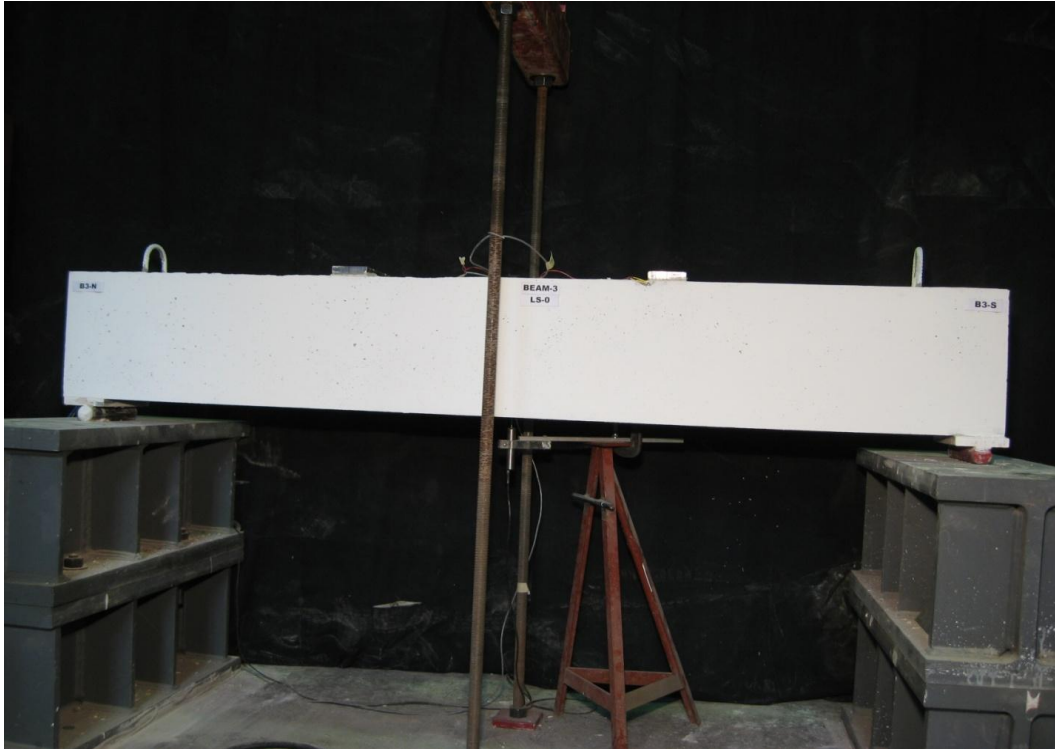
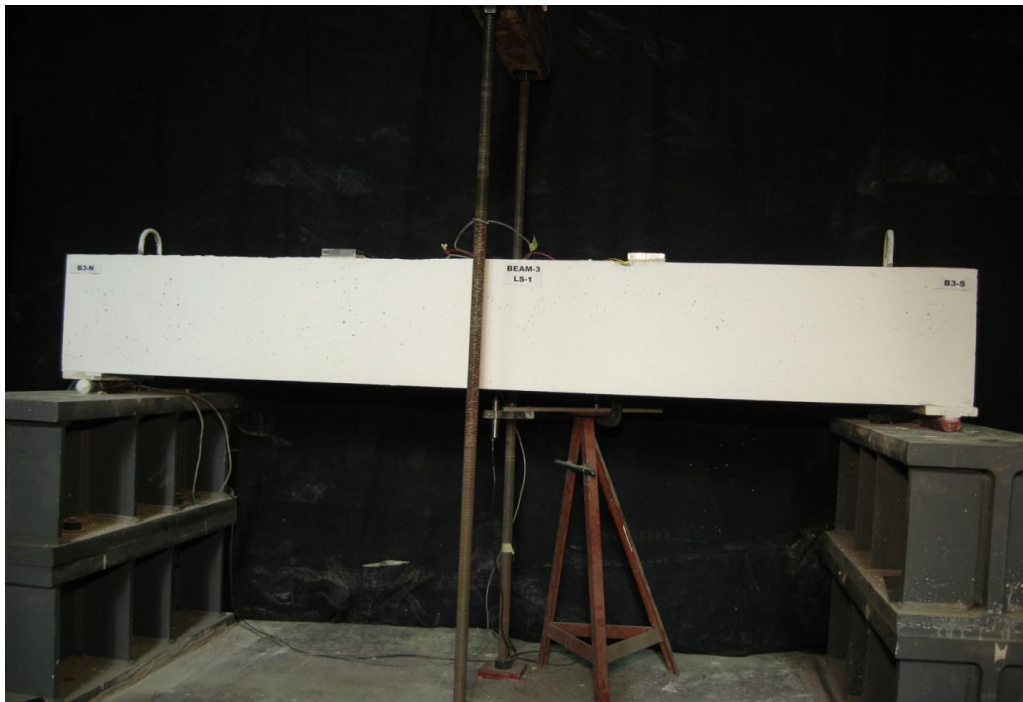
Figure D.13– Cracking pattern for beam 3 at zero load (B3-LS0)

Figure D.14– Cracking pattern for beam 3 at a load of 23.09 kN (B3-LS1)

Figure D.15– Cracking pattern for beam 3 at a load of 33.7 kN (B3-LS2)

Figure D.16– Cracking pattern for beam 3 at a load of 45.6 kN (B3-LS4)

Figure D.17– Cracking pattern for beam 3 at a load of 52.1 kN (B3-LS5)

Figure D.18 – Cracking pattern for beam 3 at a load of 59.02 kN (B3- LS6)

Figure D.19– Cracking pattern for beam 3 at a load of 68.08 kN (B3-LS7)

Figure D.20 – Cracking pattern for beam 3 at a load of 75.4 kN (B3-LS8)

Figure D.21 – Cracking pattern for beam 3 at a load of 81.5 (kN B3-LS9)

Figure D.22– Cracking pattern for beam 3 at a load of 88.996 kN (B3- LS10 )

Figure D.23– Cracking pattern for beam 3 at a load of 95.35 kN (B3-LS11)

Figure D.24– Cracking pattern for beam 3 at a load of 99.78 kN (B3-LS12)

Figure D.25– Cracking pattern for beam 3 at a load of 111.6 kN (B3-LS13)

Figure D.26 – Cracking pattern for beam 3 at a load of 122.32 kN (B3-LS14)

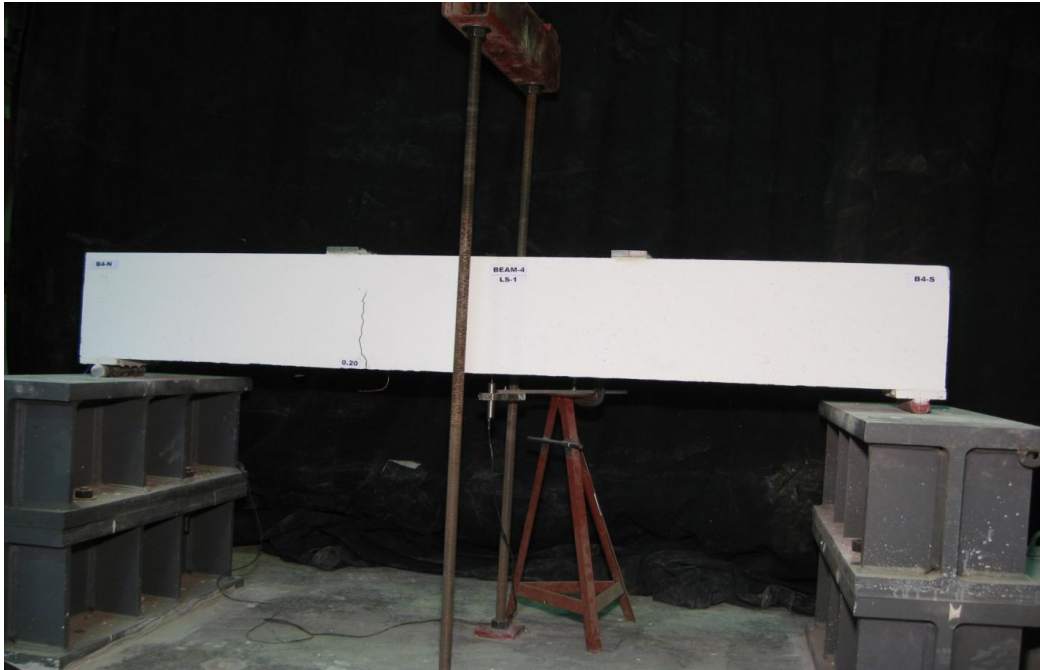
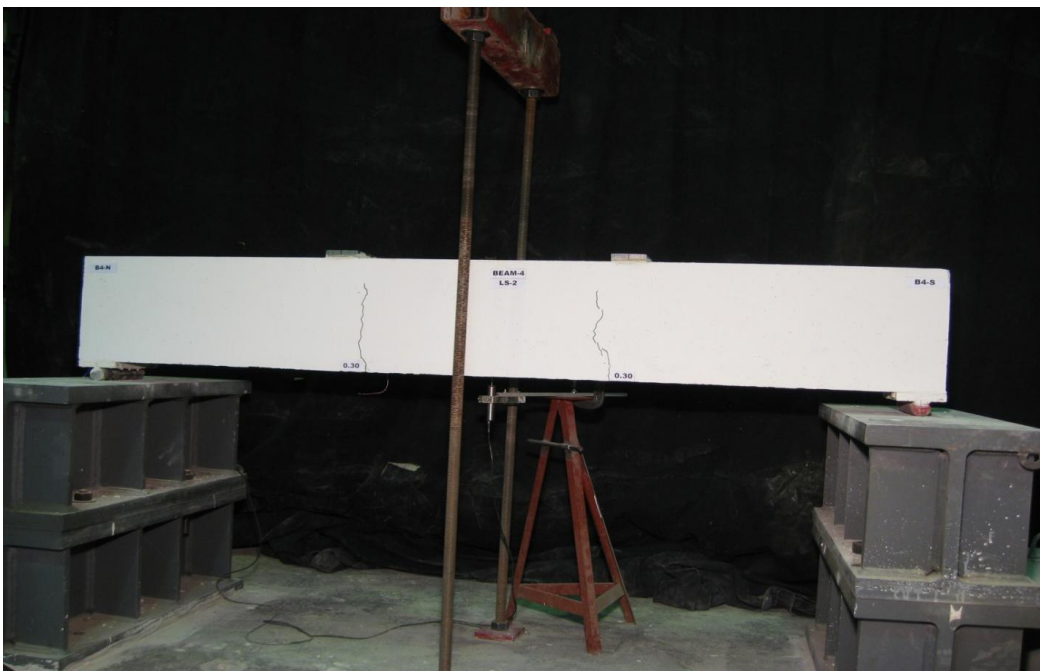
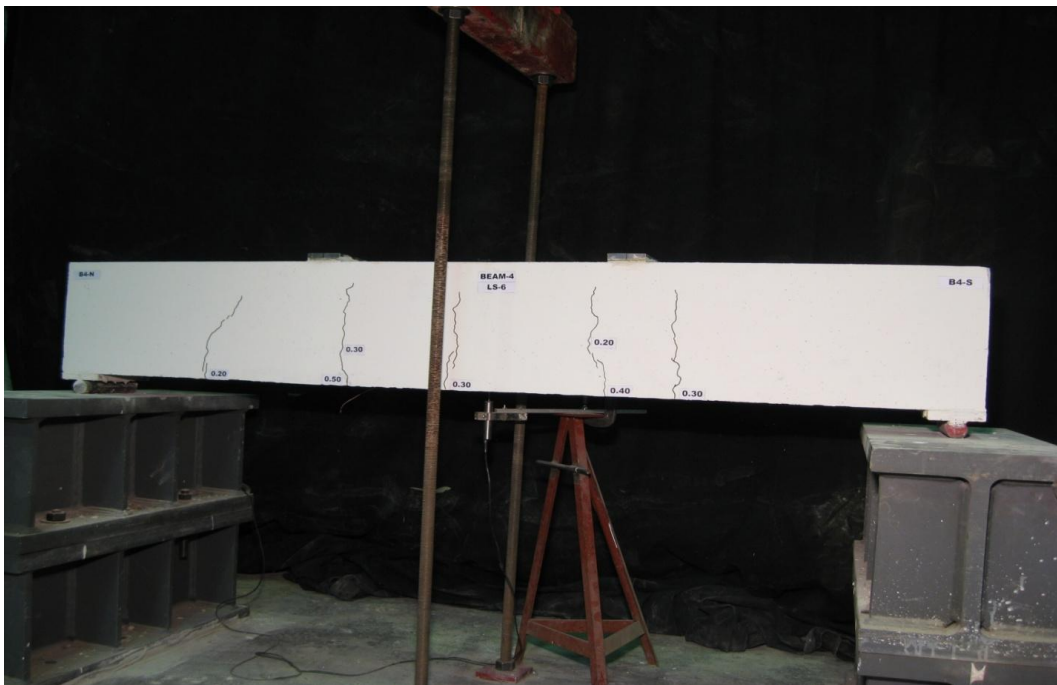
Figure D.27– Cracking pattern for beam 4 at a load of 25.23 kN (B4-LS1)

Figure D.28– Cracking pattern for beam 4 at a load of 30.2 kN (B4-LS2)

Figure D.29– Cracking pattern for beam 4 at a load of 35.19 kN (B4-LS3)

Figure D.30– Cracking pattern for beam 4 at a load of 39.66 kN (B4-LS4)

Figure D.31 – Cracking pattern for beam 4 at a load of 45.4 kN (B4-LS5)

Figure D.32– Cracking pattern for beam 4 at a load of 49.51 kN (B4-LS6)

Figure D.33– Cracking pattern for beam 4 at a load of 56.02 kN (B4-LS7)

Figure D.34– Cracking pattern for beam 4 at a load of 60.9 kN (B4-LS8)

Figure D.35– Cracking pattern for beam 4 at a load of 66.57 kN (B4-LS9)

Figure D.36– Cracking pattern for beam 4 at a load of 70.24 kN (B4-LS10)

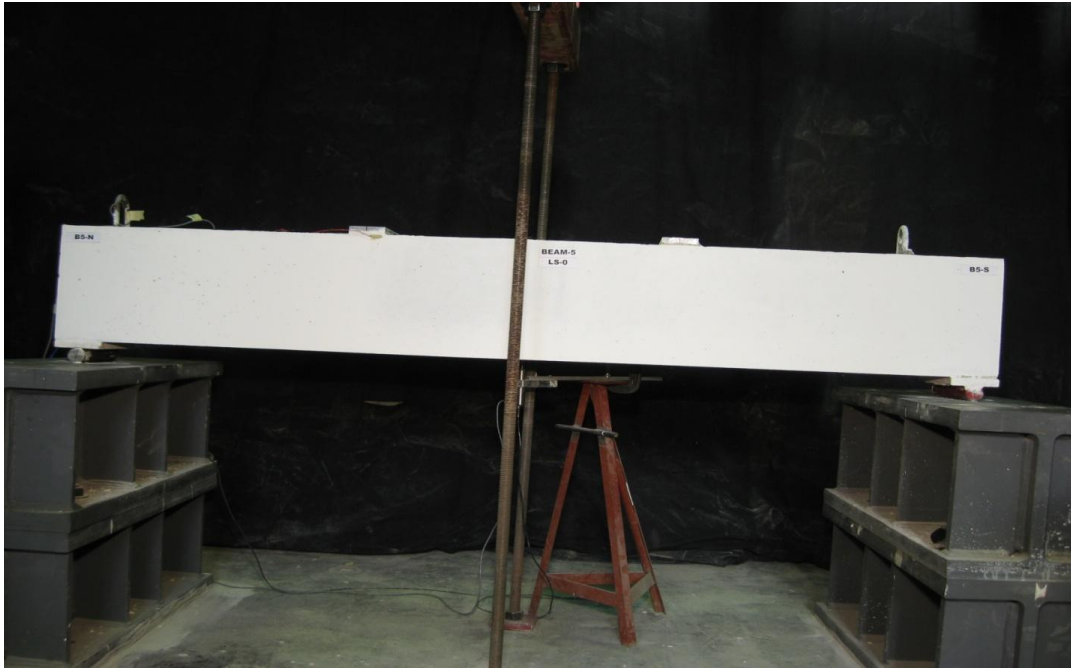
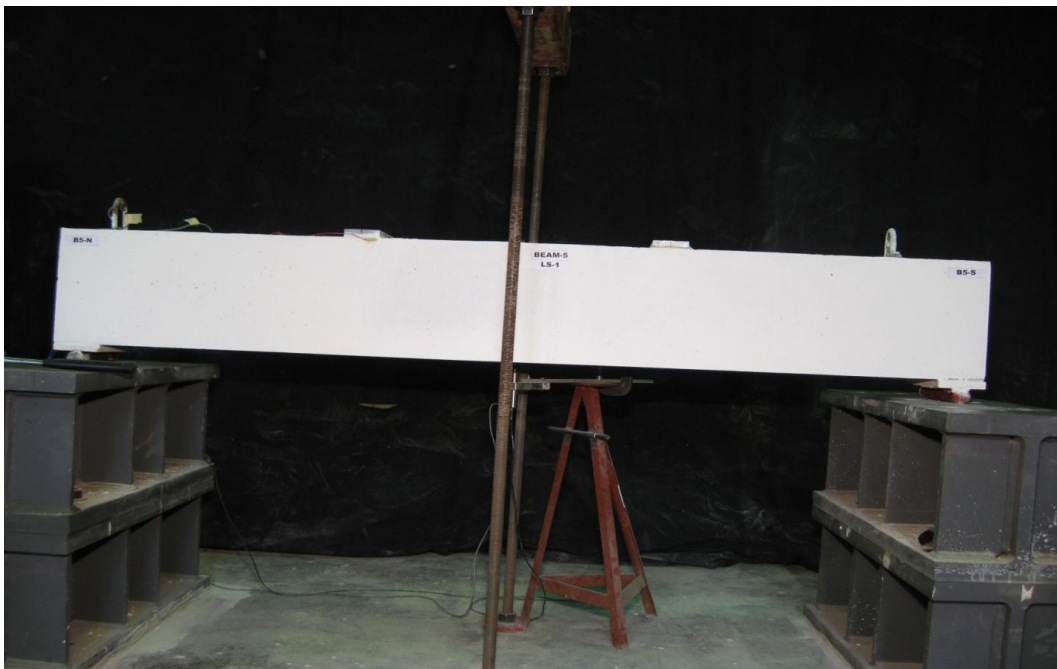
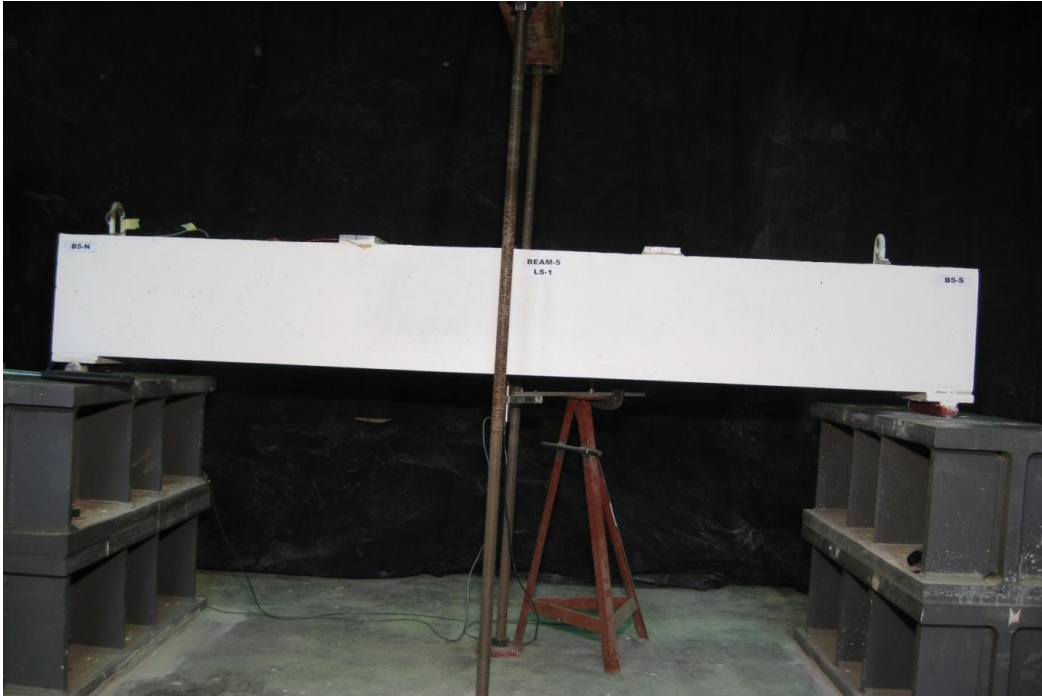
Figure D.37– Cracking pattern for beam 5 at zero load (B5-LS0)

Figure D.38– Cracking pattern for beam 5 at a load of 20.45 kN (B5-LS1)

Figure D.39 – Cracking pattern for beam 5 at a load of 34.89 kN (B5-LS2)

Figure D.40– Cracking pattern for beam 5 at a load of 44.42 kN (B5-LS3)

Figure D.41– Cracking pattern for beam 5 at a load of 55.06 kN (B5-LS4)

Figure D.42– Cracking pattern for beam 5 at a load of 64.63 kN (B5-LS5)

Figure D.43– Cracking pattern for beam 5 at a load of 74.4 kN (B5-LS6)

Figure D.44 – Cracking pattern for beam 5 at a load of 85.36 kN (B5-LS7)

Figure D.45 – Cracking pattern for beam 5 at a load of 95.03 kN (B5-LS8)

Figure D.46 – Cracking pattern for beam 5 at a load of 104.48 kN (B5-LS9)

Figure D.47 – Cracking pattern for beam 5 at a load of 114.67 kN (B5-LS10)

Figure D.48 – Cracking pattern for beam 5 at a load of 124.86 kN (B5-LS11)

Figure D.49 – Cracking pattern for beam 5 at a load of 135.19 kN (B5-LS12)

Figure D.50 – Cracking pattern for beam 5 at a load of 138.49 kN (B5-LS13)
