COLD WEATHER EFFECTS  
ON  
FRESH CONCRETE

Thesis presented for the  
Degree of Master of Engineering  
by Gordon W. Spratt

McGill University

May 1956

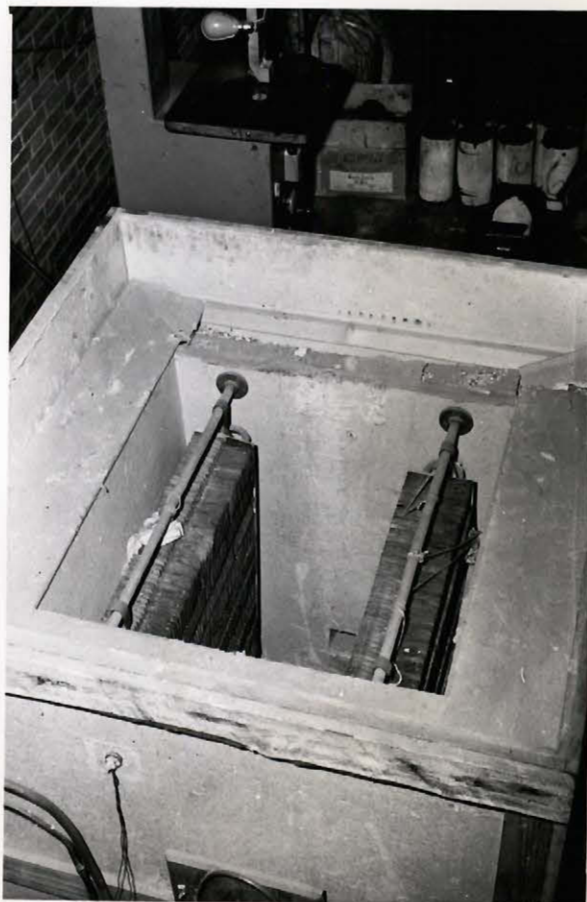
Figure 3. View showing the interior of the refrigerator.

The cold box was constructed at McGill in 1954 and was adapted for this experiment. Figure 3 shows a bird's eye view of the box with its top removed. The large top of the box was removed by an electric hoist to facilitate the entrance of the cylinders resting in their racks.

The freezing unit was of one and one half ton capacity and used freon as a refrigerant. Regulation of the temperature was done by a Minneapolis-Honeywell thermostat. Circulation within the cold box was provided by a 1/32 H.P. four inch rubber bladed fan mounted in a lower corner.

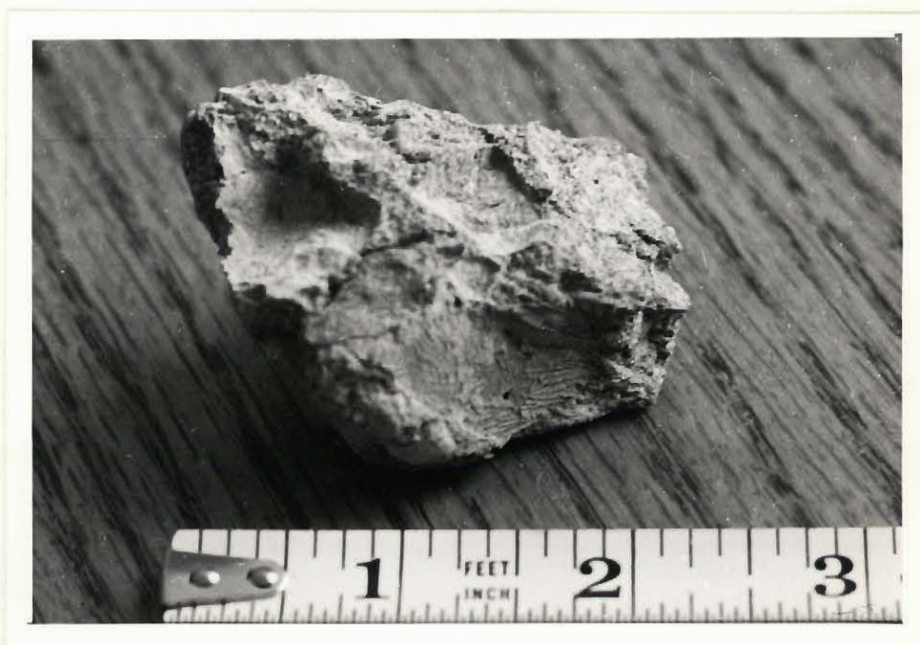
Figure 7. Rupture of the mortar in frozen concrete.

The "A" and "a" series were plastic when thawing began after removal from the cold box. It was found by examination of the "A" and "a" - 2, 7 and 28 day cylinders, that rupture of the mortar had occurred, particularly at the underside of the coarse aggregate. See figure 7 for typical appearance of freeze lines in concrete damaged by frost.

The damage resulting from freezing concrete immediately after placing appears to be from the rupture of the mortar. Whether this is caused by (a) expansion of freezing water exerting a disrupting force or (b) hydraulic pressures developed as the ice front, moving towards the center, forces unfrozen water through small capillaries rupturing them in tension, has not been determined. It is probably a combination of both forces. Factors such as water and cement contents, and size and grading of the aggregates may influence the method of distruction.
