Performance of Patch-Repair of Corroded Concrete Deck Slabs

Mohammad Saifuzzaman

December 2004

**A thesis submitted to the
Faculty of Graduate Studies and Research
in partial fulfilment of the requirements for the degree of
Master of Engineering**

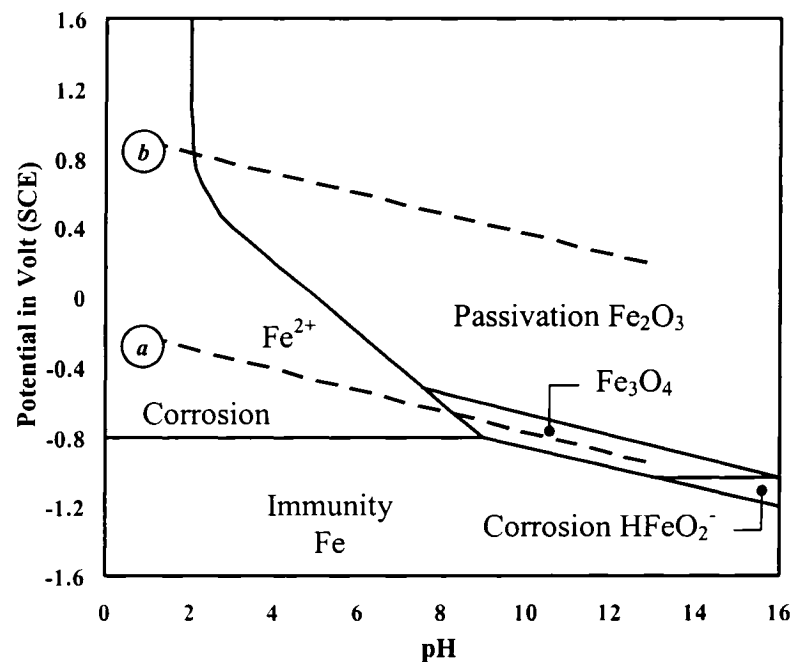
Figure 2.4: Potential vs. pH Diagram (Stability of Iron and Iron Oxide)
(Pourbaix, 1966)

The driving force in corrosion is the potential as shown in Figure 2.4, where a potential vs. pH diagram for stability of iron and iron oxides in water at +25°C is presented. Pourbaix (1966) developed this diagram to describe corrosion thermodynamically. In Figure 2.4, the potential in a given environment represents the balance between the cathodic reactions, the anodic reactions and any external current. The line “a” and “b” denotes the equilibrium potential for hydrogen evolution and oxygen reduction.

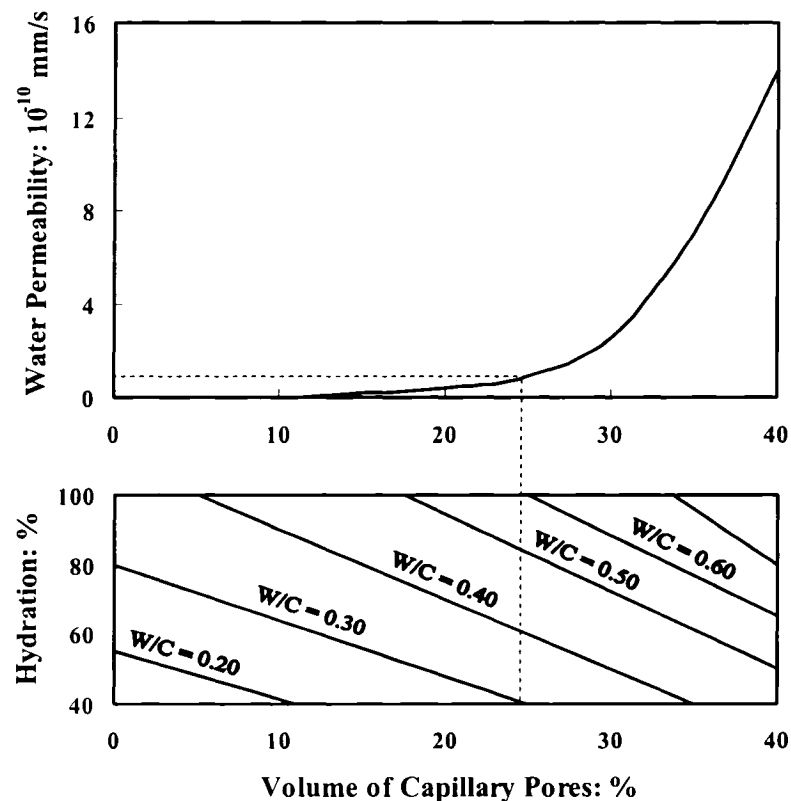
Figure 2.14: Influence of W/C Ratio on Permeability
(CEB, 1992)
