KNOWLEDGE TRANSFER IN POST-DISASTER RECONSTRUCTION

The Problem of Post-post-disaster Reconstruction

Mehran Gharaati Kopaei

School of Architecture McGill University Montreal, May 2009

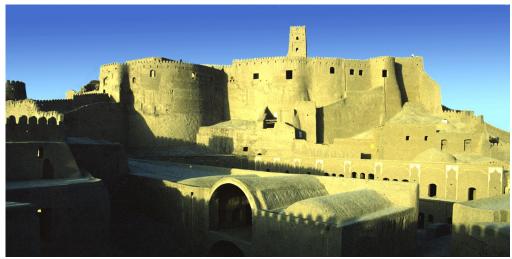
Figure 2.1. Bam citadel before the earthquake, one of the biggest earth complexes in the world

⁸ The Citadel, one of the world's largest earthen structures (Figure 2.1. next page), was badly damaged; it appears that recent inappropriate repairs are likely to be the reason.

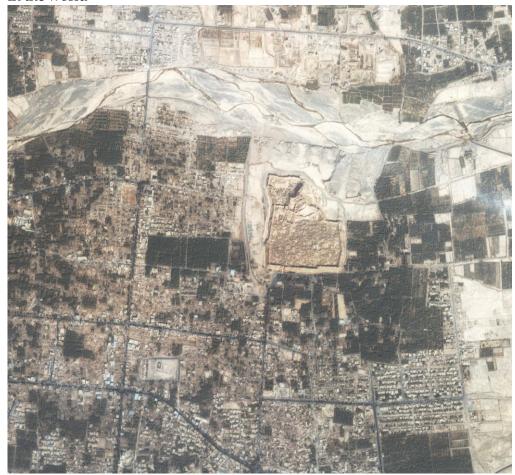
Fig. 2.2. Aerial photo of Bam taken one day after the quake (IKONOS 2003), IKONOS Image Courtesy of GeoEye

A closer look at what remained of the city, however, revealed that this was not the whole story. First of all, while the majority of earth buildings in the *new* city were demolished, a number of earth structures in the *old* city were still standing.⁸ Furthermore, although it appeared to visitors and reporters, who visited the ruins of Bam immediately after the earthquake, as if almost all of the city was constructed of adobe brick, the statistics show that 54 percent of the houses were made of adobe, and the rest (46 percent) were built using modern materials like steel and concrete (Ghafory-Ashtiany and Hosseini 2007). Another report states that only 30 percent of the buildings were built out of adobe and mud-bricks (Mehdi 2004). In fact, there were many newly built buildings that were also destroyed or seriously damaged (Murphy 2004) (see Figure 2.2. following page).

Bam presented an image of desolation in the immediate aftermath of the earthquake (see Figures 2.2 and 2.3). Many buildings which had been erected with "new" methods of construction (hybrids of concrete or steel frames, brick masonry infill, and concrete and hollow tile floors) simply broke apart. Essential junctions between structural elements failed, and heavy secondary elements fell. An examination of the typical failures revealed that reinforcing was inadequate or virtually non-existent; bonding between different materials was not installed properly or left completely out. This examination also revealed the extent to which a proper understanding of novel construction knowledge was absent.

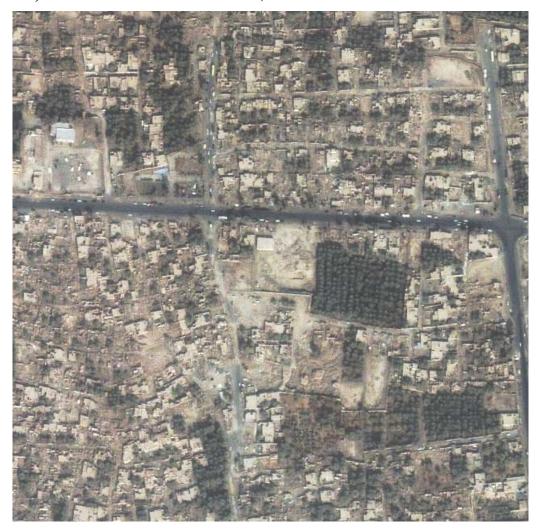
Figure 2.3. Close-up of the aerial photo of Bam one day after the quake. The collapsed roofs of both old and new houses can be seen. The upper section of the photo shows the old fabric while the lower part is mostly composed of relatively new constructions (IKONOS 2003), IKONOS Image Courtesy of GeoEye

Raeis Ghasemi and Parhizkar (2004) explain that the majority of buildings in Bam collapsed because of the failure of their structural system, and not necessarily as a result of the construction materials employed. They further assert that the most common failures they observed in the remaining structures stemmed from a lack of safe-construction knowledge and disregard for seismic building codes (Ibid). This ignorance of safe-construction practices can be seen in all types of construction methods, from masonry to concrete-frame (Khorrami and Majid-Zamani 2004; Masoumi 2004).

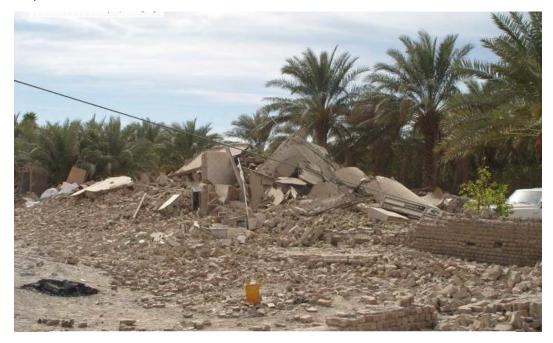
Figure 3.1. Lack of a decent foundation was a common problem among the buildings destroyed in Bam. Photo: ISEO 2004

and a number of houses did not have any sort of foundation at all (Figure 3.1).

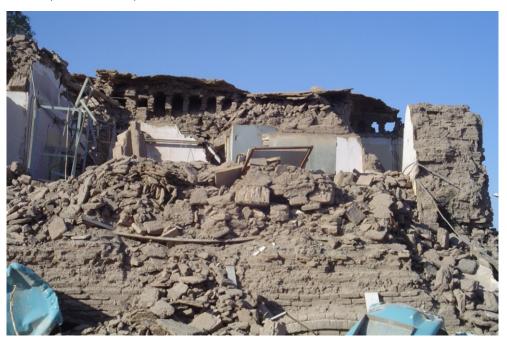
Figure 3.2. Placing reinforcements in load bearing walls is not common practice in Bam. Photo: HFIR archive

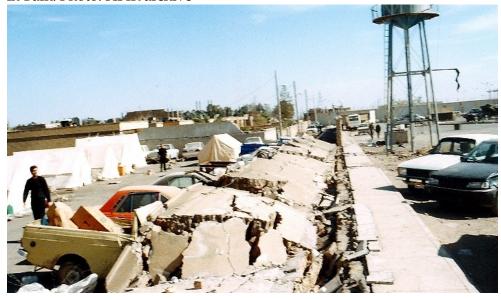
Figure 3.3. Even thick walls are destroyed when there is no pilaster along a long wall. Photo: HFIR archive

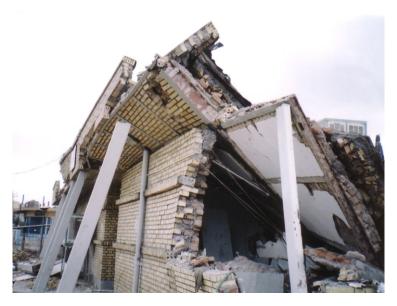
Figure 3.4. Weak columns and beams with no bracings. Photo: HFIR archive

Weak steel columns and beams and a lack of cross-bracings were the dominant mistakes in the cases of steel-frame buildings destroyed in Bam (Figures 3.4 and 3.5). Concrete buildings had inadequate numbers and/or size of reinforcement steel bars. In one case, surprisingly, the steel bars of a beam were totally omitted (Figure 3.6). This lack of knowledge about concrete construction is generally a serious problem in Iran, but in smaller cities, it is much more pronounced.

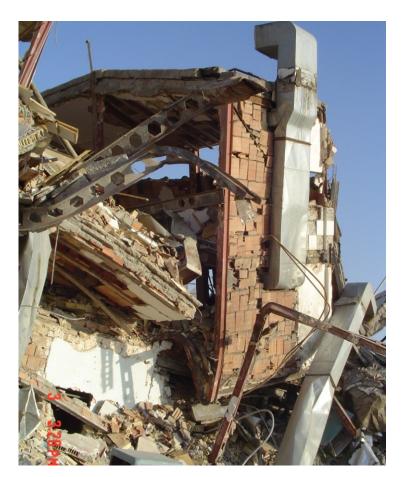
Figure 3.5.
Inadequate design and weak steel profiles have turned the entire building to rubble. Photo: HFIR archive

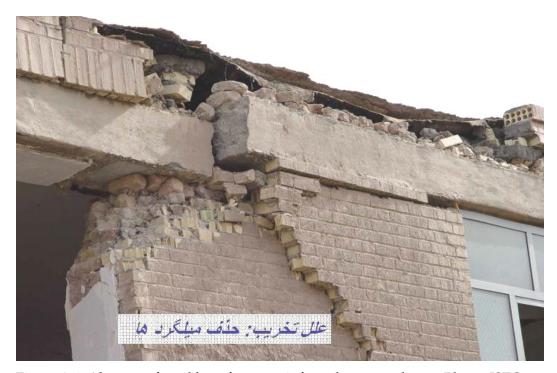
Figure 3.6. Absence of steel bars from a reinforced concrete beam. Photo: ISEO 2004

Poor workmanship in reinforced concrete buildings was also common, though not many concrete buildings had been built in Bam. Firstly, the quality of concrete was usually far below the acceptable standard because it was mixed on-site by unskilled labourers with no understanding of concrete dosage, and consequently, the quality varied over time. A large percentage (approximately three-fourths) of the volume of concrete "is occupied by aggregates consisting of such materials as sand, gravel, crushed rock;" it is axiomatic that such a large-proportioned constituent would directly contribute to the strength properties of the concrete (Legg 1998). Nonetheless, due to the lack of knowledge about concrete mix, there was a misconception among the builders that any crushed construction material can be used as aggregate in the concrete mix. So, it was typical to find concrete columns and beams, most of which were destroyed in the earthquake, with crushed or broken bricks as aggregate or filler (Figure 3.22 next page). This lack of knowledge extended to the use of steel reinforcing bars. Since hardened concrete is a relatively brittle material with a low tensile strength by itself, it must be reinforced by using steel bars embedded inside the concrete element (Mindess 2008). However, builders in Bam had mistakenly reduced the quantity of steel re-bars by increasing the distance between stirrups, reducing the girth and number of re-bar, or even eliminating bars from the beam altogether (Figures 3.6 and 3.16 above, and 3.23 next page).

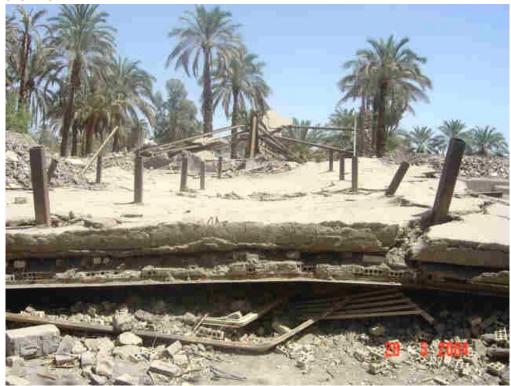
Figure 3.8. A flat roof collapsed due to its heavy weight and poor shear connection. Photo: HFIR archive

Generally, roofs and floors play an important role in the resistance of a building towards earthquakes because they constitute the main load of the building and can also act as a stiffening diaphragm. Logically, there is a smaller chance that a structure will collapse during an earthquake if its roof is light. The residents of Bam used to redo the insulation of their roofs every two to three years by adding a layer of straw-mud plaster, without removing the old layer. This practice is common among the majority of homes in Bam, creating very heavy roofs (Figures 3.7 and 3.8). In addition, a number of houses were structurally overloaded by the addition of new stories on top of the existing ones. These extensions, built on structures lacking properly engineered load-bearing walls, led to the destruction of many buildings and the loss of entire families (Maheri 2004).

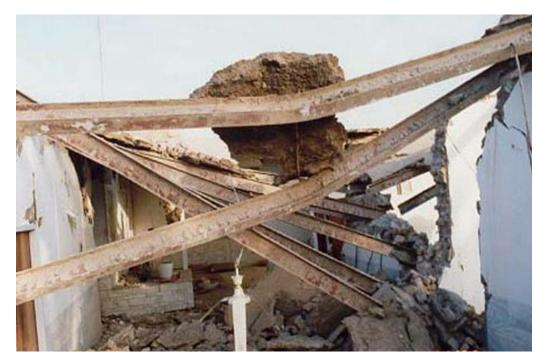
Figure 3.9. Roofing system incompatible with the load bearing elements (walls). Photo: ISEO 2004

In addition, some roofs were incompatible with the rest of the structural system in terms of material employed, leading to inconsistency of the structural behaviour in the earthquake, remarkably intensifying the damage to the structure. The uneven distribution of the load of the roof was another problem, resulting in forces being exerted on some particular parts of the structure while other load bearing elements took comparatively less of their share of the structural system (Figures 3.9 and 3.10).

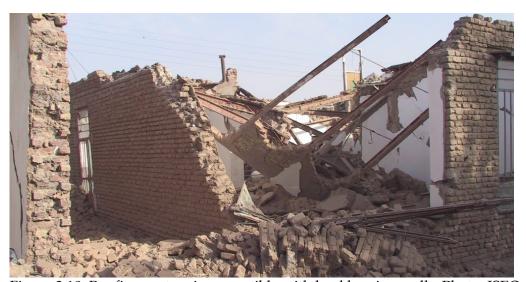
Figure 3.10. Roofing system incompatible with load bearing walls. Photo: ISEO

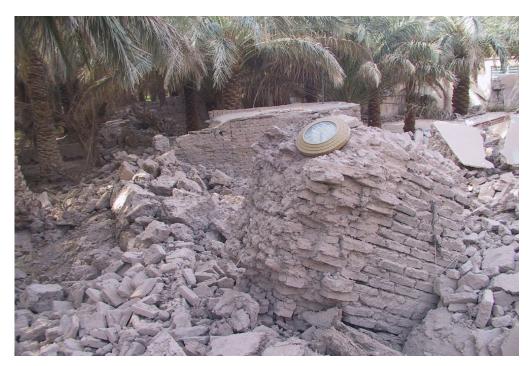
Figure 3.13. Poor quality of adobe, crushed into small pieces. Photo: HFIR archive

Since the soil used for making earthen buildings is naturally diverse in composition, and since each type of soil suits a specific construction technique, great care must be taken in choosing the appropriate soil for each construction method (Doat and Norton 1991). For example, if one wants to build with adobe, the soil contents must be suitable for making adobe bricks. Otherwise, the strength of the building will decrease remarkably. The poor resistance of the many earth buildings in Bam was due in part to the inappropriate soil content for various earthen architectural techniques; this fact illustrates that the traditional knowledge of building had already been lost to the point that it was no longer applied (PWJ 2004).

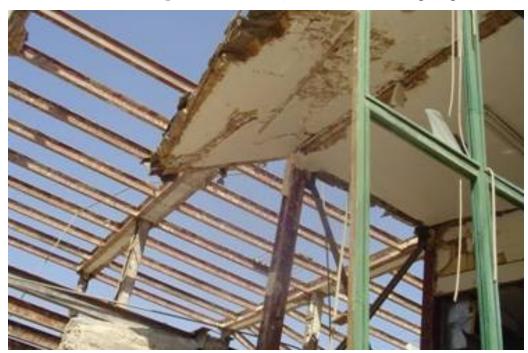
Figure 3.14. A weak bond between steel and brick resulted in the collapse of this roof. Photo: HFIR archive

In both situations, a lateral force such as an earthquake tremor can easily make the walls or jack arches spring apart from the steel frames, detaching the brick mass from the structure, causing it to collapse. Many houses were observed in Bam where the body had collapsed while the skeleton of the frame (posts and beams) remained standing (Figure 3.14).

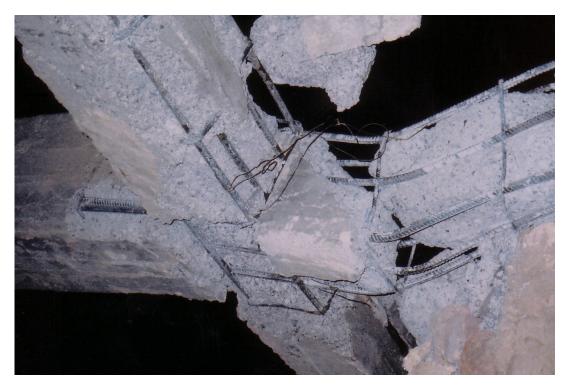
Figure 3.15. Poor quality of concrete indicates lack of concrete construction know-how. Photo: HFIR archive

Moreover, the high price of steel bars, imported from remote parts of the country, intensified the problem. Many builders and owners reduced the steel bar reinforcements in size (diameter), quantity and quality, while increasing the distance between stirrups for the sake of minimizing costs.

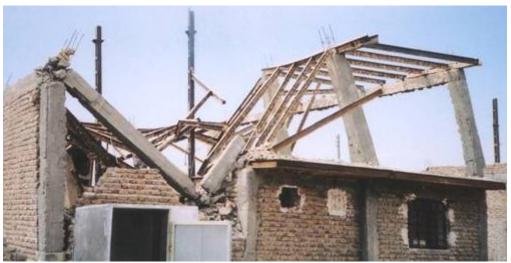
Figure 3.17. Incompatibility of materials in hybrid building results in the reduction of strength. Photo: ISEO 2004

Generally, the major problem with hybrid buildings is the incompatibility of different building materials and designs, which are unsuitably mixed together in one structure. When an external lateral force, such as an earthquake, is exerted on the different parts of the structure, they do not behave in the same way: they react differently, thereby intensifying the destruction rate and reducing the resistance capacity of the building (Figure 3.17).

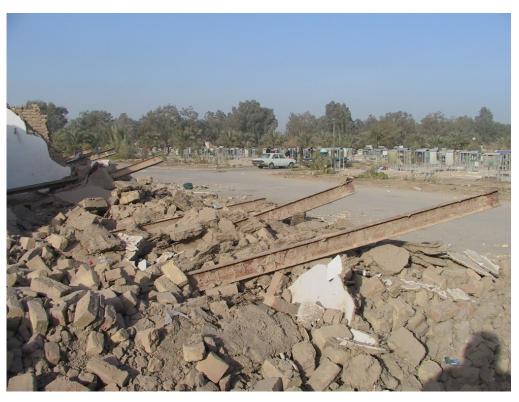
Figure 3.18. Poor bond between the bricks of the wall and the steel beams: load bearing brick walls with steel girders and a jack arch roof were destroyed completely, while the beams have remained intact. Photo: HFIR archive

In addition, the difference in materials of the walls and roofs in wall-bearing structures, common in many kinds of hybrid buildings in Bam, requires relatively sophisticated construction methods at the joints where the two systems meet. If joined improperly, these junctions are often the starting points of collapse (Figure 3.18). Furthermore, it was very common in Bam, and still is in many other Iranian cities, to reuse construction materials such as bricks, obtained from demolished buildings, in the construction of new ones. Used bricks often do not bond properly with mortar, and therefore, walls made of such bricks cannot withstand earthquakes.

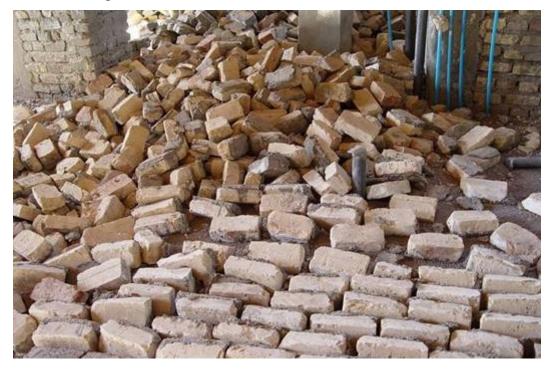
Figure 3.19. When bricks are laid without being soaked, they make a very weak wall. Photo courtesy of Peace-Winds Japan

Although Bam has achieved fame for its adobe buildings and earthen structures, the knowledge of bricklaying has seemingly been forgotten among local masons over the last few decades. For example, the simple though important practice of soaking dry bricks in water before laying them was ignored in the construction of many buildings in Bam (Figure 3.19). Serious problems occur when dry bricks absorb the water from the sand-cement mortar, which requires adequate moisture to be cured and to make a strong bond.

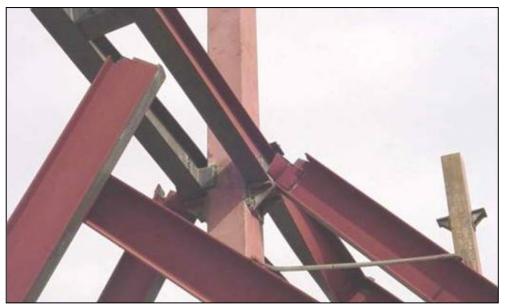
Figure 3.20. Inadequate welds at the joints was the most prevalent problem. Photo: ISEO 2004

steel-frame buildings in Bam (Figure 3.20). The lack of gusset plates, stiffener plates, and reinforcing plates were very common problems of such structures in Bam; these problems were intensified by the poor quality of welding in the joints and anywhere else that reinforcement plates were placed (Hosseini Hashemi 2004) (Figure 3.21).

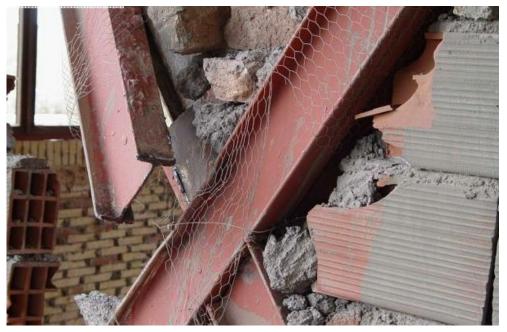
Figures 3.21. Poor quality of welding in steel construction in Bam. Photo: ISEO $2004\,$

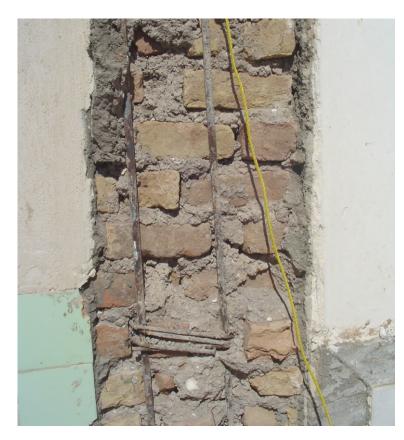
Figure 3.22.
Reinforced concrete column with poor concrete mix, inadequate steel bars, and poor execution. Photo:
HFIR archive

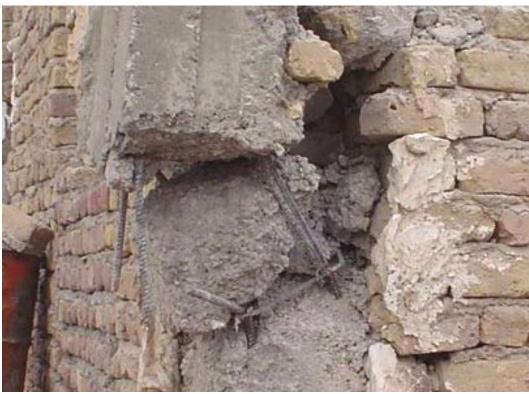
Figure 3.23. Reinforced concrete column with inadequate steel bars. Photo: HFIR archive

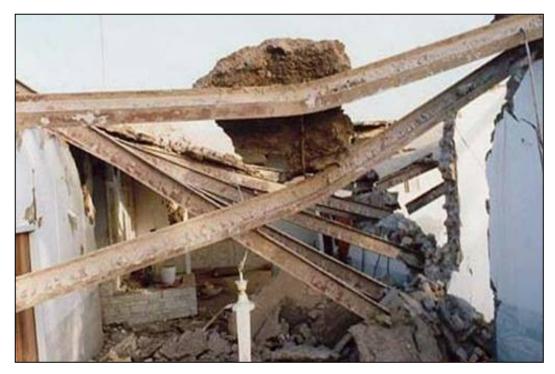
Figure 3.24 . Weak junctions in a hybrid building; steel beams resting on adobe walls. Photo: HFIR archive

Some points of a building are more vulnerable to earthquakes due to the diversity of forces exerted on them. Thus, a thorough construction system should reinforce these critical points. It must be emphasized that all structural joints are critical locations, including wall intersections, corners, roof-wall junctions and the junctions between foundations and walls. These vulnerable points need more attention and close inspection during the construction process. As was the case of the majority of buildings in Bam, ignorance of the important role these critical joints play in the resistance of buildings to seismic forces resulted in fragile buildings. This problem could be seen in all types of construction methods in Bam, including earthen, steel-frame, concrete, and hybrid buildings (Figures 3.24, 3.25).

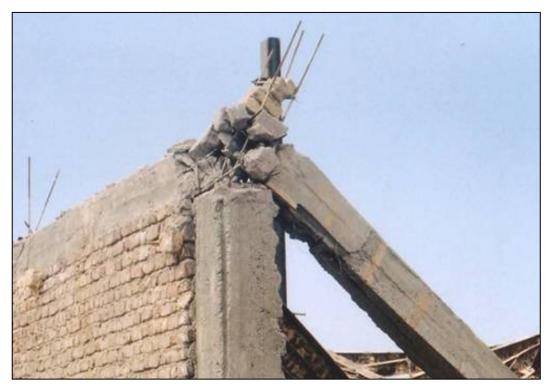
Figure 3.25. Weak junctions in a reinforced concrete-frame building. Photo: HFIR archive

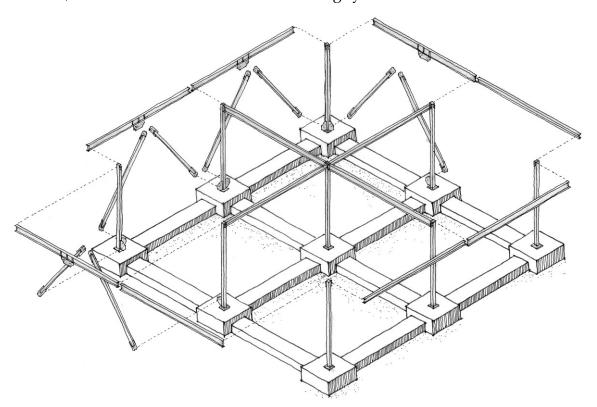
Figure 3.26. The structure proposed by HFIR; steel columns and beams are fastened together by bolts and nuts

HFIR had built an educational sample of the proposed structure on the exhibition site, where citizens could visit and learn about essential construction details. The whole structure was placed on a reinforced concrete foundation, to which the frame was connected using bolts and nuts (Figures 3.26 and 3.27, also C.7, C.8, C.9 in Appendix C). The roofing system and wall infill technique remained flexible to the constructor or owner's discretion. HFIR, however, was building a number of publicly funded buildings using ordinary bricks and/or hollow blocks as wall infill, and a reinforced concrete slab roofing system.

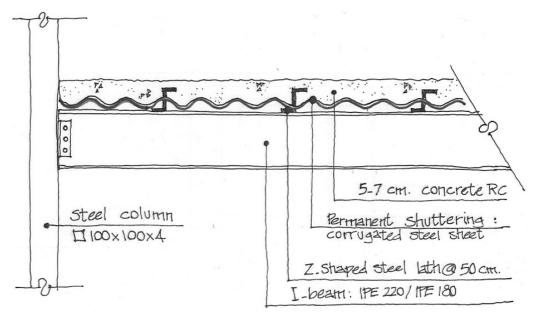
Figure 3.28. Roofing system suggested by HFIR

when citizens or other builders in the city began to make decisions concerning their building. For instance, the wall infill could vary from double-side-meshed polystyrene sandwich panels to ordinary burnt bricks or hollow blocks. The roofing system also could vary from thin concrete slabs on steel girders to a block-joist system.

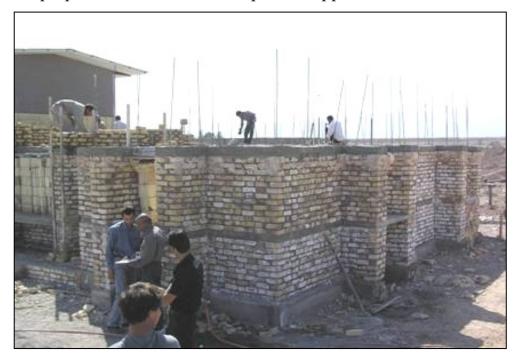
Figure 3.29. Horizontal reinforcements (ring beams) Photo courtesy of Peace-Winds Japan

There were two foreign institutions, Auroville (India) and Peace-Winds (Japan), who had proposed masonry-based construction techniques. In these methods there were three essential elements responsible for consolidating the building, thereby increasing its resistance to earthquakes. These three components were horizontal reinforcement elements (ring beams), vertical reinforcements (steel bars), and buttresses alongside the openings (Figure 3.29). Horizontal reinforcements consisted of reinforced concrete beams placed around the building wherever the load-bearing walls are located, usually at four levels: plinth, sill, lintel, and roof height. Vertical reinforcements were comprised of steel bars placed within the walls, which ran from the foundation to the upper ring beam at the roof level (Figure 3.30).

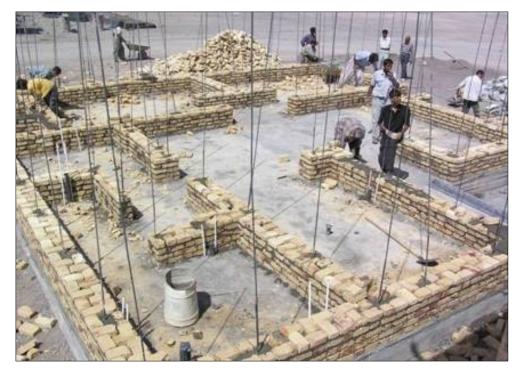
Figure 3.30. Vertical reinforcements. Photo courtesy of Peace-Winds Japan

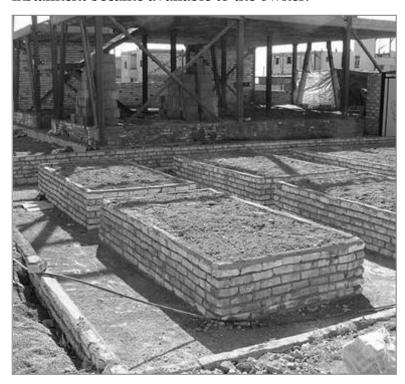
Figure 3.31. Foundation formwork made of brick walls

The next step was building the foundation. Usually the foundation formwork was made of brick walls (Figure 3.31). These bricks were usually recycled (reused) from the debris of the destroyed house. During this stage, the inspector was required to frequently check the construction process and express his or her approval by signing a progress report sheet. When the progress at the site was approved by the inspector, the second instalment became available to the owner.

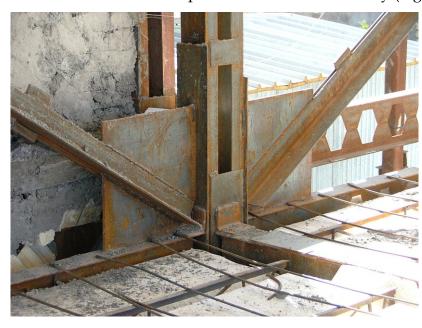
Figure 3.35. Over-designed framework of a two-storey house

Naturally, the tendency to over-design resulted in higher construction costs. In almost all the buildings, the framework structure was purposely over-designed. Gusset plates, base plates, clips and links, and stiffeners were overdone and steel plates were used excessively (Figure 3.35).

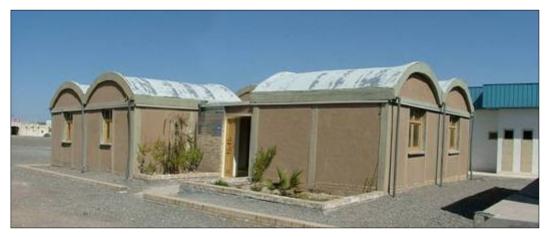
Figure 3.37. The prototypical house developed by UNDP and CRATerre

According to the HFIR statistics at the time of the second visit (February 2007), approximately 65 percent of the houses were completely finished, and a further 20 percent of the houses had been rough-finished. Glancing at the city, it was evident that the new buildings did not resemble their former vernacular architecture, although some structures had tried to mimic its details. Essentially, no vernacular architecture existed in the city after the disaster. Although attempts had been made to create earthquake-resistant housing prototypes that would suit the vernacular architecture of the city, none of these designs had been chosen by the populace in the reconstruction effort. This was despite the fact that HFIR's policy included accepting such designs, thus ensuring that these types of houses could be funded equally with the others. For instance, a prototypical house and construction method (Figure 3.37) that was thoughtfully designed to suit the vernacular architecture of Bam, developed and built by UNDP in collaboration with CRATerre (Grenoble, France), was not selected by a single home owner.

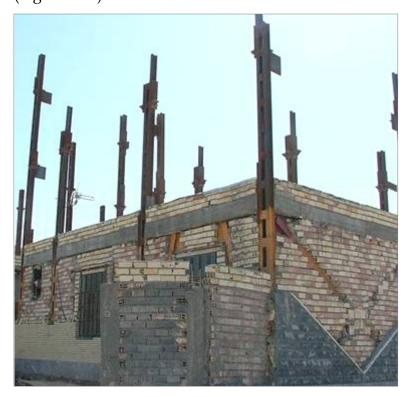
Figure 3.38. Columns extended above the roof line, ready for the future extension of the house

Another observation of interest was that the majority of households were planning to extend their houses in the future. Many of these homeowners had prepared the ground for further construction and had built their current homes accordingly. One of the most common practices was to extend the columns of the building above the roof line so that the house would be ready for an addition of another floor in the future (Figure 3.38).

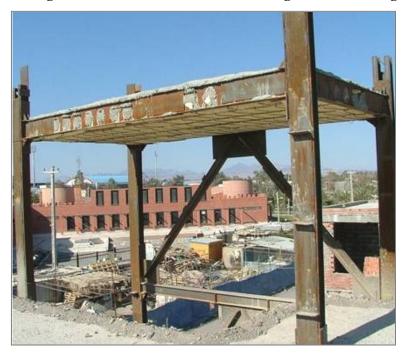
Figure 3.39. An oversized structure: there is little load to bear, yet the posts are highly reinforced; double I-beams are welded together, reinforced by a longitudinal steel plate welded all the way to the two beams

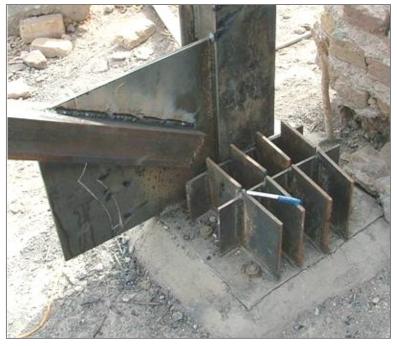
Figure 3.40. Overuse of stiffeners and gusset plates represents the citizens' fear of building collapse

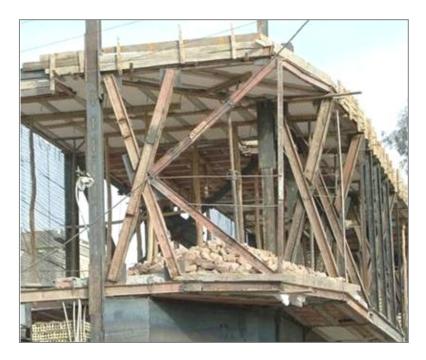
Figure 3.41. Improper use of reinforcement illustrates the presence of a blind knowledge of safeconstruction.

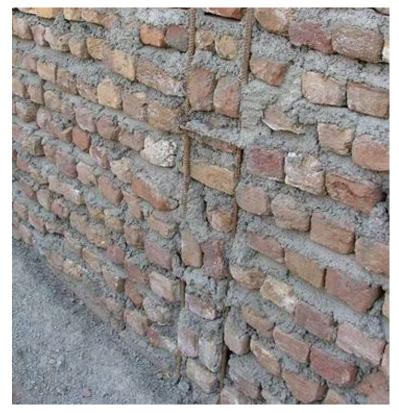
Figure 3.42. The space that was supposed to be poured with concrete to form the vertical column. Here, reinforcement is filled with bricks instead. This demonstrates an absence of proper understanding.

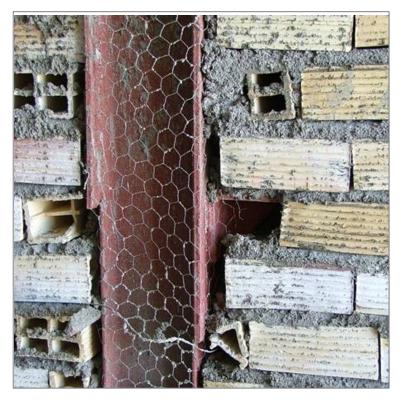
Figure 3.43. Chicken wire wrapped around a steel column to make a strong bond with the plaster.

2. Reinforcing had become a general notion in the building practice in Bam. It was common practice to use vertically reinforced-concrete pillars (every 3 meters/ 10 feet) to which horizontal steel bars were connected (every 5 courses of brick) in order to strengthen brick walls. However, although this reinforcement technique was being practiced in Bam quite predominantly, one could still find buildings that illustrated faulty knowledge. For example, in one building the space left for pouring the concrete of a wall pillar (the vertical reinforcement component) was filled up with bricks instead, which demonstrated a lack of understanding of the concept (Figure 3.42). Other reinforcing techniques that were properly employed included wrapping chicken wire around steel columns in order to make a solid bond with the sand-cement plaster (Figure 3.43). Another reinforcement measure that the builders considered was anchoring brick walls to steel columns by means of steel rods welded to the column on one end and extended to the courses of brick on the other end (Figure 3.44).

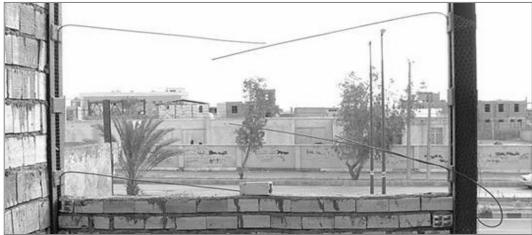
Figure 3.44. Steel rods that will be embedded in the brick wall are welded to stee columns, in order to tie the brick wall to the column.

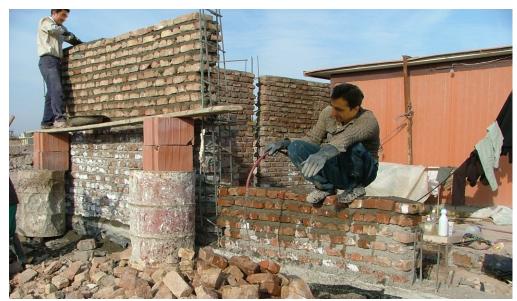
Figure 3.45. Sprinkling water onto the pile of bricks instead of soaking them

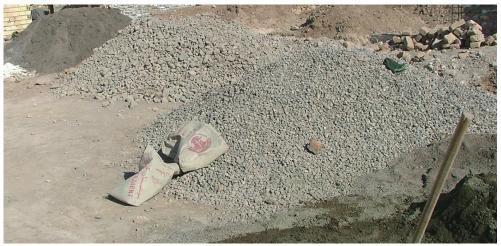
Figure 3.46. A wide variety of aggregates and fillers was available

4. A large variety of materials were available to the locals. For example, a wide range of sizes of concrete fillers (aggregates such as washed sand and gravel) was available to the builders. Such materials were not known to the local builders before the reconstruction program, which had resulted in people using construction waste as concrete fillers instead (see Figures 3.46 and 3.47).

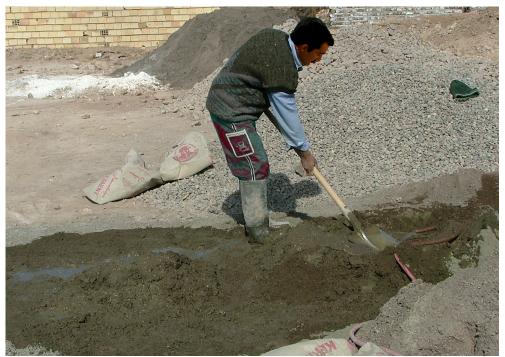
Figure 3.47. A wide variety of aggregates and fillers was available to the construction market

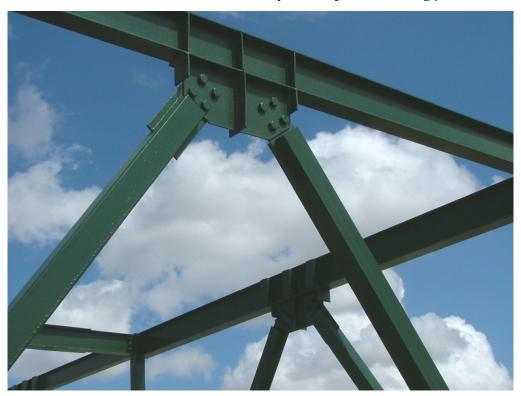
Figure C.10. The structural system proposed by HFIR can be easily and quickly assembled with bolts.

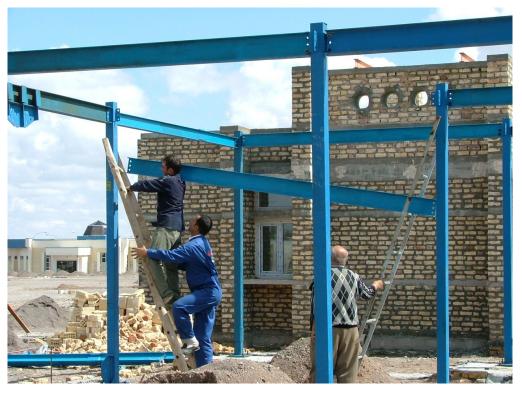
Figure C.11. The structure of a $9x9 \text{ m}^2$ house can be installed in its place in few hours by only two labourers.

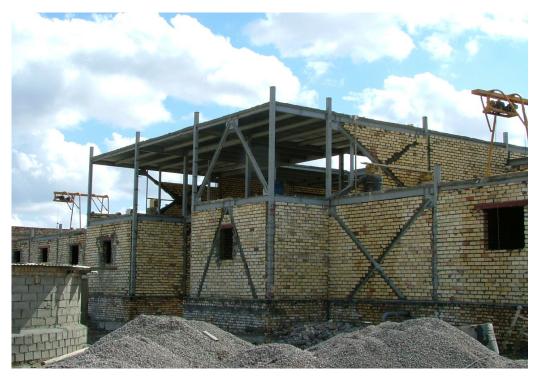
Figure C.12. A publicly funded building being built by HFIR, employing its recommended structural elements.

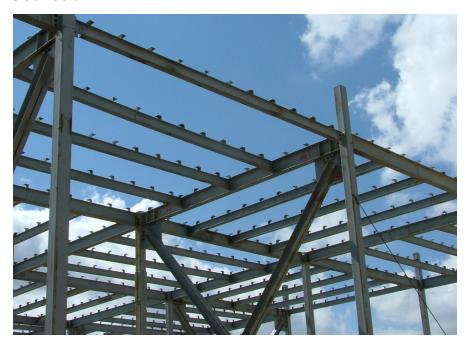
Figure C.14. Small Z-shaped steel laths are welded to the beams, connecting the concrete slab to the beams every 50 centimetres.

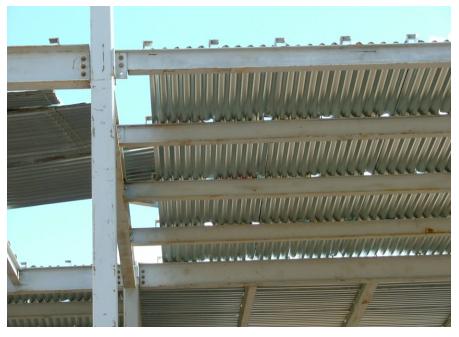
Figure C.15. Corrugated galvanized steel sheets are used as permanent shuttering.

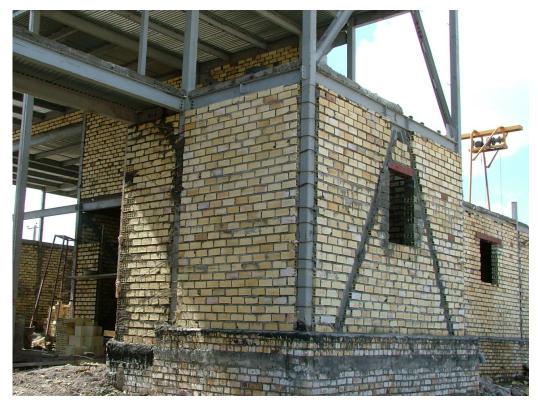
Figure C.16. Hollow blocks are employed as wall infill, and are fixed to the column by means of L-shaped steel bars that are welded to the column.

To strengthen the bond between bricks and steel columns and prevent bursting corners during earthquakes, either L-shaped steel bars were placed in the corner joints, or columns were wrapped with chicken wire to create a proper bond with the sand-cement mortar (Figure C.13).

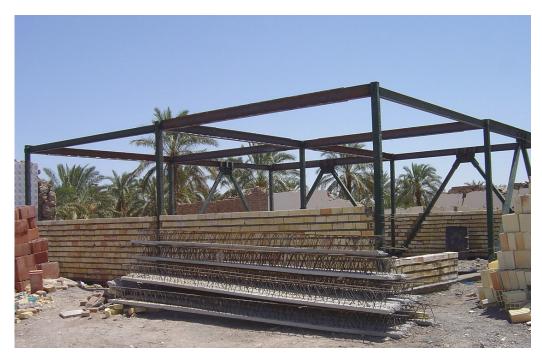
Figure C.17. The wall infill and roofing system may change from the HFIR recommendations. Here, hollow blocks were used as wall infill and a joist-block roofing system was employed. Photo: HFIR archive

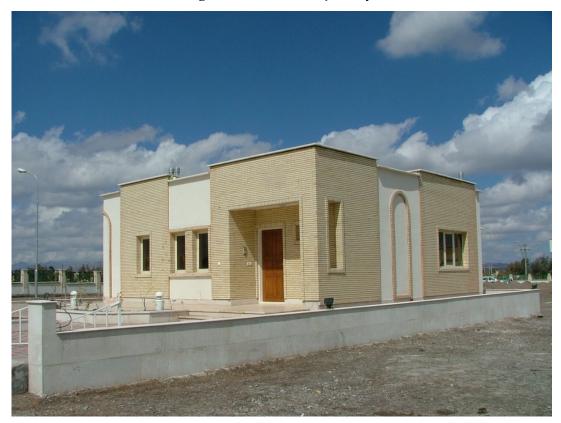
Figure C.18. The demonstration unit that HFIR has built at the exhibition site; the building uses its recommended construction method.

HFIR built an educational sample of the proposed structure on the exhibition site, where citizens could visit and learn essential construction details by looking at the structure. The whole structure was placed on a reinforced concrete pad foundation, to which it was connected by means of bolts and nuts (Figures C.7 to C.11). The roofing system and wall infill remained flexible, left up to the constructor or owner to decide. HFIR, however, built a number of publicly funded buildings; ordinary bricks and/or hollow blocks were chosen as wall infill, and a reinforced concrete slab roofing system (see Figure 4.28 on page 79) was employed in all of them.

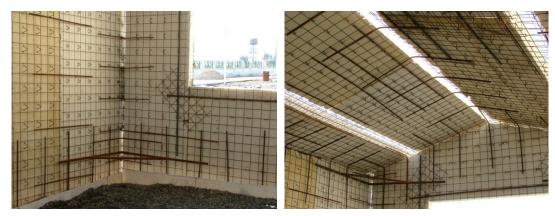
Figures C.21, C.22. Reinforcements are created in the corners as well as other critical joints by additional steel bars.

BBOI built two demonstration houses at the exhibition site. The first one was a small incomplete hut built entirely with sandwich panels; the final stage (i.e. shooting concrete on the panels) was not done in order to let the visitors see the details of implementation of this technique (Figure C.20). The building was placed on a concrete slab foundation, from which steel bars were projected to connect the building to the foundation later on. All critical areas such as corners, around openings, and joints were reinforced by additional steel bars (Figures C.21 and C.22).

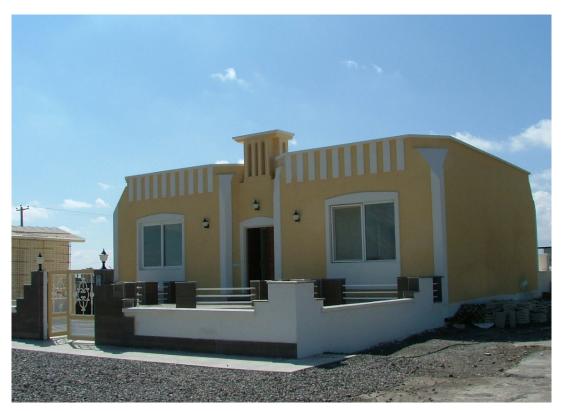
The second sample house built by BBOI was a complete building with an area of around $102 \, \text{m}^2$, also built with sandwich panels. The house was fully furnished luxuriously, with hardware and finishes to catch the eye of visitors.

Figure C.23. The demonstration house built out of sandwich panels by BBOI at the exhibition site.

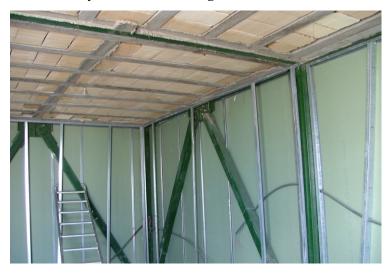
Azar-Mahd was another private construction company working in Bam. The housing method proposed by this company consisted of the HFIR's steel frame structure with a block-joist roofing system. Walls were made of drywall sheets hung on steel studs.

Figure C.28.
The block-joist roofing system and drywall on steel studs

The pros and cons enumerated for the HFIR method hold true for this method too, along with the fact that drywall is a very expensive construction material in Bam, like in other parts of Iran. The use of conventional brick/block walls is the predominant partitioning method and the most popular one, and the drywall system is a relatively new technique.

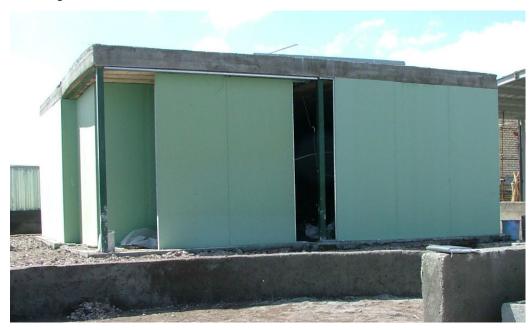
Figure C.29. The sample house built at the exhibition site by Azar-Mahd Construction Company. The house was not finished at the time of visit.

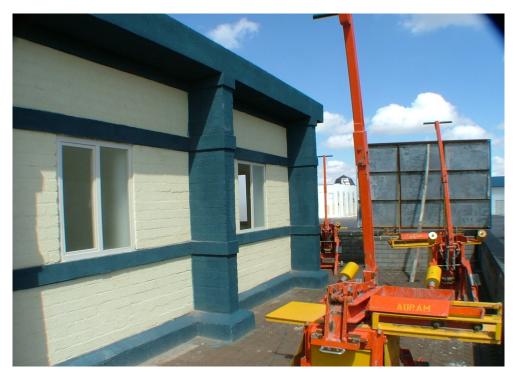
Figure C.32. The house is reinforced by ring beams at three levels.

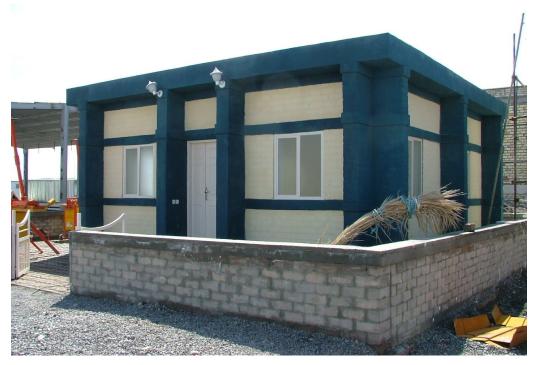
Figure C.33. The house built cooperatively by Auroville and the International Blue Crescent, using CEB and vertical steel bar reinforcements along with ring beams at three levels: sill, lintel, and roof.

levels: sill level, lintel level, and the top of the wall (Figure C.32). Interlocking CEBs were connected together by vertical steel bar reinforcements placed inside the walls, running from the foundation to the roof level ring beam. The roof was composed of concrete joists with hollow blocks in between, resting on load-bearing CEB walls.

Building with CEB has shown to be promising in terms of cost efficiency and earthquake resistance in many parts of the world, especially in India where Auroville is renowned for developing earth buildings and new methods of using earth in earthquake-prone regions. Nonetheless, the main problem of this prototypical house, which might have impeded the absorption of this method into the popular housing sector of Bam, was the heavy roofing system employed. The experience of heavy roofs collapsing during the earthquake spread fear of living under such roofs among the citizens. In addition, since this method was very new to the local residents, it would take some time to be absorbed into the community and the builders.

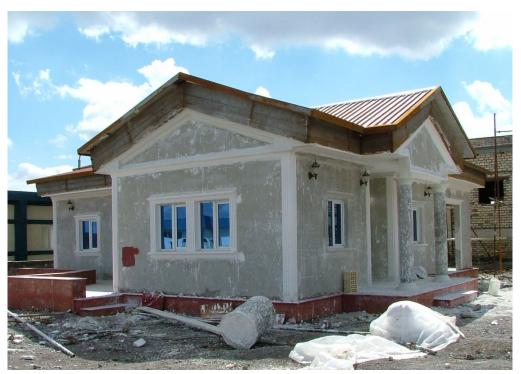
Figure C.35. The unit built by Qata'at Foolad Corporation.

Similar to the techniques reviewed before, the use of steel sheets for covering the roof in a climate like Bam's is troublesome, especially during the extreme weather of summer and winter, unless proper insulation is provided. It is obvious that the insulation would significantly increase the costs of construction. Moreover, pitched roofs are not appropriate for this climate because there is very little rain during the year; in addition, the shape of this roof did not suit the vernacular architecture of Bam. Furthermore, this method of construction would require special skills if further additions on the home were desired in the future.

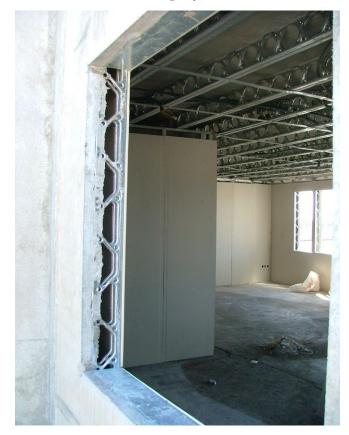
Figure C.36. Cold-formed truss-like studs serve as drywall studs and roof girders.

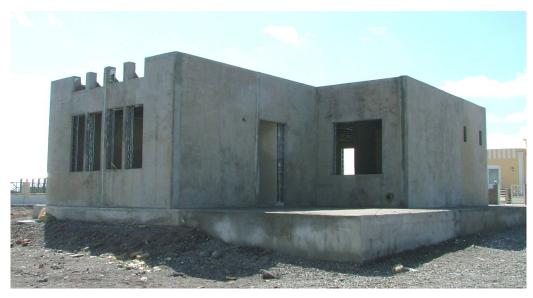
Figure C.37. The sand-cement plastered exterior of the demonstration unit built by MEHRSA Company.

studs for all components of the structure, including walls and roof. The coldformed truss-like studs hold drywall sheets while taking the load of the roof to the foundation. The roof was composed of wider cold-formed joists, serving as girders for the prefabricated, pre-stressed hollow-core concrete slab roof. The exterior façade was waterproofed by sandcement plaster finish applied on drywall.

This method can be implemented very quickly and the weight of the roof is low in comparison with conventional methods. The construction cost, however, remained the main problem, and was very high due to the relatively high-tech method employed. Another major disadvantage of this method was that the local builders would be unable to implement and/or extend this kind of house themselves.

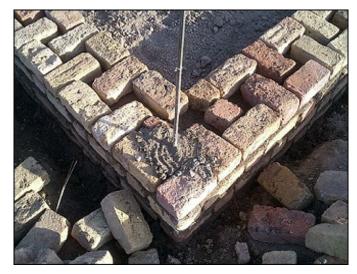
Figure C.39. Steel bars placed within the walls as vertical reinforcements Photo: PWJ

PWJ built four buildings in Bam. Although the materials used and the construction methods employed in each building varied slightly from one another, the concept (technique) was the same in all four. This concept involved reinforcing wall-bearing buildings by means of concrete ring beams placed around the perimeter of the building at four levels, namely: plinth, sill, lintel and roof height (Figure C.38), along with the insertion of vertical steel bars within the walls, running from the foundation to the

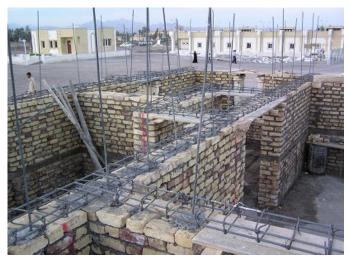
Figure C.41: The third ring beam is being prepared for the pouring of the concrete. Photo: PWJ

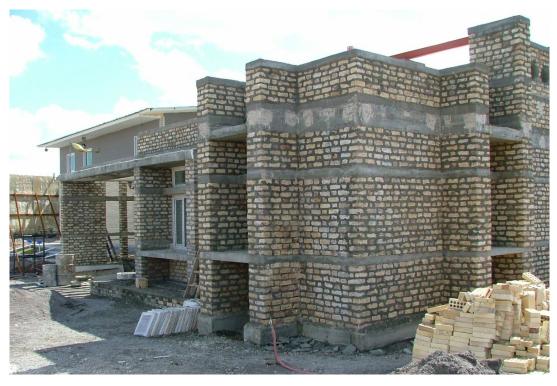
Figure C.44. The demonstration house that PWJ was building at the time of visit. The four horizontal reinforcements (ring beams) are clearly shown in the picture.

disseminate the knowledge of such reinforcing methods among the local builders (Figures C.40 and C.43). The third building PWJ built was a demonstration house at the HFIR's exhibition site; burnt brick was used as the main material for this house (Figure C.44). The last building constructed was a school located in the centre of the city, in which CEBs are employed instead of ordinary burnt bricks.

learning this technique, which aimed at improving upon the local construction methods rather than introducing completely foreign techniques, made this method promising for absorption into the popular housing sector in Bam. However, the heavy roof employed in this method was fearsome for the Bam citizens and could potentially impede this technique from gaining wide-spread appeal.

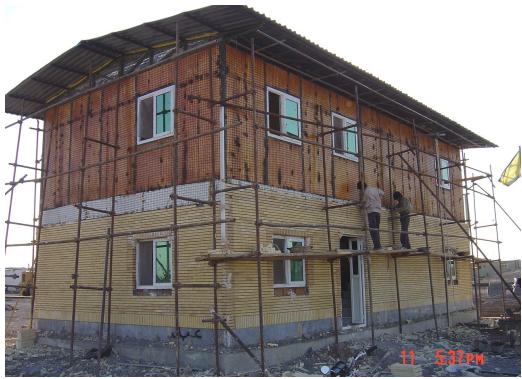
Figure C.47. The façade is being covered with slim façade bricks. The steel mesh makes a good bond between the façade bricks and sandwich panels. Photo: HFIR archive

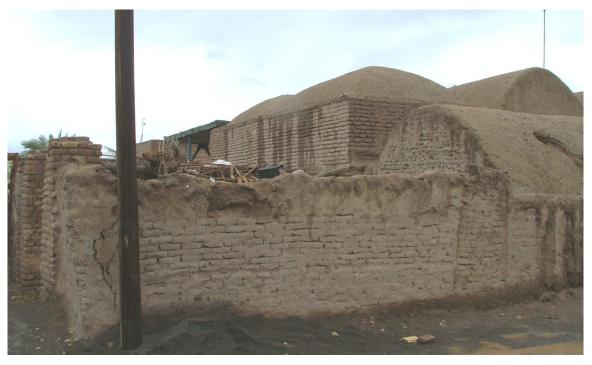
Kūrk is a village located approximately 20 kilometers northeast of Bam. Almost all of the buildings in Kūrk were built of adobe brick (or burnt brick in some cases) with mud used as mortar and roofed with barrel (Nubian) vaults.

Figure C.49. The vernacular architecture of Kūrk consisted of adobe load bearing walls and barrel vault roofs.

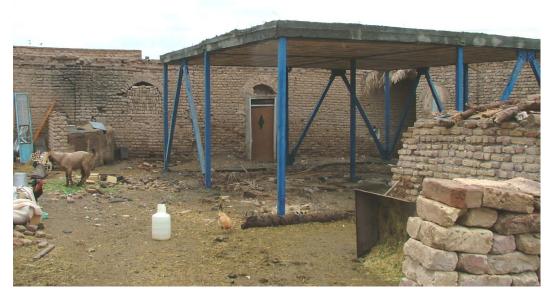
Figure C.50. HFIR is constructing new houses in the existing courtyards of the old houses of the villagers.

prefabricated steel posts and beams. Although the majority of the existing buildings of the village received no damage or little damage during the earthquake, HFIR erected new houses in courtyards or on the lots of open barns. HFIR's intent was to move the inhabitants to the new houses and abandon the old, seemingly vulnerable ones. There were some difficulties, however, that seemed to have obstructed this construction method from being widely disseminated.

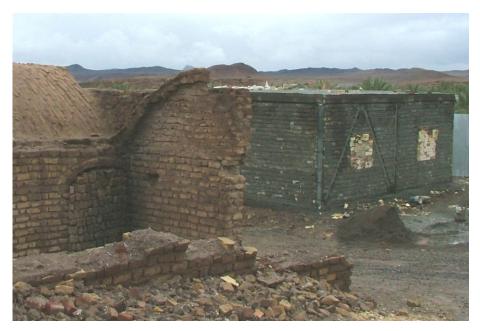
Figure C.51. The new house took the place of the courtyard. The windows of the new house were bricked due to the climatic problems they created.

Firstly, the proposed method was very expensive for the villagers; they could not afford the new homes without government subsidies or loans. Moreover, the method was relatively sophisticated and new to the local residents and consequently, it was impractical for them to construct on their own. In addition, the new buildings were being built with no attention to the local climatic concerns and criteria. For instance, a number of windows of the new buildings were filled with bricks because of the uncomfortable conditions they produced inside the house; the prevalent wind together with the unpleasant sunshine from windows facing west were undesirable to the homeowners.

Furthermore, these new houses occupied the space of the courtyard, where the majority of a village housewife's activities take place. The fact that these new constructions replaced one of the most active and useful parts of the house and community resulted in serious problems in using the new spaces, social concerns aside.

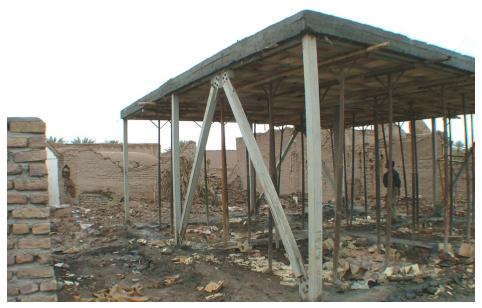
Figure C.52. The HFIR's recommended structure used for the construction of new houses in Kūrk.

The structure proposed by HFIR consists of prefabricated steel posts, beams, and bracings that are designed for ease and speed of assembly, using only bolts and nuts for fastening the elements together. For example, the structure of a regular house (9 x 9 m², as HFIR recommends) can be installed in place in just a few hours, and requires only two labourers. Aside from the quick installation time, the employment of labourers only to fasten the bolts is supposed to remarkably reduce the number of structural failures caused by inadequate welding jobs.

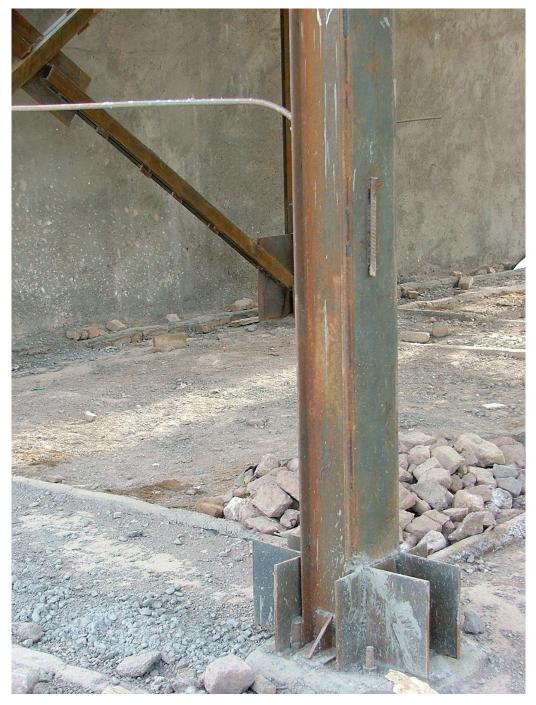
Figure E.13. An example of a column, oversized and overdone by the builder for the sake of a stronger structure

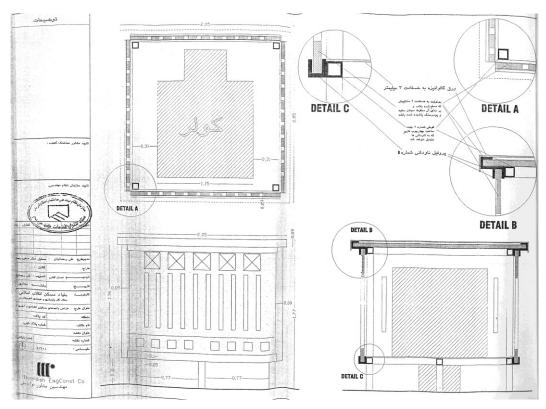
Figure E.22. Set 2: Details of the box to cover the air conditioner. Although shown in all plans in Bam, this box was never been built in any house in Bam.
