**A survey of earthquake-induced damage to  
telecommunications towers (1999-2011)**

**By Mahtab Ghafari Osgoie  
Approved by Prof. Ghyslaine McClure**

**Structural Engineering Series Report No. 2012-15**

**Department of Civil Engineering and Applied  
Mechanics**

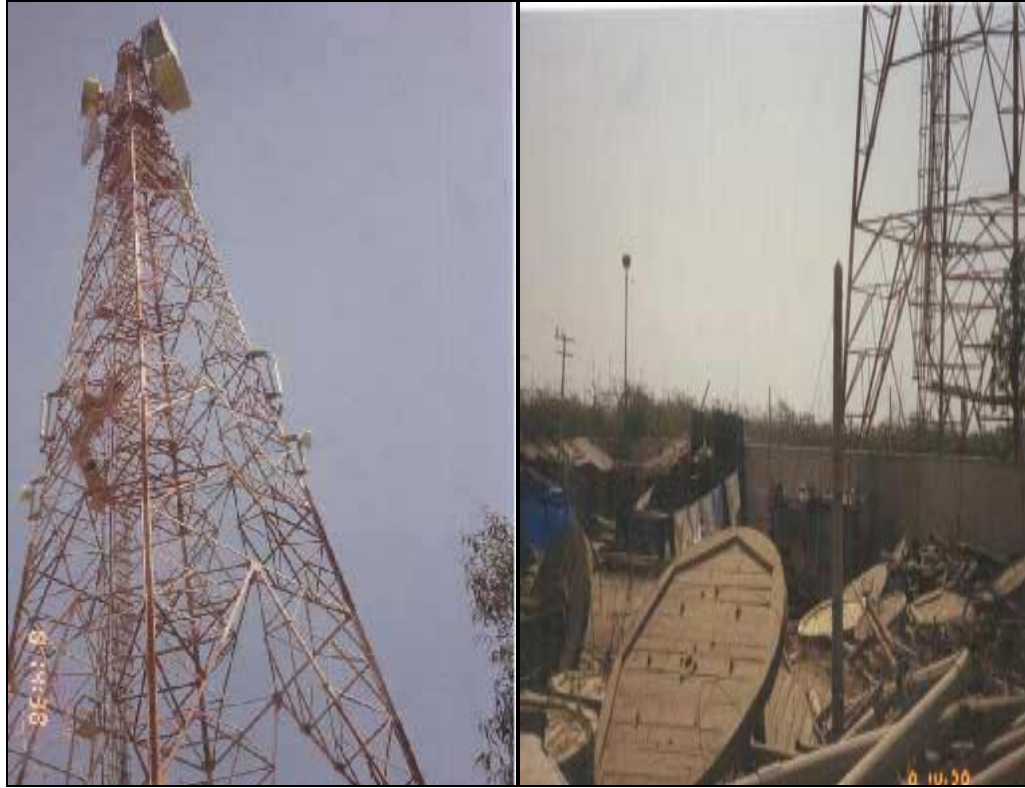
Telephone communications suffered serious disruption during the earthquake. In Kachchh, most communication cables were damaged. The alternative mode of communication was a satellite phone service, which was used for about 16 hours following the disaster. Field measurements showed that although at first it seemed the damages were due to severe ground motion, later investigation showed that most of the damages were exacerbated because of a poor quality of engineering and construction.

*Figure 1. Destruction outside the Communications Center for Kachchh District, Gandhidham, March 2, 2001, with tower remained standing (Ravi Mystry et al., 2001).*

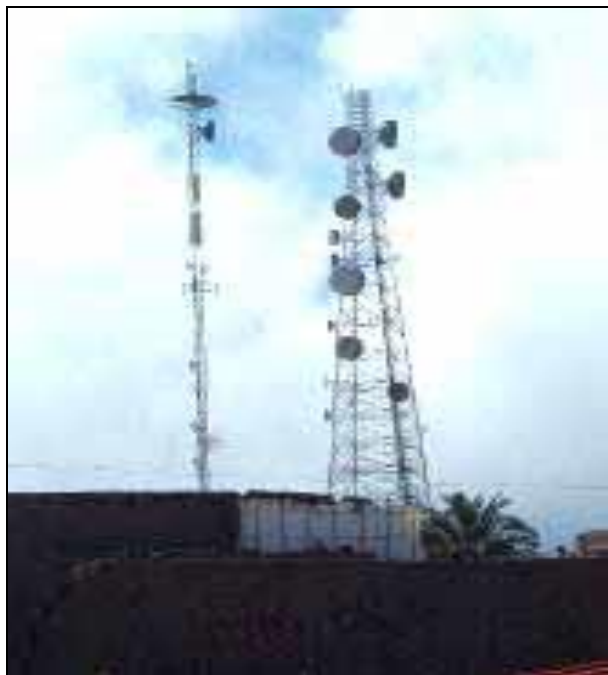
*Figure 2. One of the main telecommunication towers in Bam which survived the earthquake (A. Manafpour, 2003).*

Despite the damage, cell phones started to work within a few hours following the quake. The telecommunication disruptions were mainly caused by non-structural damage to telecom central offices which were located outside the principal area of destruction. In addition to their location, these buildings suffered less because of their relatively recent equipment and construction quality compared to other residential buildings. There were some governmental reports that represented the telecommunication central offices had

primarily non-structural damage as well as damage to unanchored equipment. The most important telecom towers more or less stood strong against the quake.

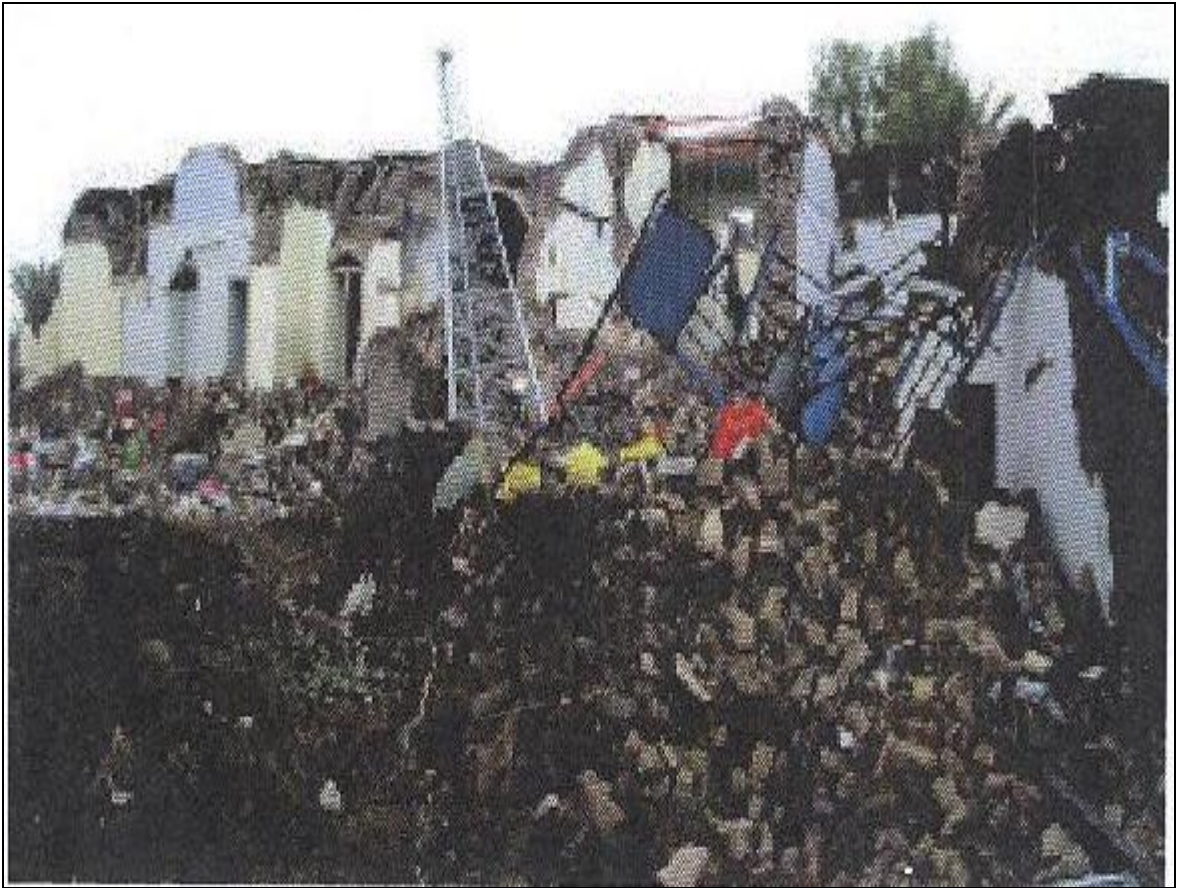
Other communication towers located on roofs of some of the collapsing buildings were also damaged.

*Figure 3. Failed tower due to building collapse (Masoud Moghtaderi-Zadeh et al., 2003).*

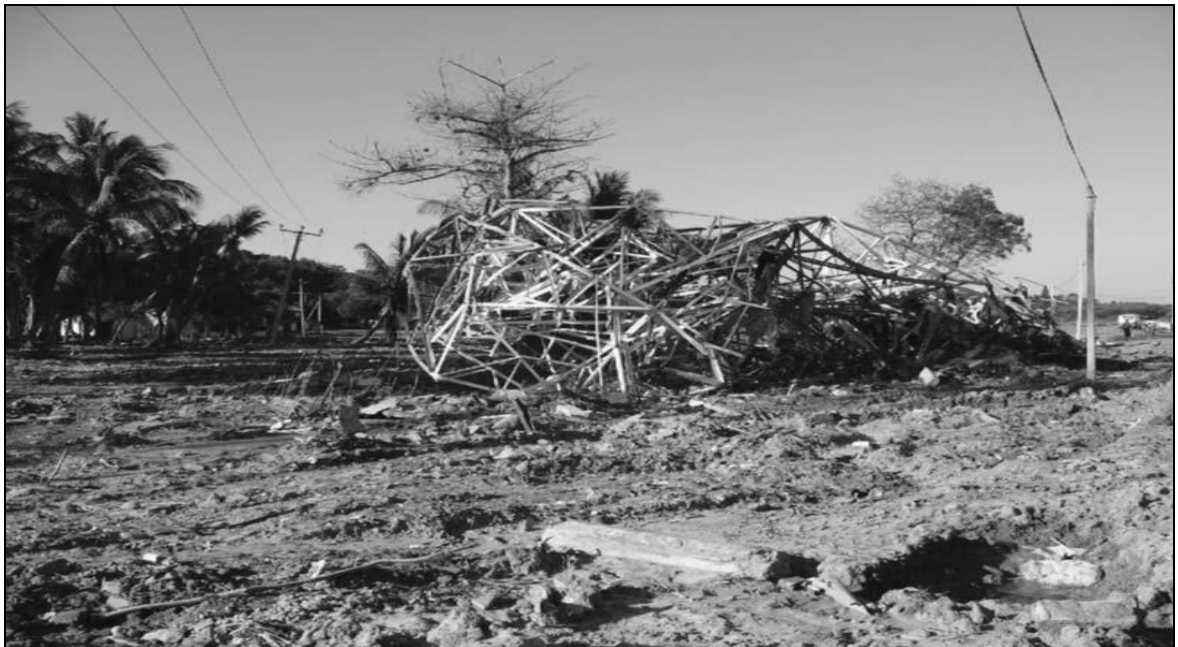
*Figure 5 One self-supported lattice communication tower in Hambantota (Indonesia) was toppled by the tsunami (Donald Ballantyne, 2004)*

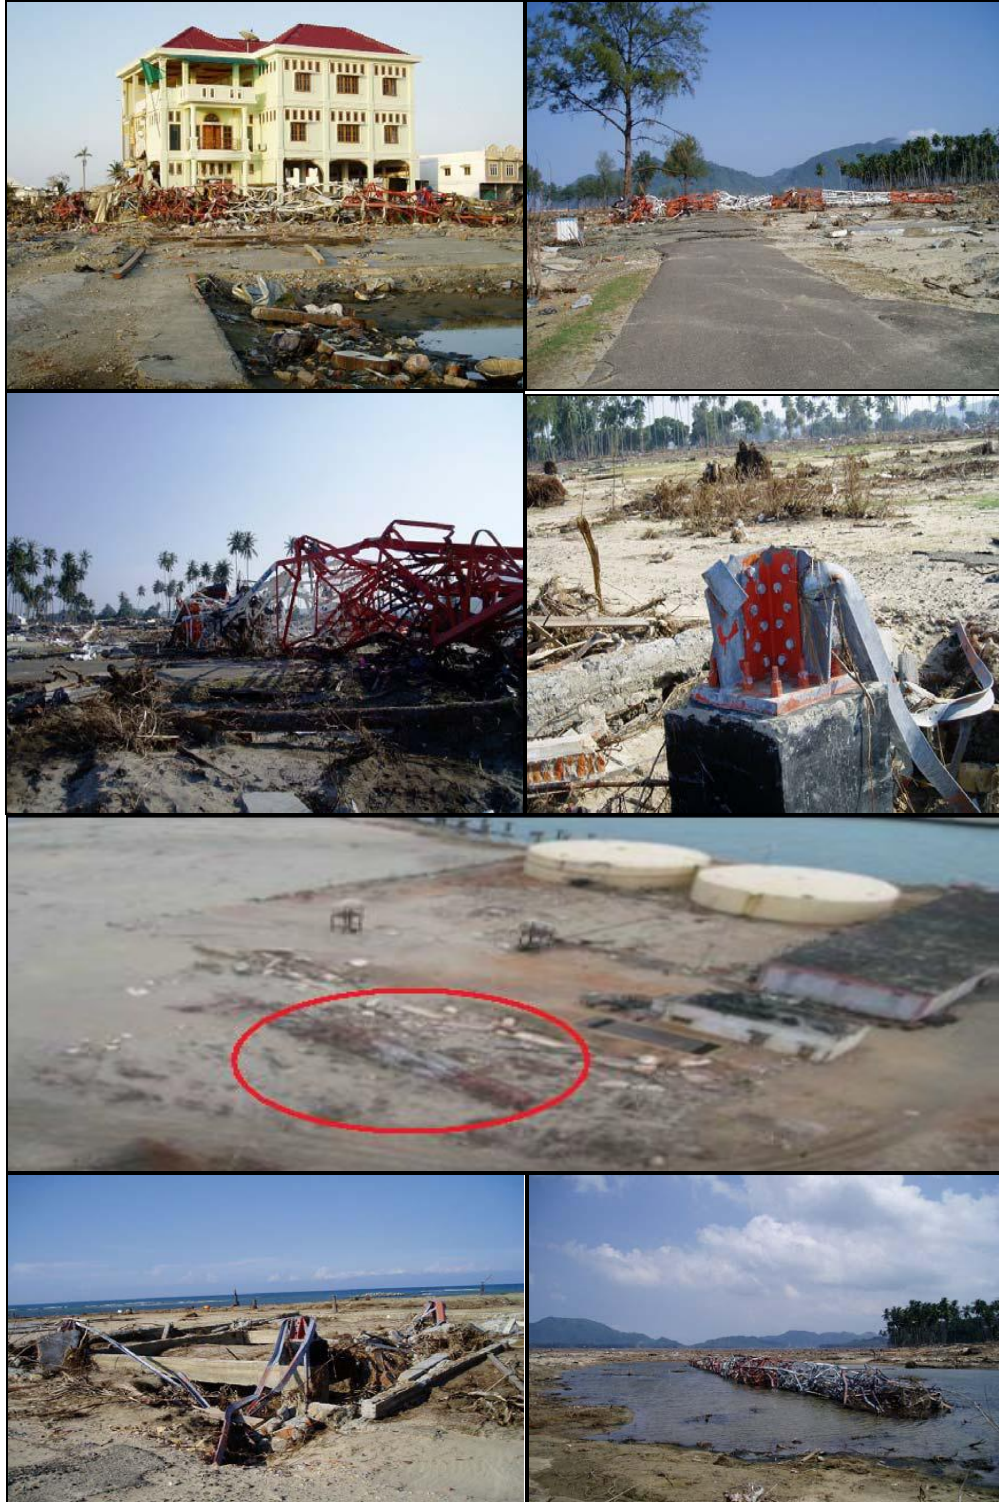
Figure 6 Collapsed telecommunication tower as a result of Sumatra tsunami (Teddy Boen, 2004)

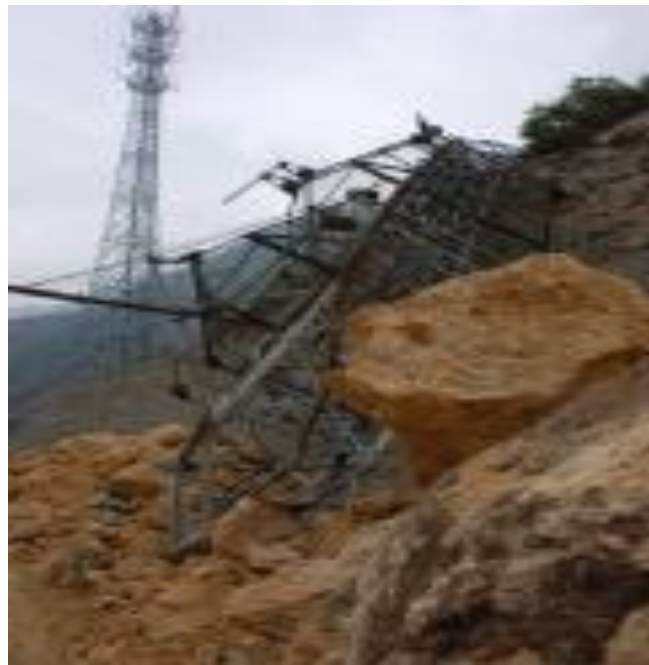
Government efforts during the first week following the earthquake restored electric power and telecommunication services in priority. Figure 1-8 presents one collapsed telecommunication system during the Sechuan earthquake.

*Figure 8 Collapsed telecommunication tower in the Sechuan2008 earthquake (Aiping Tang et al., 2010)*

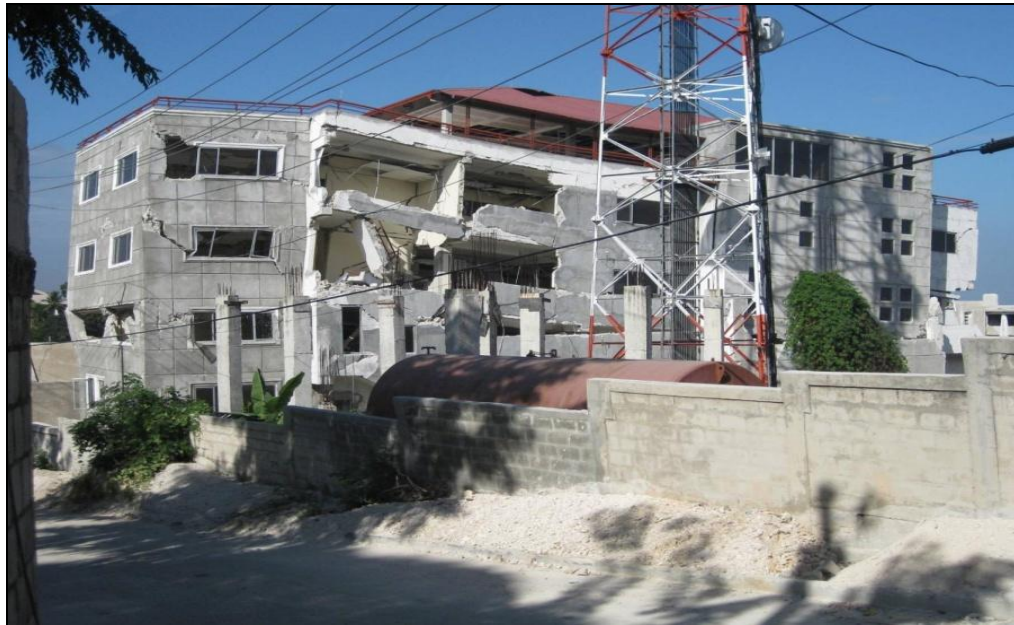
*Figure 13      Partially collapsed telecom switch building as a result of Haiti earthquake*  
[http://mrpenengineering.com/haiti\\_images.htm#thumb](http://mrpenengineering.com/haiti_images.htm#thumb)

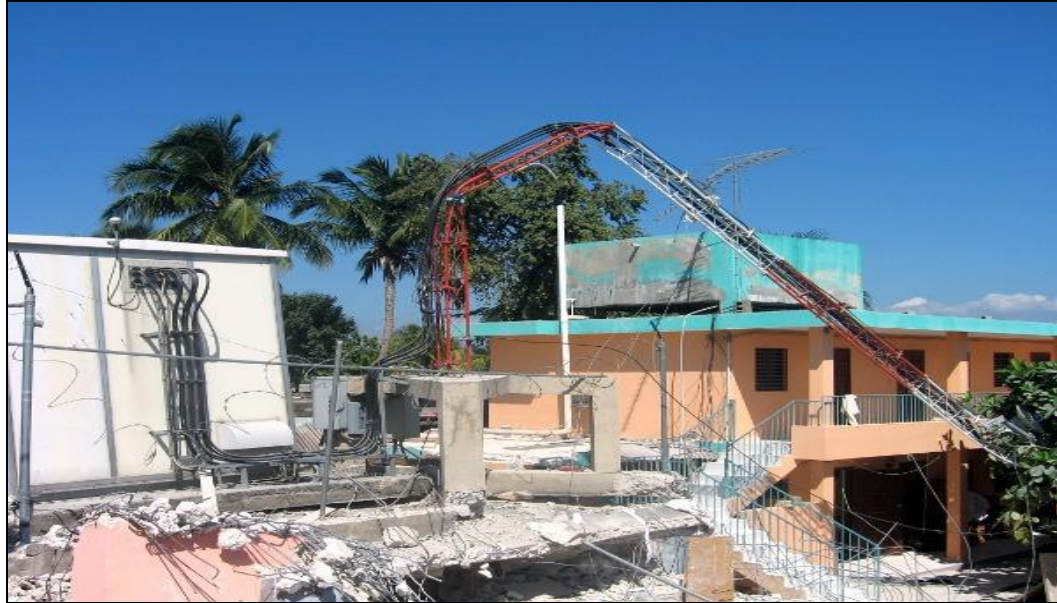
*Figure 14      Antenna damaged in Carrefour as a result of Haiti earthquake (Adele Waugaman et al., 2010)*

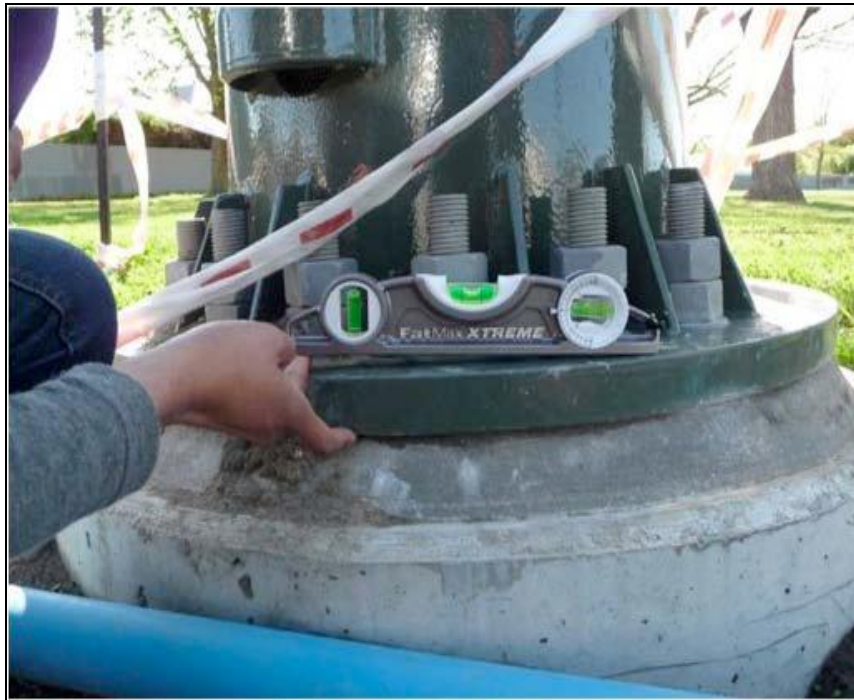
Two cell phone towers tilted because of liquefaction. The towers were out-of-plumb by  $2^{\circ}$  to  $5^{\circ}$ . Since these rotations did not cause any considerable effect on the serviceability of the towers, no effort was made for repairing them within the first 6 weeks after the earthquake. In some cases, fixed telecommunication lines remained in service. Although there was no significant problem due to the tower's damage, people nonetheless experienced service problems. Because many people only have mobile phones, they were unable to maintain communication while there was power loss.

*Figure 16 Cellular antenna tower out of plumb due to ground deformation as a result of New Zealand earthquake (JM Eiding, 2012)*
