**Surface Characterization of Metal-Metal Hip
Implants Tested in a Hip Simulator**

Adi Wang

**Metallurgical Engineering Department
McGill University, Montreal**

**A thesis submitted to the Faculty of Graduate Studies and Research in partial
fulfillment of the requirements of the degree of Masters of Engineering**

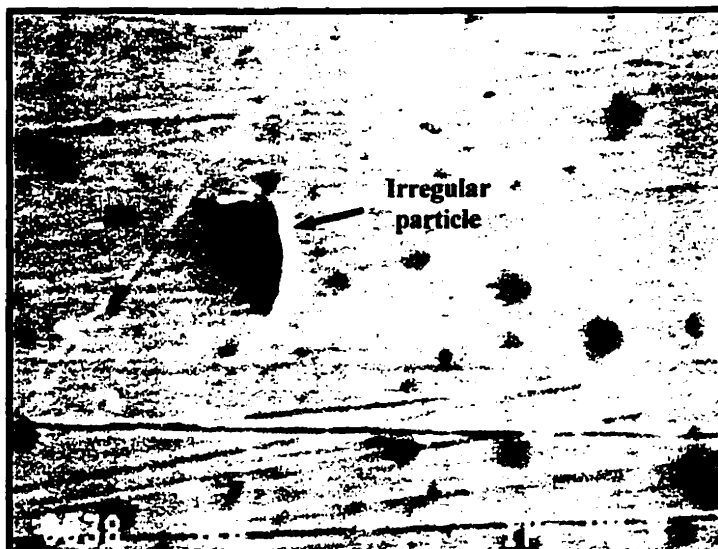
All 15 heads possessed small embedded particles on their surfaces. These particles were not present during the microstructural examination and have therefore been identified strictly as a surface phenomenon. The particles had two distinct appearances. Most were of the spherical kind, which negatively charged when examined in the secondary electron mode with the SEM (Fig. 5.15). Close-up imaging of these particles was difficult due to the charging. When examined at a very low accelerating voltage (2.5 kV) the charging was reduced and it became apparent that the spherical particles were comprised of a shell and a core (Fig. 5.16). The second type of particle, found much less frequently, was irregular in shape and appeared dark when examined with the SEM in the secondary electron mode (Fig. 5.17).

Figure 5.17 – SEM image of irregularly shaped particle detected on HC wrought implant after 3 million cycles of testing (head #8).

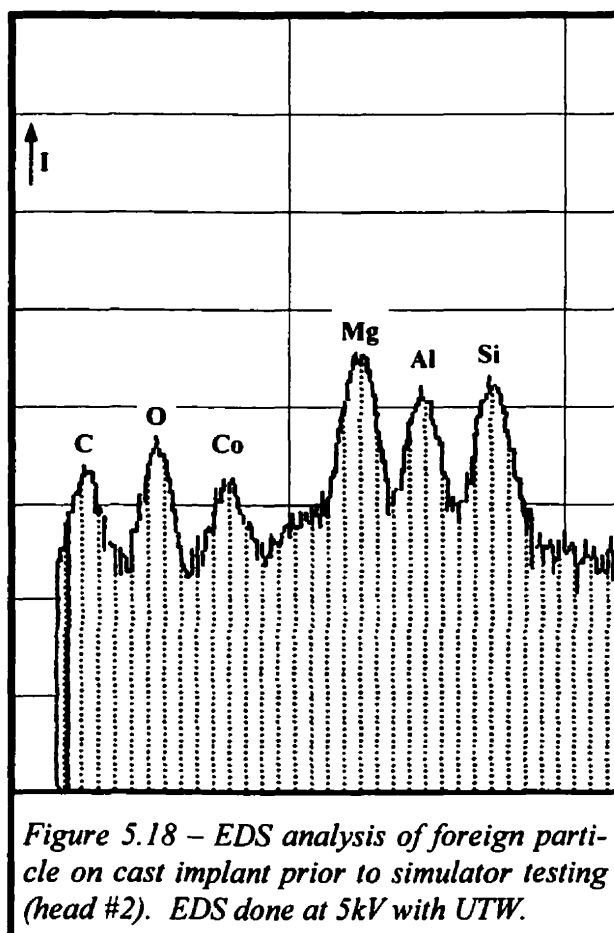
as described in 4.7.1. Figures 5.18, 5.19 and 5.20 are examples of the patterns obtained from analyses of different particles. The particles were shown to have Si, Al, Mg, Co, O and C in their composition. The relative amounts of these elements varied from particle to particle. Most often, the irregularly shaped parti-

Figure 5.18 – EDS analysis of foreign particle on cast implant prior to simulator testing (head #2). EDS done at 5kV with UTW.

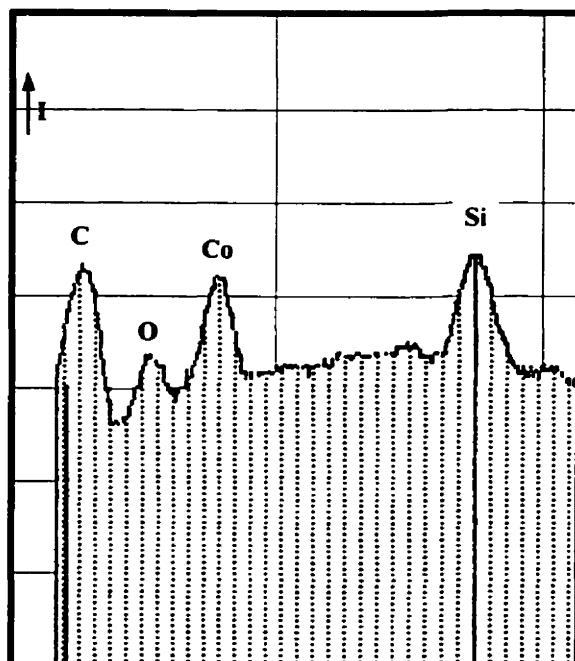
cles contained Si and C (Fig. 5.19) and the spherical particles contained Si, Al and O (Fig. 5.20). Except for the cobalt and carbon, the elements present in the particles were not in the composition of the alloys as given in the standards (Table 4.2). This, coupled with the fact that the particles were strictly a surface phenomenon sug-

Figure 5.19 – EDS analysis of irregularly shaped particle on LC wrought alloy after 3 million cycles of simulator testing (head #9). EDS done at 5kV with UTW.

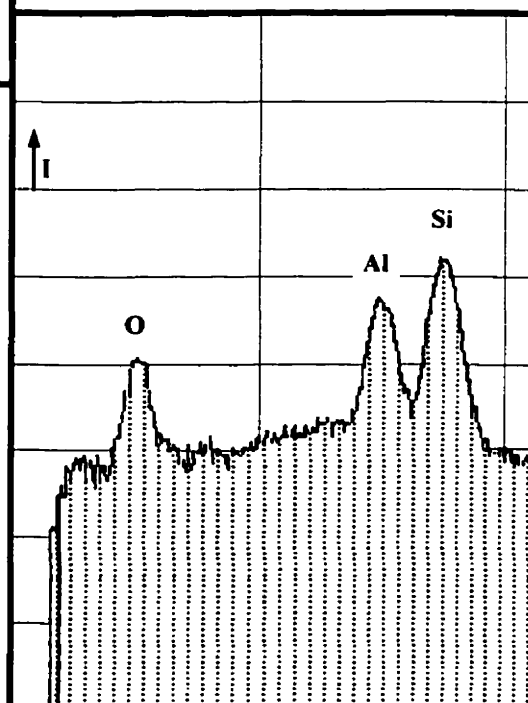
Figure 5.20 – EDS analysis of spherical particle on LC wrought alloy after 3 million cycles of simulator testing (head #9). EDS done at 5kV with UTW.

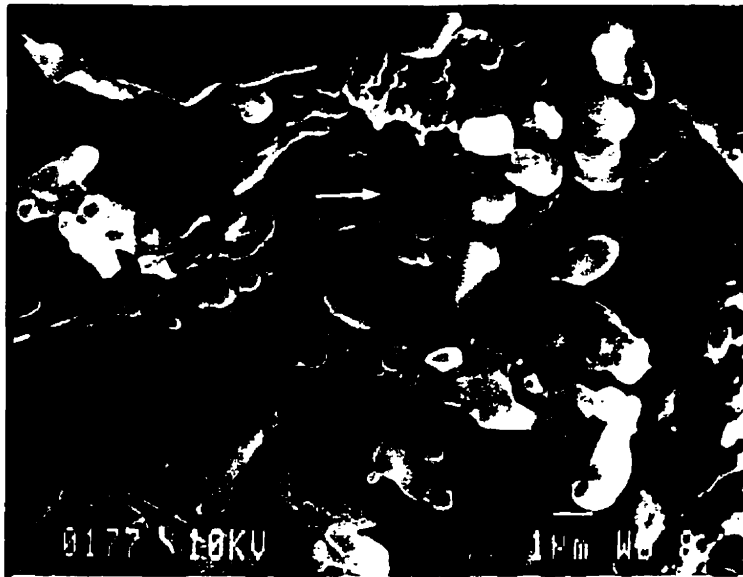
Although the roughing and finishing grinding stones appeared similar, they did have one distinct difference. Occasionally, pockets of spherical particles were found in the roughing stone (Fig. 5.24), a feature that was not detected in the finishing stone. When analyzed with the EDS, the spherical particles were shown to contain Si, Al and O (Fig. 5.25). These particles were probably the glass binder as their composition was consistent with that of the binder as given by the manufacturer. Carbon was present probably because the electron beam picked up on some of the abrasives adjacent to the spherical particles. Sulfur was present because the stones were dipped in sulfur once consolidated. The spherical binder in the grinding stone

possessed the same morphology and general size as the spherical particles found on the implant surfaces (Fig. 5.16). In fact, they too were comprised of a shell and a core (arrow on Fig. 5.24).

Figure 5.24 – SEM image of a pocket of spherical particles found in the roughing grinding stone. Arrow serves to point out particle similar to that seen in Fig. 5.16.

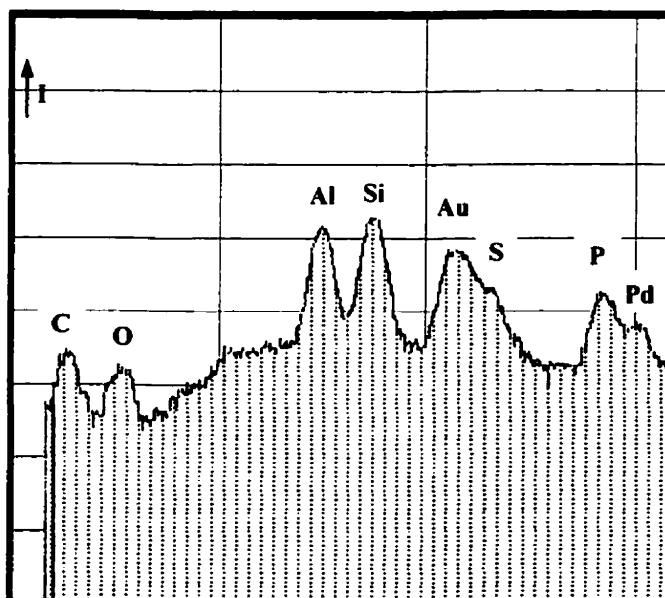
Figure 5.25 – EDS analysis of one of the spherical particles seen in Fig. 5.24. EDS done at 5kV with the UTW.

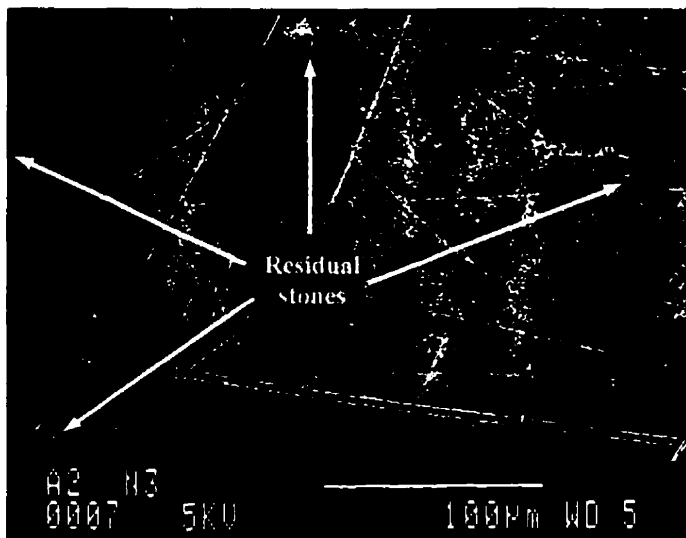
Figure 5.52 – SEM image of cast implant after 2 million cycles of testing (head #1) taken at the same location as in Figure 5.51. Featured are the same embedded residual grinding stones. Also featured are straight, second-body abrasive scratches.

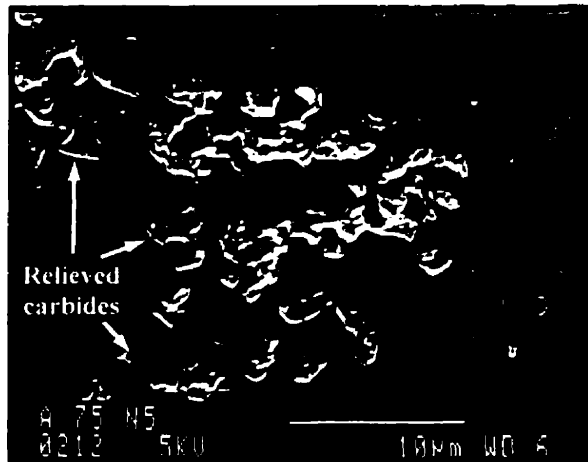
Figure 5.55 – SEM image of cast implant after 0.75 million cycles of testing (head #2). Featured is a relieved carbide chain with pits.

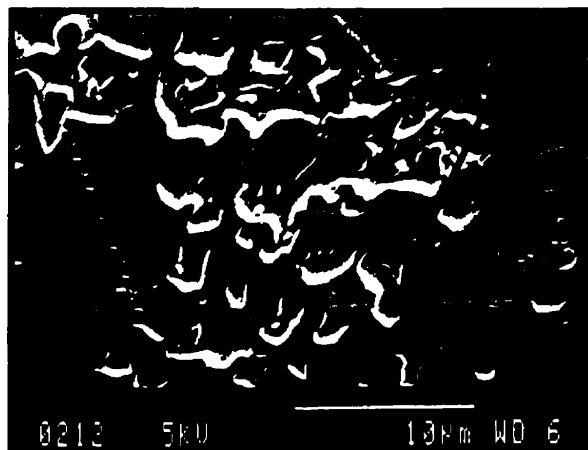
Figure 5.56 – SEM image of cast implant after 1 million cycles of testing (head #2). Featured is the same relieved carbide chain as in Fig. 5.55. Pits were now larger and more numerous.

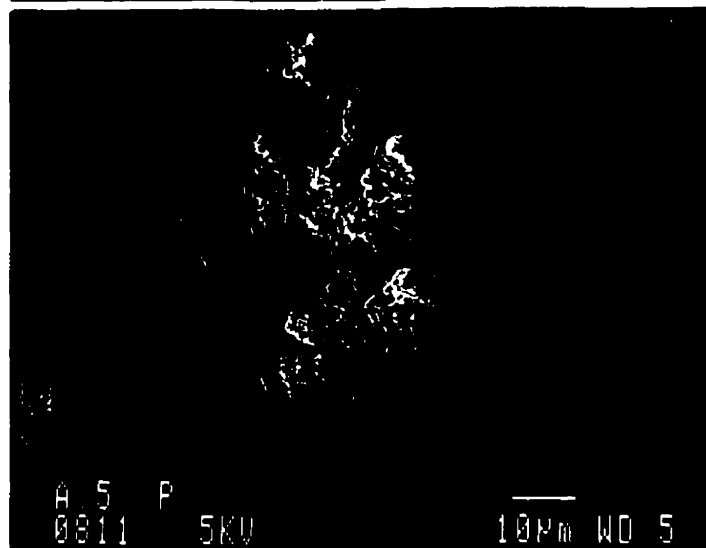
Figure 5.64 – SEM image of low carbon wrought surface after 0.45 million cycles of testing (head #6). Featured are pits in the same location where the blisters were at 0.25 million cycles of testing (Fig. 5.63).

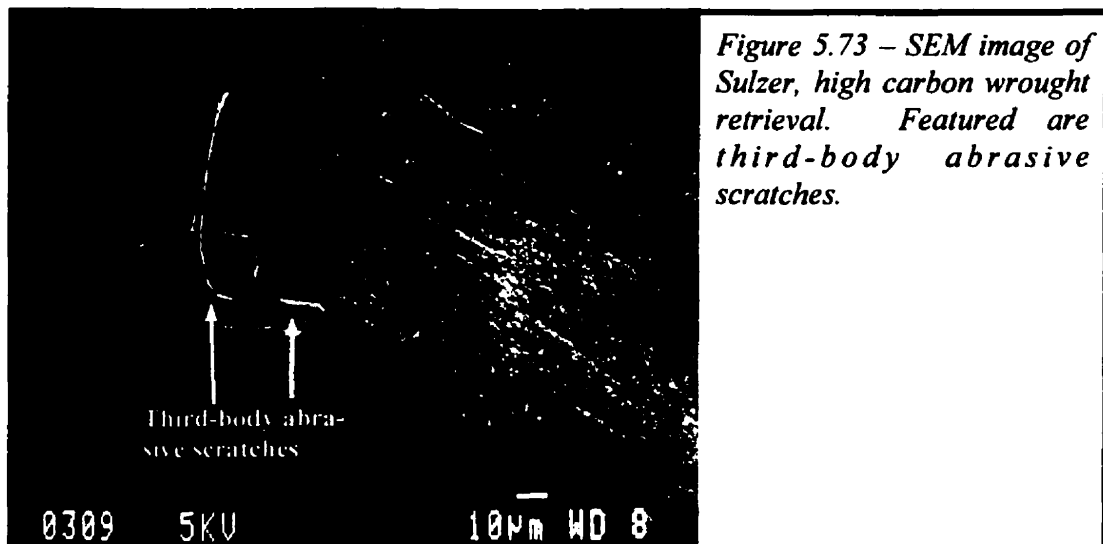
As with the Wright Medical implants, the retrieval exhibited both second and third-body abrasive scratching (Figs. 5.72 & 5.73). Although the amount of scratching was small, it was more prevalent than observed on the other high carbon wrought implants examined in this study. The scratches were very similar in appearance to those on the other implants, exhibiting no pile-up on the edges.

Figure 5.74 shows some residue on the implant that could not be removed with the cleaning methods employed in this study. This area appeared to have a concentration of abrasive scratching. Close-up imaging (Fig. 5.75) revealed the presence

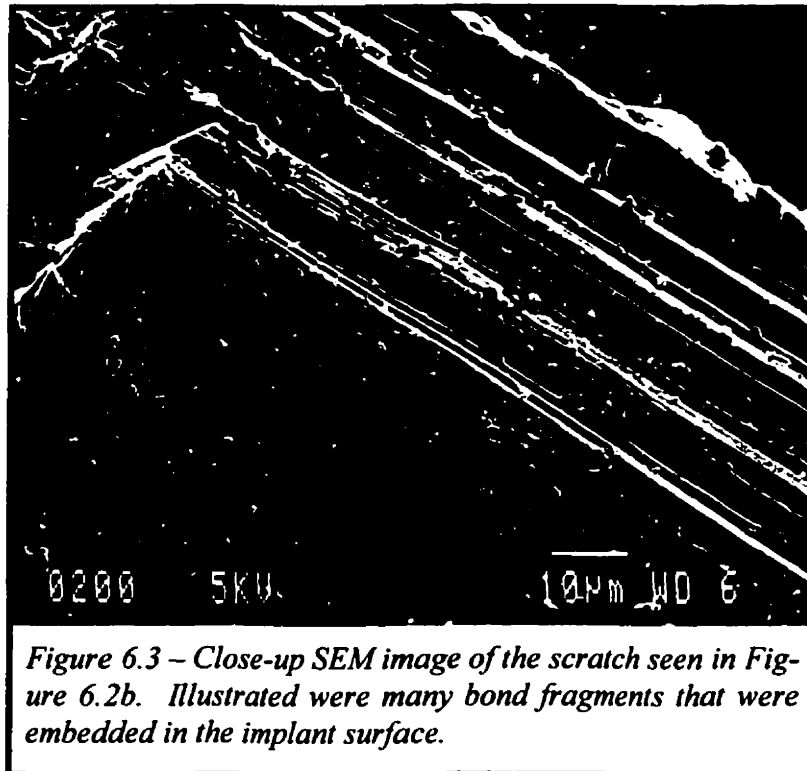
Figure 6.3 – Close-up SEM image of the scratch seen in Figure 6.2b. Illustrated were many bond fragments that were embedded in the implant surface.
