AN EROSION CONTROL PLAN FOR PART OF
THE GREEN'S CREEK RAVINE

BY
ROBERT BOYD BONNELL

REPORT SUBMITTED IN PARTIAL FULLFILLMENT
FOR COURSE 336-490D

APRIL, 1983.

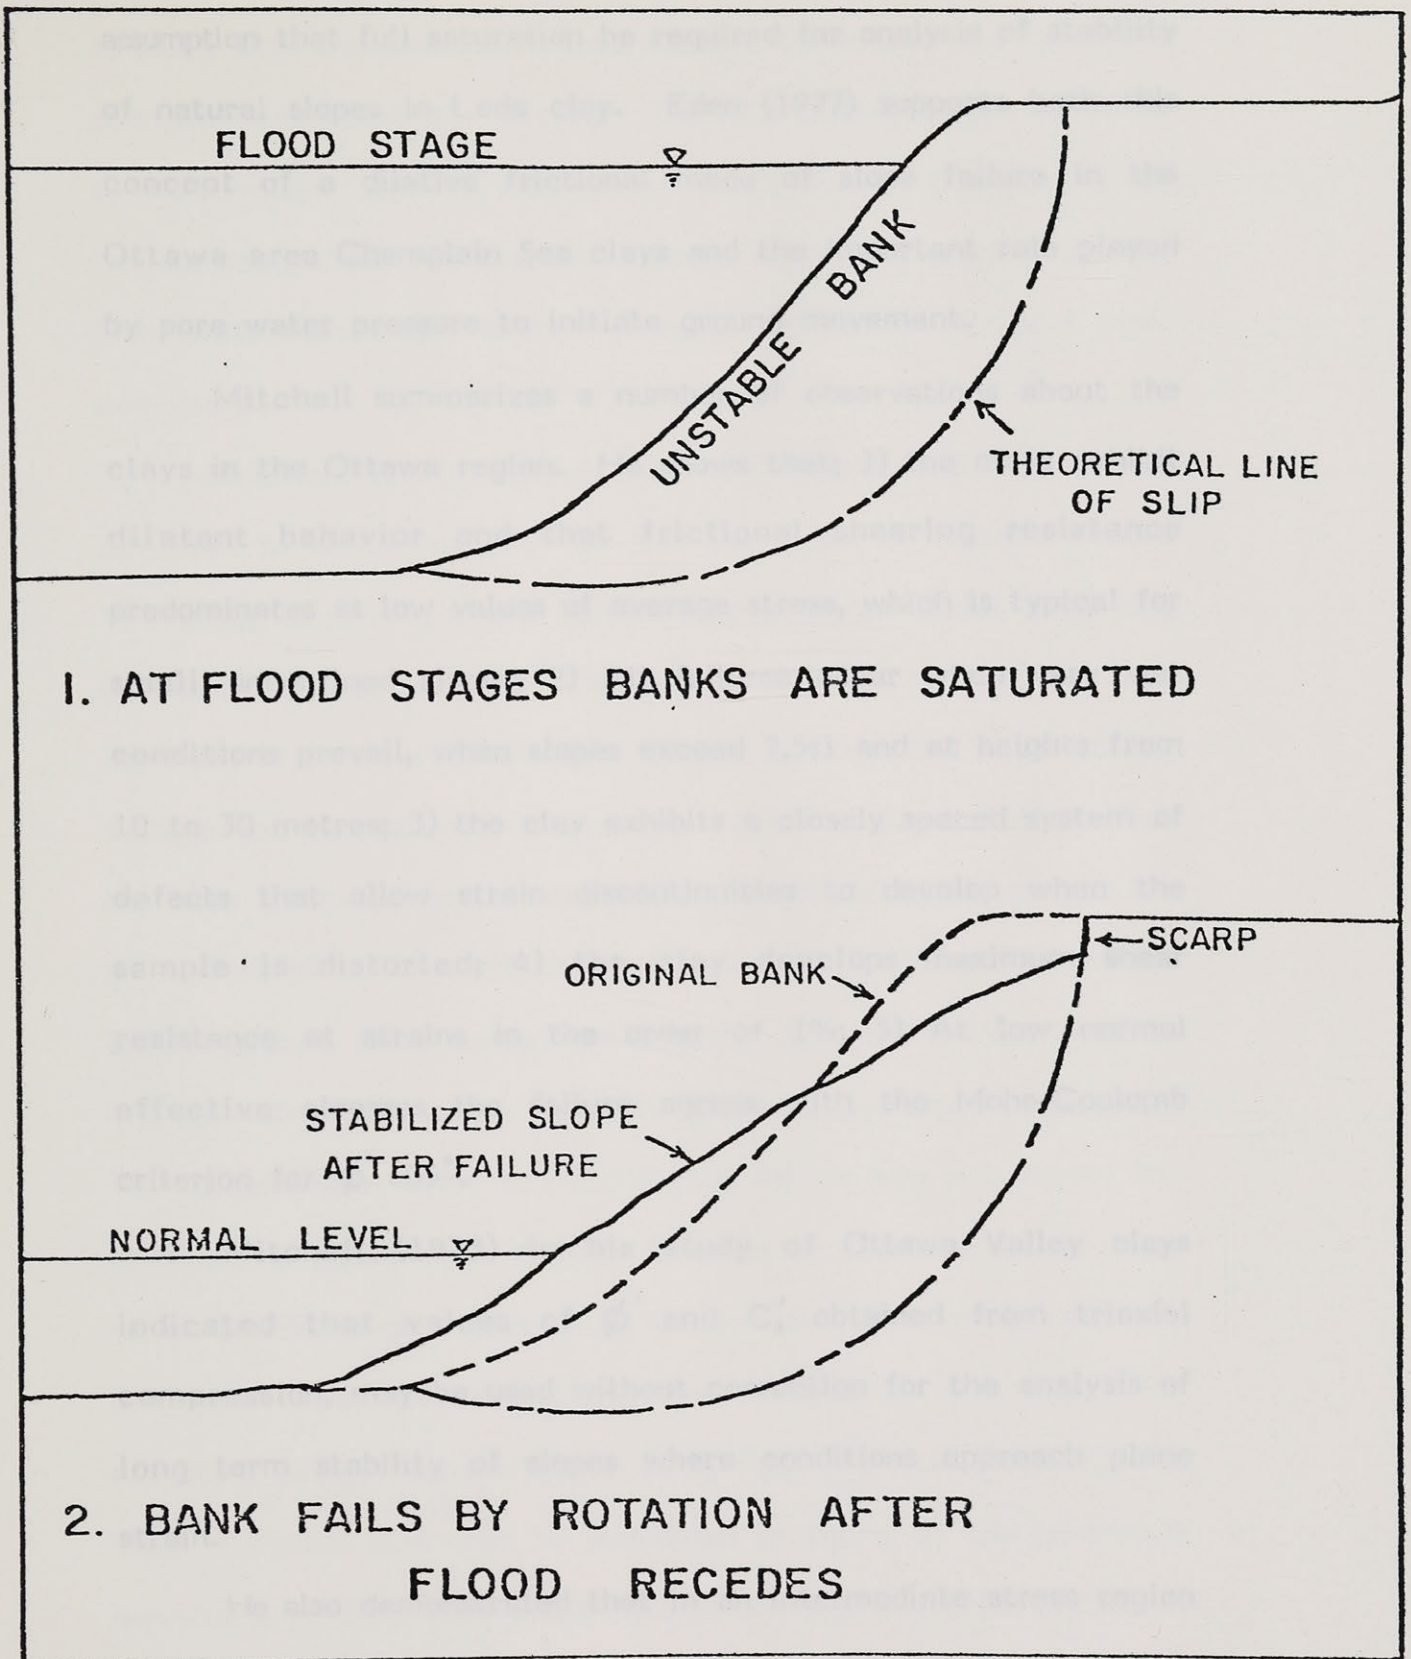
**FIG 2. DEEP SEATED ROTATIONAL
BANK FAILURE**

Most slope failures in this area occurred at wet times. It has been observed that high ground water pressures and subsequent deep-seated creep movements create tension cracks near the top of the slope. These cracks allow surface water to infiltrate directly into the critical zones thereby promoting failure (Eden and Mitchell 1973). Figure two illustrates how deep seated rotational bank failure can occur.

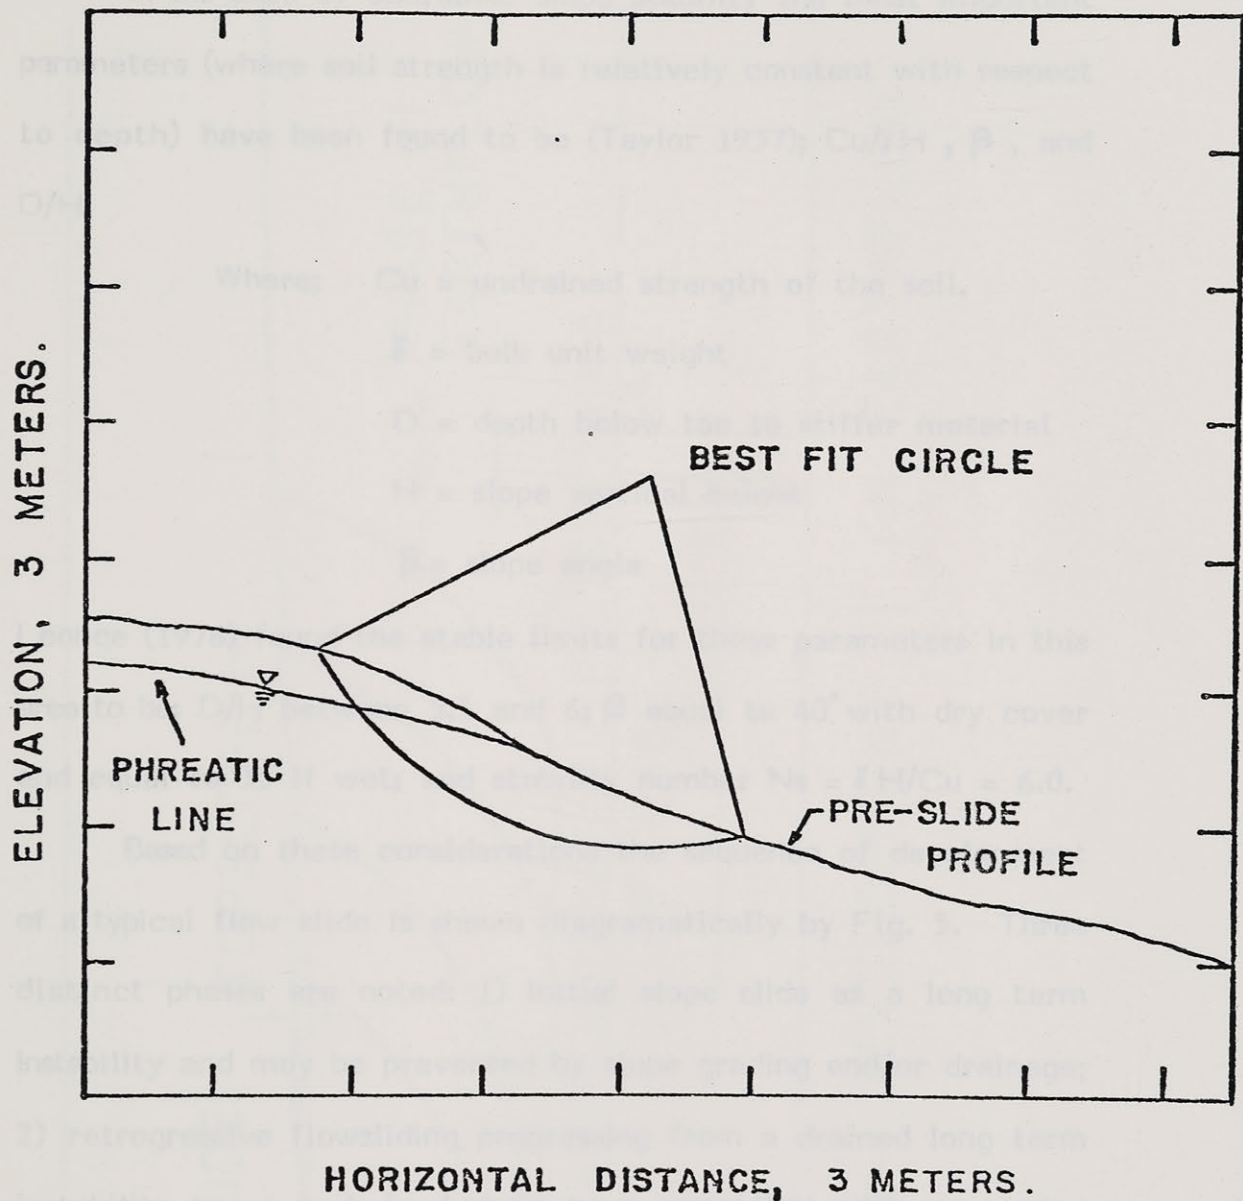
FIG. 4. GREEN'S CREEK SLIDE OF 1967.
(MITCHEL, 1970.)

Mitchell (1970) studied a small slide (1560 M^3) which occurred in November 1967 on the west bank of Green's Creek. The slide, occurring in the shallow crater of an earlier slip, was studied using tube samples. The slope was about nine metres high inclining at an average of 28° . Figure 4 shows the slope before failure and the best fit slip circle. Piezometers installed after the slide indicated an artesian effect of ground water at the toe of the slide. The phreatic level was found to be 2.4 metres below ground level during the summer subsequent to the slide. The R_u value (defined in appendix B) was determined to be 0.45. The groundwater level at the time of failure was not known but Mitchell suggests that surface freezing at the toe would have raised the inner pore-pressure. Analysis was then made with the post-peak envelope using R_u values of 0.4, 0.5 and 0.6. The resulting safety factors were 1.26, 0.95 and 0.81 respectively. Thus the slide may well be explained in terms of the post-peak envelope, yielding data pertaining to the average effective shear and normal stresses on the probable slip surface. The values for Green's Creek were found to be 12.4 kpa and 13.2 kpa respectively. It was also found that the post-peak envelope could be approximated by a straight line defined by $C'=0$ and $\phi'=43^\circ$. Hence as a first approximation to the long term strength

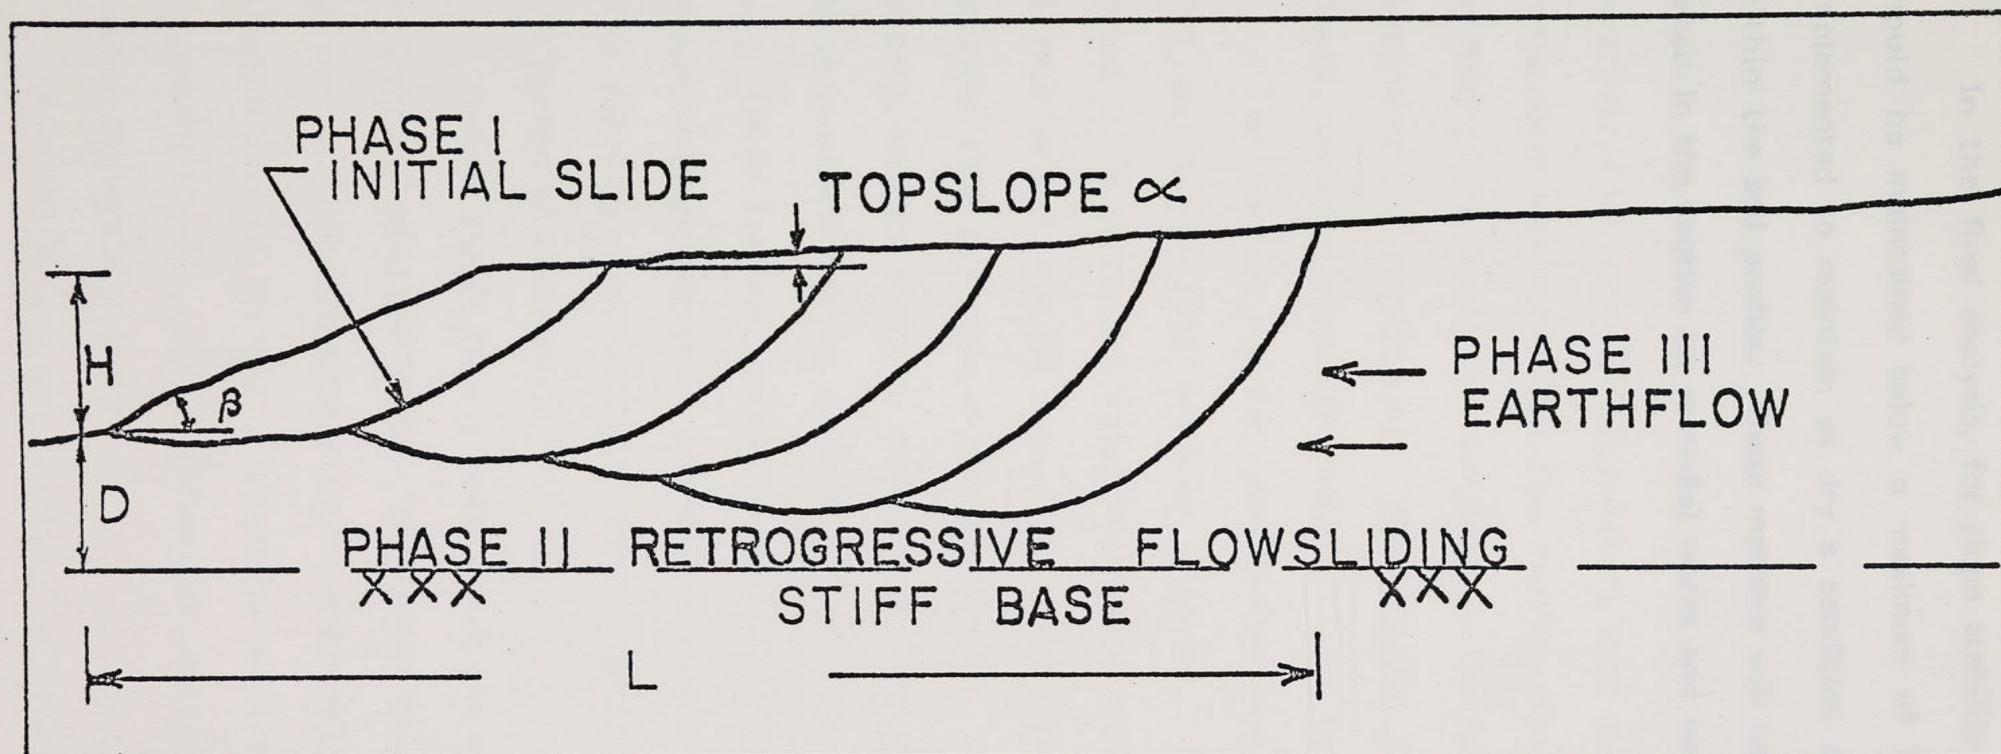
FIG. 5. DEVELOPMENT OF AN EARTHFLOW

Based on these considerations the sequence of development of a typical flow slide is shown diagrammatically by Fig. 5. Three distinct phases are noted: 1) initial slope slide as a long term instability and may be prevented by slope grading and/or drainage; 2) retrogressive flowsliding progressing from a drained long term instability to an undrained short term instability with successive slides involving deeper layers (when possible) and producing steeper back slopes; 3) earthflows involving extrusion and flow of soft underlying materials thus transporting the overlaying materials along.

Observations of the Green's Creek study area establish it as an area mainly involving the first type followed by minor retrogression extending generally in the order of 60 metres and up to a maximum of 120 metres.

In the final analysis, for slope stability, the valley banks should be maintained below a maximum of 2.5:1 and methods implemented to maintain as dry a condition as possible on and within the soil profile. These methods will be discussed in more detail in the section on remedial works and recommendations.
