Experimental Validation of New Vacuum Bag Only Processing Techniques for Co-bonded Composite Repairs

Andrew MACLEAN
Department of Mechanical Engineering
MCGILL UNIVERSITY, MONTREAL
August 2017

*A thesis submitted to McGill University in partial fulfillment of the requirements
of the degree of Master of Engineering*

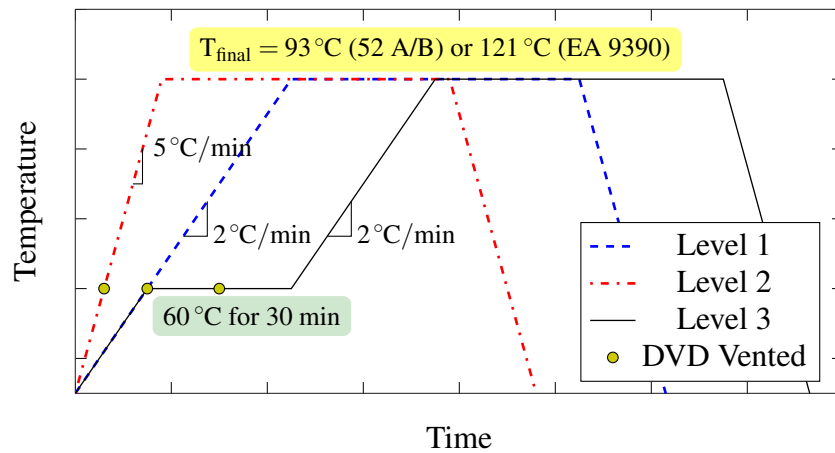
FIGURE 2.9: Cure cycle levels. If the DVD bagging arrangement was used, the point at which it was vented is indicated.

H. Cure Cycle The cure cycle influences several variables critical to patch quality, including the resin viscosity and volatile pressure. The three cure cycles considered are shown in Figure 2.9. The final hold temperature of all three cure cycles was set to 93 °C for the Epocast 52 A/B and 121 °C for the EA 9390. This was done because at these temperatures, the resin datasheets recommend similar hold times (2 hours and 2.5 hours respectively), as the Epocast 52 A/B is more reactive at lower temperatures [49], [50]. The single dwell level 1 and 2 cure cycles assess the difference between a 2 °C/min and faster 5 °C/min ramp rate. The level 3 cycle aims to increase the time for which both resins are near their minimum viscosity with an intermediate dwell at 60 °C, before ramping up to the final hold temperature of each resin.

All patches were cured according to the *two dwells* cure cycle of the DOE study (Figure 2.9), venting the DVD chamber at the same point (15 min into the 60°C dwell) and with a final hold temperature of 93°C . The resin impregnation technique, vacuum bagging arrangement and RT debulk time were varied according to Table 2.7 for each sample. The processing levels were chosen so as to include the optimal process (vacuum/DVD patch), a slightly less optimal random blob/DVD patch and a more standard wet layup process (manual impregnation patch).

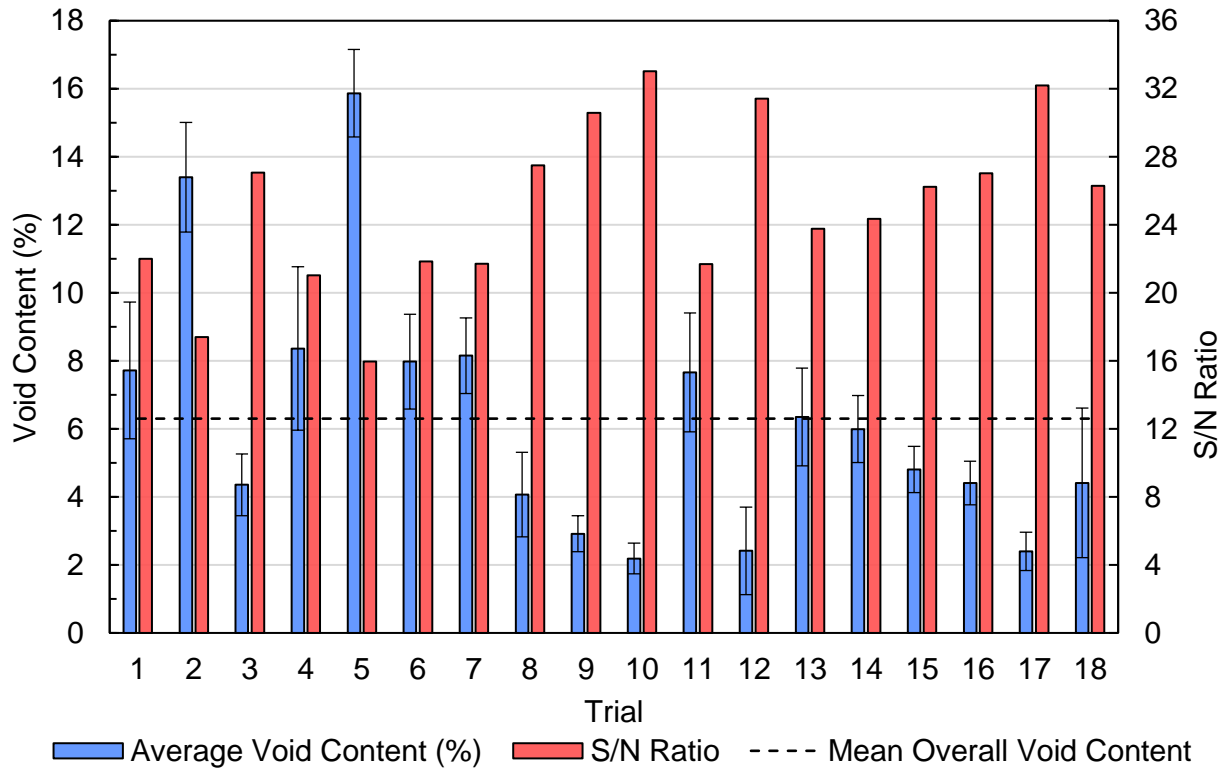
FIGURE 2.10: Void content.

The average void content for each trial was determined from 6 samples as described above and is presented in Figure 2.10, with error bars representing the (sample) standard deviation. There is a

very wide variation in quality: the average void content of each trial ranged from 2.2 % (Trial 10) to 15.9 % (Trial 8), with an overall average of 6.3 %. The standard deviation for each trial shows a similar scatter, ranging from 0.4 % (Trial 10) to 2.4 % (Trial 4).

The logarithmic transformation to an S/N ratio linearizes any non-linear behavior that is present. The S/N ratio for each trial is plotted in Figure 2.10, for comparison with the average void content. For each trial, a larger S/N ratio is desirable. For instance, Trial 10 had both the lowest average void content and standard deviation, as indicated by the error bars. Consequently, it had the highest S/N ratio of 33.04. Trial 12 and Trial 17 had the same average void content (2.4 %), however Trial 17 had a lower standard deviation (0.6 %) than Trial 12 (1.3 %). This explains why the S/N ratio of Trial 17 (32.20) is higher than that of Trial 12 (31.41). So clearly the S/N ratio allows quantifying which results are closest to the quality characteristic (smaller is better) and which have the least amount of variability.

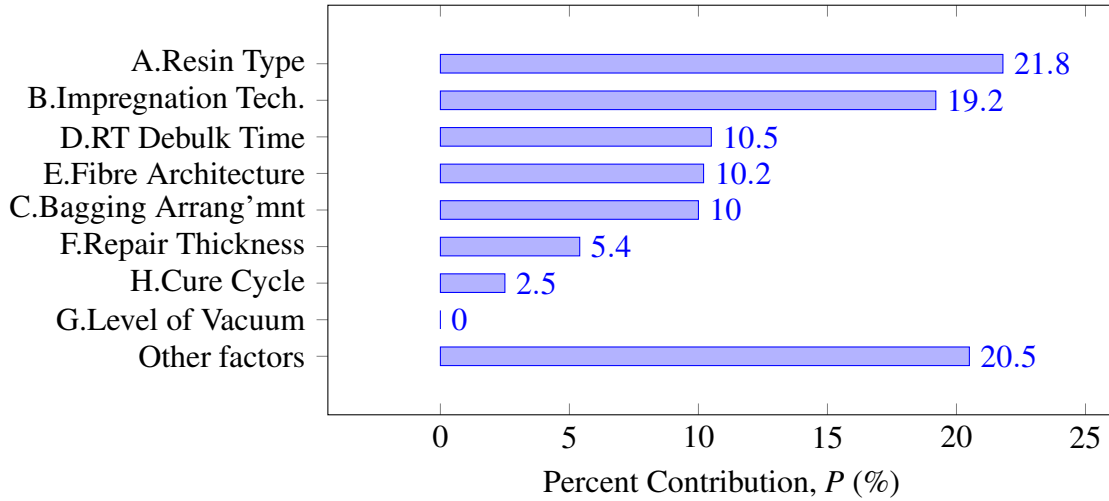
FIGURE 2.11: Percent contribution of each factor to void content.

The percent contribution of each factor is the ratio of pure sum of squares to the total sum of squares, Equation 2.15. This value quantifies how much each factor contributes to the average S/N ratio, and hence provides the percent contribution of each factor to void content and variability in void content. The percent contribution for each factor is plotted in Figure 2.11. Note that factors F

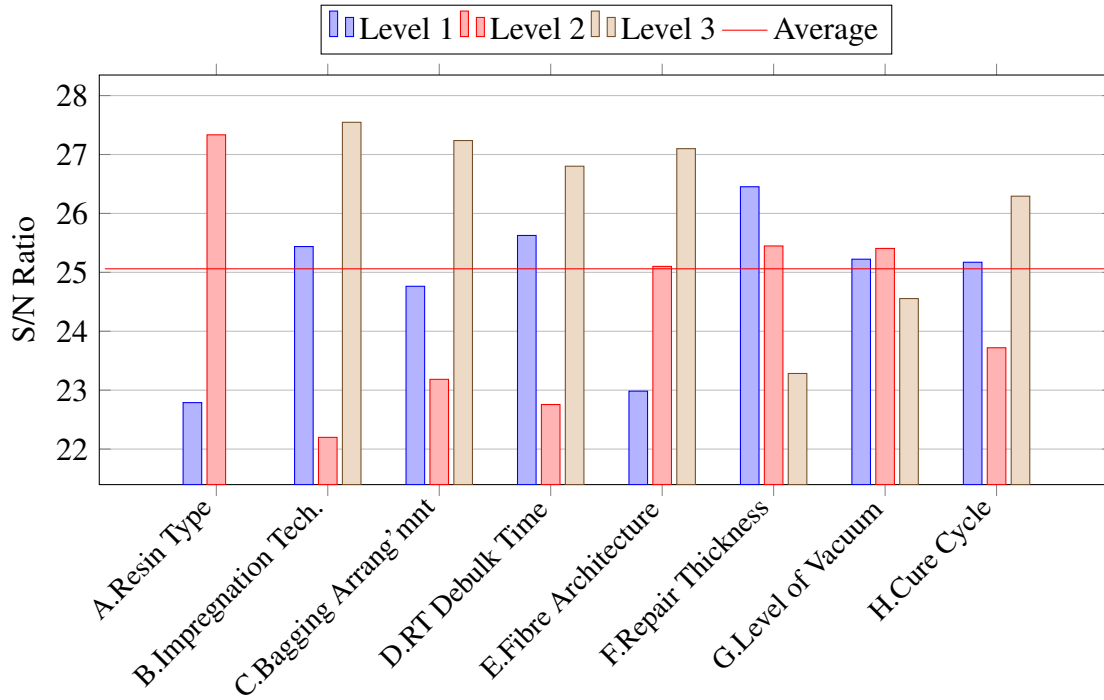
FIGURE 2.12: Main effects of each factor on the S/N ratio for void content.

Optimal Levels The main effect of each factor at a given level can be assessed by Equation 2.16, which computes the average S/N ratio for a factor (X) at a given level (k), $(\bar{S/N})_{Xk}$. These values are plotted in Figure 2.12. The most desirable level for a factor is the one that yields the highest average S/N ratio. For example, from the main effects plot (Figure 2.12), it is clear that level 2 is the most desirable level for factor A (Resin Type), as level 2 yields a much higher average S/N ratio of $(\bar{S/N})_{A2} = 27.3$ compared to $(\bar{S/N})_{A1} = 22.8$ for level 1. The optimal levels for each factor determined in this way are presented in Table 2.4.

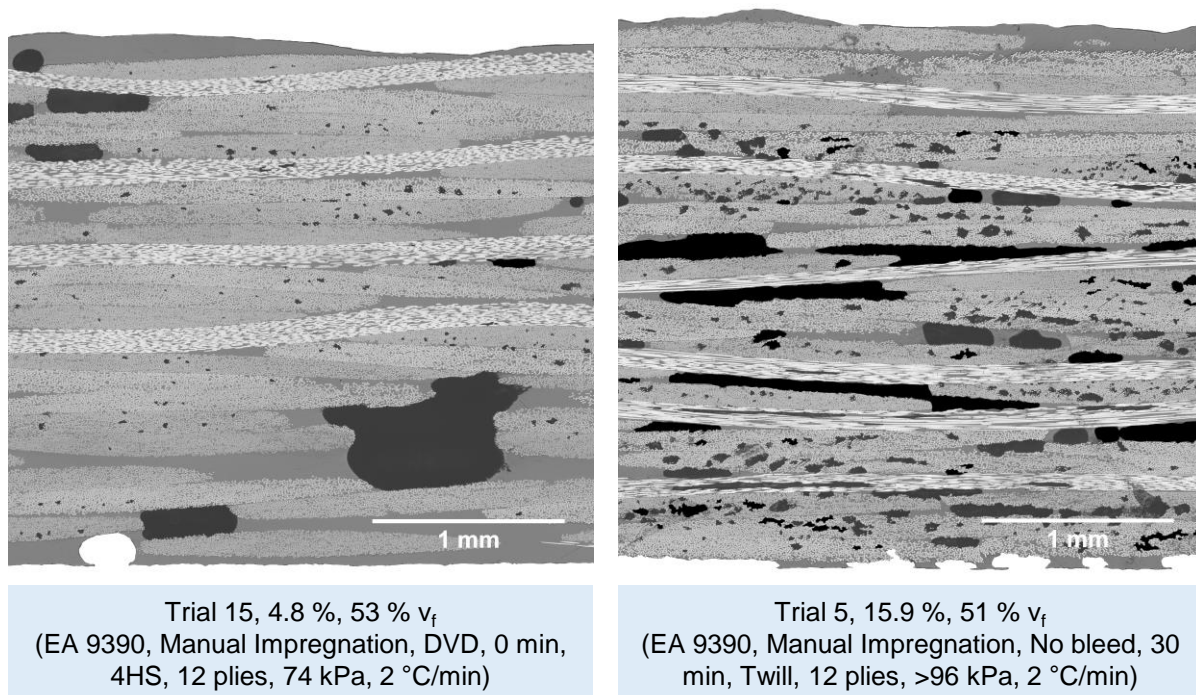
FIGURE 2.14: Micrographs of the lowest and highest void content manual impregnation patches.

Two examples of the manual impregnation method are in Figure 2.14, representative of the lowest and highest porosity patches produced by this technique. Trial 5 in Figure 2.14 also demonstrates the worst porosity observed of all trials, at 15.9 %. Significant intra-tow micro voids and inter-ply macro voids were present in all manual impregnation patches.

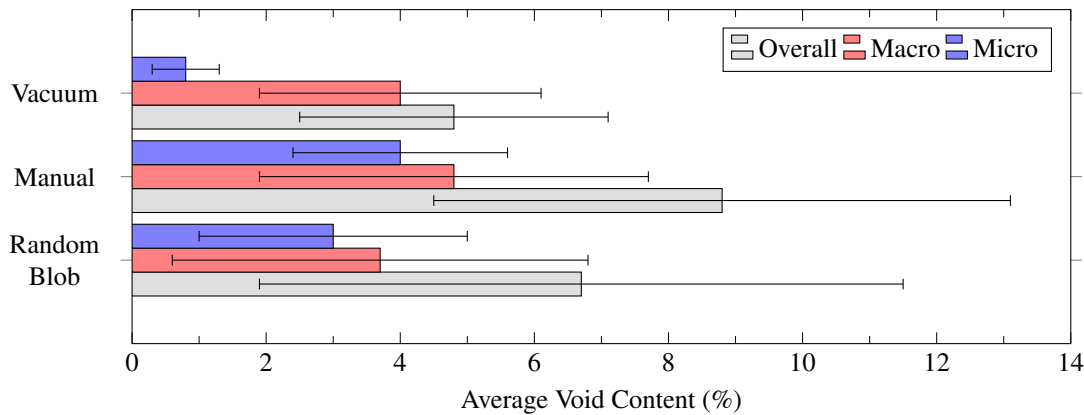
FIGURE 2.15: Average void size distribution by impregnation technique.

noted from observing the micrographs of Figure 2.13, the void morphology seems to be related to the resin impregnation technique. Using $10000\ \mu\text{m}^2$ as the cut-off between intra-tow micro and inter-ply macro voids, the average void content for each trial was split into micro and macro components. From these values, the average overall, micro and macro void contents were determined for each impregnation technique and are plotted in Figure 2.15. In agreement with the previous observation, the vacuum impregnation technique had the fewest micro voids, while the random blob impregnation technique had the fewest macro voids. The manual impregnation technique had both the most macro and micro voids. Finally, it is clear why the vacuum impregnation technique led to the optimal process, as it has the lowest average overall void content and standard deviation.

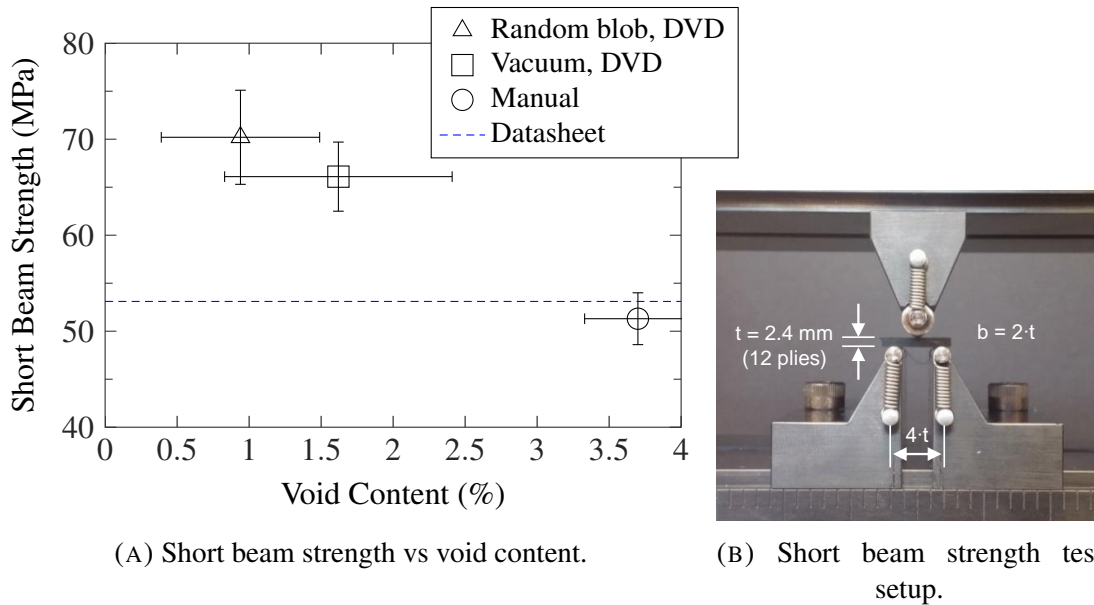
FIGURE 2.22: Short beam shear testing of Epocast 52 A/B repair patches with 3k carbon twill in a $[0_{12}]$ sequence.

Testing was performed at a rate of 1 mm min^{-1} and a span of $4.0t$ with a Wyoming Test Fixtures short beam shear fixture in an Insight 5 kN uniaxial electromechanical load frame (MTS Systems Corporation). In accordance with the standard, the fixture's supports and loading nose were 3.0 mm and 6.0 mm in diameter respectively. The test setup is shown in Figure 2.22b.

All short beam strength samples appeared to fail in flexural compression. F^{sbs} is plotted against the measured void content for all three patches in Figure 2.22a. While there are only three data points, there is a very strong linear correlation between F^{sbs} and void content for these samples, with a sample Pearson correlation coefficient $r = -0.91$. For each data point, the error bars represent the sample standard deviation.

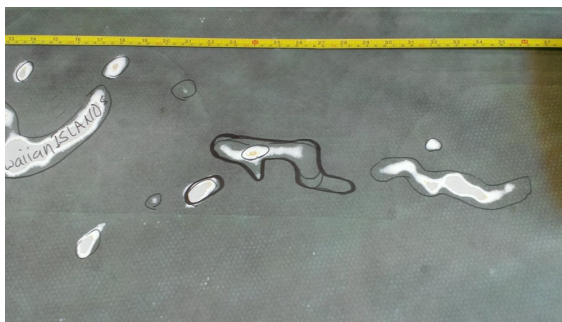
(A) Top view, damage is circled.

(B) Cross-section of damage.

FIGURE 3.3: Impact damage in the as-received lower skin plate.

The lower skin plate was chosen for all repairs performed later in this chapter since it was free of repairs, bonding straps and was mostly undamaged. The only damage found was likely due to impact and occurred over a rectangular area of 1.0 m by 0.3 m as shown in Figure 3.3a. All paint was removed from the external face of the lower skin plate prior to reception except on these damaged regions. When panels were later cut out of the elevator, cracks in the core parallel to the skins were found in these damaged areas as revealed in Figure 3.3b. This damage was probably not repairable because limits are set for repair size and damage spacing: for example these were 250 mm diameter and 150 mm edge to edge for a Boeing SRM section for a similar part [11].

due to hailstorm, runway debris or ground vehicles [87]. The existing damage found on this elevator, core fracture, Figure 3.3b, is an example. With much of the elevator's facesheets having only two plain weave plies for a total thickness of 0.4 mm, the core can easily be damaged.
