# **SEISMIC UPGRADING OF EXISTING STRUCTURES**

**ALAIN DANDURAND**

**Department of Civil Engineering and Applied Mechanics**

**A thesis submitted to the Faculty of Graduate Studies  
and Research in partial fulfillment of the requirements  
for the degree of Master in Civil Engineering**

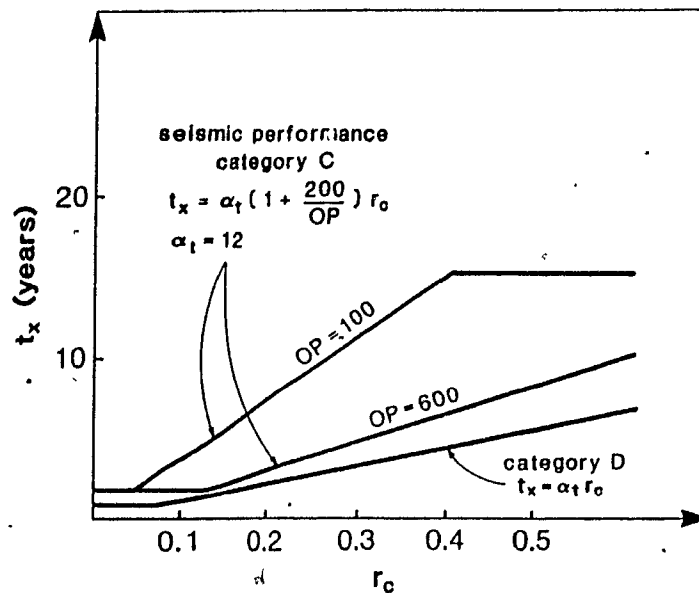
**Figure 1.2** Time Limit for the Upgrading of Existing Structures<sup>2</sup>.

The value of  $\alpha_t$  has not been defined and should be determined by the local regulatory jurisdiction. The ATC provisions give an example with  $\alpha_t$  equal to 12. Fig. 1.2 illustrates the factors influencing the time limit to either strengthen or demolish the building. As can be seen from Fig. 1.2, post-disaster buildings (category D) in high seismic zones would have the shortest time limit. In addition, this approach would satisfy the need to quickly upgrade the most hazardous structures (i.e., having low values of  $r_c$ ) while also recognizing the need for more rapid upgrading of structures having higher occupancy levels.

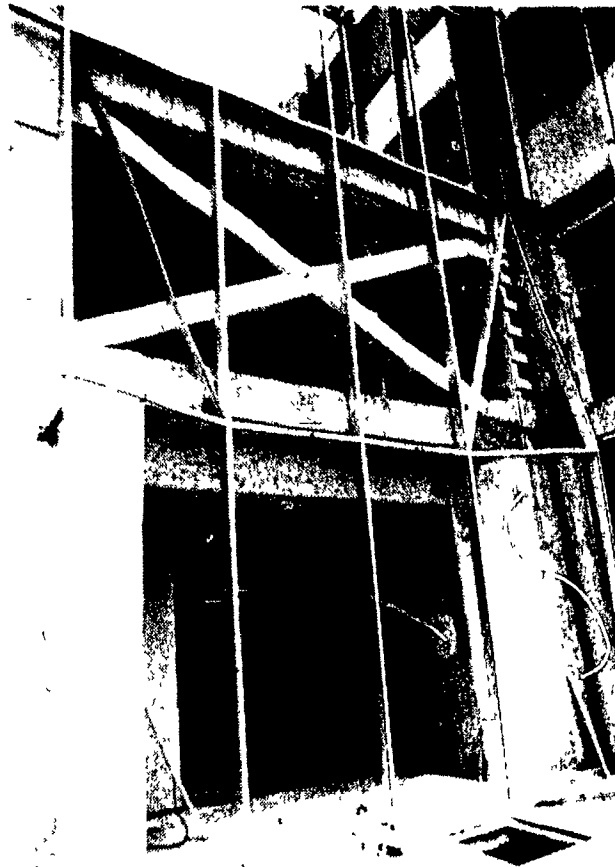
Figure 3.4 illustrates the method used to strengthen the ground floor columns in the end bay. The first step was to chip the column faces in order to expose the existing reinforcement and roughen the concrete surfaces. As can be seen, the column sizes have been significantly increased and large amounts of steel reinforcement have been added. A beam was added beneath the floor slab in order to connect the tops of the ground floor columns (see Fig. 3.4a). The steel corner angles were extended from the second floor columns some distance into the ground floor columns in order to ensure continuity of the vertical reinforcement.

a) Overall view

b) Cross-section of ground floor columns

**Figure 3.4** Transition from Steel Cross-Bracing to Enlarged Columns at Ground Floor Level.

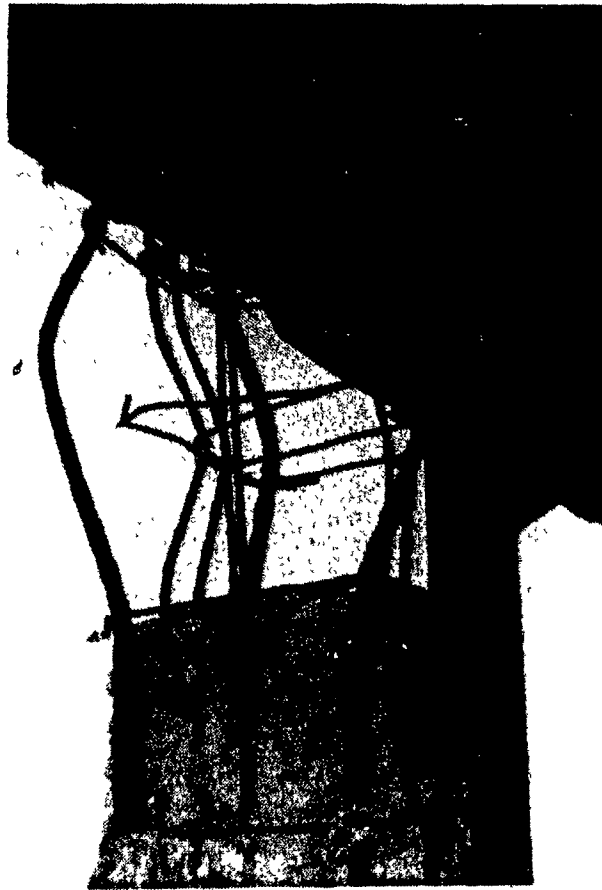
**Figure 3.10** Shear Failure of a Fourth Floor Exterior Column<sup>26</sup>.

The nine-storey office building located at 88 Liverpool in Mexico City was constructed in 1971. It is located in subsoil zone III (see Fig. 3.1) and was severely damaged during the 1985 Mexican earthquake. The structure had a period of about 1.3 s, which was close to the 2 s period of the ground motion. This together with the large accelerations experienced during the earthquake resulted in severe damage. Figure 3.9 shows the structure in its damaged condition with temporary timber shoring while the building was being repaired. A number of columns failed in the structure. Figure 3.10 illustrates the shear failure of a fourth floor exterior column. The extremely large tie spacing, which was inadequate to provide confinement of the concrete core, together with the poor anchorage details of the ties (i.e., only 90 degree bend anchorages at the ends of the ties) were the primary causes of the shear failure. As can be seen, after spalling of the concrete cover, the column ties lost their anchorage and the longitudinal bars buckled.

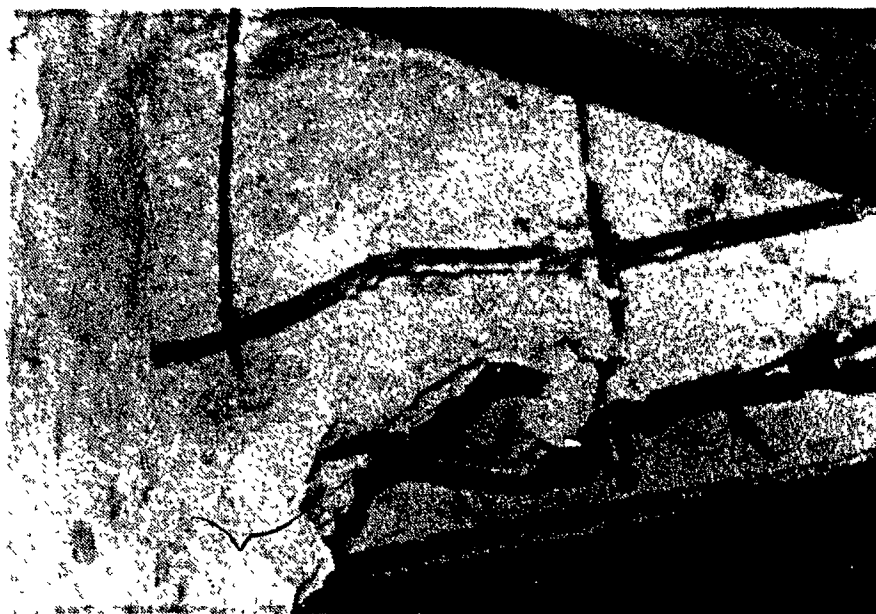
**Figure 3.12** Buckling of Bottom Longitudinal Beam Bars<sup>26</sup>.

dition to the damage to the columns, some beams displayed buckling of the bottom longitudinal bars due to excessive stirrup spacing (see Fig. 3.12).

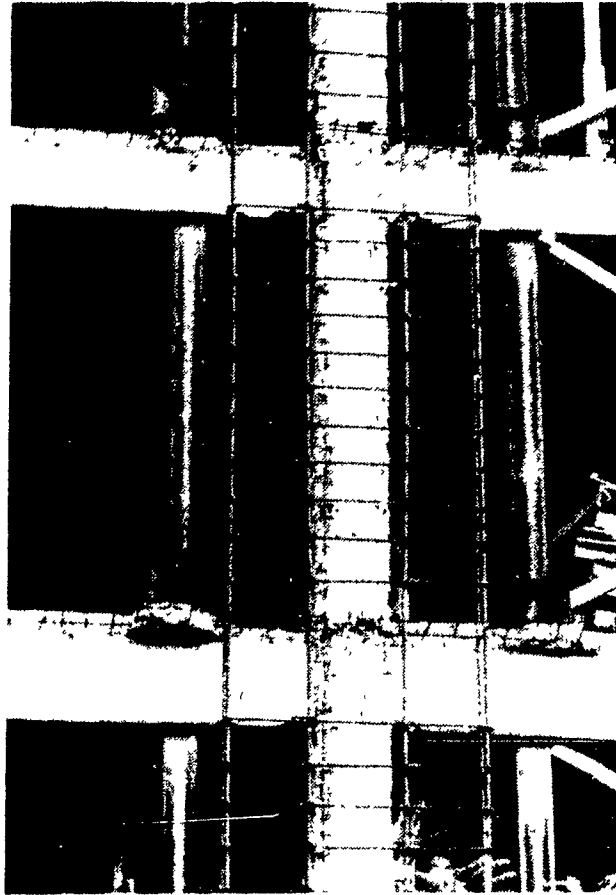
**Figure 3.18** Typical Enlarged Edge Column.

(d) The exterior columns and spandrel beams along column lines A and 1 were significantly increased in size and additional reinforcement was added. The reinforcement details for typical enlarged column at the ground level can be seen in Figs. 3.17 and 3.18. Note that the longitudinal reinforcement in the columns passes through the floor slabs. Figure 3.19 shows the reinforcement and formwork for the exterior columns and spandrel beams.

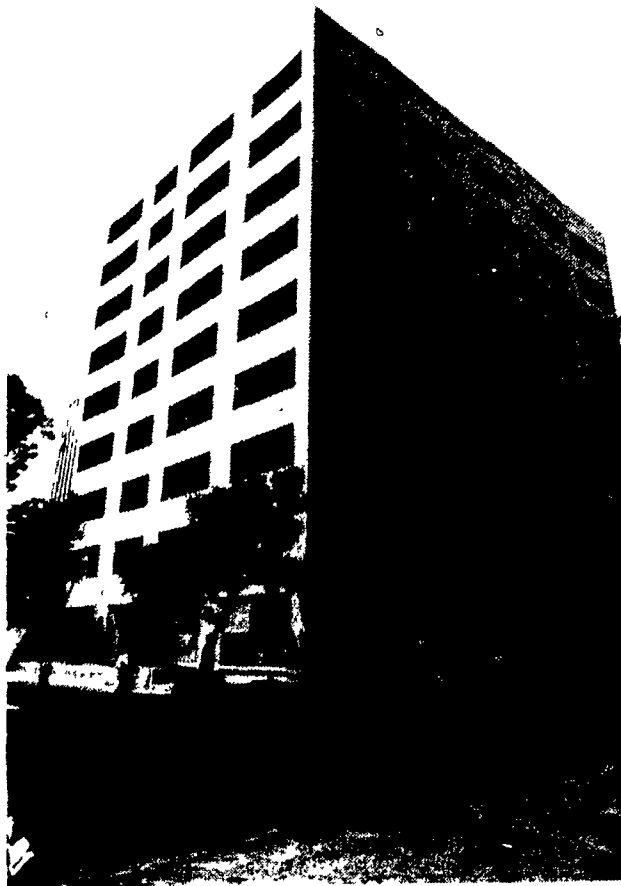
**Figure 3.21** View of Nearly Completed Office Building at 88 Liverpool.

The combined effects of joining together the two parts of the structure, the enlargement of the columns together with the addition of reinforced concrete shear walls and braces resulted in a significant stiffening of the structure. This stiffening lowered the first period from about 1.3 s to about 0.7 s. This shift in the period of the structure away from the dominant 2.0 s natural period of the ground motion would lead to significant improvement in the response of the building. In the design of the strengthening a ductility factor,  $Q$ , of 2.0 was used. Figure 21 shows the structure near completion.

The nine-storey office building situated at 80 Liverpool in Mexico City was originally constructed in 1971. This structure is located directly across the street from the structure described in Case Study 2 (see Fig. 3.21).

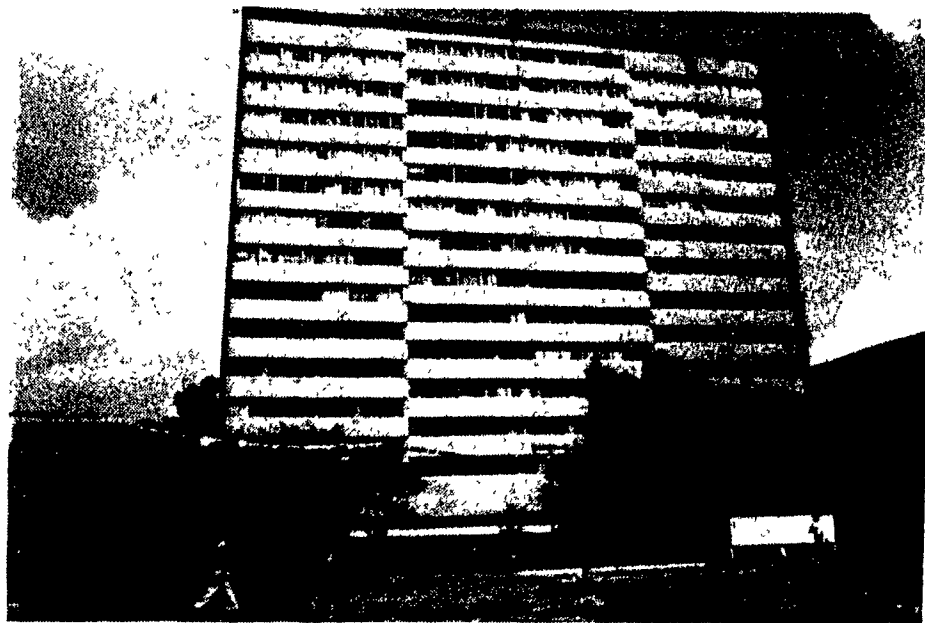
**Figure 3.28** Fourteen Storey Apartment Building with Offset Floors which was Damaged in the 1985 Earthquake (Mitchell et al 1986).

Figure 3.28 shows a 14 storey building with offset floors which, due to this poor lateral load resisting system, suffered severe damage along the line of interconnection of the offset floors. In the short direction, the lateral load resisting elements consisted of reinforced concrete shear walls for the bottom 5 storeys and reinforced concrete diagonal braces, with infilled masonry for the upper storeys. The measures taken to

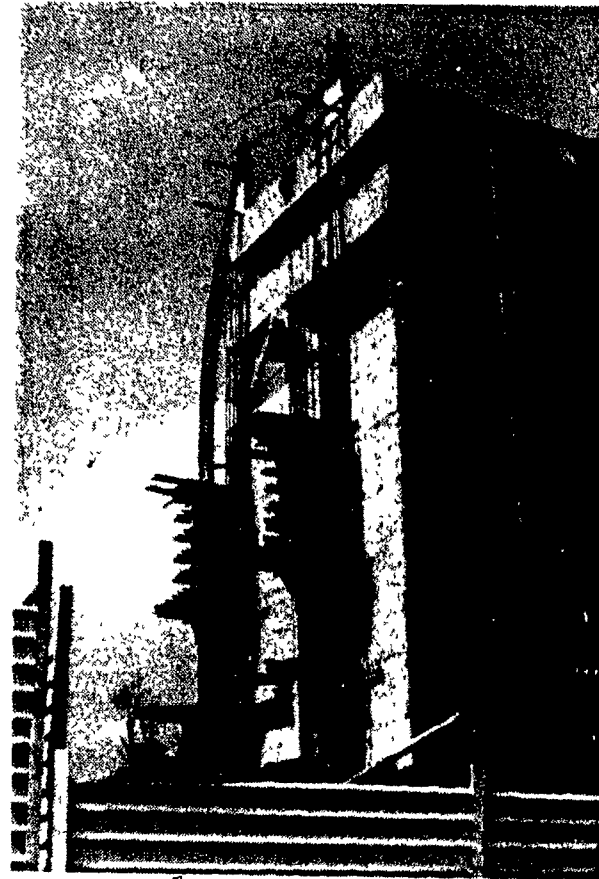
**Figure 3.30** Construction of End Shear Walls.

- (a) The structure was reduced to 7 storeys in height as shown in Fig. 3.29.
- (b) Enlarged exterior reinforced concrete columns were added along the lines of interconnection of the offset floors.
- (c) At the ends of the structure the diagonal braces were replaced by reinforced concrete shear walls. In addition, 2 wing walls, perpendicular to the shear walls, were also added at each end of the structure as shown in Fig. 3.30. These walls, which were channel-shaped in cross-section, were oriented such that the flanges of the channels pointed outwards, thus minimizing the obstruction of the interior space.
