Low Input Techniques for the Installation of Sewer Lines in Saturated Sandy Soil: A Case Study

This paper discusses the low input methods used in the construction of large diameter sewer lines in cohesionless soil near the Caspian Sea in Iran. Partially funded by the World Bank, the main features of the project include the installation of 77 km of 200 to 1200 mm diameter polyethylene and glass reinforced pipes as well as two conventional treatment plants covering 252,000 inhabitants in year 2029. Installation of the sewer along the Caspian Sea coast lines, characterized by the presence of saturated sandy soil and water flow, posed various challenges during the course of construction. Challenges include the risk of sudden collapse of excavated trenches, possibility of collapse of machineries, risk of street subsidence and the threat of damage to the neighboring properties. Given the required extended length of pipe lying and the high cost of utilizing high technique facilities, the use of low input simple techniques to stabilize the soil and proceed with the secure pipe installation was vital. This paper provides an overview of the challenges and the nature of the adopted low input

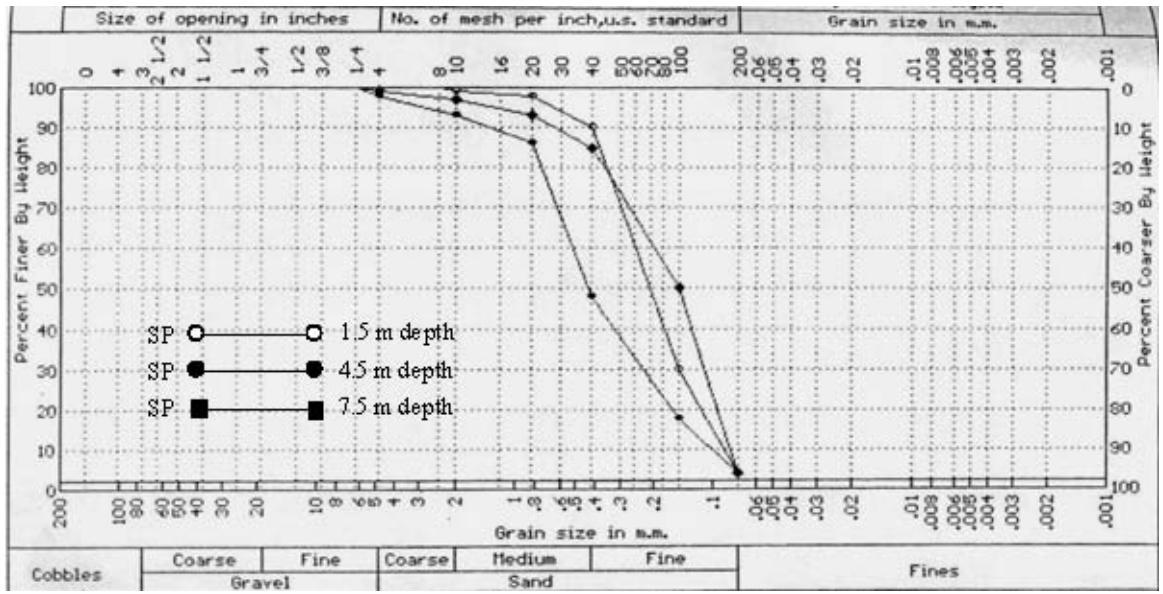
Figure 1: Grain size distribution

Initial site investigation classifies the soil as sand (SP) using the Unified Soil Classification System. Table 1 presents a typical soil profile from the ground surface up to a depth of 10 m. The soil consists of loose to very loose poorly graded sand with groundwater table located at a depth of approximately 1.5 m below ground surface. Fig. 1 shows the grain size distribution obtained for three soil samples located at 1.5, 4.5 and 7.5 m below surface. The direct shear tests conducted on the soil samples indicated an angle of friction of $\phi = 28^{\circ}$ and a cohesion of $c = 0.0 \text{ kN/m}^2$. The in-situ SPT test results showed an increasing N-value with depth ranging from 10 to 28 blows per 30 cm. The presence of cohesionless sand coupled with a relatively high water table indicates that the soil in the area is likely to be unstable during trench excavation.

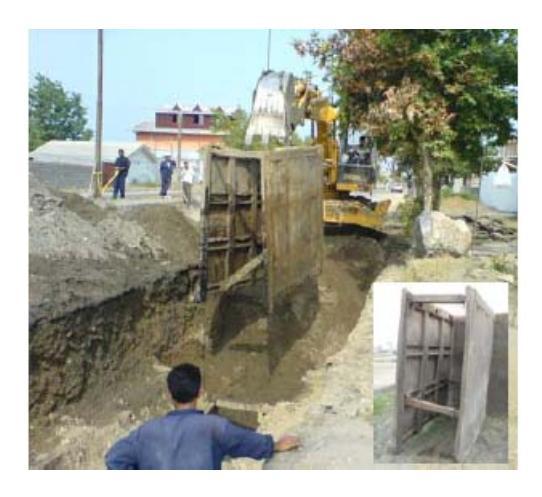
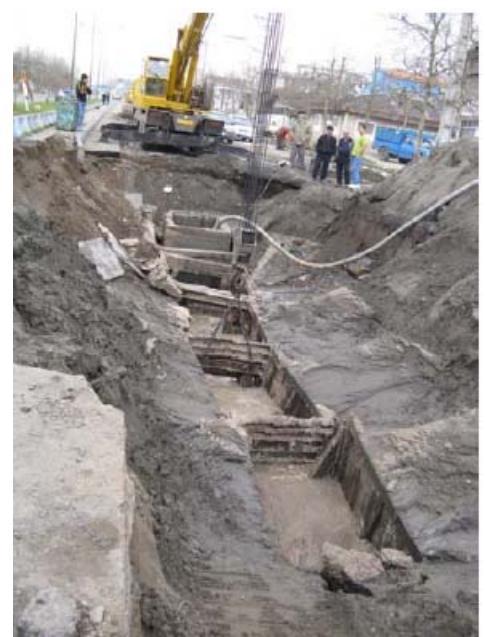
(*a*) Installation of the initial trench box (*b*) Installed trench boxes **Figure 3:** Installation of trench boxes showing the in-trench dewatering

For the loose sandy soil with zero cohesion existed at the site, the use of trench boxes within the excavated area deemed effective as they do not rely on the passive resistance of the soil. To comply with the minimum safety requirement and ease of working conditions, portable steel trench boxes were first used to support the sides of the excavated trenches. A series of trench boxes (also called a trench shield) were progressively placed in the excavated strips to prevent wall movement from disrupting the excavation process and injuring workers. As illustrated in Fig. 3a, the trench box consisted mainly of two large steel plates parallel to the walls of the trench, and horizontal cross-members holding the two plates apart. The lower edge of the box rests on the bottom of the trench, and the top edge extends above the ground surface. The workers stayed between the plates of the trench box, so that if the excavation wall collapses, the soil would be stopped by the presence of the box. As work progresses, the trench boxes are removed and prepared for reuse in the next sections.

Although the initial excavation size was slightly larger than the width of the box, as the excavation progresses, the loose sand that had no stand-up time moved rapidly filling up the gap behind the walls and the supported soil leading to the development of active and passive pressures. The active lateral pressure was assumed to develop on the sides of the box as the soil mass is allowed to stretch sufficiently to mobilize its shear strength. However, the initial trench boxes failed to cope with the soil movement causing damage to the boxes and interrupting the installation process as illustrated in Fig. 3b.

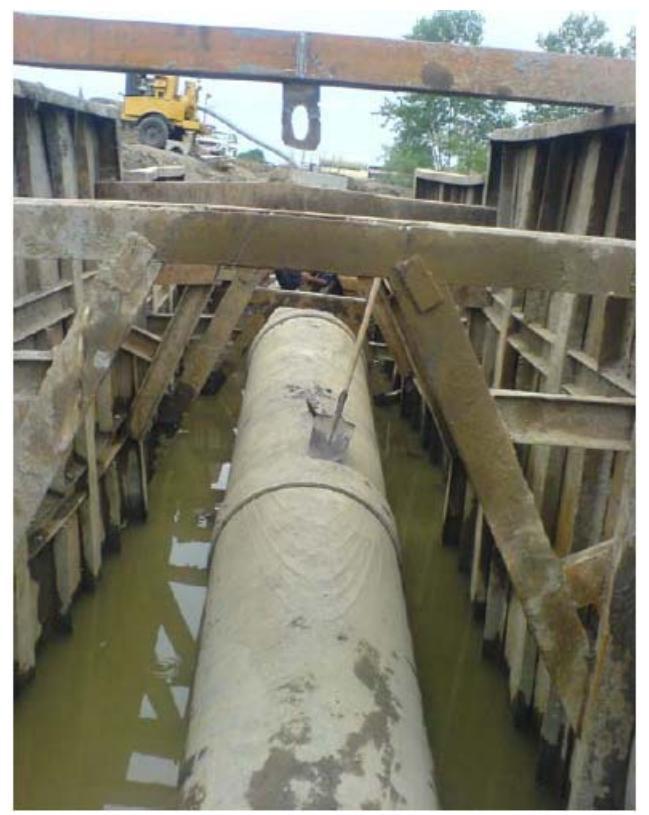
Figure 4: Improved trench boxes

The above conditions has lead to redesigning of the trench boxes to improve their performance, as illustrated in Fig. 4, by using additional hinges at the top and middle of the wall height.

The new design considered the pressure acting on the wall to be at-rest. This condition assumes zero wall rotation which corresponds to the condition of no lateral strain. The at-rest condition was chosen for the new box design to increase the safety factor and ensure that the boxes withstand the ultimate lateral pressure imposed by the supported soil (Weber, 2010).

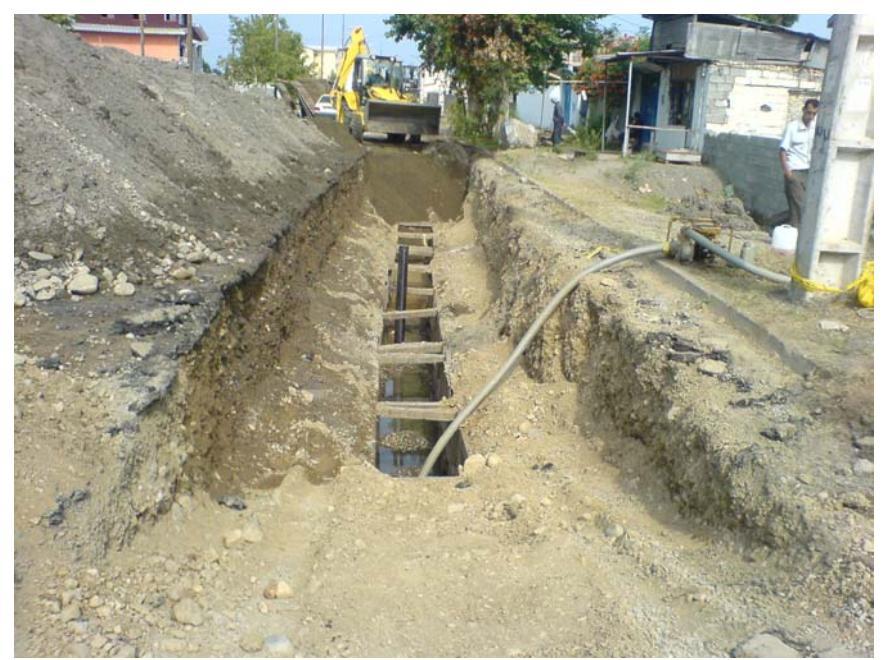
Figure 5: Two-stage excavation method

Another interesting approach that has been used in this project is the construction of two-stage deep cuts proved to be a very successful practice in places where contractors could afford to have a wider access to the exaction strips. In a first run a wider shallow trench would be excavated to be used as platform for the second box protected deep cut to the required grade as illustrated in Fig. 5. This simple approach was very welcomed by the contractor's since no extra equipment was involved. However, this technique highly relies on the skills of the well experienced machine operator. In fact, a continuous intrench dewatering along with two-stage deep cut proved as the most successful sewer installation approach in comparison to the other observed experiences in this sandy soil.

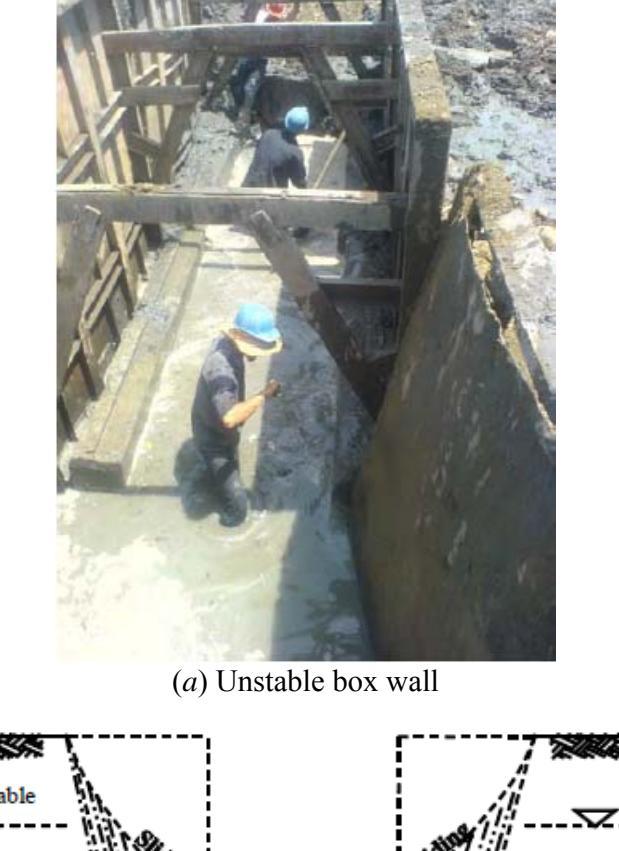
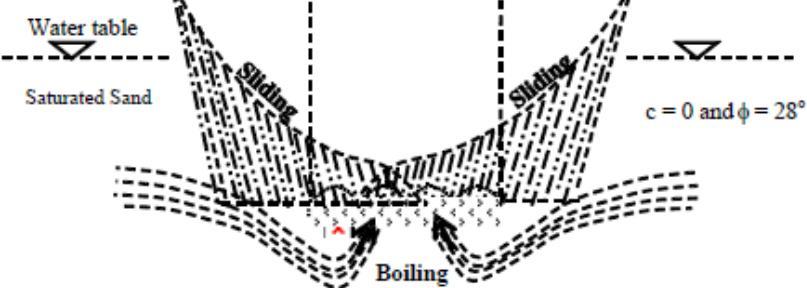
(*b*) Sand boiling at the base of excavation **Figure 6:** Simultaneous sliding and boiling in the excavated trenches

Upward water flow through the excavation base was observed at several locations along the pipe alignment during the excavation process. This was evidenced by the sand boiling at the excavation base as illustrated in Fig. 6a. Sand boiling was also associated with sliding of the excavation even when trench boxes were used (Fig. 6b).

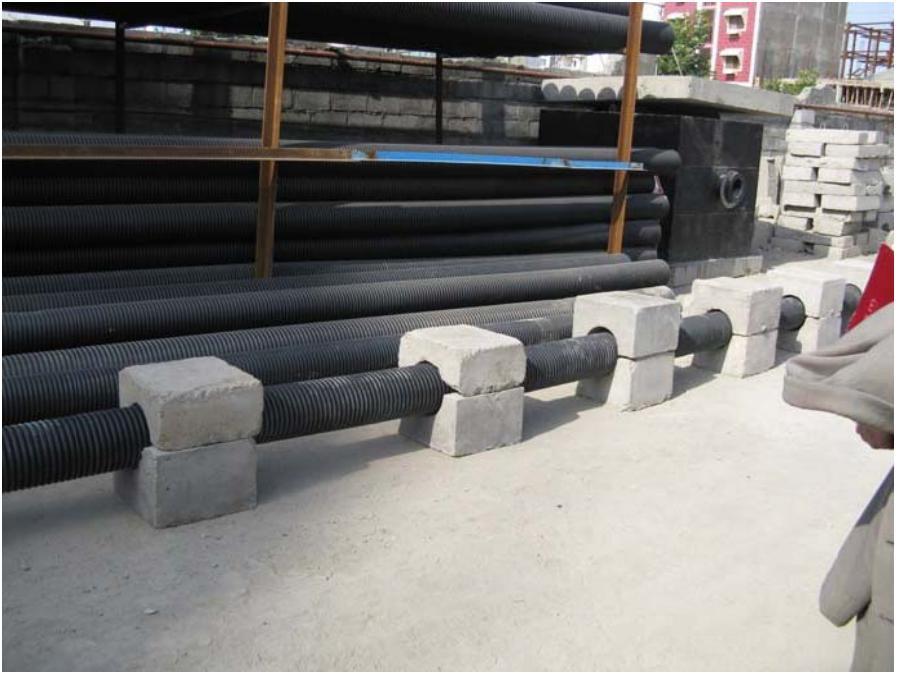
Figure 7: Concrete casings used to protect the pipes against uplift

Unstable condition caused by hydrostatic uplift developed during pipe installations since the unit weight of PE and GRP pipes could not balance off the uplift force. In order to avoid floating of pipes during installation, either water infiltrating into the excavation face must have be prevented by reducing the piezometric head (e.g., using prior dewatering techniques) or anchoring and supporting the pipe to the ground. In fact, both approaches were put in to practice at several locations. In this particular project, the intrench sump pump dewatering technique proved to be the applicable approach. However, in some occasions the high water head forced the contractor to adopt a concrete around the pipe. As Fig. 7 illustrates, concrete casing stend to surround the pipes during the installation preventing them from floating. Each concrete casing comes in two similar segments. The first half (the saddle) sits at the bottom of a gravel trench and the second half embraces the pipe. The spacing between concrete casing segments are two meters apart and the saddles are tailored to fit the diameter of the sewer pipes. Obviously, as the diameter of pipe grows so does the dimension of the casings as well as their weights which had a significant effect on uplift resistance (Choobbasti et al., 2009).

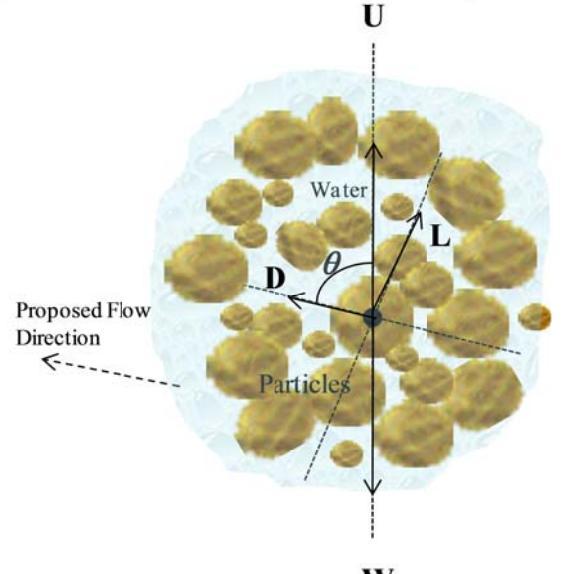
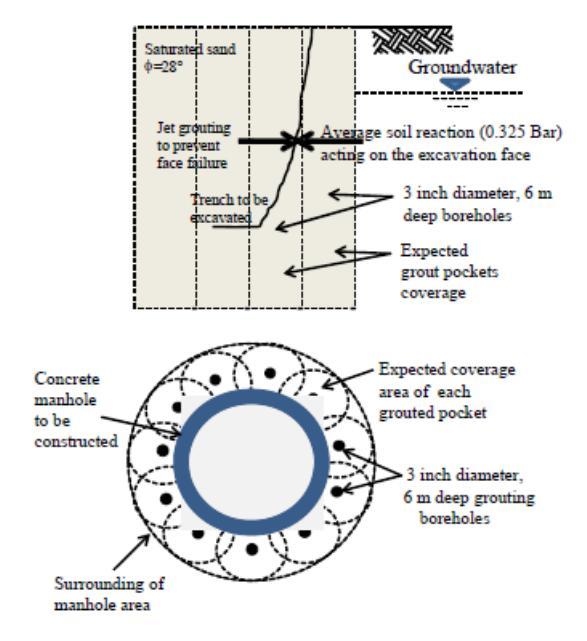
W Figure 8: Forces acting on the submerged sand particles

Primary assessment of soil data (low numbers of SPT blows and zero cohesion) showed that due to zero standup time the cement grouting of sub-soil around the manhole and deep cuts may provide solid pockets and stabilize the surrounding soil during the course of excavation. This was intended to stabilize the soil particles against the dragging force motivated by the hydraulic gradient during the excavation. The stabilized soil would then tend to prevent boiling of particles into the trench yielding in failing excavated face. Any soil particle in saturated circumstance at rest is subject to three forces. The first one is gravitational force *W*, which acts downwards to the centre of particle (Fig. 8).

For spherical sand particle with uniform density the gravitational force has the value:

The second force is the buoyant force B, which acts vertically upwards at the centre of the particle and for a spherical sand particle, is equal to:

The resultant of the gravitational force and the buoyant force balances the vertical upward hydrodynamic force, U (the third force, uplift) so that U = W - B, therefore,

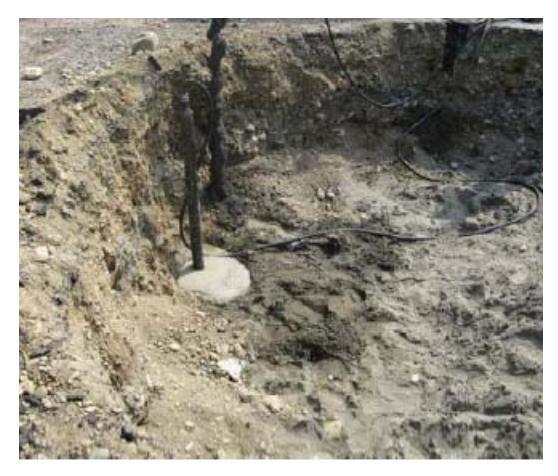
(*a*) Jet grouting boreholes

To investigate the efficiency of grouting, 50 psi cement grout was injected in a series of 3 inch diameter by 6 m deep boreholes around the selected manhole areas as shown in Figure 9. It was anticipated that, as it is illustrated in Fig 10a, each jet grouted borehole would create a pocket of solidified pillar overlapped with other adjacent pockets providing a stabilized ground for a secured excavation face.

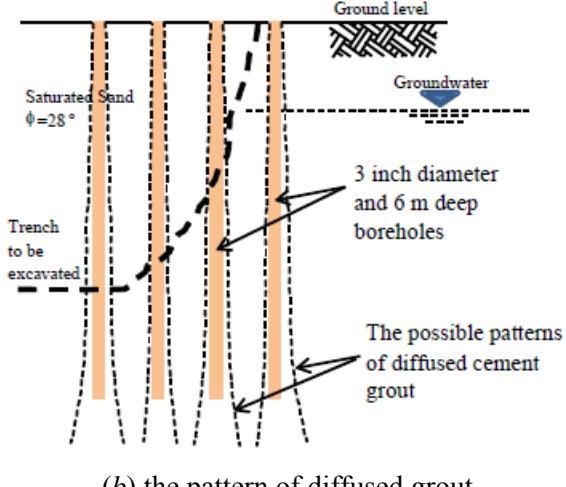
(b) the pattern of diffused grout

However, later observations in the grouted soil segments did not show enough strength and yet the walls were unstable. This was explained by the possible vertical and horizontal diffusion of cement mortar into the adjacent soil as illustrated in Fig. 10b. It was concluded that due to high soil permeability and no rigid vertical and horizontal boundaries, the grout palm diffused and diluted into the sandy soil.

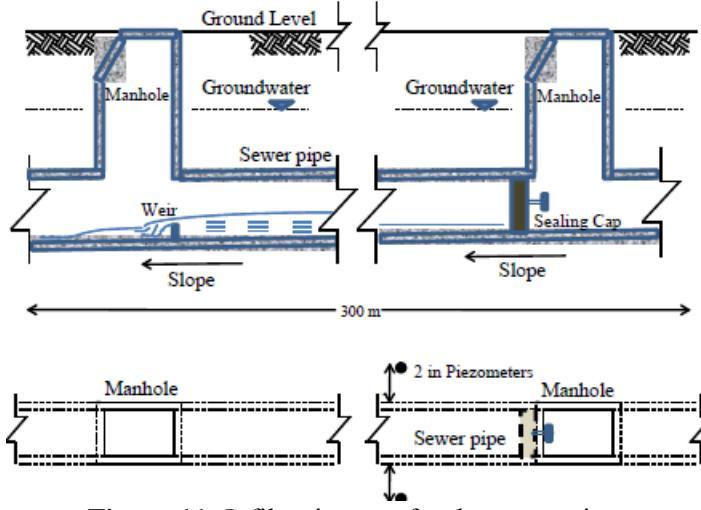
Figure 11: Infiltration test for the sewer pipes

The difficulty of supplying and disposing of huge amount of water for hydraulic test of large diameter sewer pipes stimulated the idea of utilization of infiltration test method vs. the conventional exfiltration approach (ASTM, 2009). The other fascinating advantage of infiltration was the enormous time saving since each run of infiltration test could cover several hundred meters of sewer lines vs. only 60 m length in conventional test. This approach was initially adapted for GRP sewer pipes where the groundwater level is predominantly above the sewer pipes. The adapted approach allowed replacing the conventional exfiltration method which tends to fill up the pipes with water and then to observe the loss of pressure in due time. The in-filtration approach requires at least 60 cm hydrostatic head above the top of sewer pipes. To ensure the presence of required hydrostatic head, a 2 inch diameter piezometer (perforated PE pipe) is installed one meter from the side of the sewer line 24 h before the test begins. As it is shown in Fig. 11, any possible infiltration of ground water into sewer pipes is measured with a free weir installed at the end each selected reach.

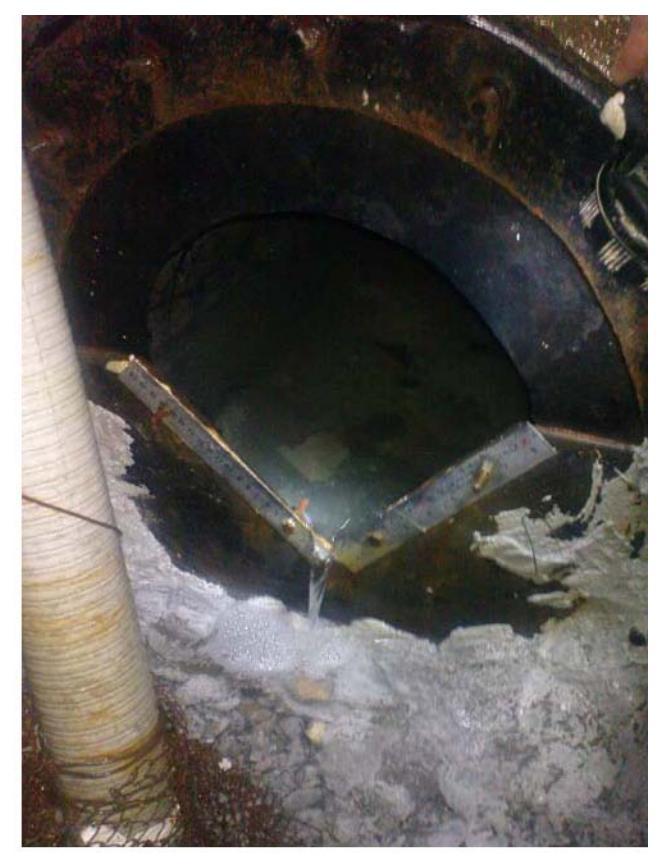
Figure 12: Free weir flow used to measure water leakage

The infiltration method was successfully put into practice for 600 mm pipe every 300 m reach (Fig. 12). The leaked water was measured using free weir flow. The expected discharge was estimated using the following equation (Brater et al., 1996):
